HIGGINS CANYON ROAD BRIDGE AT MILLS CREEK EMBANKMENT AND WINGWALL REPAIRS PROJECT

ADDENDUM NO. 1

HIGGINS CANYON ROAD LANDSLIDE REPAIR PROJECT

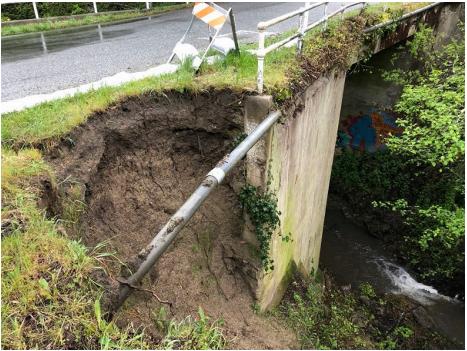
View of the landslide looking down from the south roadway shoulder. Note the exposed communication conduit.

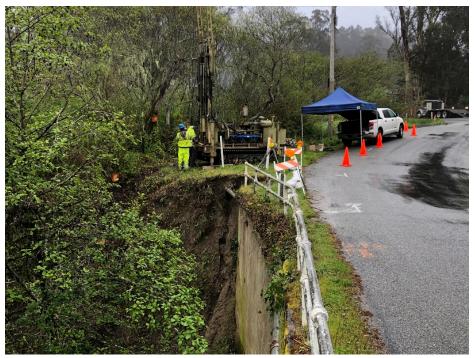
View of the landslide looking south along the roadway.

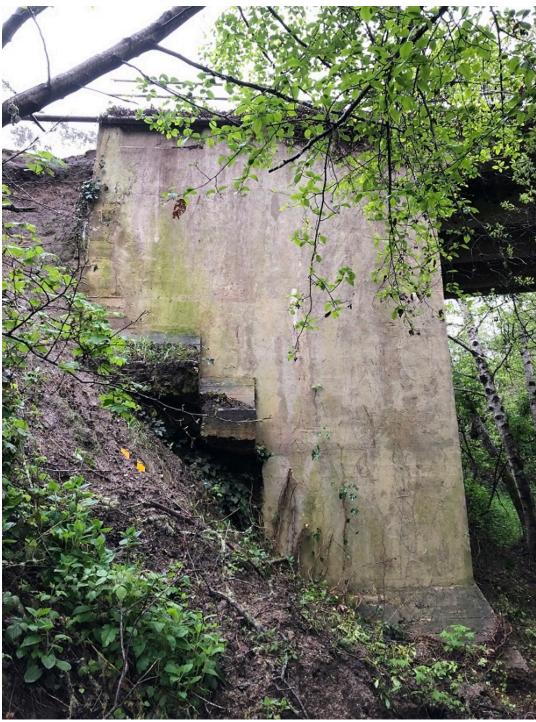
View of the southeast wingwall looking west.

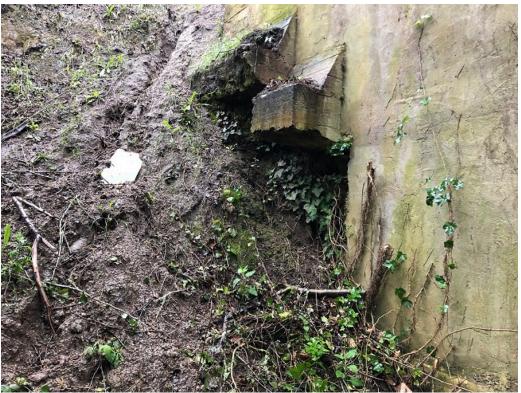
View of the undermined portion of the southeast wingwall.

Bedrock was exposed in the north side of creek, but not found in the south side of creek, which is the area beneath landslide. Due to the landslide and erosion, the conduit going through the bridge was exposed and the foundation of the wing wall was undermined. A temporary swale has been dug out approximately 8 feet south from the top of landslide to prevent potential sheet-flow from draining over the scarp. The landslide is approximately 20 feet in width and 26 feet high. While much of the landslide mass has been eroded and carried downstream during heavy creek flows, we estimate the form of the landslide was that of a slump-earth flow. There was no evidence observed that would suggest deep-seated landsliding.

Considering the observation that the foundation of the wing wall was undermined, and the conduit was exposed, a much higher water level within the creek channel was present around the time of the landslide. The erosion of foundation soils are possibly attributed to both surface and subsurface water movement and fluctuation.

To restore foundation support for the exposed wingwall, an underpinning system is recommended. Underpinning is to consist of drilled piers designed to transfer the load from the wingwall to the bedrock below. A grade beam may be needed to facilitate a structural connection between the grade beam and the piers.

- Minimum pier diameter of 18 inches.
- Allowable skin friction of 500 psf in competent soil below a depth of 3 feet below the finished grade.
- Minimum pile spacing of three diameters on center.
- Minimum pier depths of 12 feet.
- We recommend as a minimum, that the piers be at least 18 inches in diameter and be reinforced with at least four #5 vertical bars with horizontal stirrup's extending

- the entire depth of the pier. The project structural engineer should make the final determination of the pier dimensions and reinforcement.
- Underpinning piers should be drilled near vertically and structurally connected to the existing wingwall foundation (or to a new perimeter grade beam where necessary) so that all foundation loads are transferred to the piers.
