GEOTECHNICAL DESIGN REPORT

2023 SLIP-OUT REPAIR NEAR 2180 HIGGINS CANYON ROAD

CE&G DOCUMENT: 0207686.001

APRIL 17, 2023

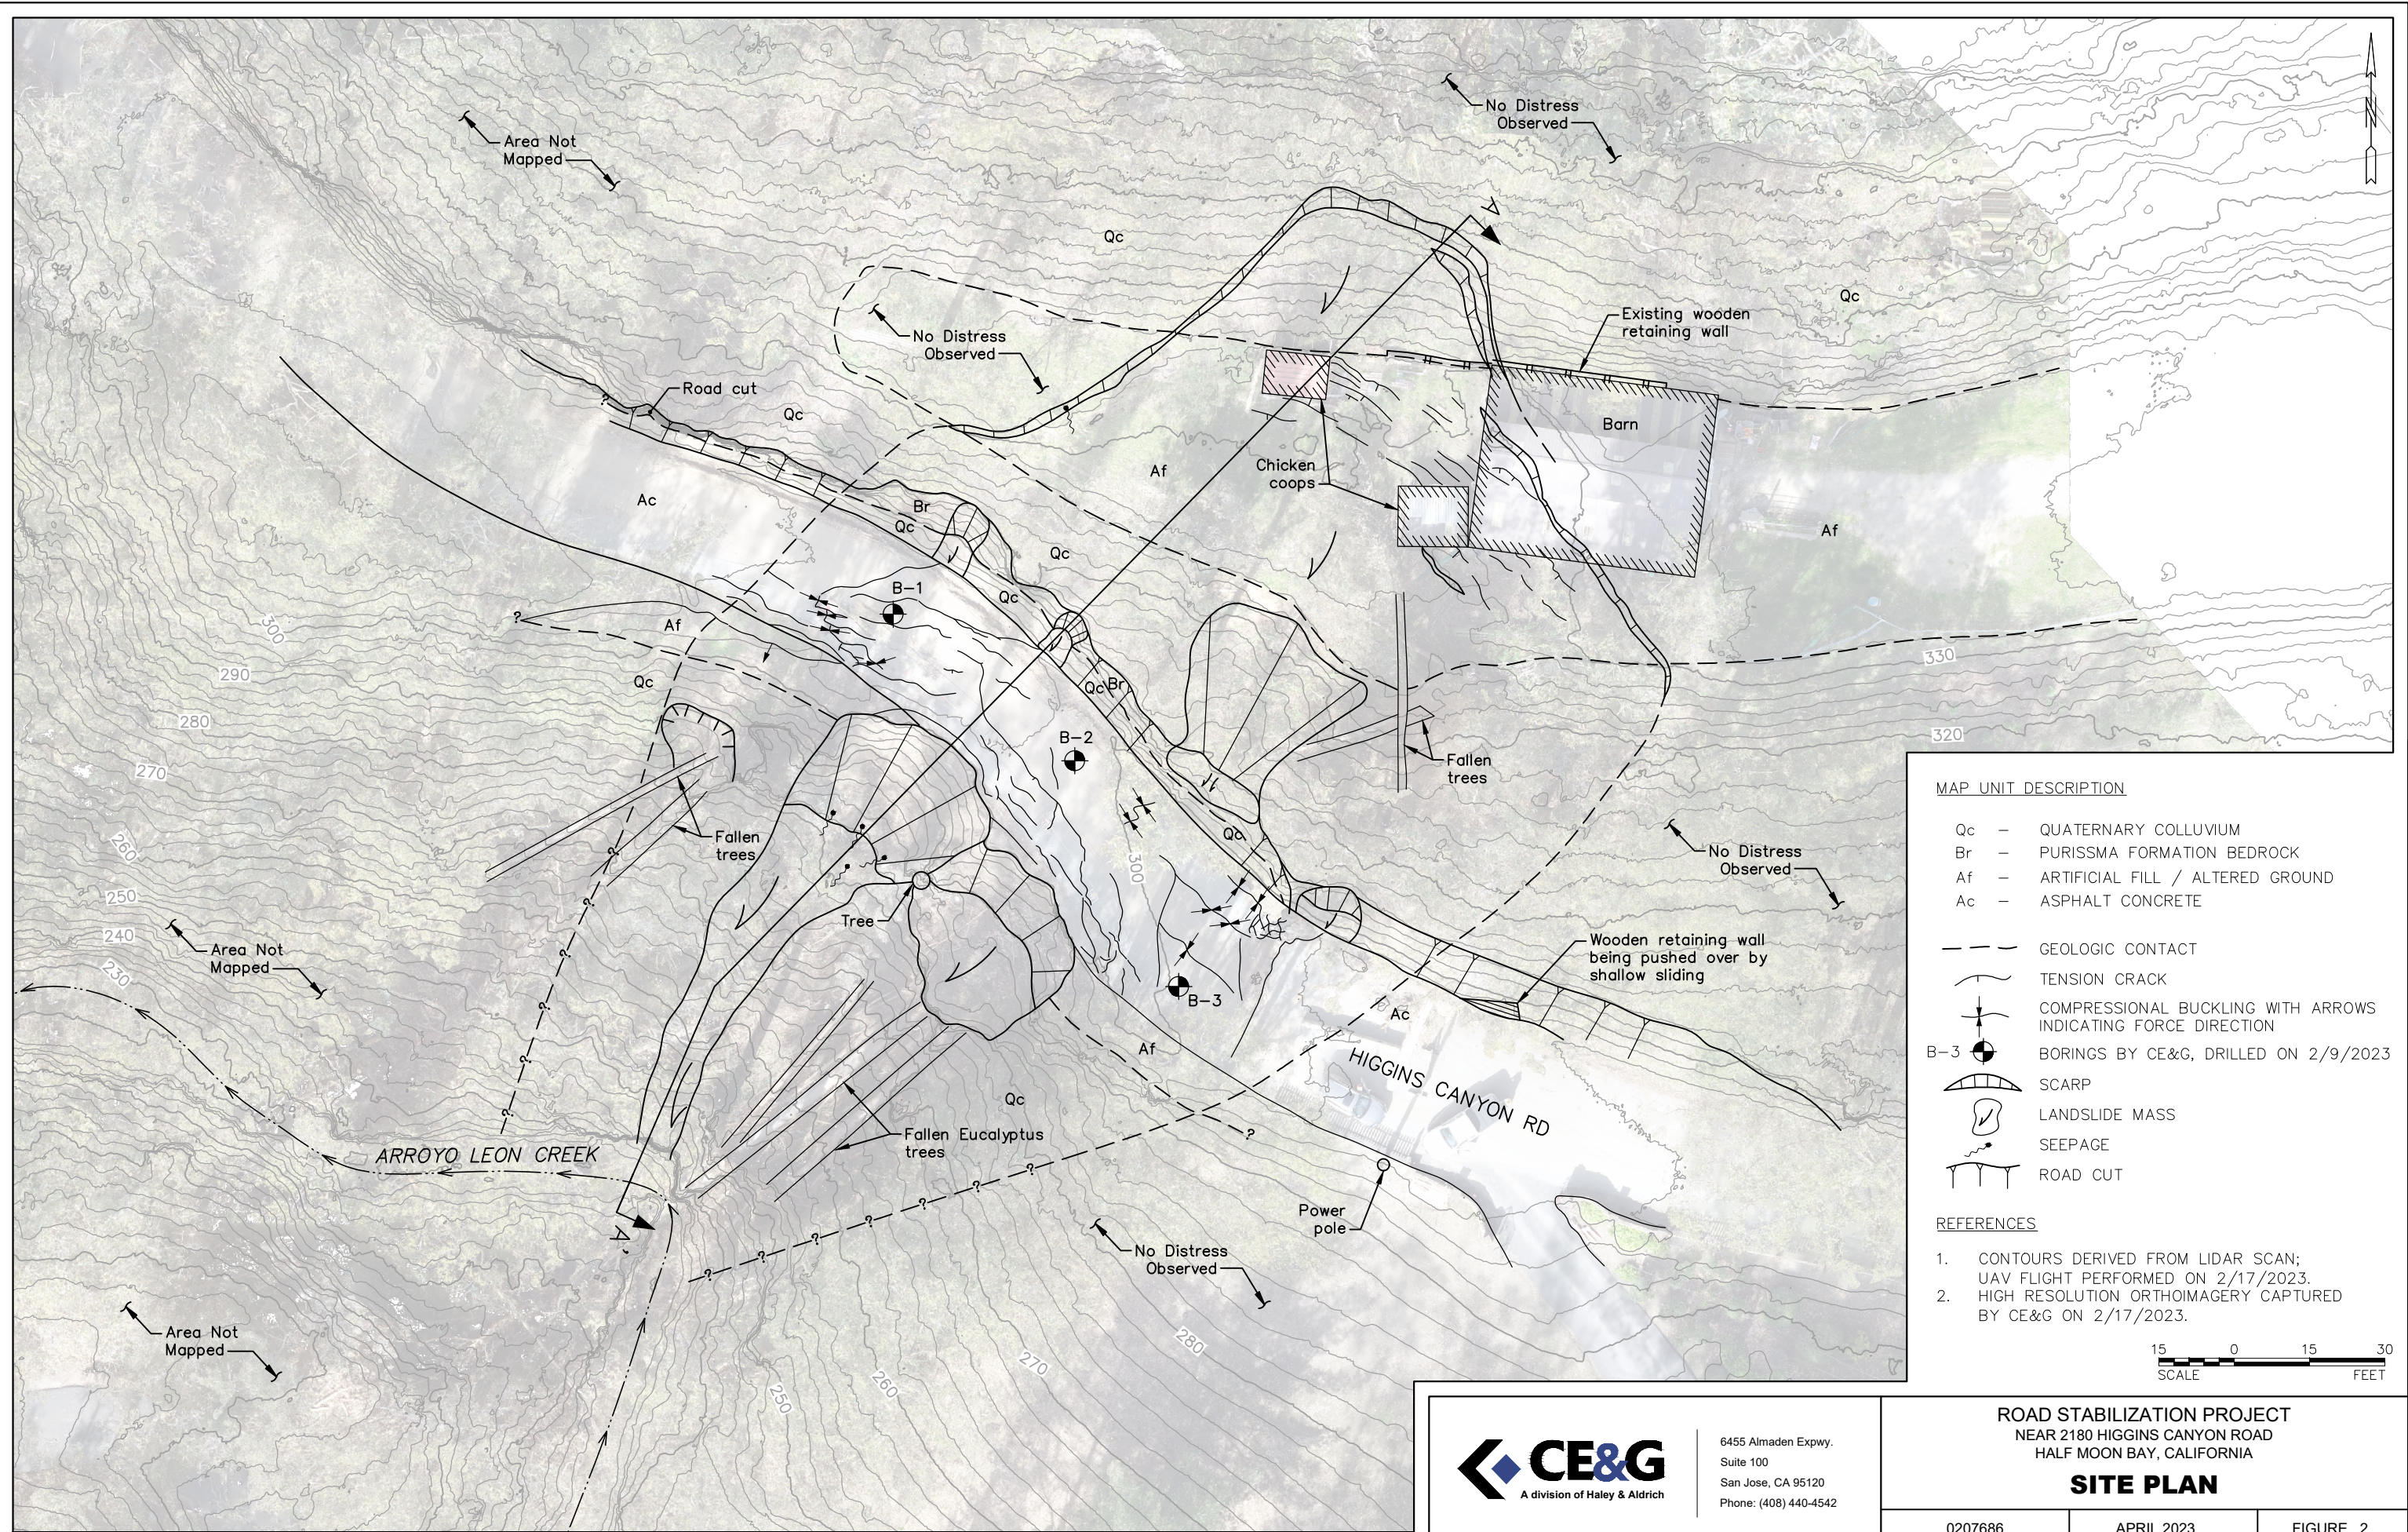
0207686	APRIL 2023	FIGURE 2
---------	------------	----------

- Minor seepage was observed along the slope in some areas.
- Multiple shallow landslides were observed along the road cut and are depicted in Figure 2.

- A significant landslide scarp with horizontal displacements up to 1.2 feet and vertical displacements of 1 to 5 feet was observed and mapped across the property (Figure 2). The easternmost portion of the scarp is first exposed south of the barn and has an azimuth in this area of about 145° (Photo 16). The scarp then continues beneath the western half of the barn and cuts into the slope to the north before turning west, where it peaks at an elevation of about 347 feet (Photos 13 and 17) before it dives to the southwest and continues back down the slope and onto the bench with an azimuth of about 235° (Photo 18). The scarp then dies out along the southwestern end of the bench, approximately 20 feet northeast of Higgins Canyon Road (Figure 2). This scarp appears to be the main scarp of a large landslide that likely extends beneath Higgins Canyon Road to the southwest. Additionally, the western and eastern extents of the scarp generally align with the deformation observed in the Higgins Canyon Road asphalt pavement.

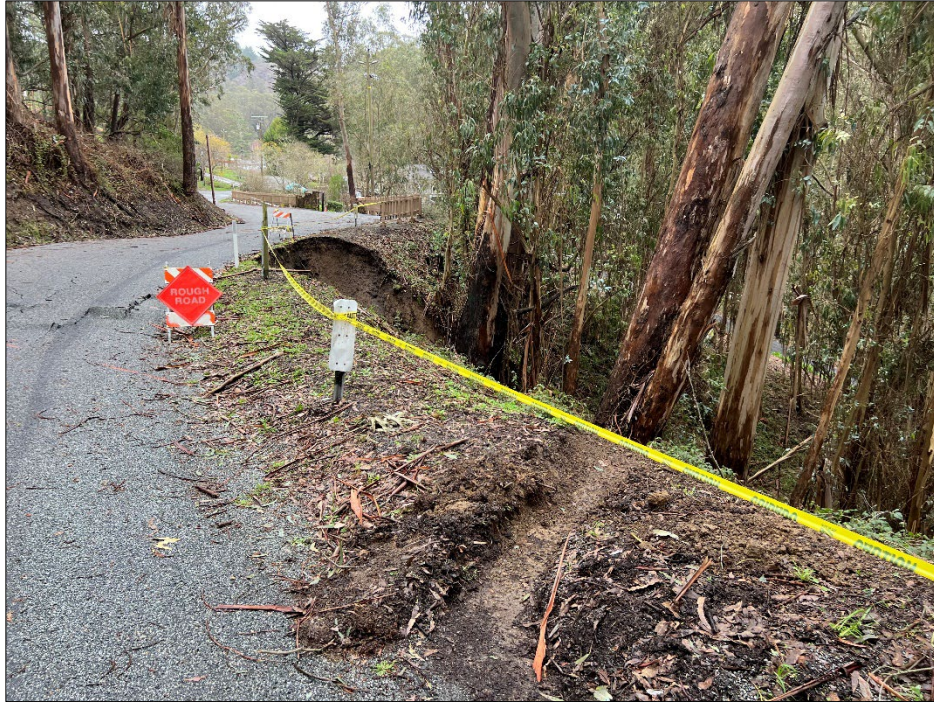
Photo 1: View of first slip-out (facing southeast) during our initial site visit on January 10th, 2023.

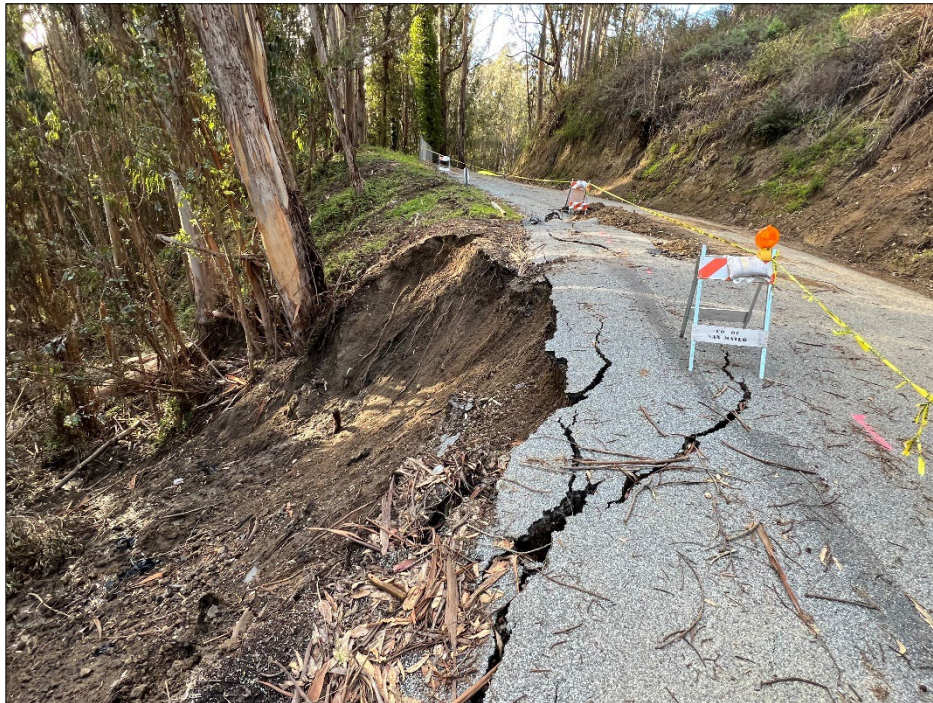
- The scarp to the northwest appeared to be a combination of a rotational failure followed by an earth flow of the slide debris. The scarp was approximately 30 feet wide with a rupture surface length of about 20 to 25 feet (Photo 2). The slide debris extended from the base of the scarp down to Arroyo Leon farther downslope (Photo 3). Seepage was observed in at least 5 locations along the base of the scarp, approximately 9 feet below the adjacent road elevation (Photo 4). Overall, the slide debris likely consisted mostly of road fill and highly weathered Purisima Formation bedrock.

Photo 2: Northwest-facing view of the original scarp during our second site visit on February 20th, 2023

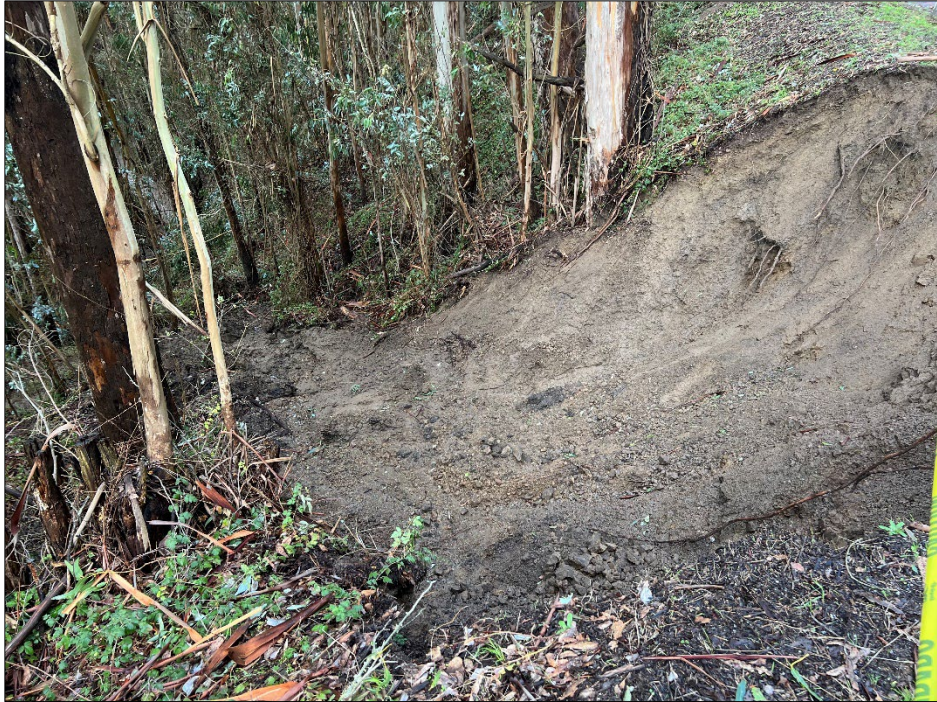
Photo 3: West-facing view of the downslope extent of the original slip-out along the outboard edge of Higgins Canyon Road. Photo was taken during our initial site visit on January 10th, 2023.

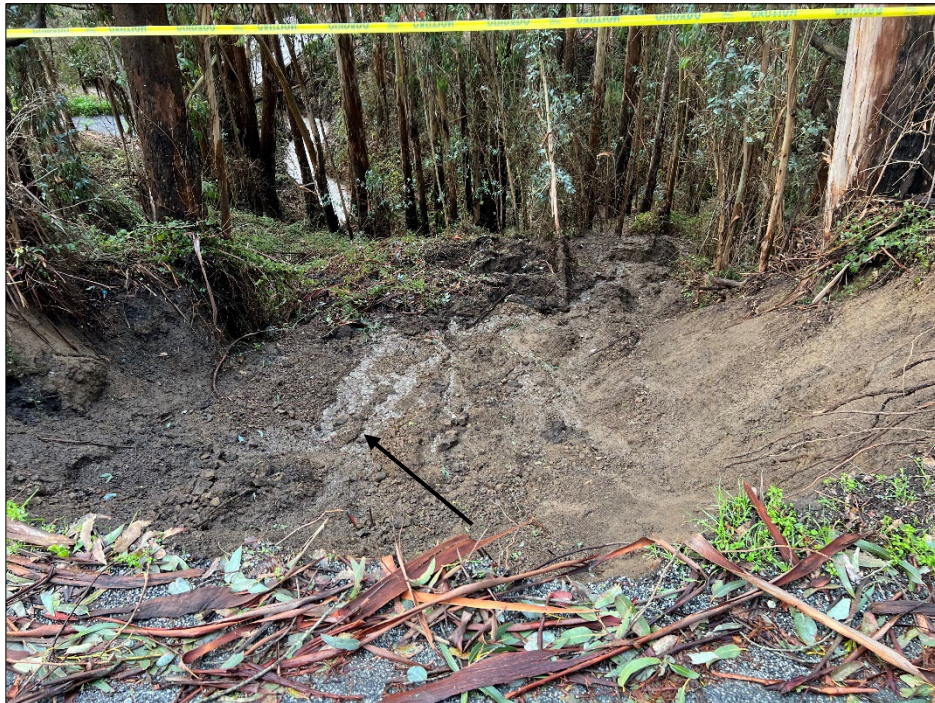
During our initial site visits, an approximately 30-foot-wide landslide scarp was observed along the outboard edge of the road. Water was observed seeping in five different areas near the base of the scarp, approximately 9 feet below the road elevation. Although the slide scarp had not encroached into the adjacent asphalt pavement by our initial site visits, tensional and compressional cracking within the asphalt pavement was observed and indicated a much larger (approximately 120-foot wide) slide was likely to occur. Vertical and horizontal displacements of these cracks at the time of our first site reconnaissance were approximately 0.5 to 3 inches. By our second and third site reconnaissance on January 19th and 23rd, 2023, vertical displacements of cracks in the asphalt pavement were as high as 7 inches, and areas of compressional buckling were as high as 12 inches. During these additional site visits, a second landslide initiated by fallen trees was observed along the road shoulder approximately 33 feet wide.

Photo 4: Southwest-facing view of the slip-out downslope of Higgins Canyon Road. Several seepage areas were observed along the base of the scarp (see black arrow). Photo was taken during our initial site visit on January 10th, 2023.

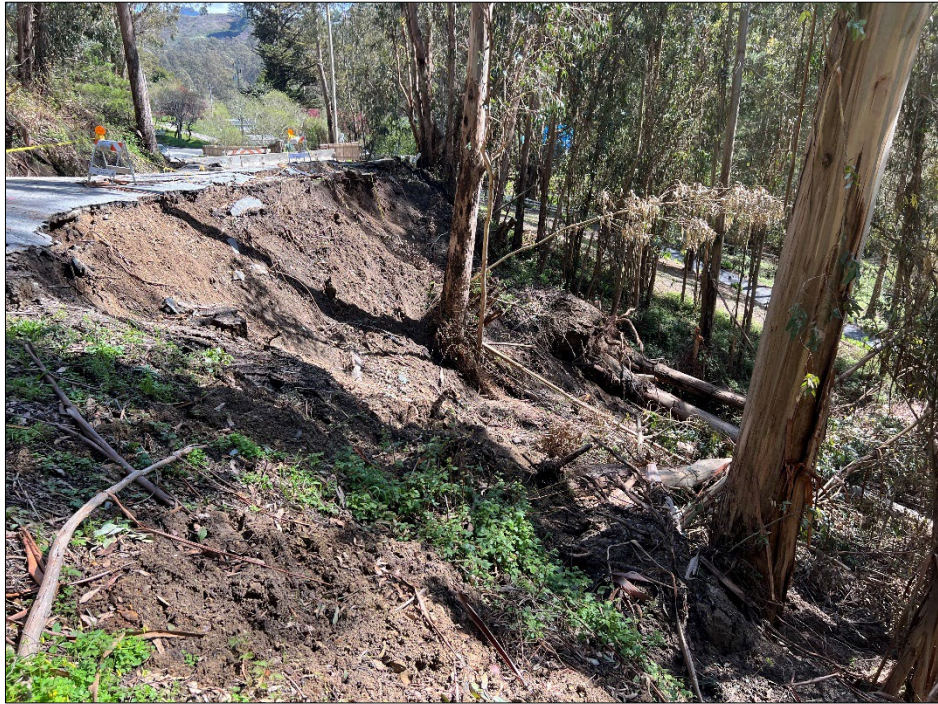
Photo 5: General southeast-facing view of slide area along the outboard edge of Higgins Canyon Road. Photo was taken during our last site visit on March 20th, 2023.

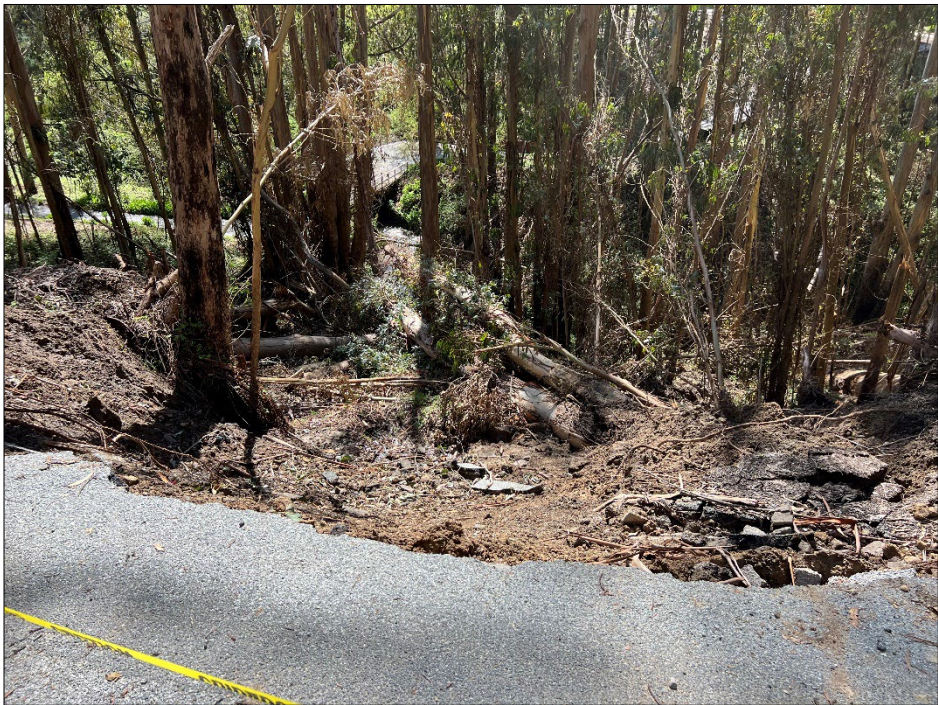
- The scarp to the southeast appeared to have been caused by 4 large eucalyptus trees falling during the recent storm events. The trees fell in the downslope direction, extending all the way down to Arroyo Leon and exposing their root masses near the scarp's toe. The scarp was approximately 33 feet wide and about 12 feet long.

Photo 6: General southwest-facing view of slide area and fallen trees along the outboard edge of Higgins Canyon Road. Photo was taken during our last site visit on March 20th, 2023.

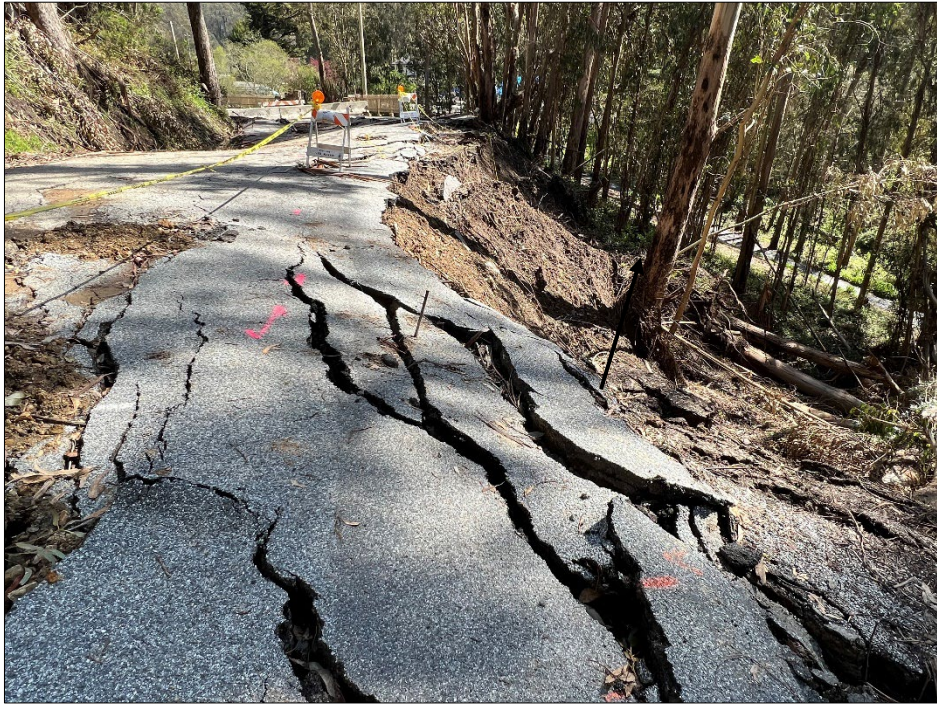
Photo 7: General southeast-facing view of the outboard edge of Higgins Canyon Road. Photo was taken during our last site visit on March 20th, 2023.

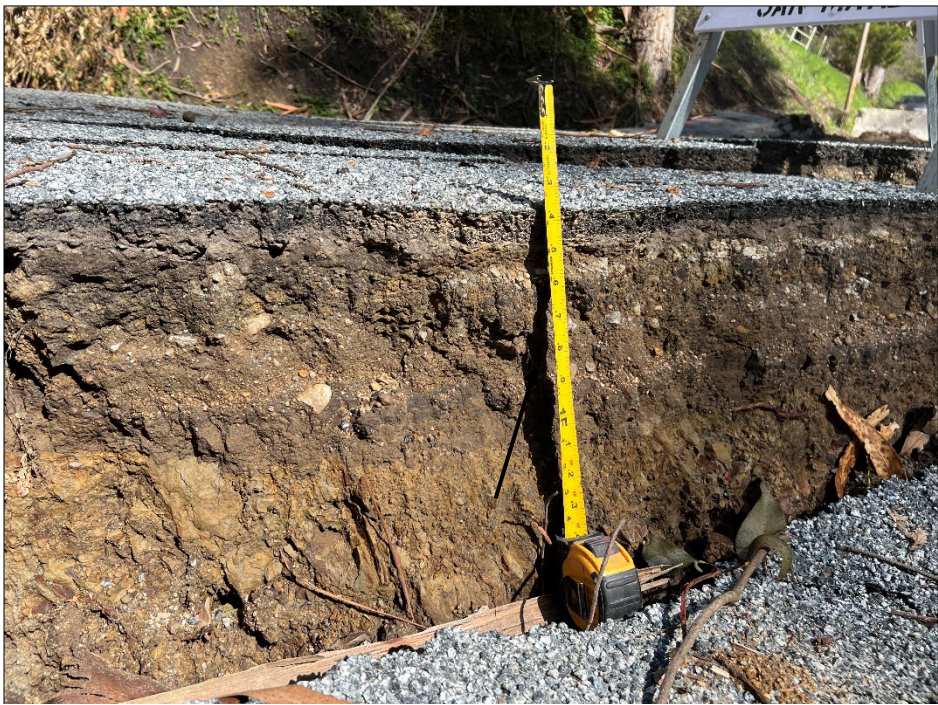
- Cracking in the road adjacent to the downslope scarps generally consists of transverse tension cracks up to about 12 inches wide, up to 30 feet long, and vertical displacements up to 14 inches (Photo 8). These cracks extend from the scarp edges about 10 to 15 feet into the road.

Photo 8: Approximately 13 inches of vertical displacement in Higgins Canyon Road pavement. Photo was taken during our last site visit on March 20th, 2023.

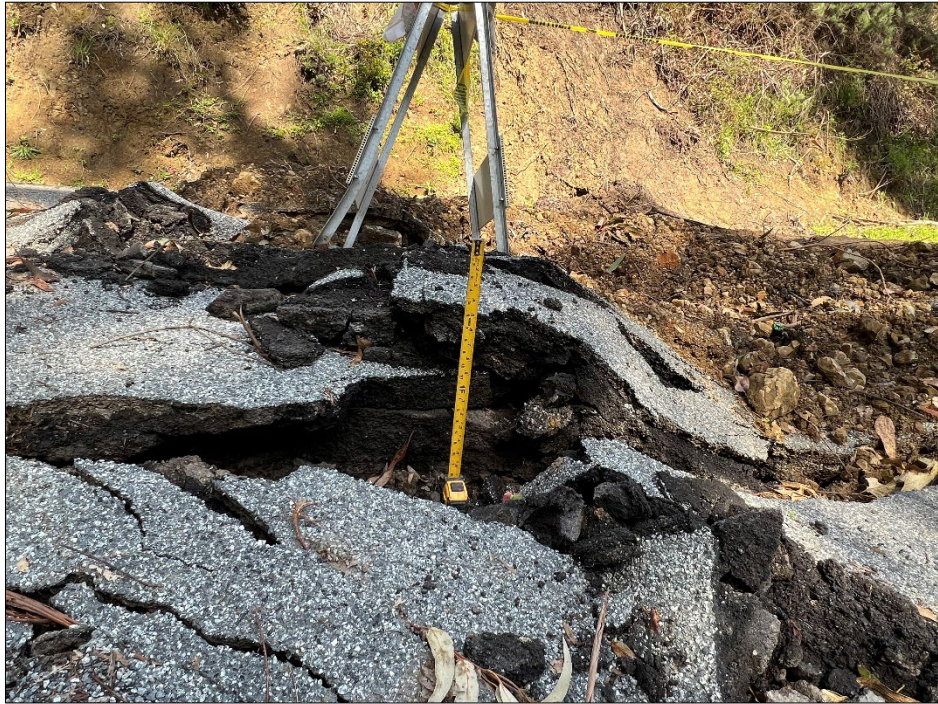
Photo 9: Vertical displacement in Higgins Canyon Road pavement due to buckling and thrusting. Photo was taken during our last site visit on March 20th, 2023.

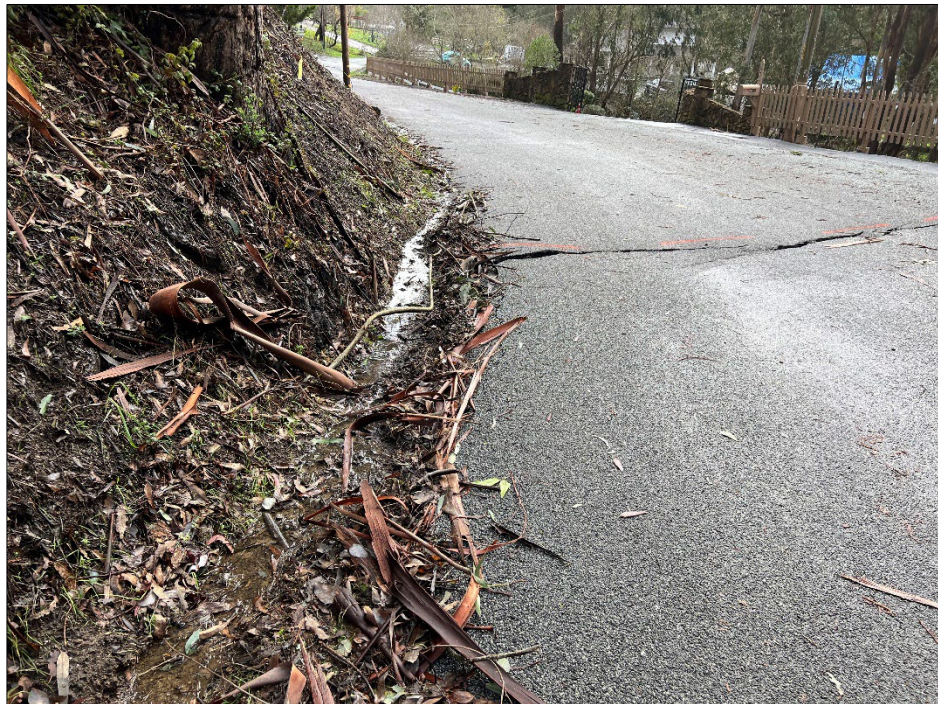
- The southeasternmost extent of observed road distress consists of a near-continuous crack that extends across the entire roadway and has a minor (approximately 3 inches) left-lateral sense of movement (Photo 10). The crack is oriented with an average azimuth of 050°. Where this crack dies out into the road cut, there are additional signs of buckling in the pavement, indicating forces in the southwest direction near the inboard edge of the road (Photo 11). The buckling is likely due to additional slide forces from upslope.

Photo 10: Southeastern extent of road deformation expressed as a crack with left lateral movement during our initial site visit on January 10th, 2023.

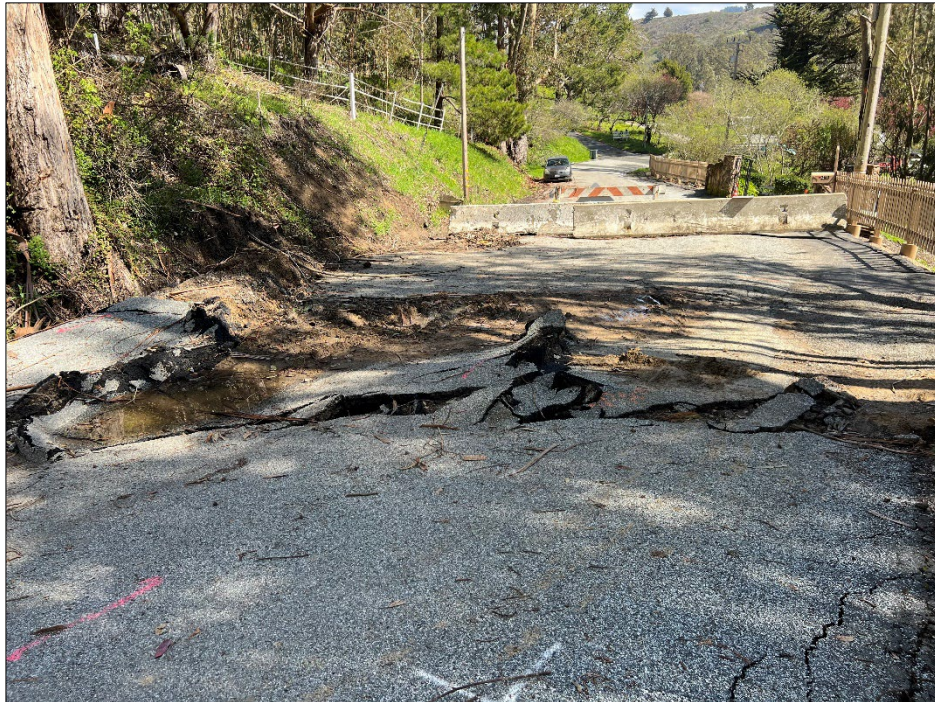
Photo 11: Buckling and thrusting of Higgins Canyon Road pavement near the inboard edge of the road and at the eastern extent of the road deformation. Photo was taken during our last site visit on March 20th, 2023.

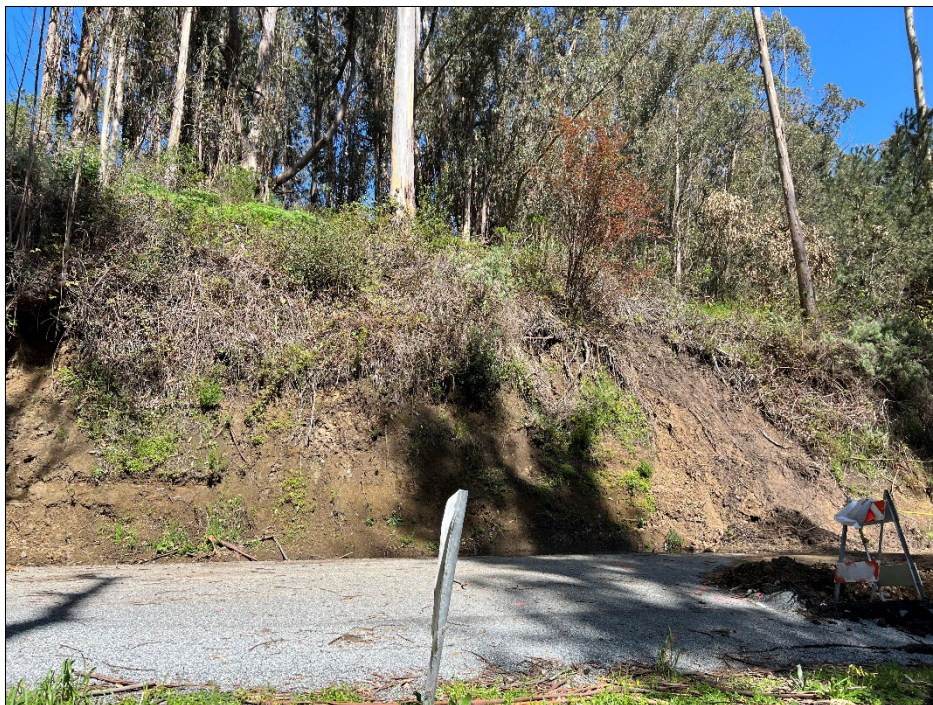
- Highly fractured siltstone bedrock was observed along the upper portions of most of the road cut. The bottom half of the road cut generally consists of colluvial piles of silty soils and siltstone fragments from the bedrock above.

Photo 12: Northwestern view of the road cut along the inboard edge of Higgins Canyon Road. Photo was taken during our last site visit on March 20th, 2023.

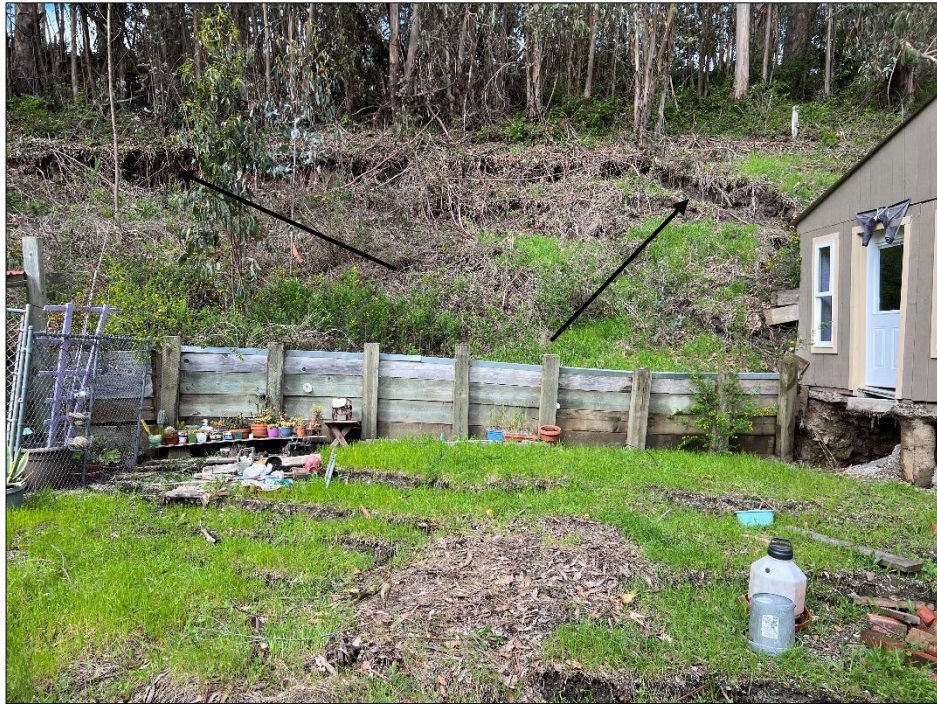
- Tension cracks were observed in the grass-covered bench to the west (Photo 13) and south of the barn and extend beneath the barn's western half. The tension cracks in the bench generally trend to the northwest, with the land dropping to the southwest in some occurrences. During our site visit, the tension crack apertures ranged from approximately 0.5 to 1.2 feet. The depths of the tension cracks were also measured but were only about 1.5 feet deep due to soil in-filling the cracks. Therefore, the cracks were likely deeper when initially formed. Tension cracks that extend beneath the barn resulted in horizontal and vertical displacements in the barn's foundation (Photos 15). Most of the tension cracks were mapped and depicted in Figure 2.

Photo 13: Northeast-facing view of the retaining wall on the upslope private property at (2175 Higgins Canyon Road). Note the main landslide scarp exposed upslope of the retaining wall. Also note tension cracks in the grass in front of the retaining wall. Photo was taken during our last site visit on March 20th, 2023.

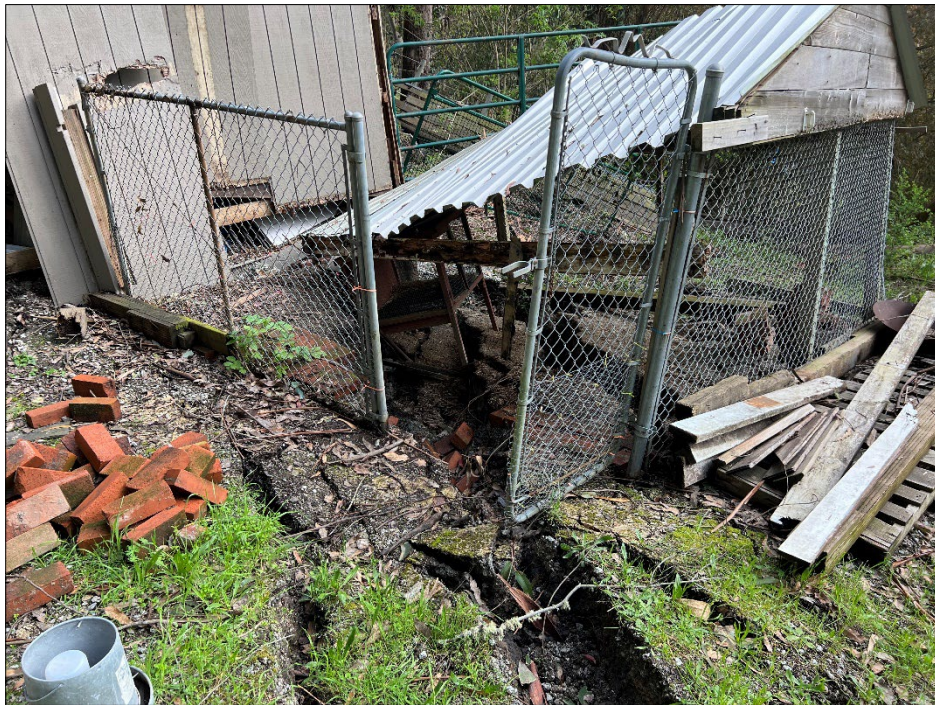
- Multiple areas along the flat-lying portion of the property (bench) and the adjacent slope to the north showed significant signs of distress. They included tension cracks and scarps with horizontal and vertical displacements (Photo 14).

Photo 14: Southeast-facing view of tension cracks on the upslope private property at (2175 Higgins Canyon Road). Photo was taken during our last site visit on March 20th, 2023.

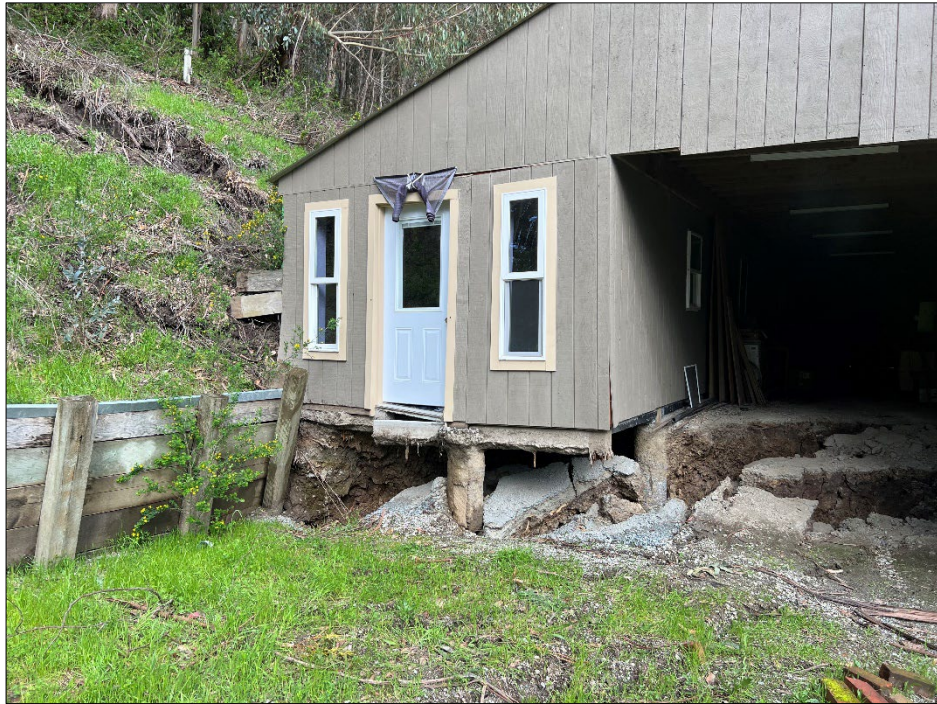
Photo 15: Northeast-facing view of the main scarp exposed beneath the barn on the upslope private property at (2175 Higgins Canyon Road). Note the main landslide scarp continues upslope after cutting beneath the barn. Also, note exposed barn foundation piers. Photo was taken during our last site visit on March 20th, 2023.

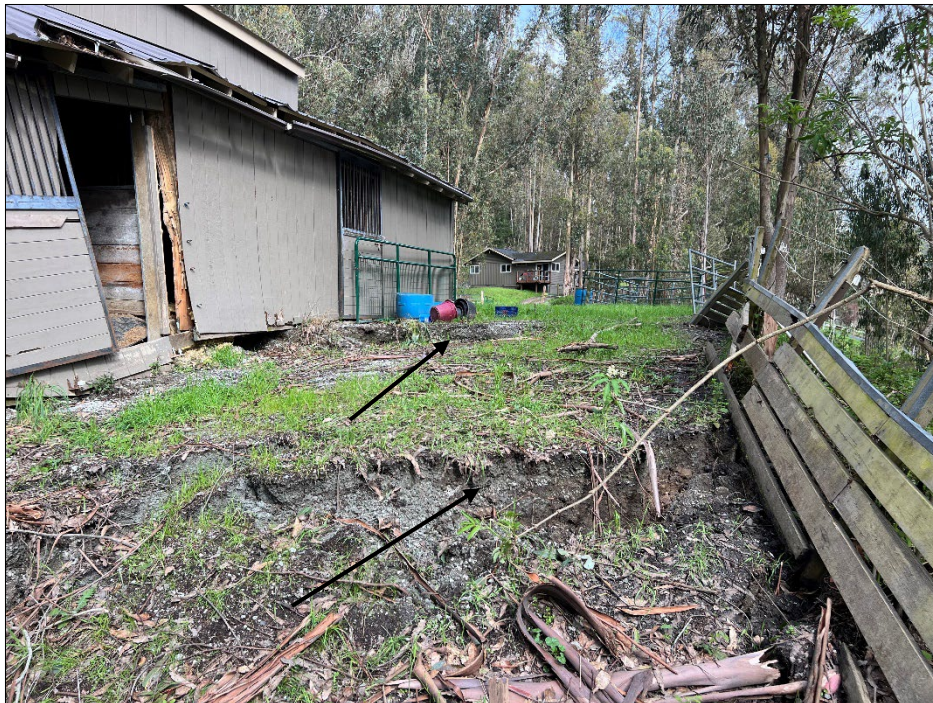
Photo 16: East-facing view of the northeastern extent of the slide deformation on the upslope private property at (2175 Higgins Canyon Road). Photo was taken during our last site visit on March 20th, 2023.

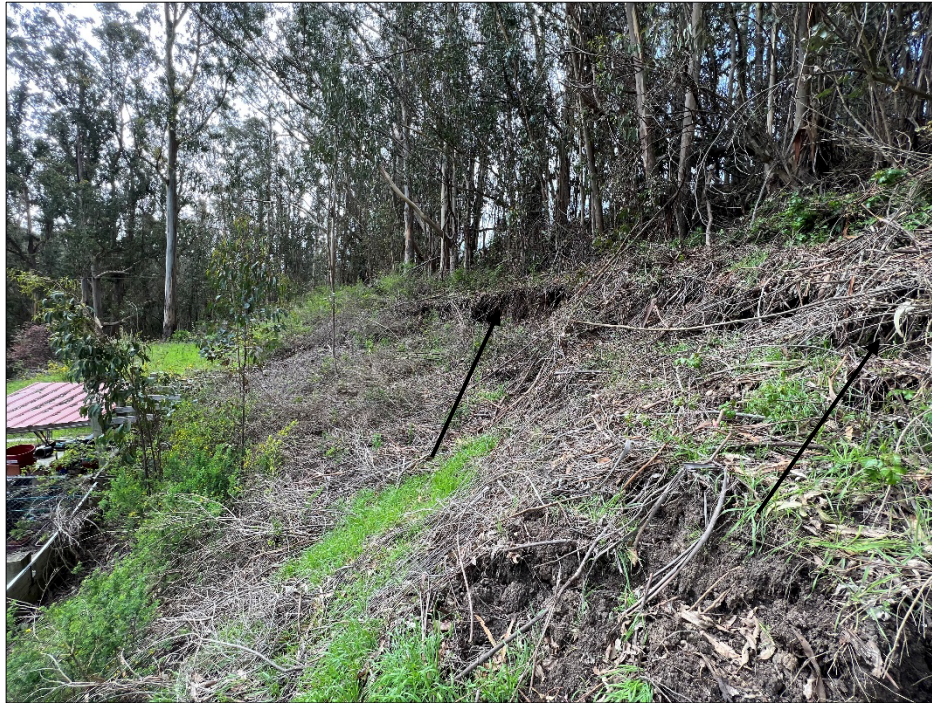
Photo 17: Northwest-facing view of the exposed main landslide scarp, upslope of the private property at 2175 Higgins Canyon Road. Photo was taken during our last site visit on March 20th, 2023.

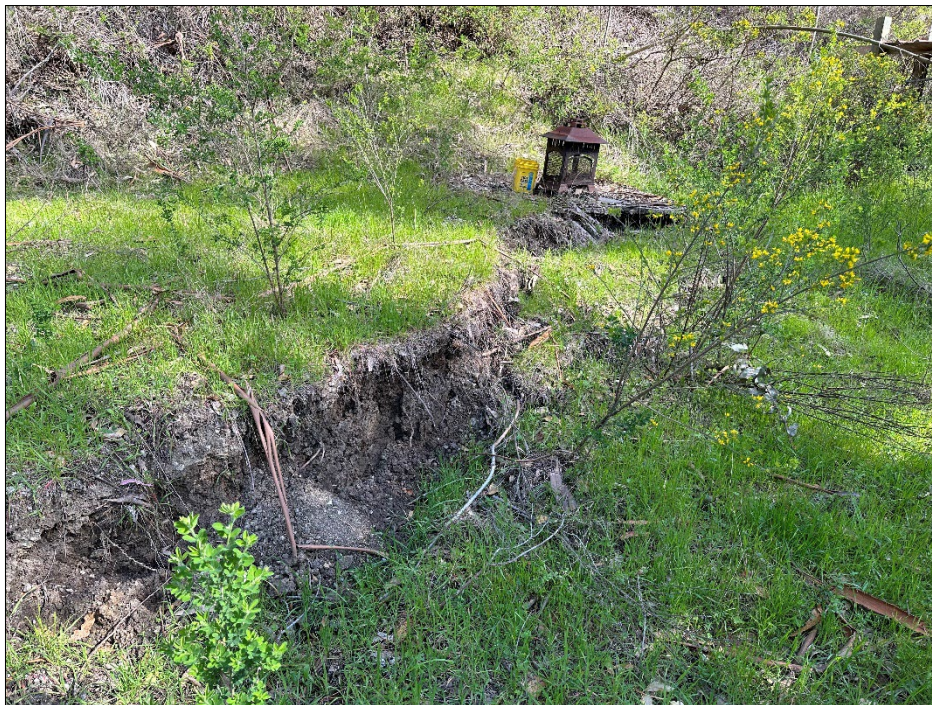
Photo 18: North-facing view of the exposed northwestern extent of the main landslide scarp on the private property at 2175 Higgins Canyon Road. Photo was taken during our last site visit on March 20th, 2023.
