Sierra West Report

TECHNICAL MEMORANDUM

**RE: CCTV Survey Results Evaluation and Pipeline Replacement Priorities
Areas 1, 3, and 4**

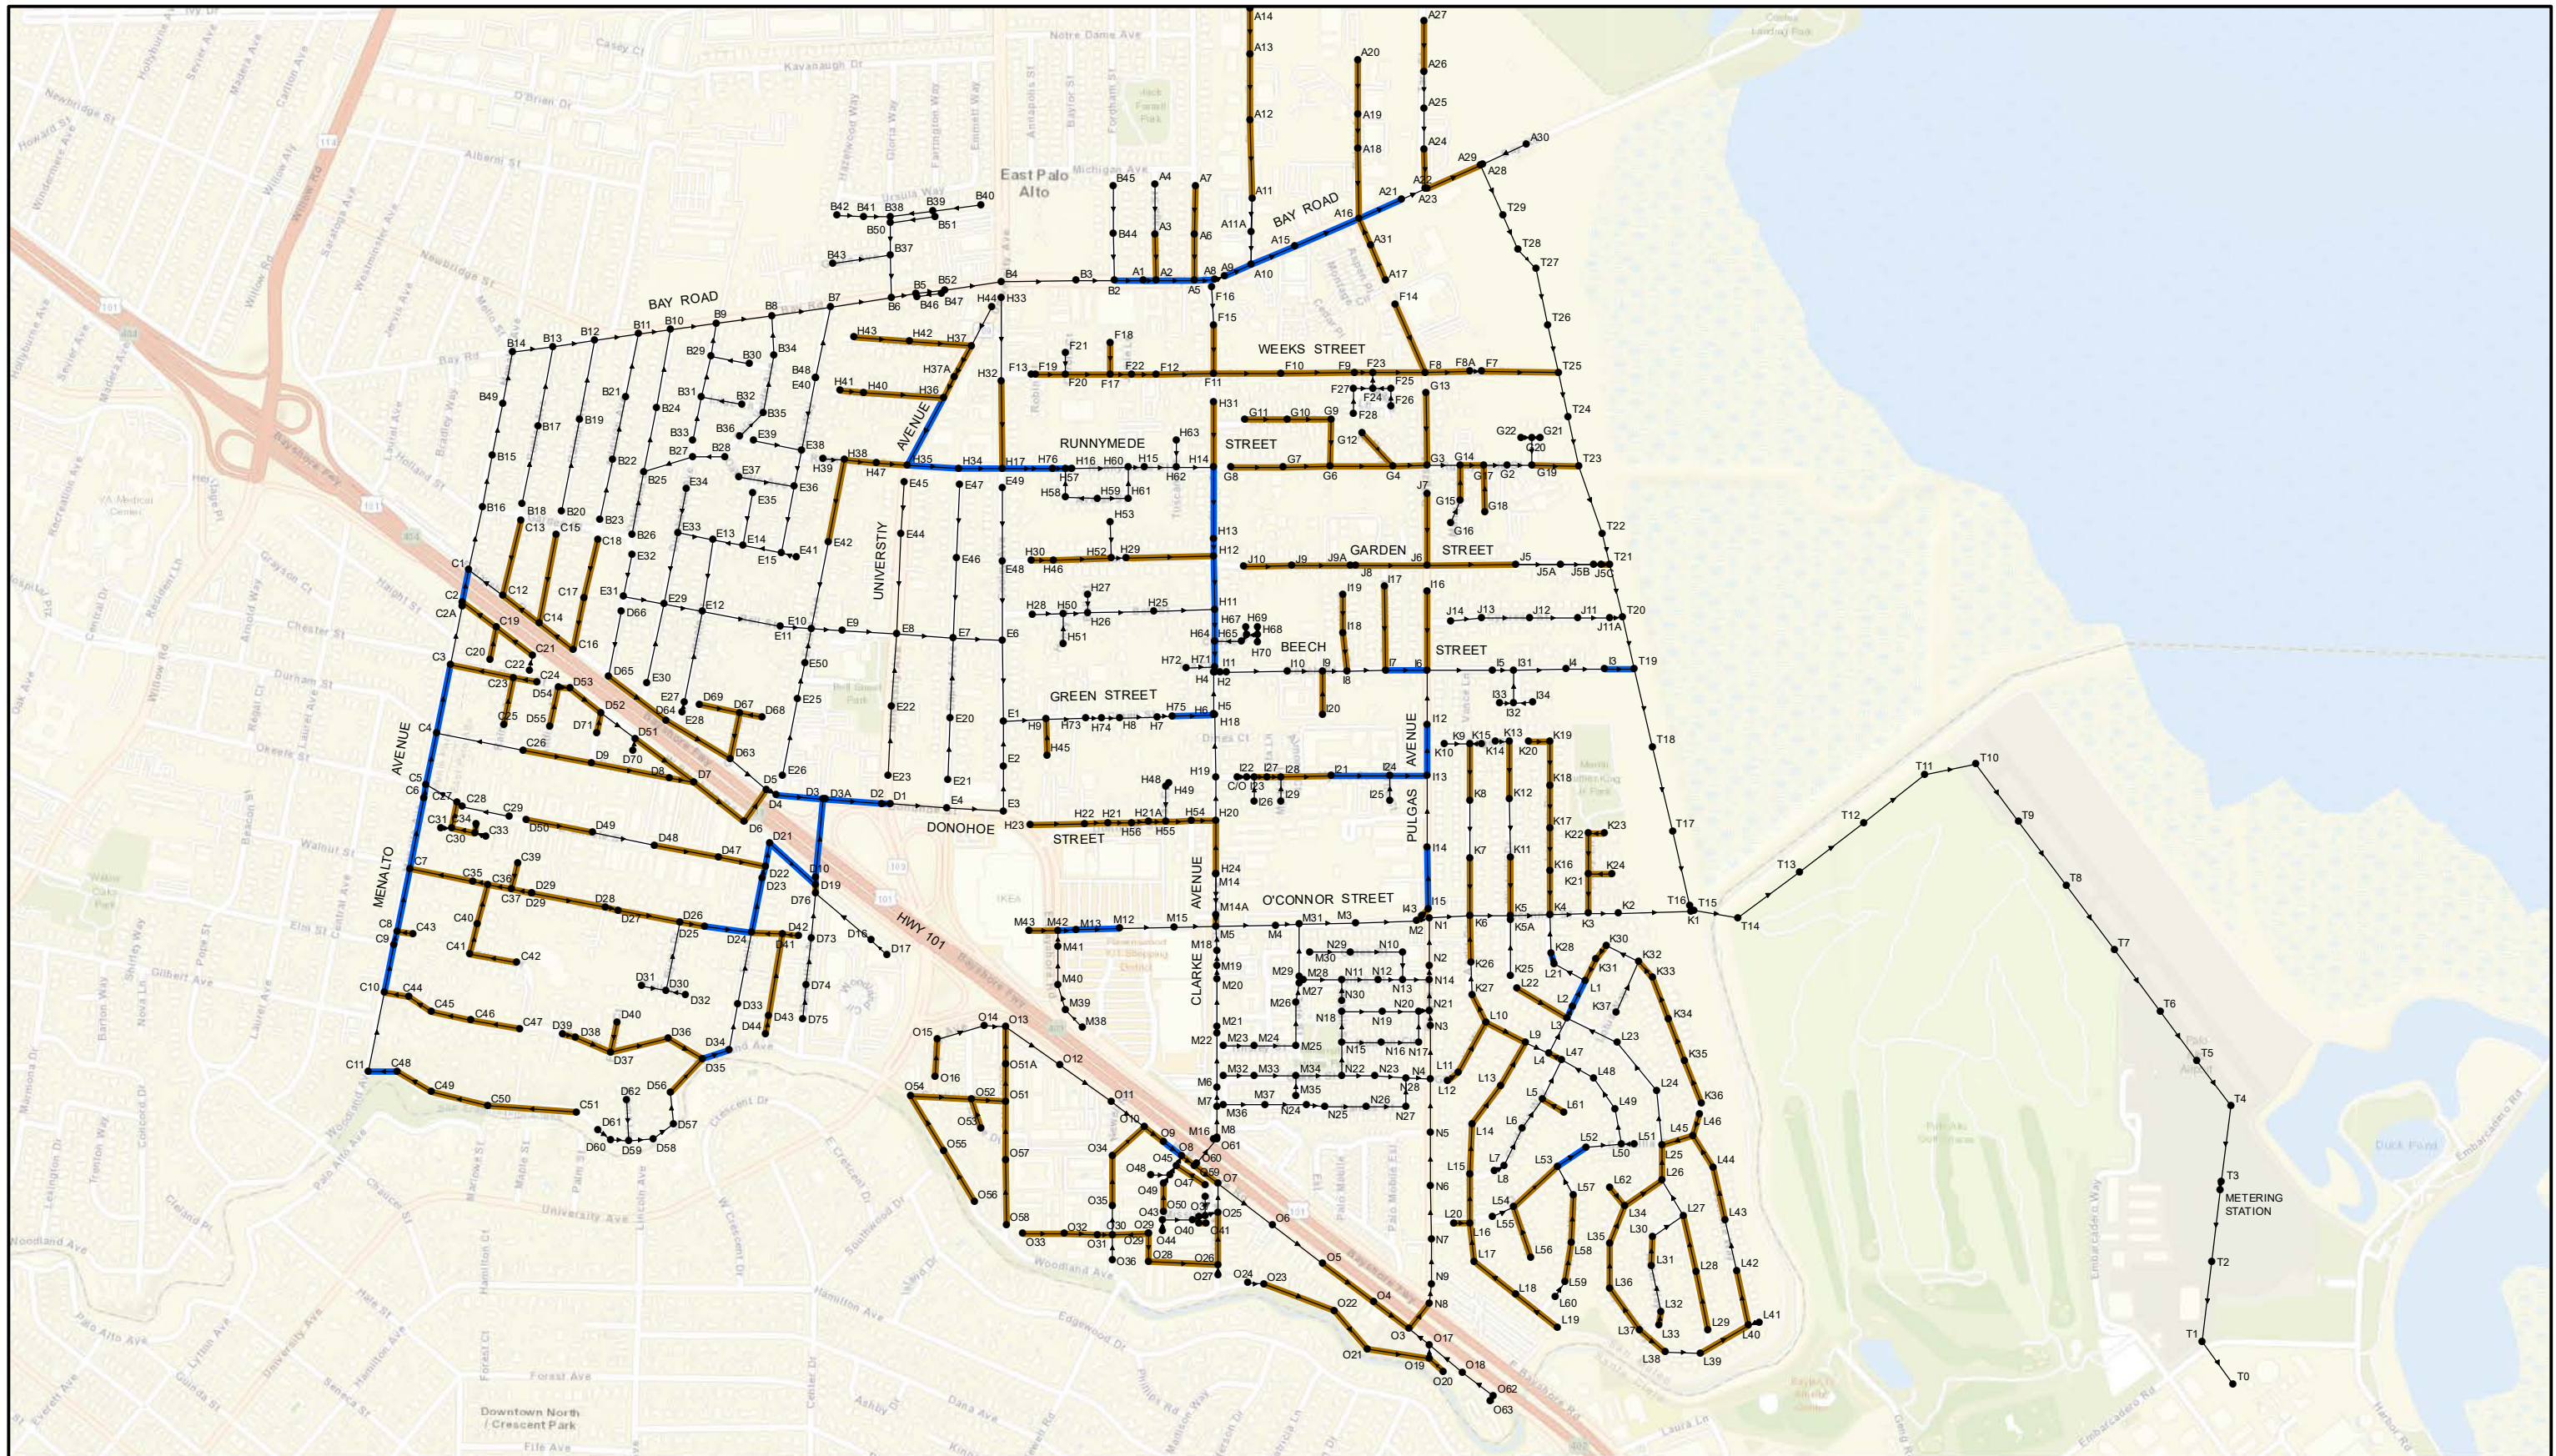
The Structural, Notable Defects, and Sagging scores are added to create the Total Score for each pipeline segment. The Total Scores are ranked from highest to lowest to generate a priority list of pipelines to replace (Table 1). Pipelines with a score greater than 25 from each Area were selected as the group with significant structural defects needing replacement. A geographic information system (GIS) was used to generate Figure 2 showing the pipelines that need to be replaced to resolve structural defects in Areas 1, 3, and 4.

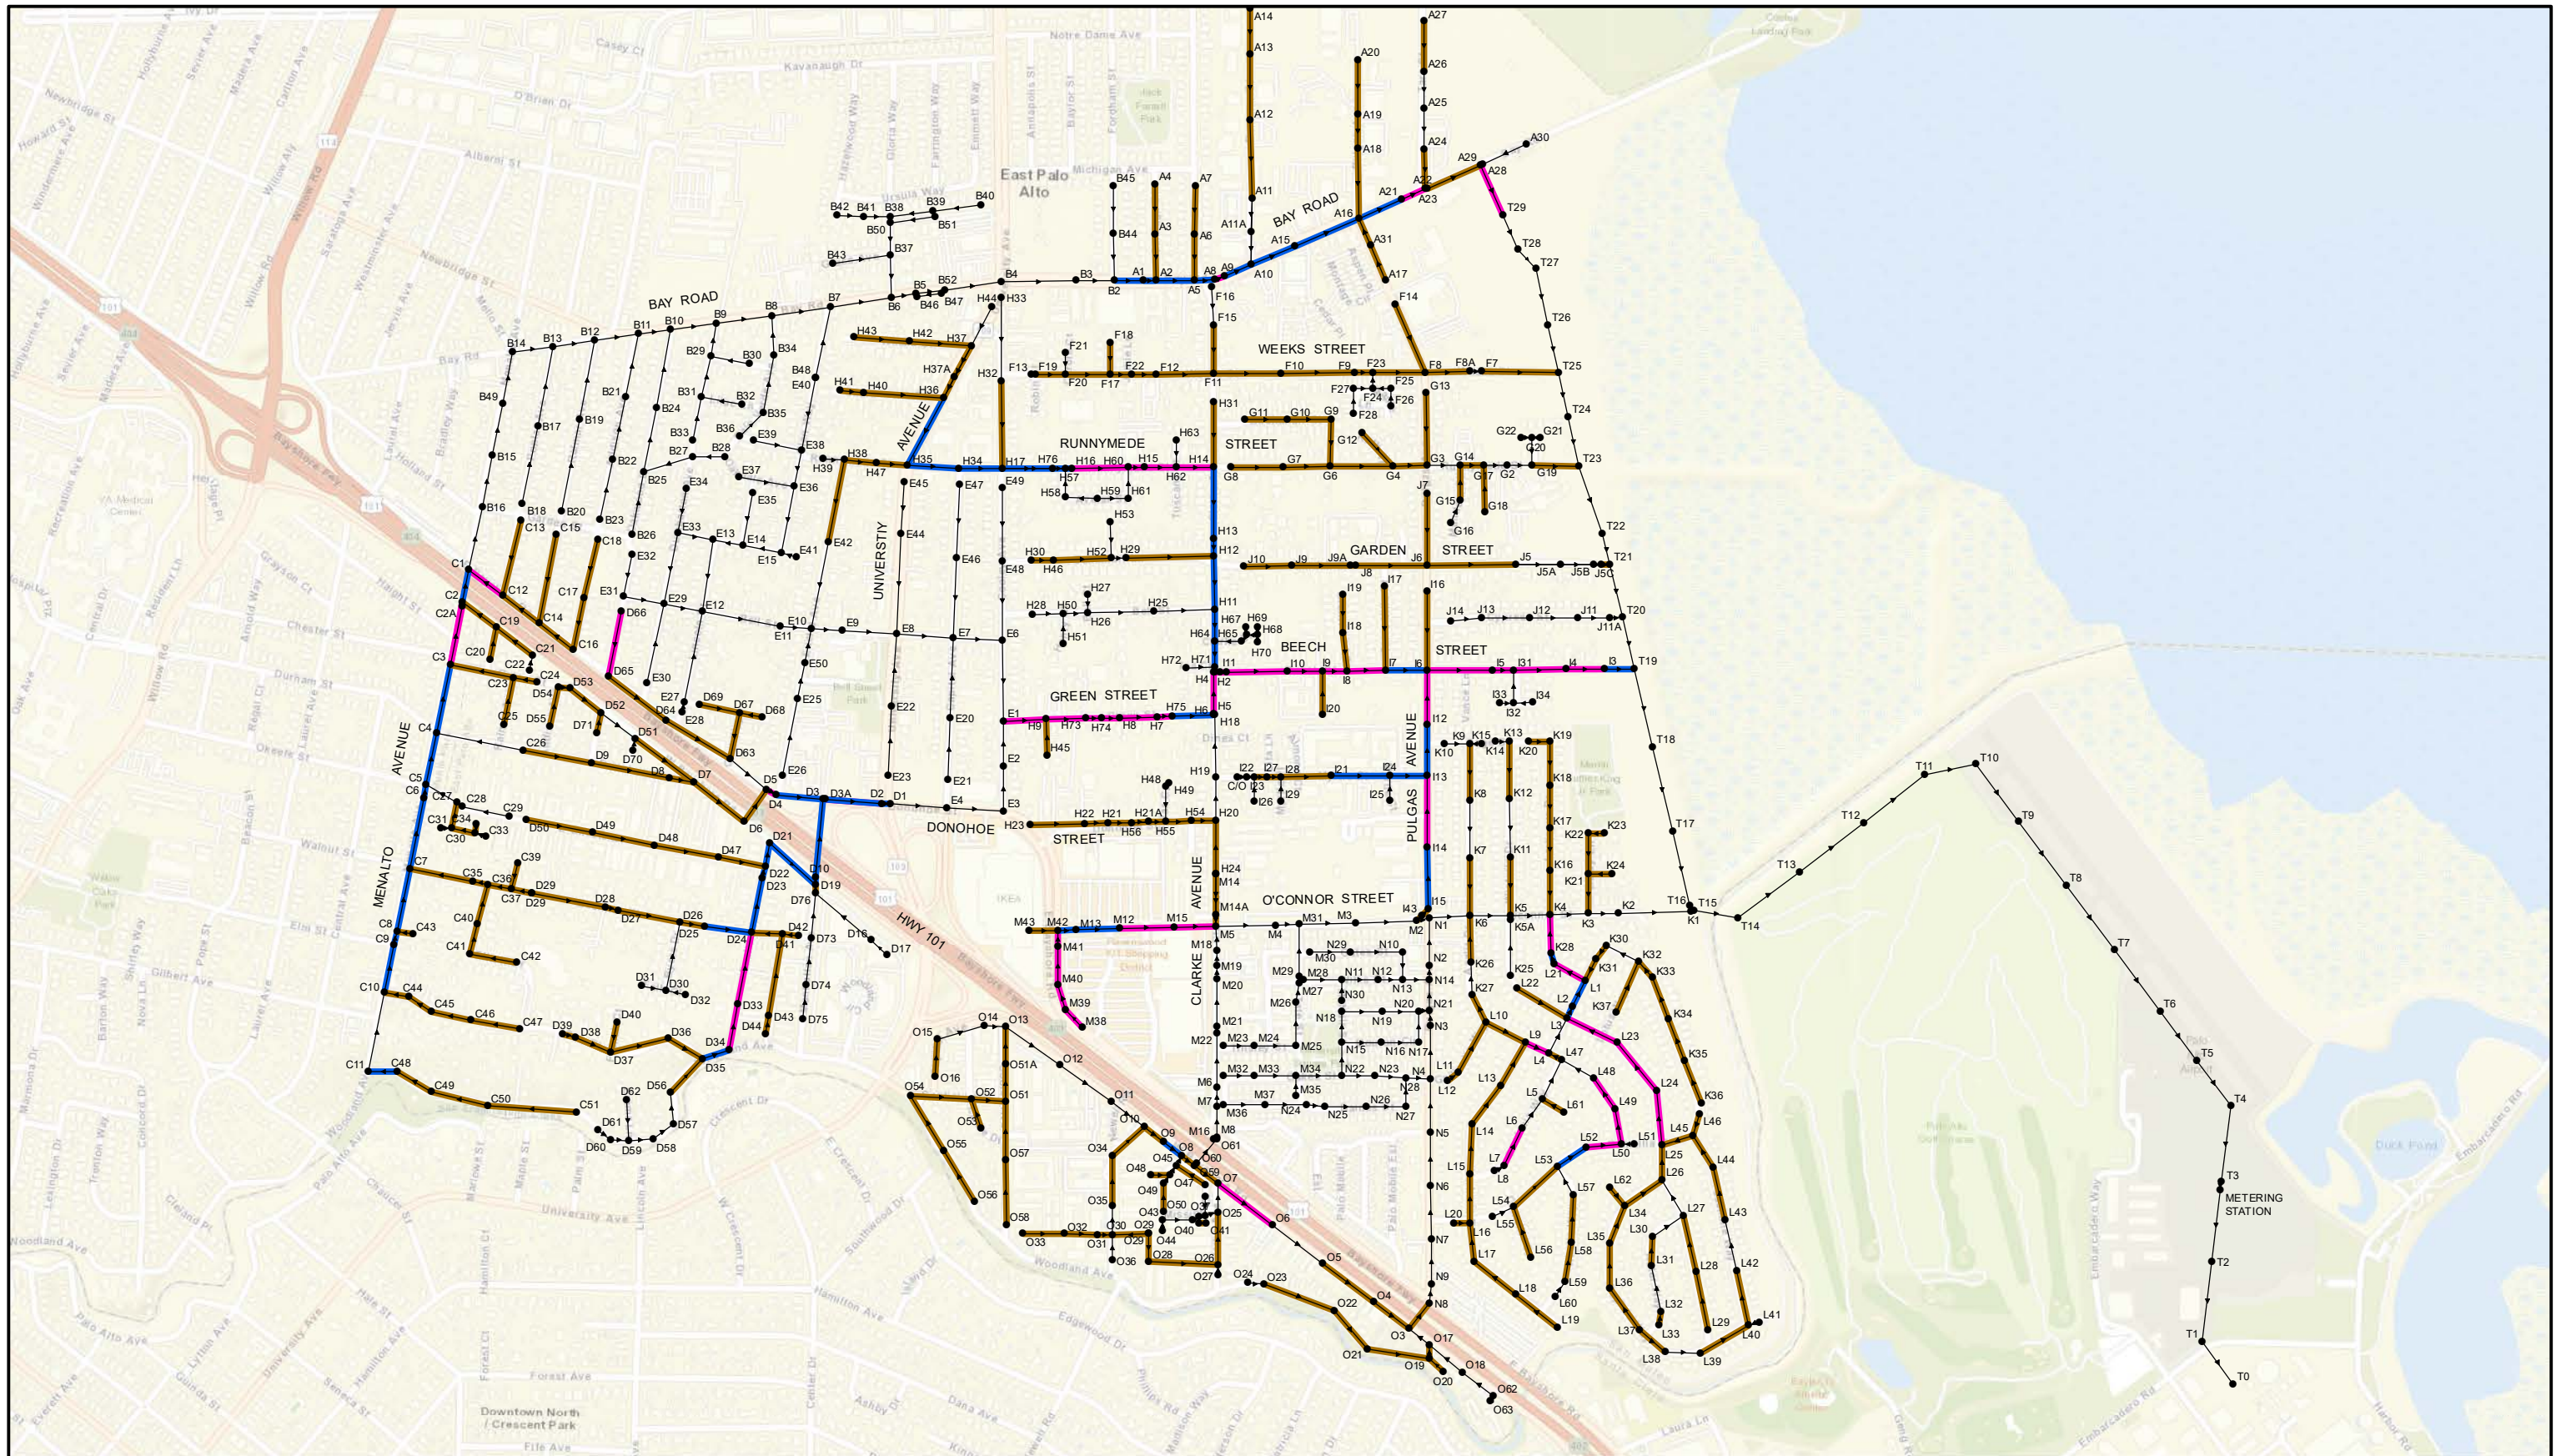
The Structural, Notable Defects, and Sagging scores, and the Capacity score, are added to create the Total Score for each pipeline segment. The Total Scores are ranked from highest to lowest to generate a priority list of pipelines to replace. Pipelines with a Total Score greater than 25 were selected as pipelines for replacement (Table 4). The GIS was used to generate Figure 3 showing the pipelines that need to be replaced to resolve structural defects and capacity inadequacies in Areas 1, 3, and 4.

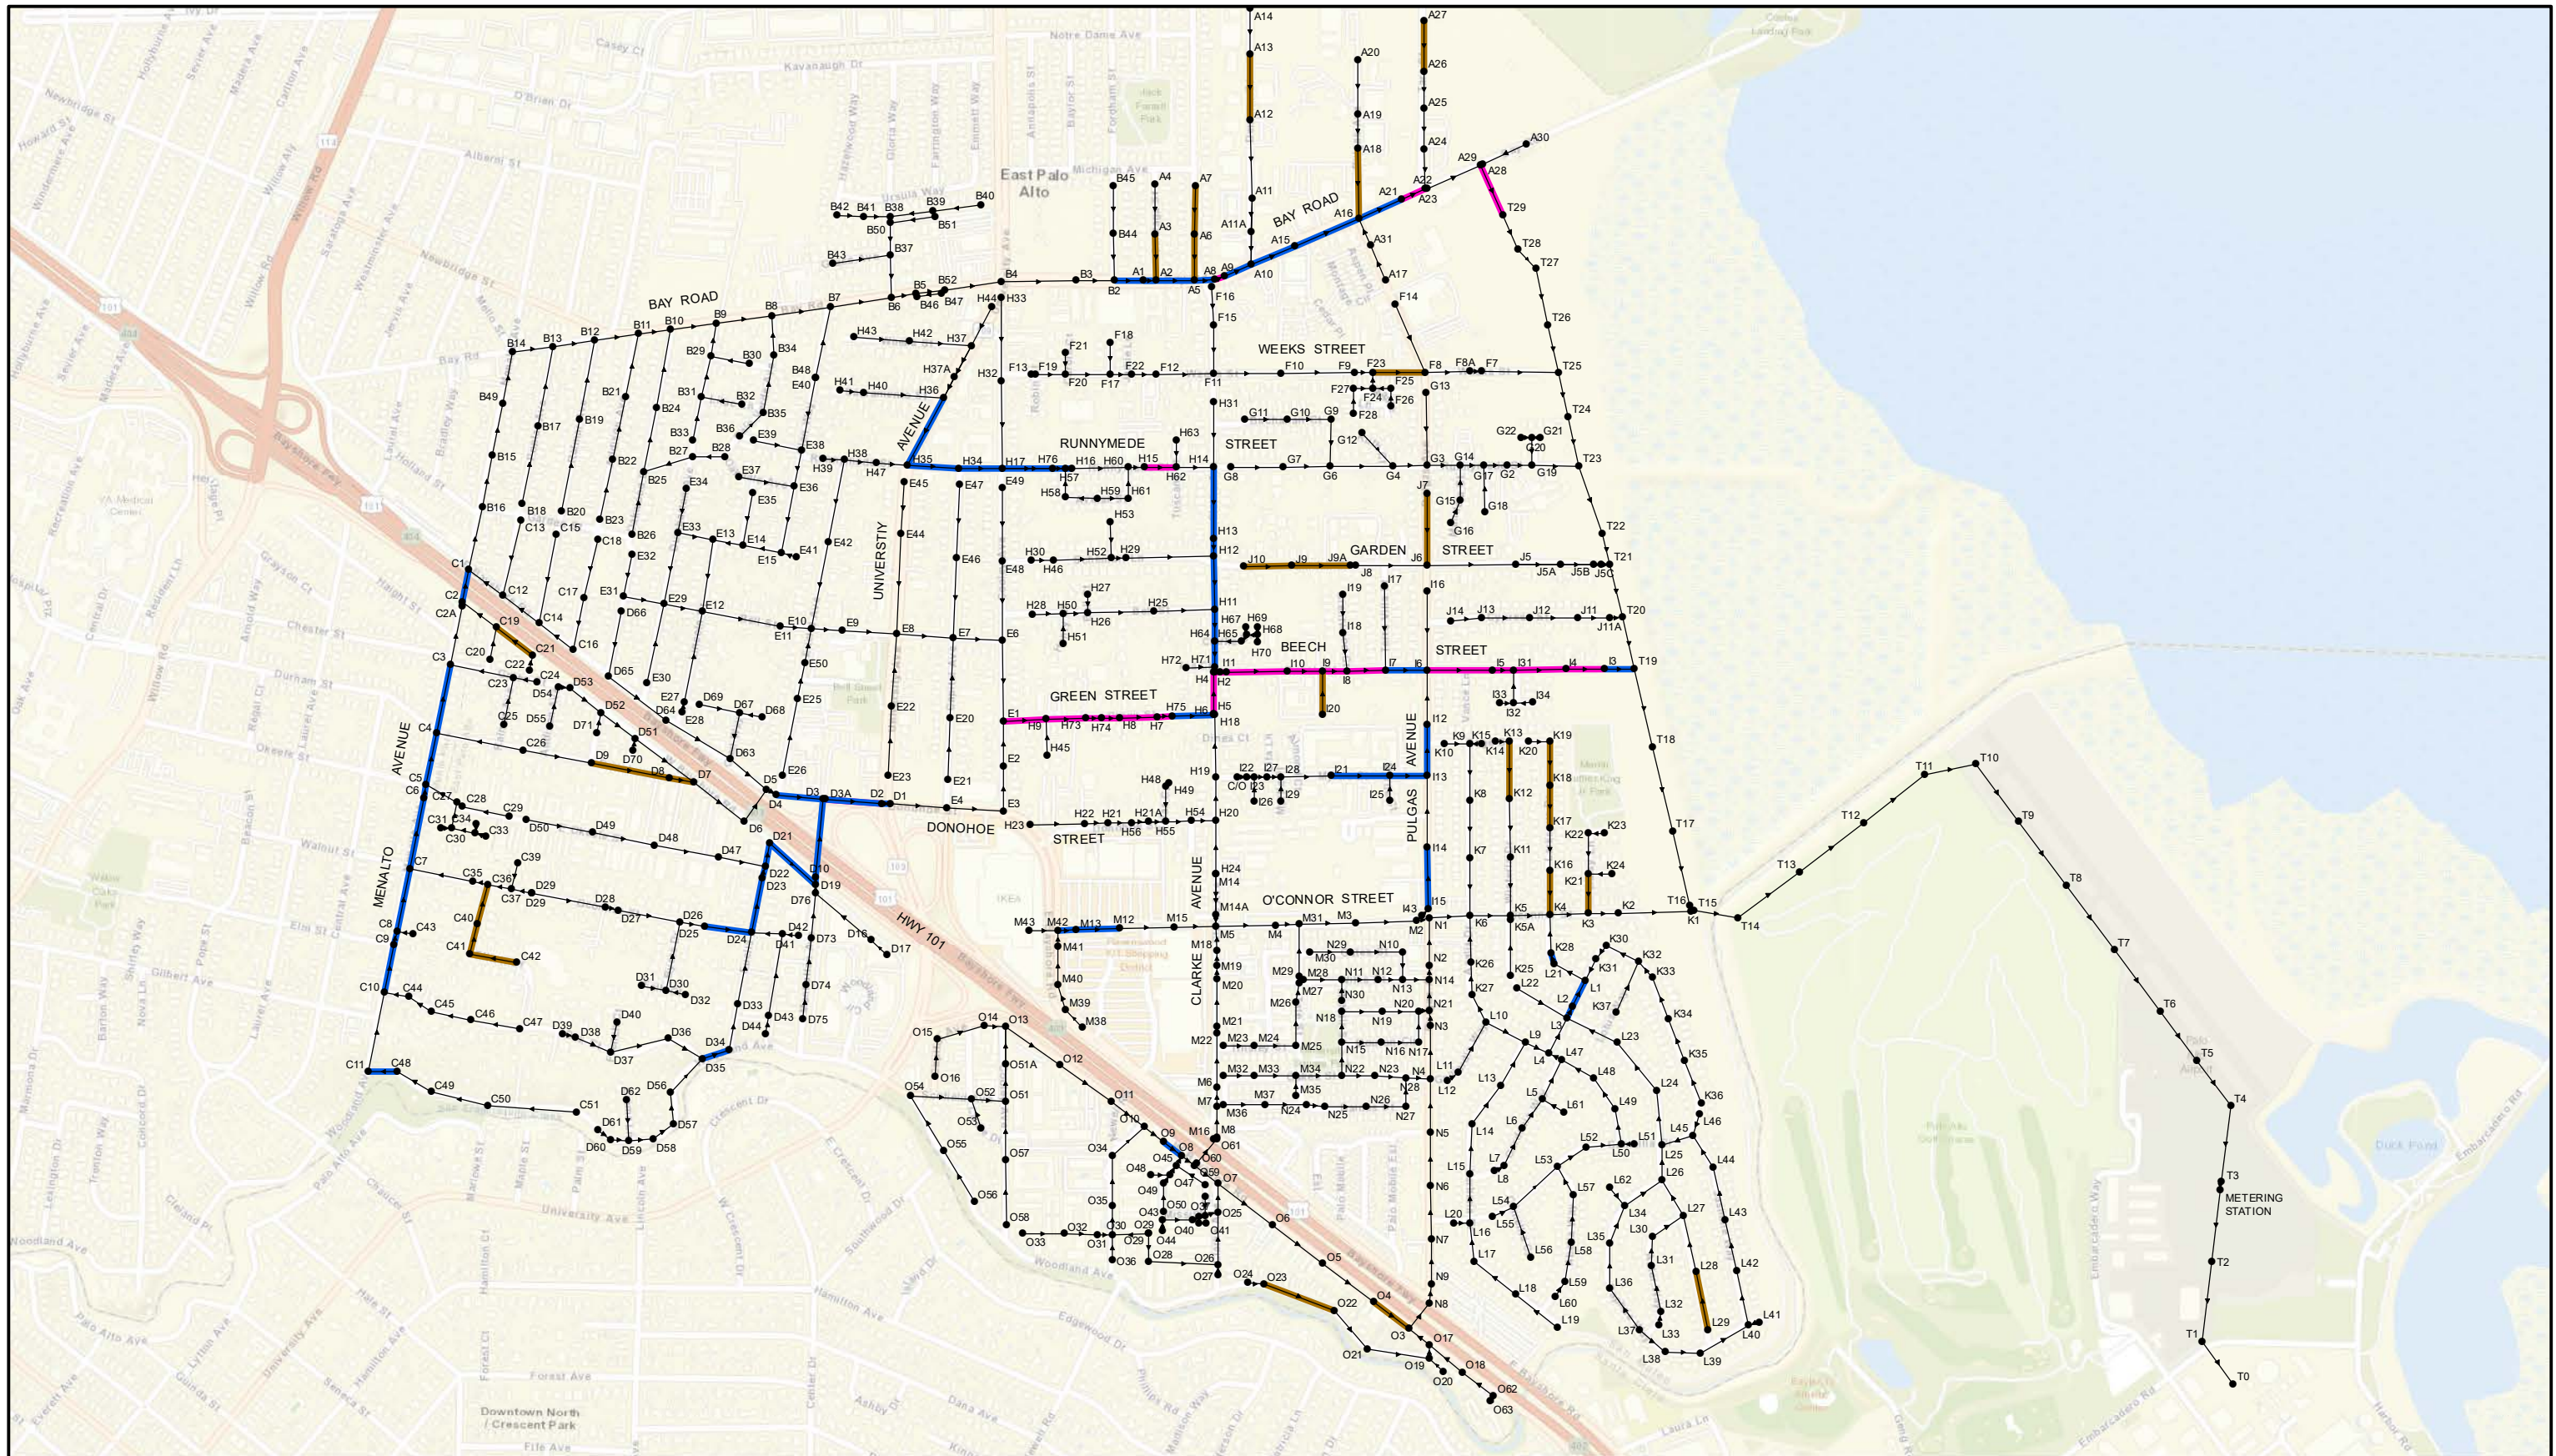
Pipeline segments with a Total Score greater than 75 were selected as the group of pipelines to be replaced (Table 7). A geographic information system (GIS) was used to generate Figure 4 showing the pipelines that need to be replaced.
