COUNTY OF SAN MATEO

Burlingame Hills  
Sewer Maintenance District

SEWER MASTER PLAN

Prepared by:  
Brown and Caldwell  
December 1999

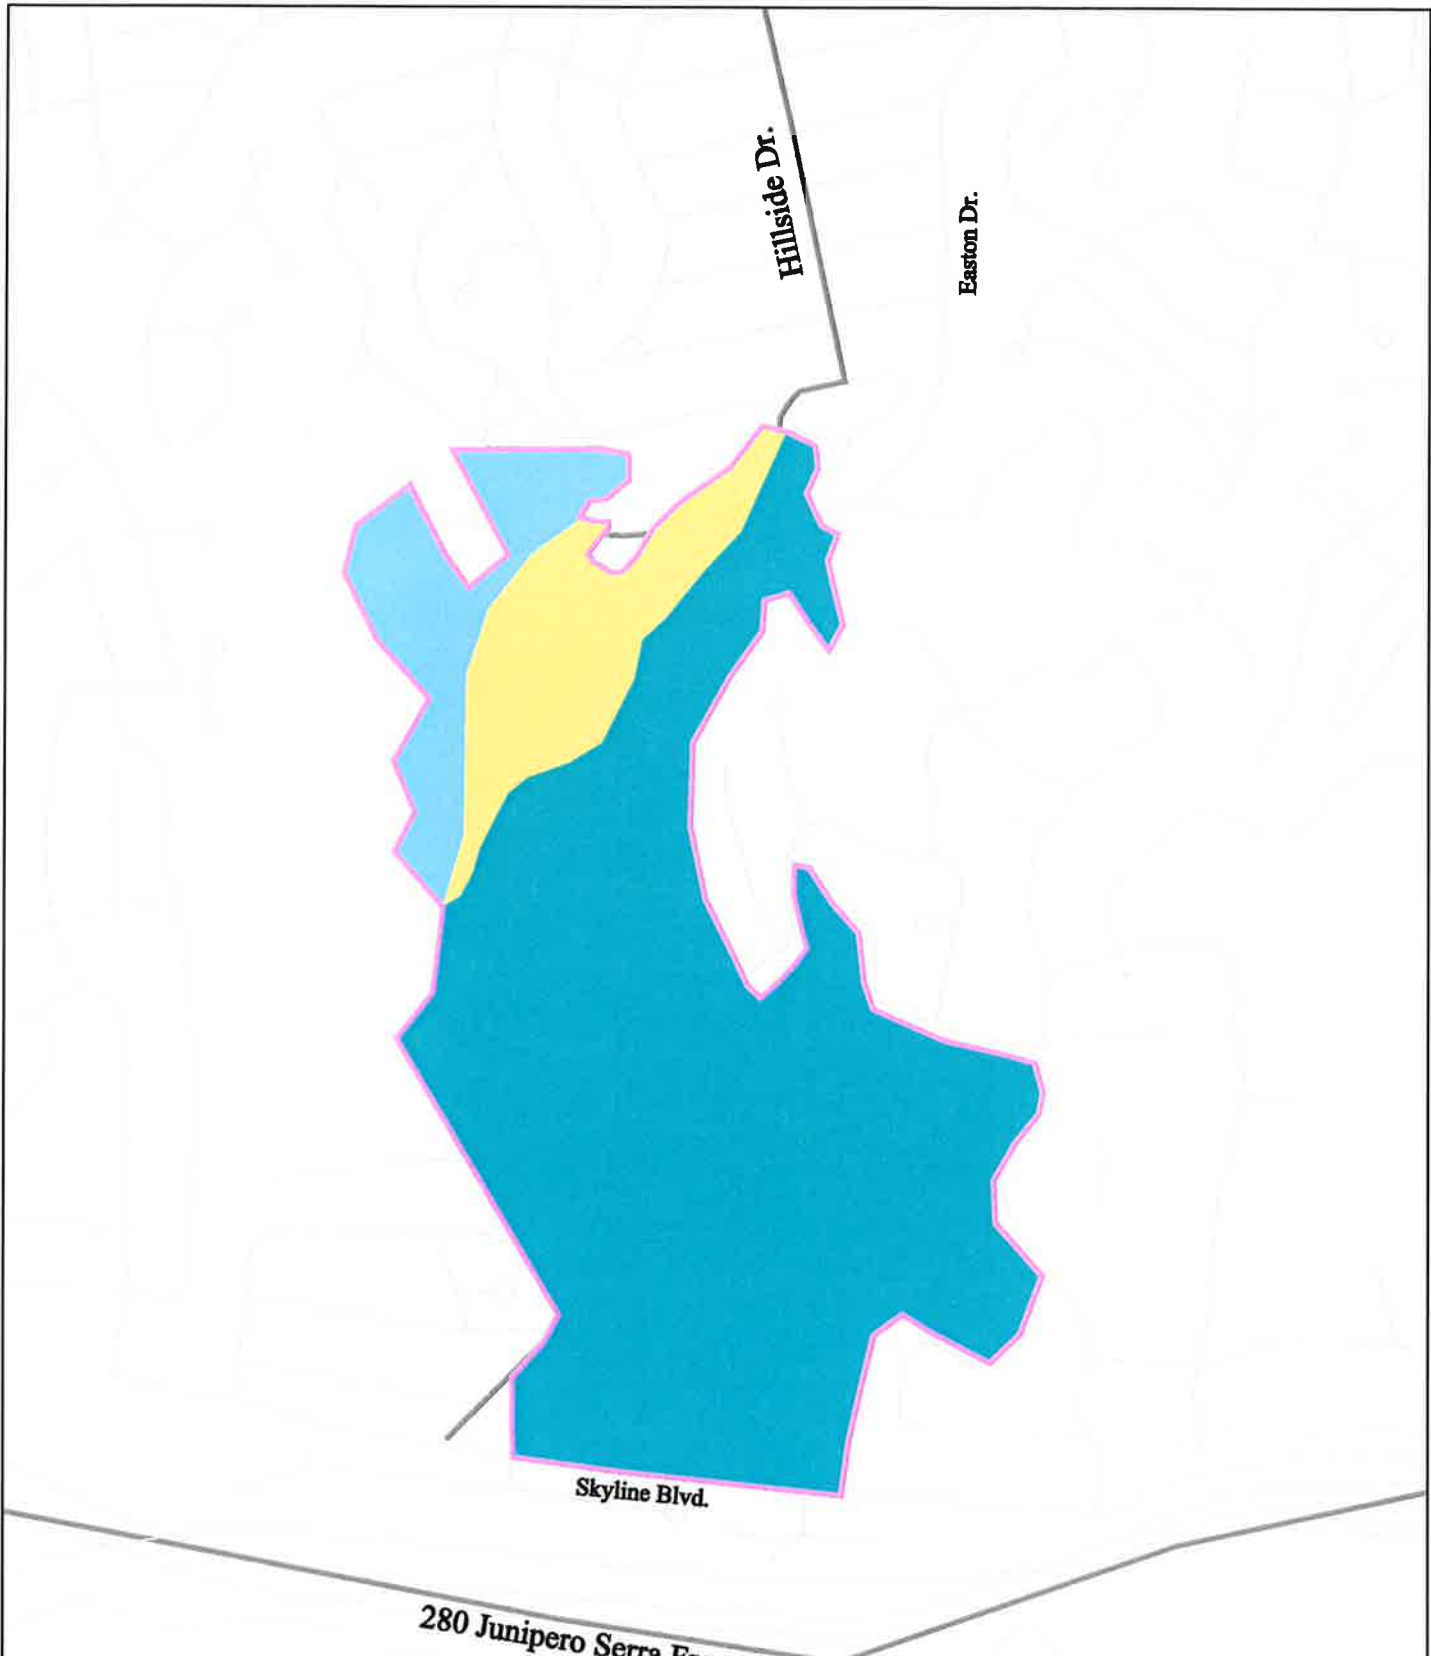
**Smoke Testing Areas**  
**Figure 6-1**

No major defects were noted during the smoke testing program. A total of 57 defects were located and documented during the program. The most prevalent defect was missing or damaged cleanout covers. The majority of these defects are located on the private side of the property line. A summary of the smoke testing defects is provided in Table 6-1. A technical memorandum, dated October 13, 1998, describing the smoke testing program in more detail is provided in Appendix C. Smoke testing reports and photographs are also provided in Appendix C.

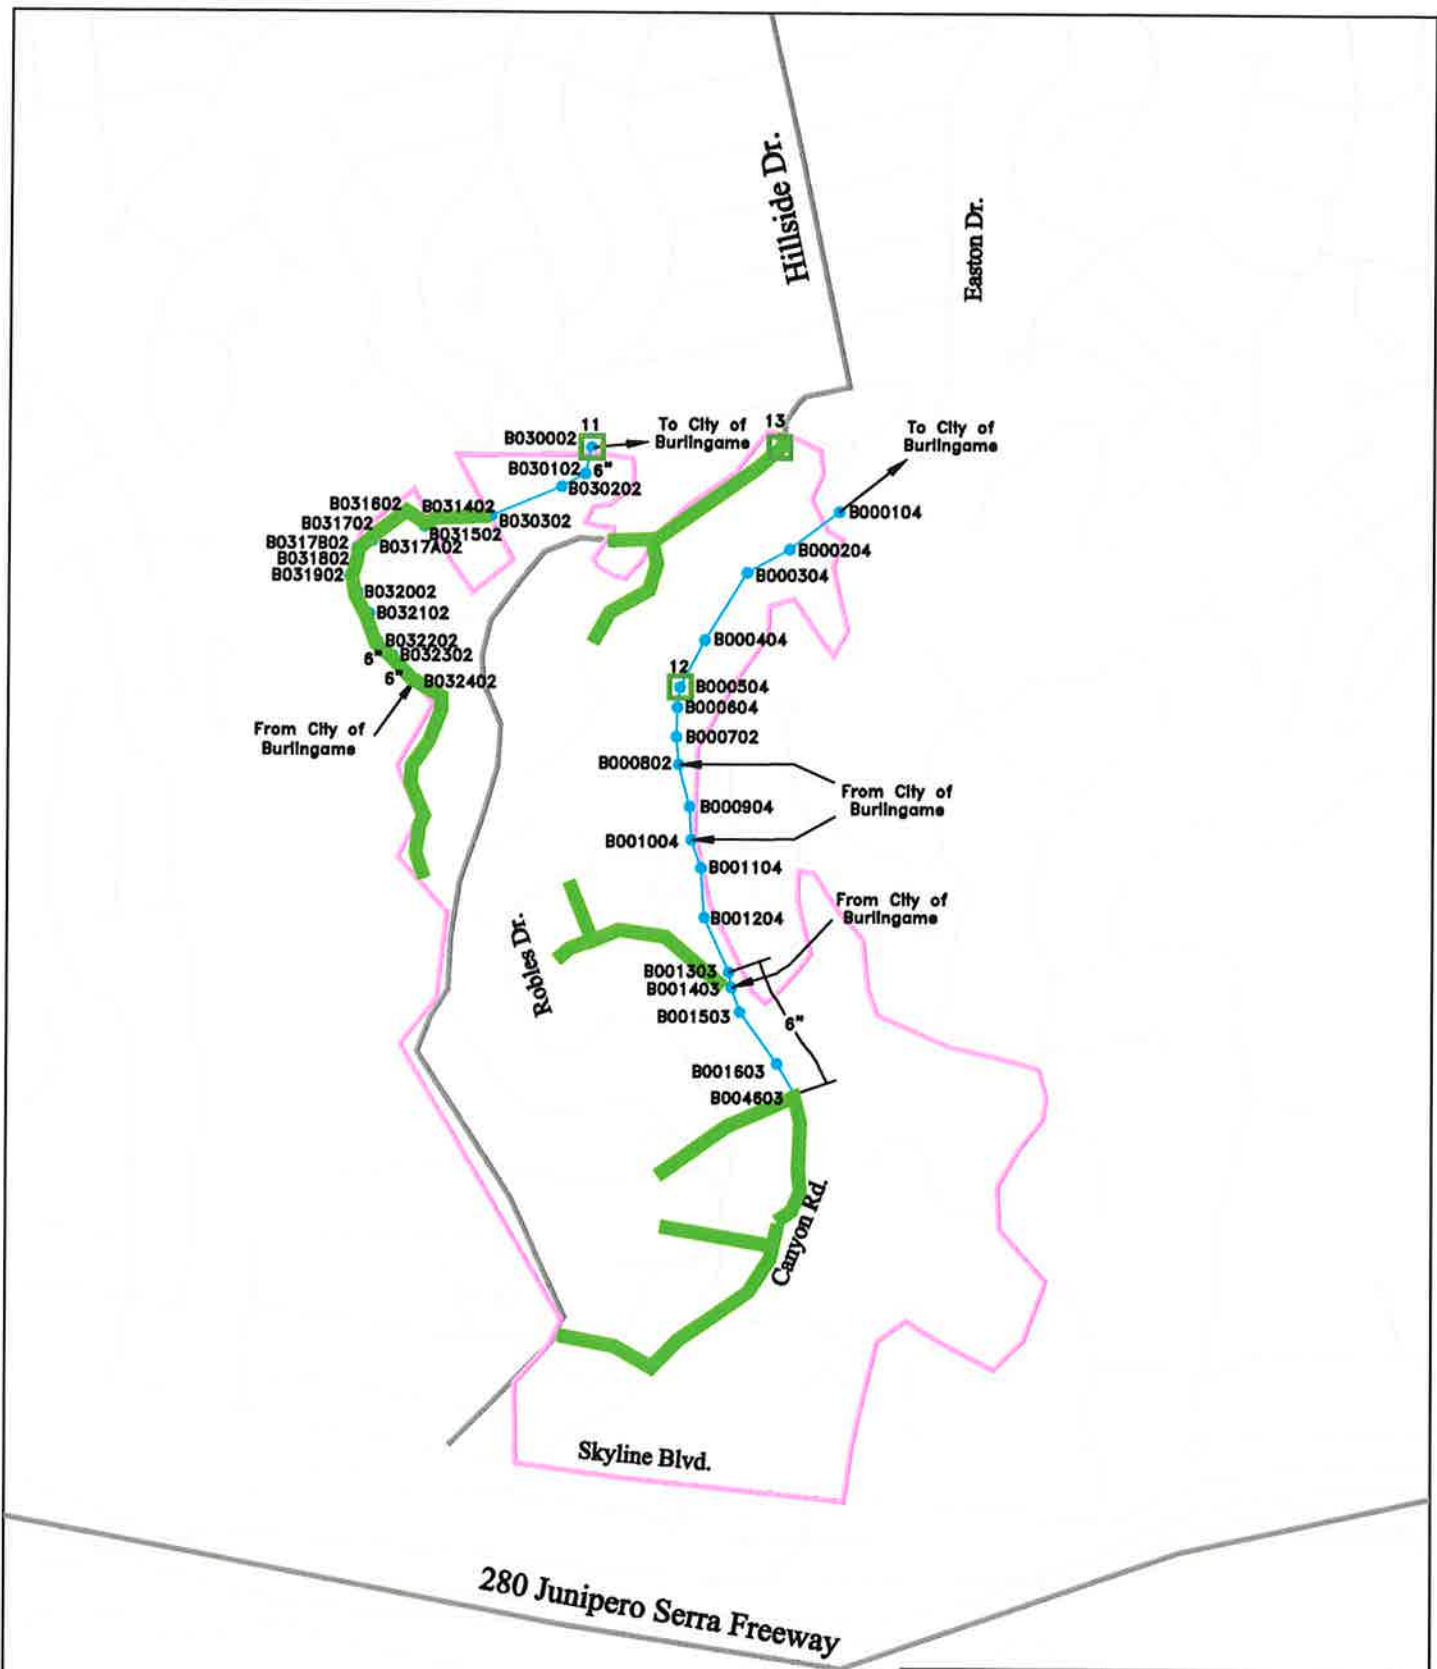
# Television Inspection Program

Sewers scheduled for television inspection were cleaned or flushed prior to inspection to allow for a better structural inspection. Approximately 3,100 linear feet of mainline sewer could not be inspected due to severe defects in the line, which blocked the path of the camera, or lack of access to the sewer. When a severe defect was encountered, the camera setup was reversed to attempt an inspection of the sewer whenever possible. Results of the television inspection program are summarized in Table 7-1. Complete results of the program are provided in Appendix D.

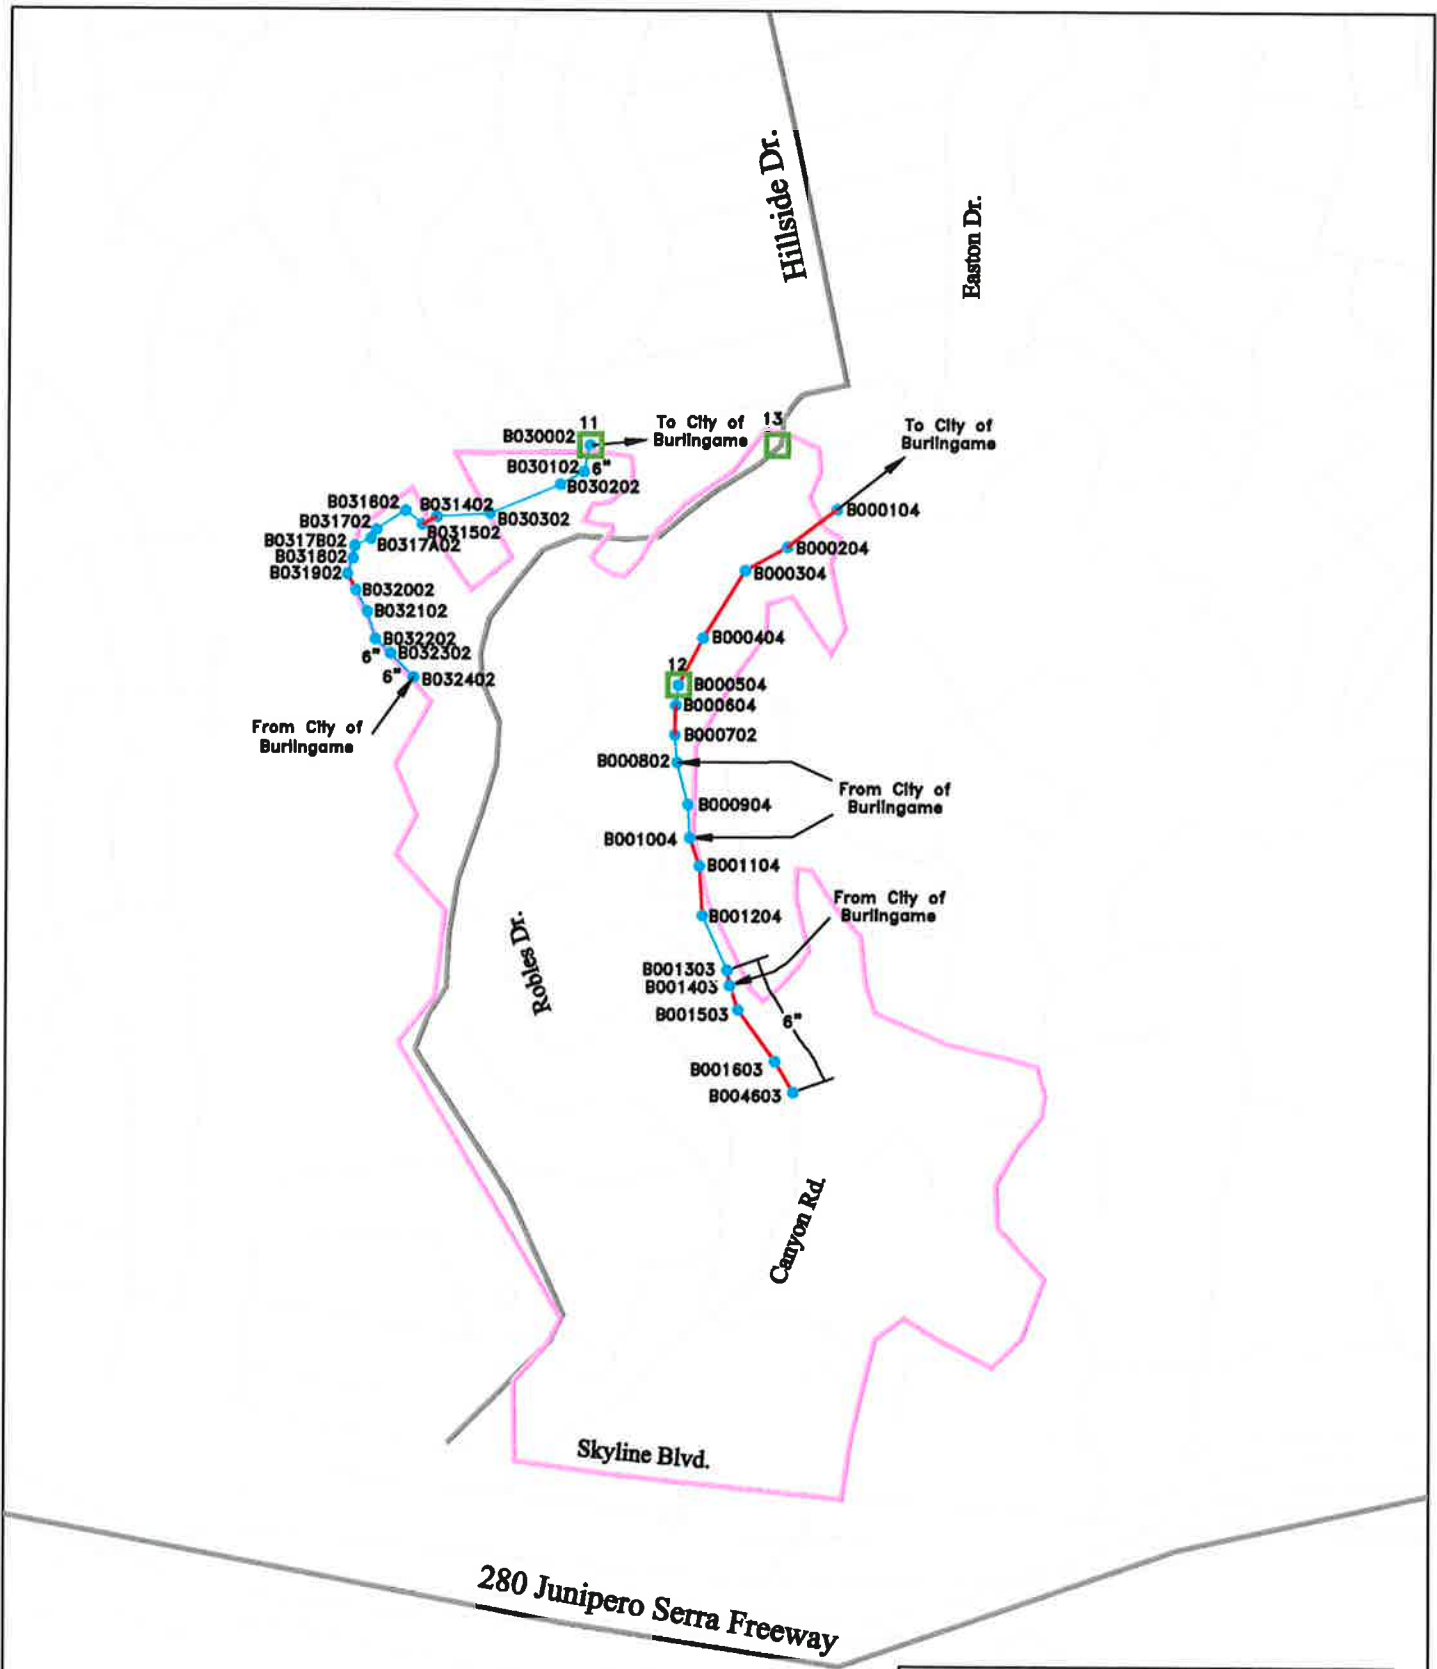
**Model Results**  
**Figure 11-1**

The results of the model indicate that nearly all of the Canyon Road trunk sewer has insufficient capacity. This includes both the 6-inch and 8-inch diameter sections of the trunk sewer. Additionally, several localized sections of the trunk sewer on Adeline Drive are hydraulically inadequate. Model results are shown on Figure 11-1. The technical memorandum describing the flow development and modeling is provided in Appendix E. Additionally, the complete HYDRA modeling results are provided in Appendix E.
