MEMORANDUM

DATE: January 19, 2024
TO: Mark Chow, County of San Mateo
FROM: Ben Shick, PE
SUBJECT: Crystal Springs County Sanitation District – Pipe
and Manhole Assessment and Recommendations

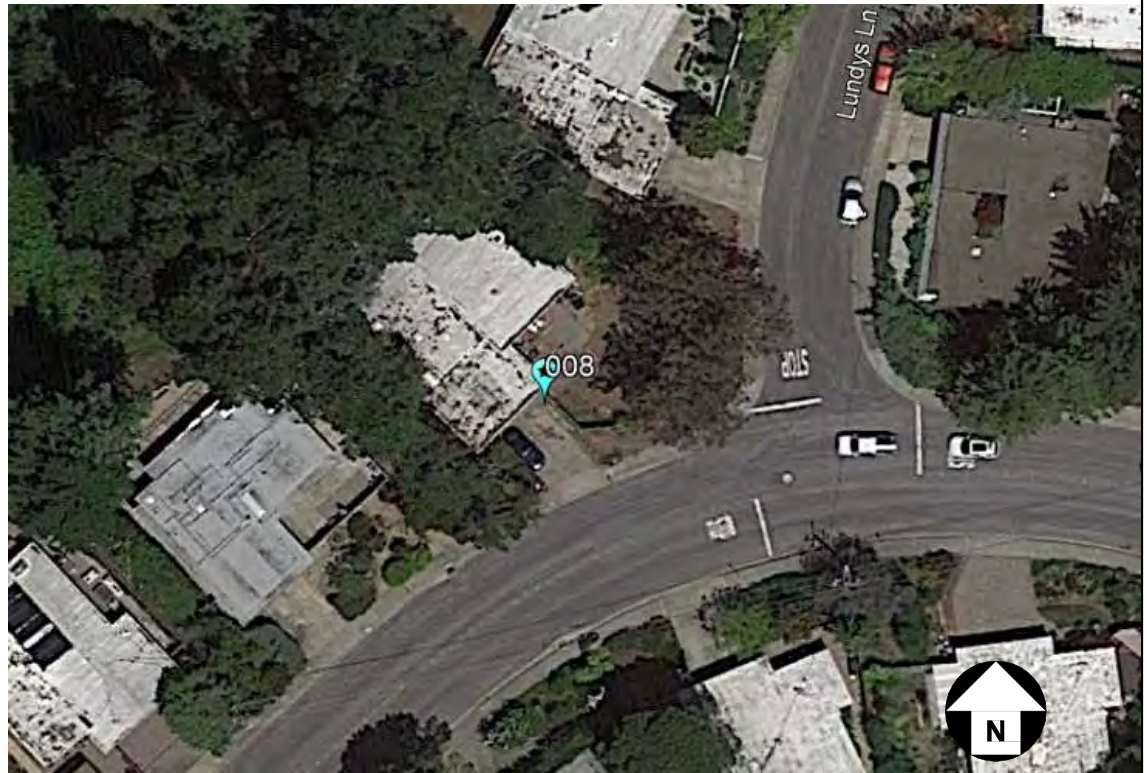
Comments: No Cap

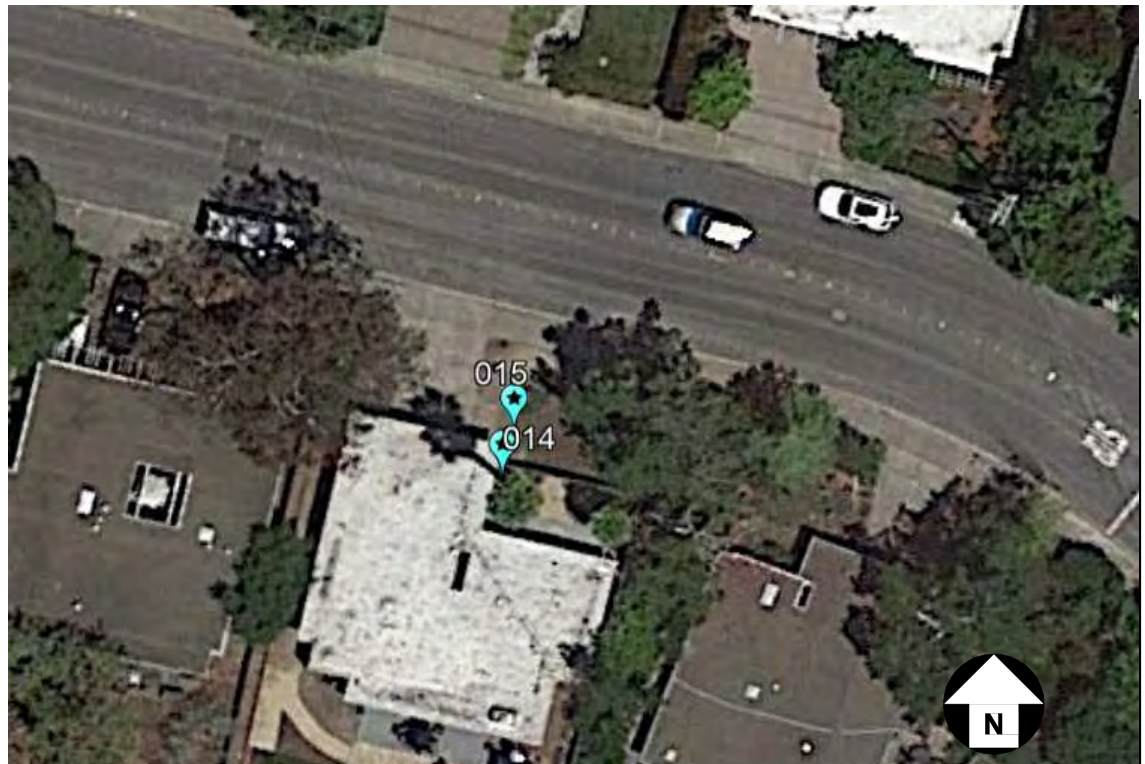
Comments: 014: Cracked lateral near downspout 015: Smoke coming from edge of concrete

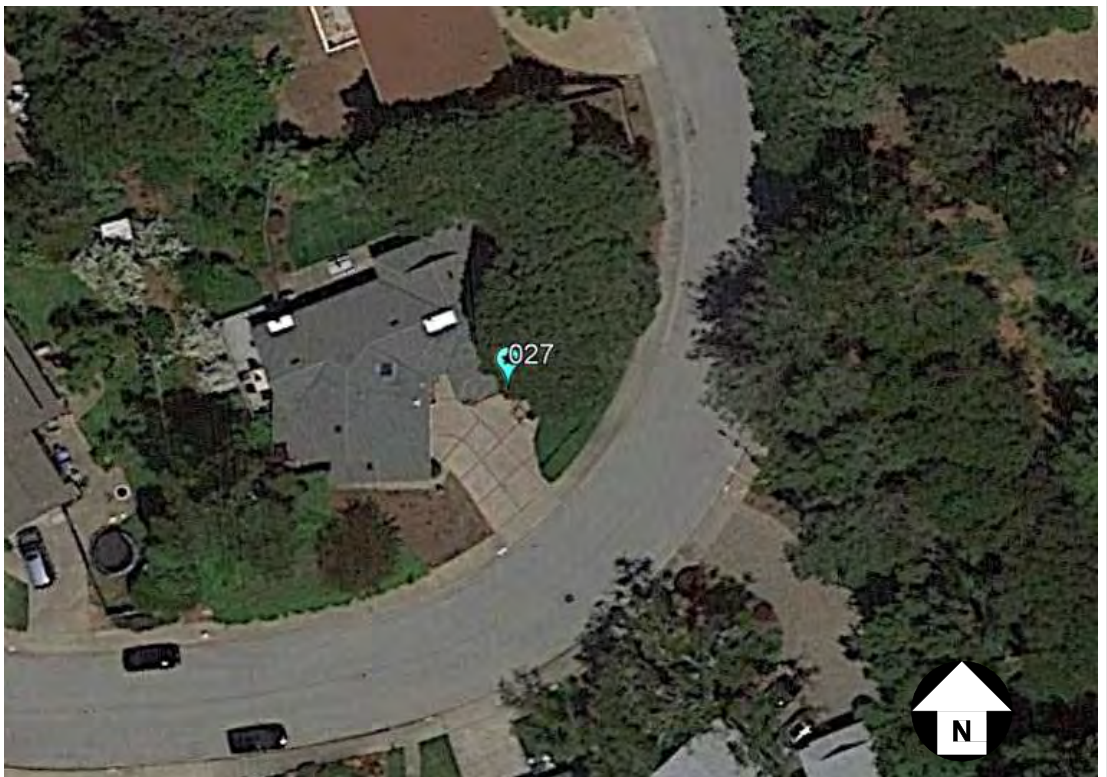
Comments: Area drain not lowest point

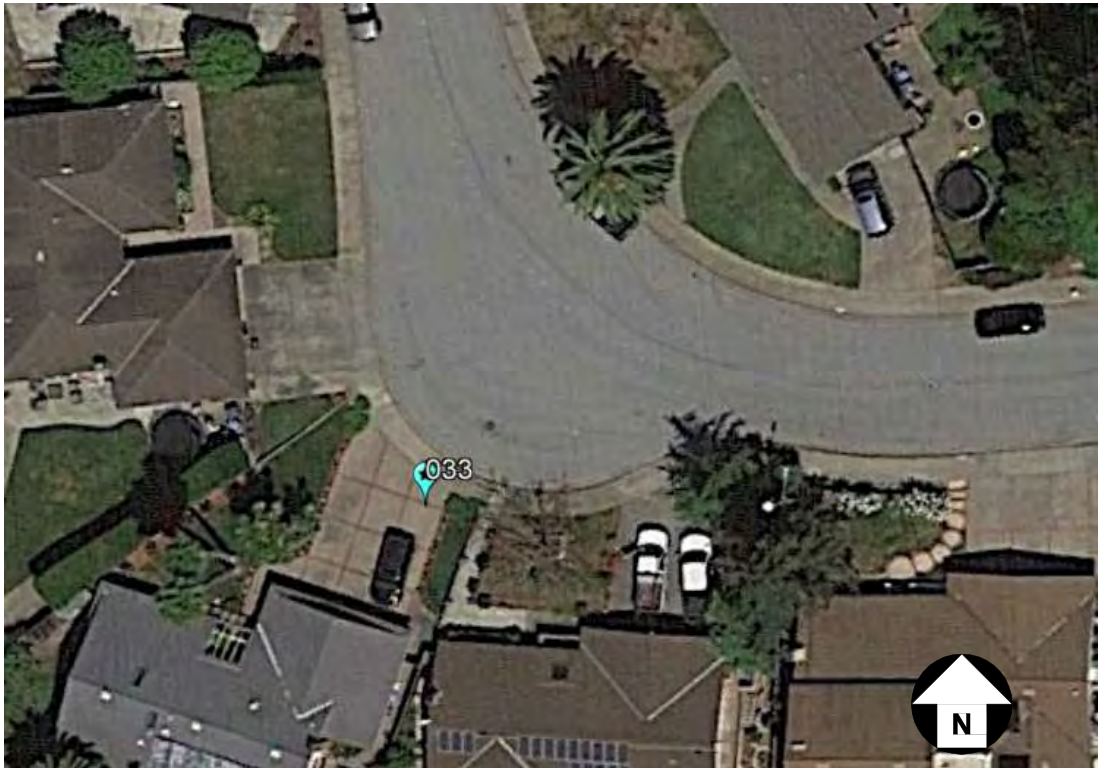
Comments: Rusty/Deteriorated Cap

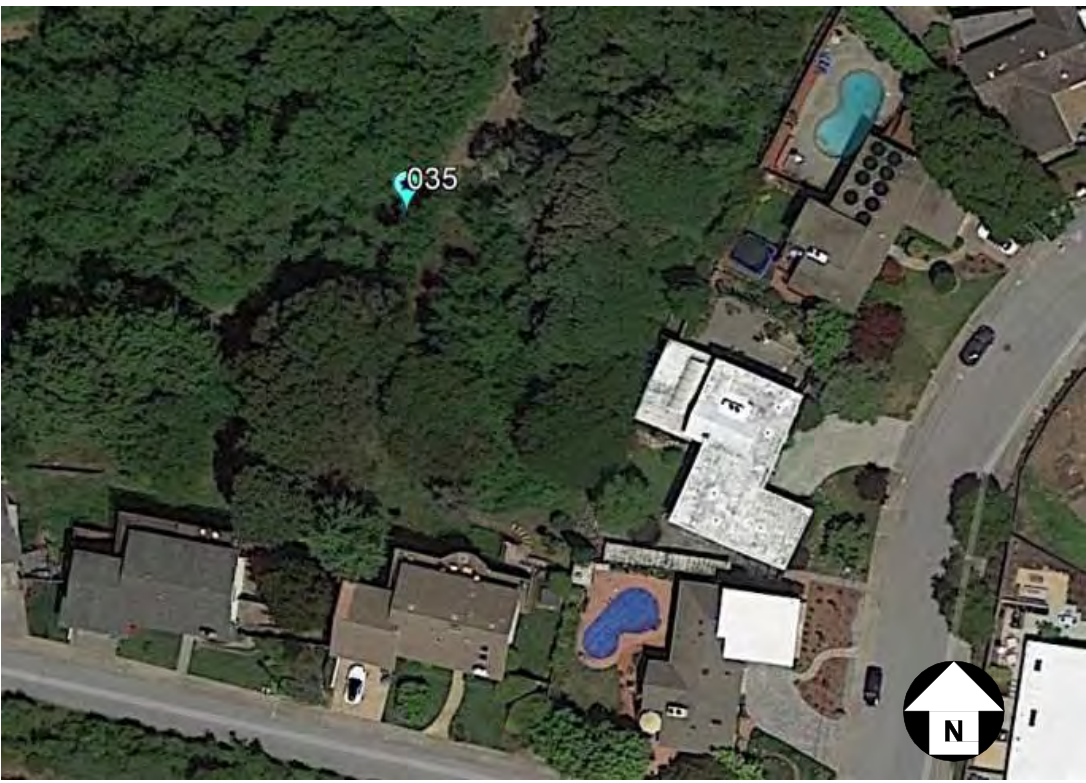
Comments: Pipe surcharged. Smoke cannot enter this area.

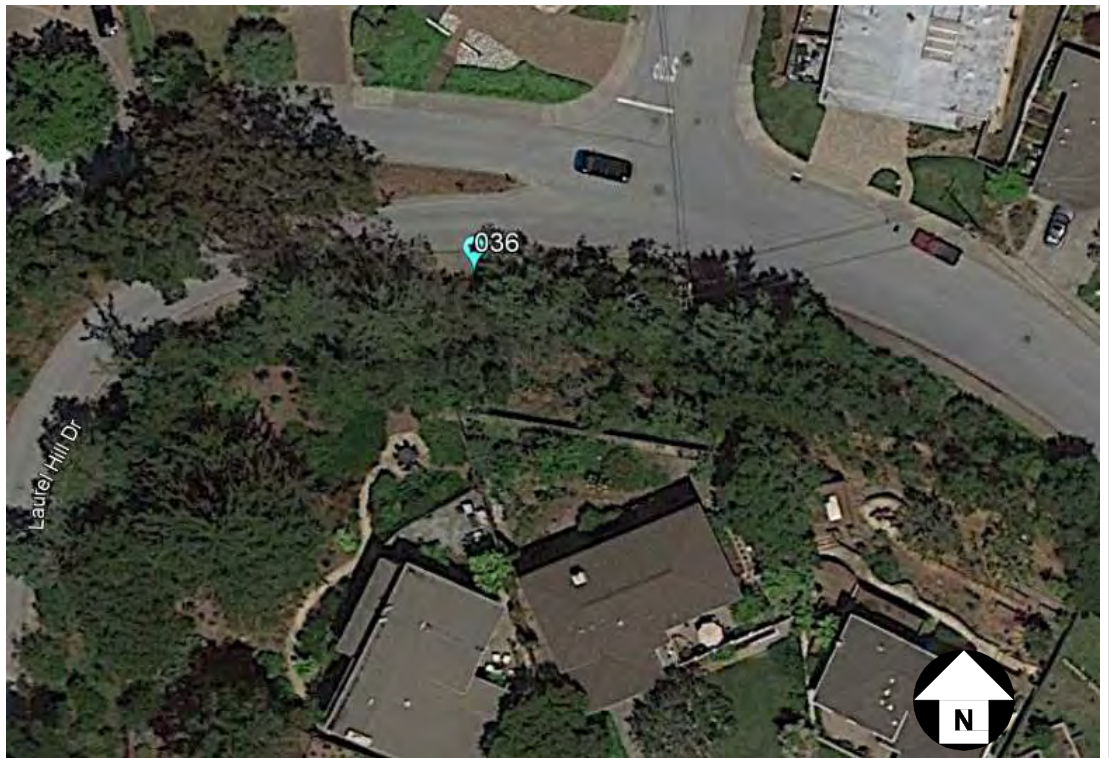
Comments: Missing cap; low spot; Backside of property

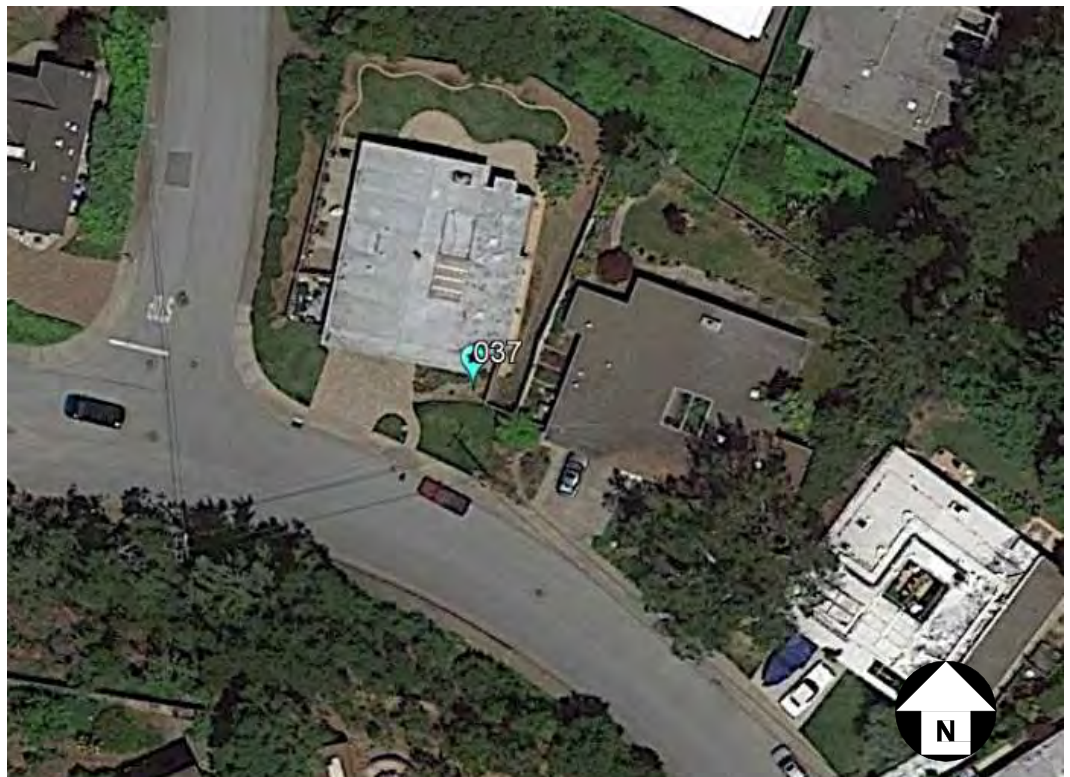
Comments: Missing cap; low spot;

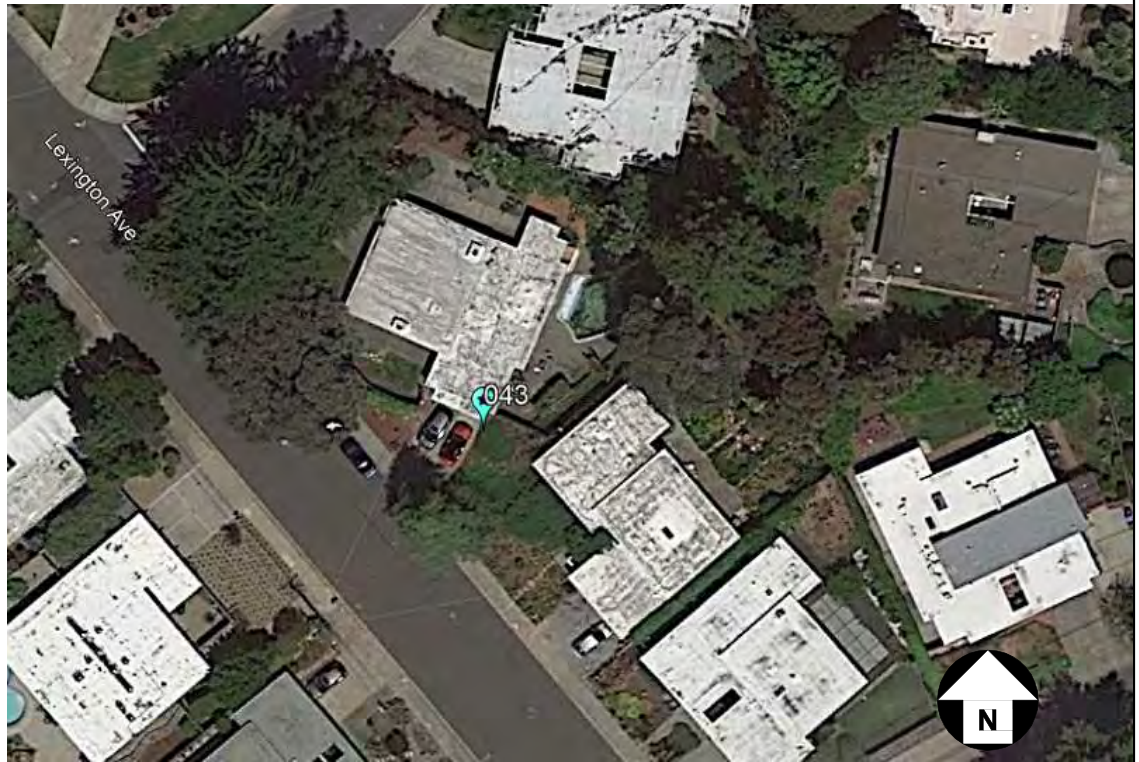
Comments: Downspout draining into cleanout.

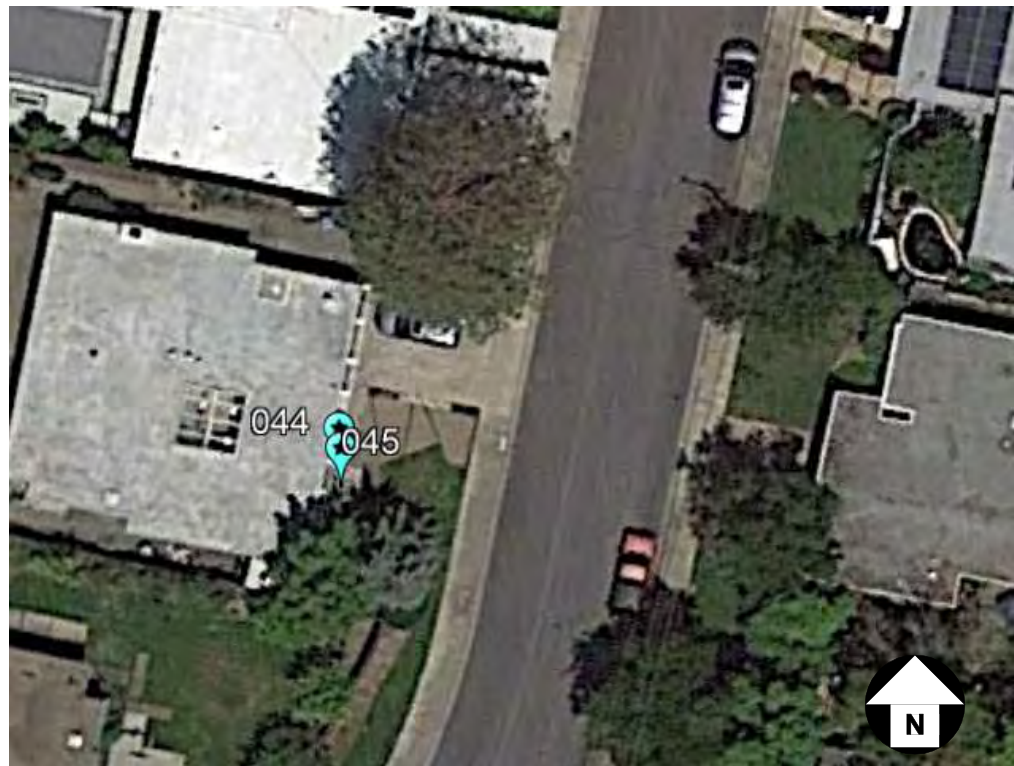
Comments: 044: Cap off/ cleanout box shifted joint and the smoke is spreading into the area.

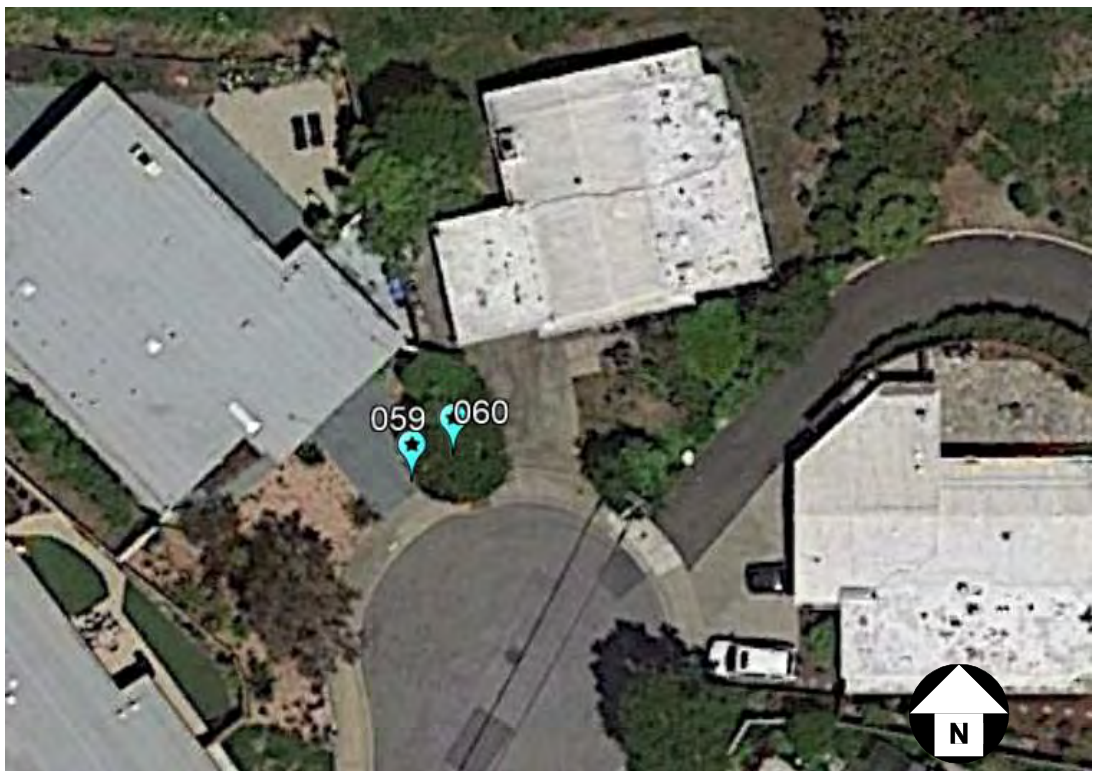
Comments: 059: Smoke coming from concrete joints in driveway. Water should drain into crack
 060: Smoke coming from edge of concrete and dirt. Water should drain into this edge

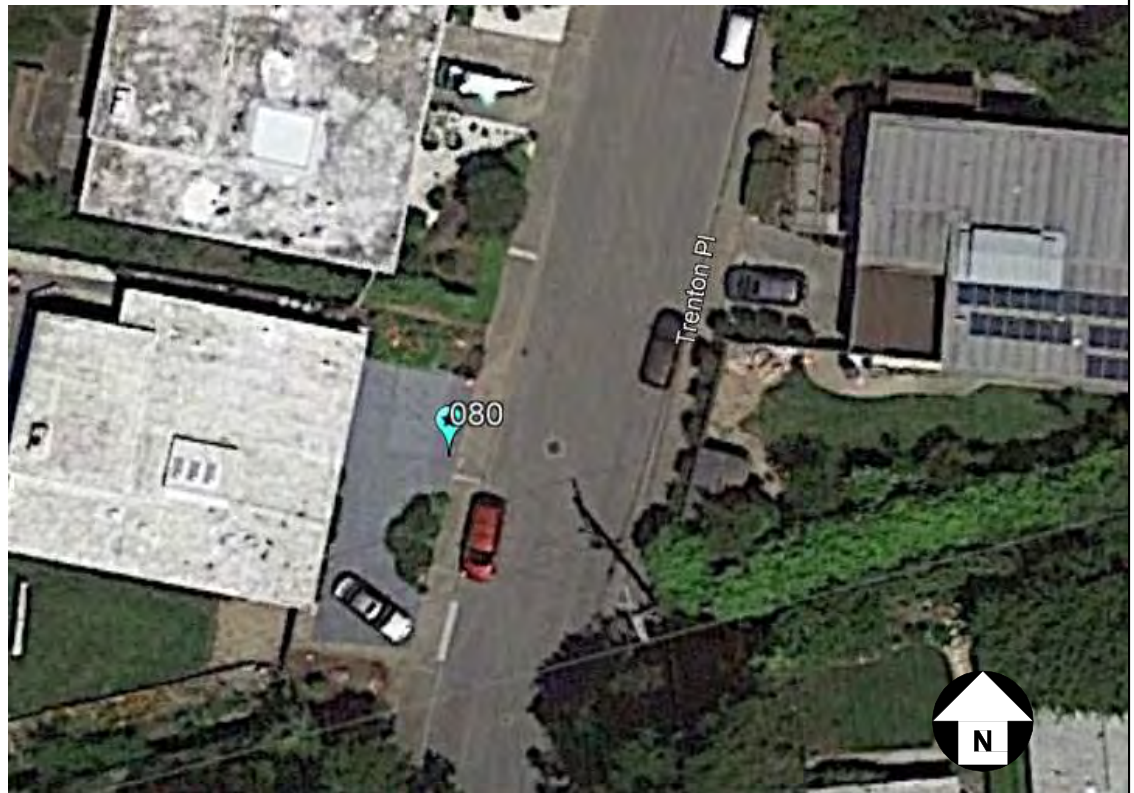
Comments: Not lowest point but water will funnel here.

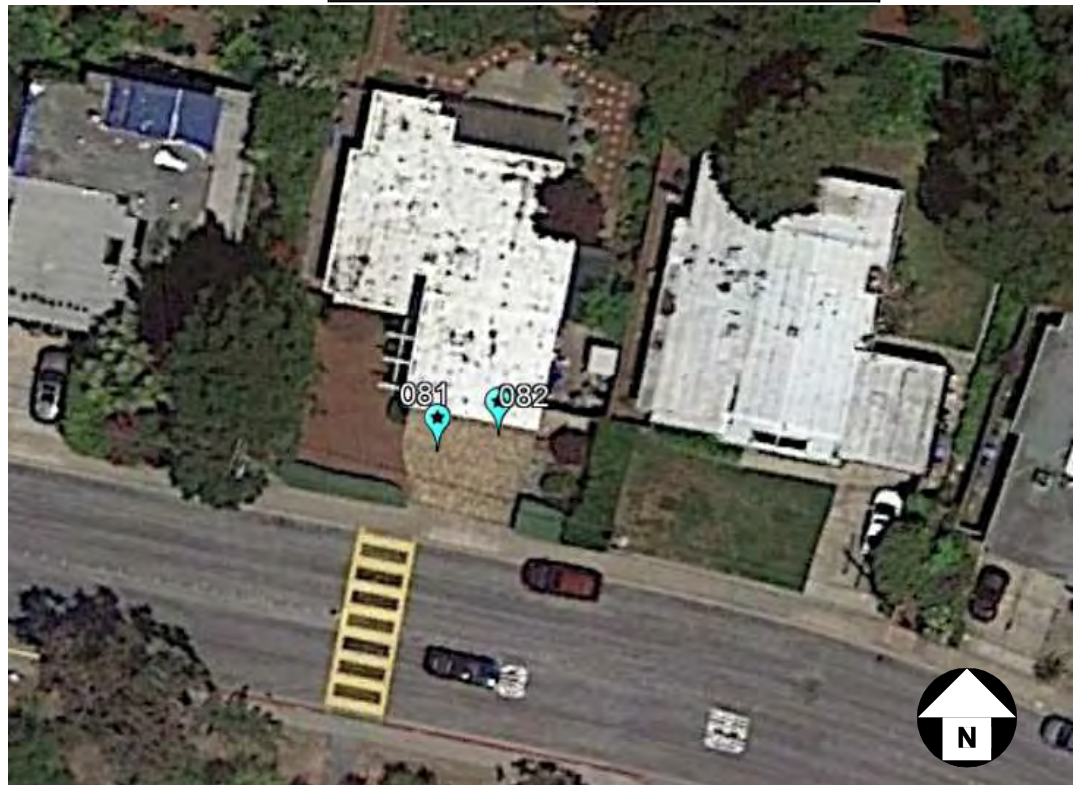
Comments: 081: Area drain low point of driveway. 082: Gutters feed to these drains.

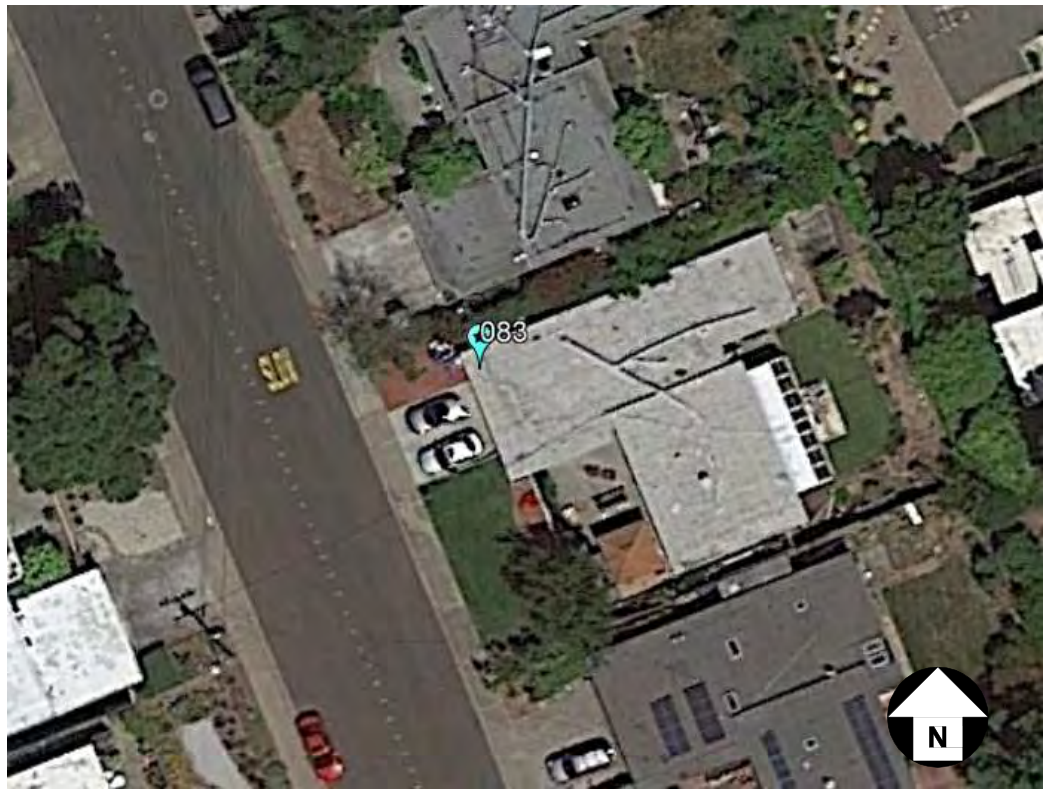
Comments: Main area drain of entire driveway and gutters also drain here

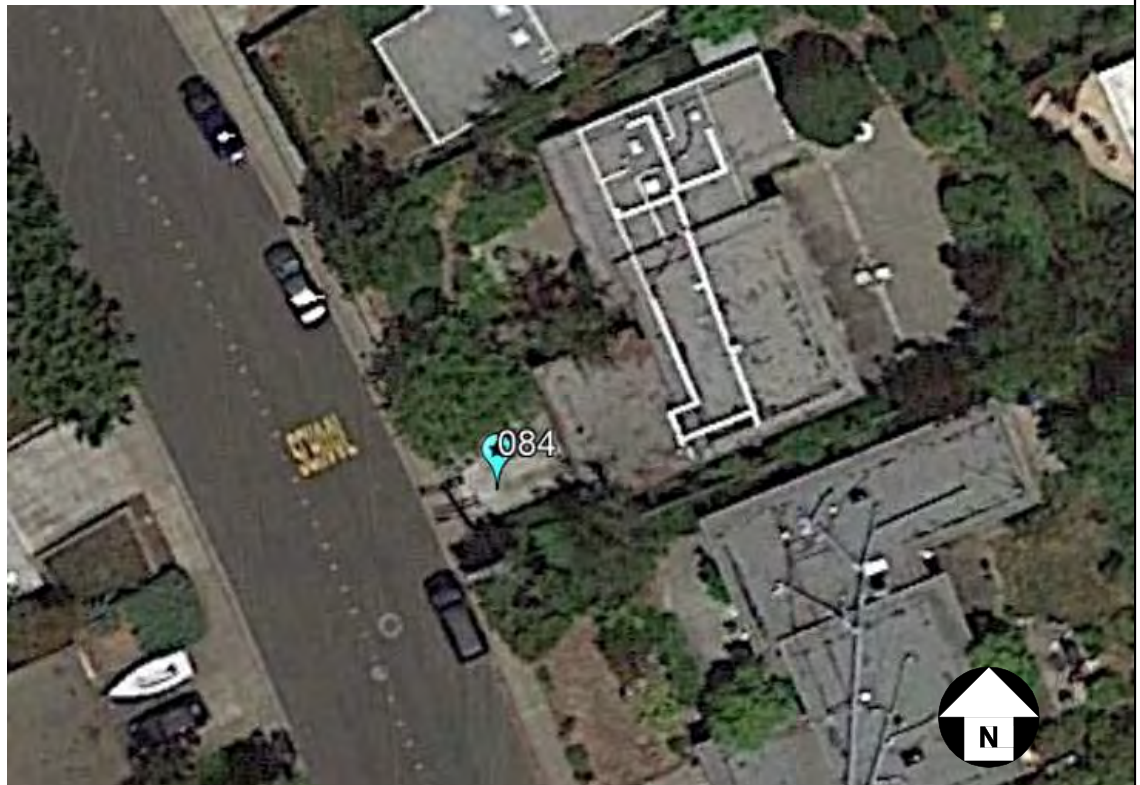
Comments: Not lowest point but does funnel here through pavement groove. Gutter also drain here

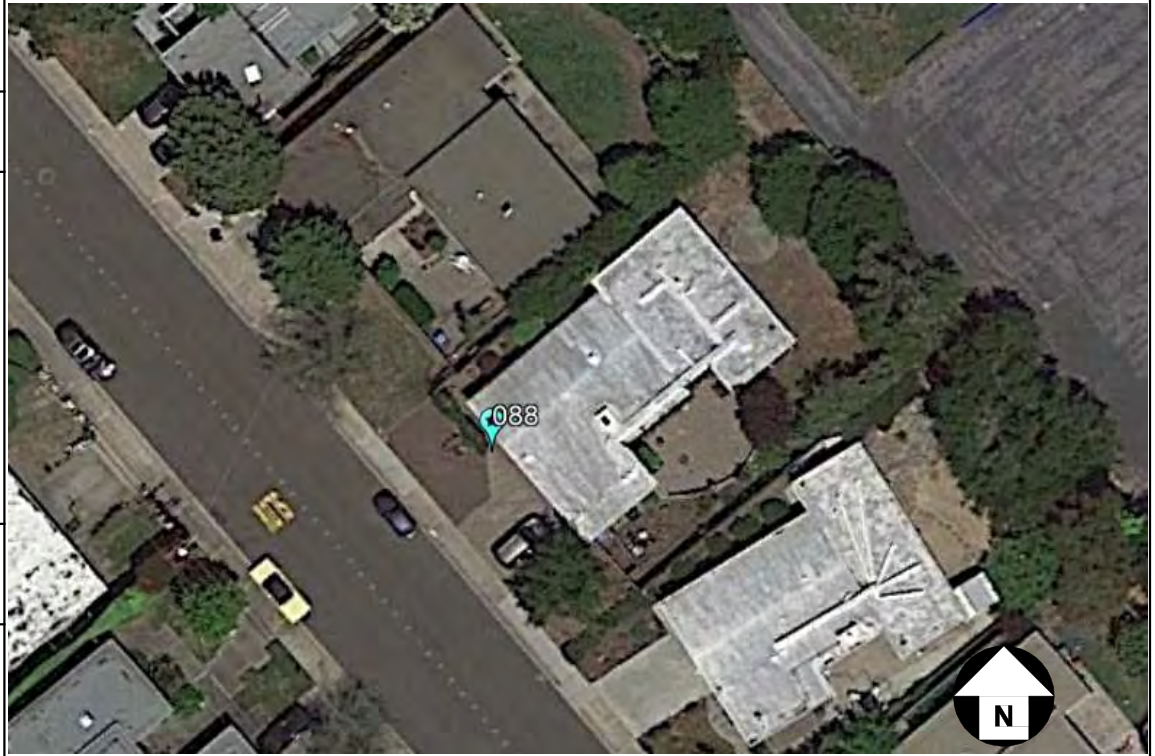
Comments: low spot; cap loose

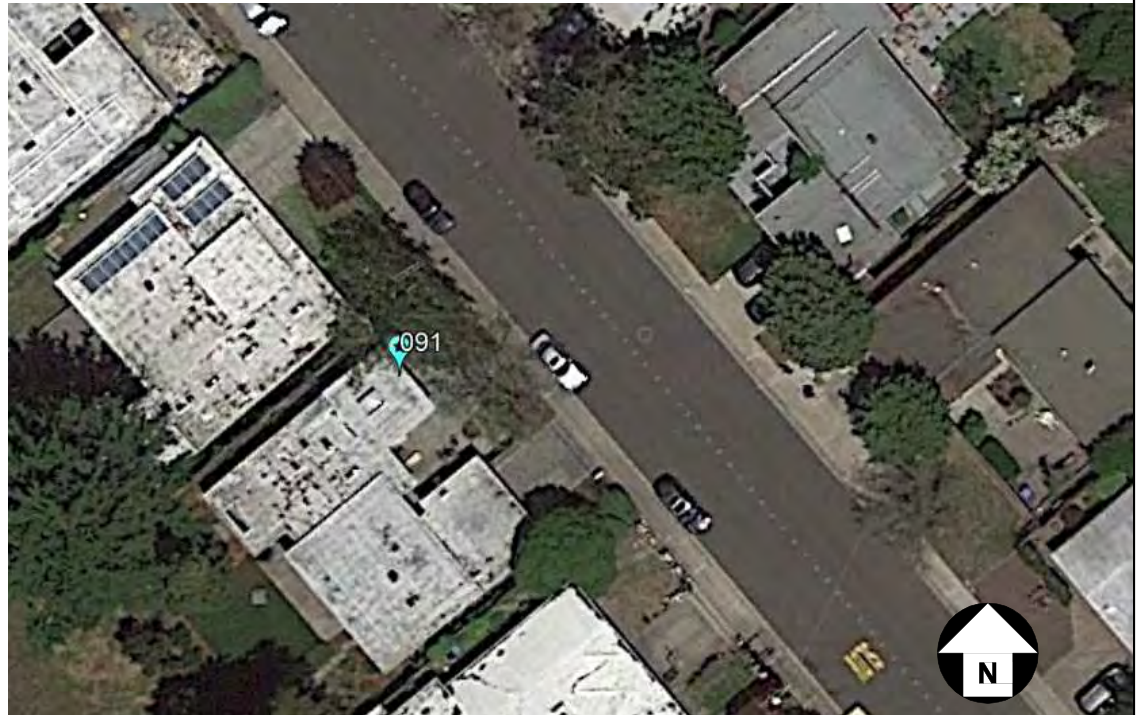
Comments: Area drain or lateral

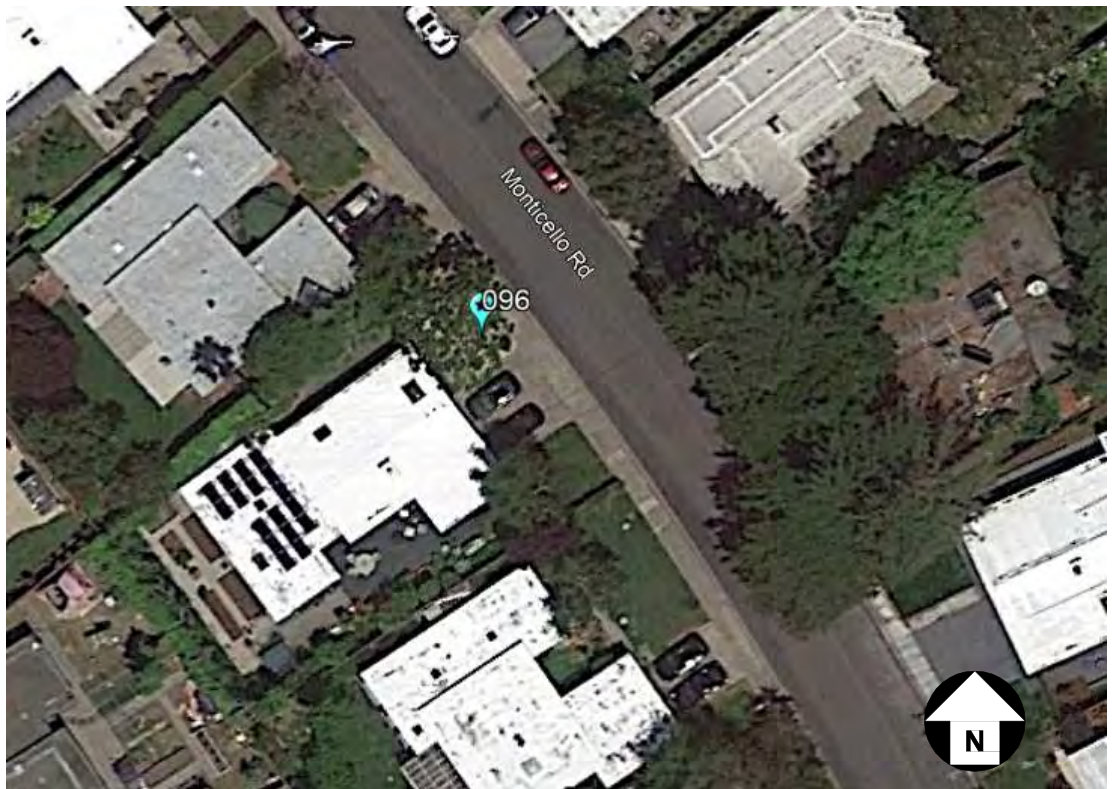
Comments: Rusty/Deteriorated Cap. Low point

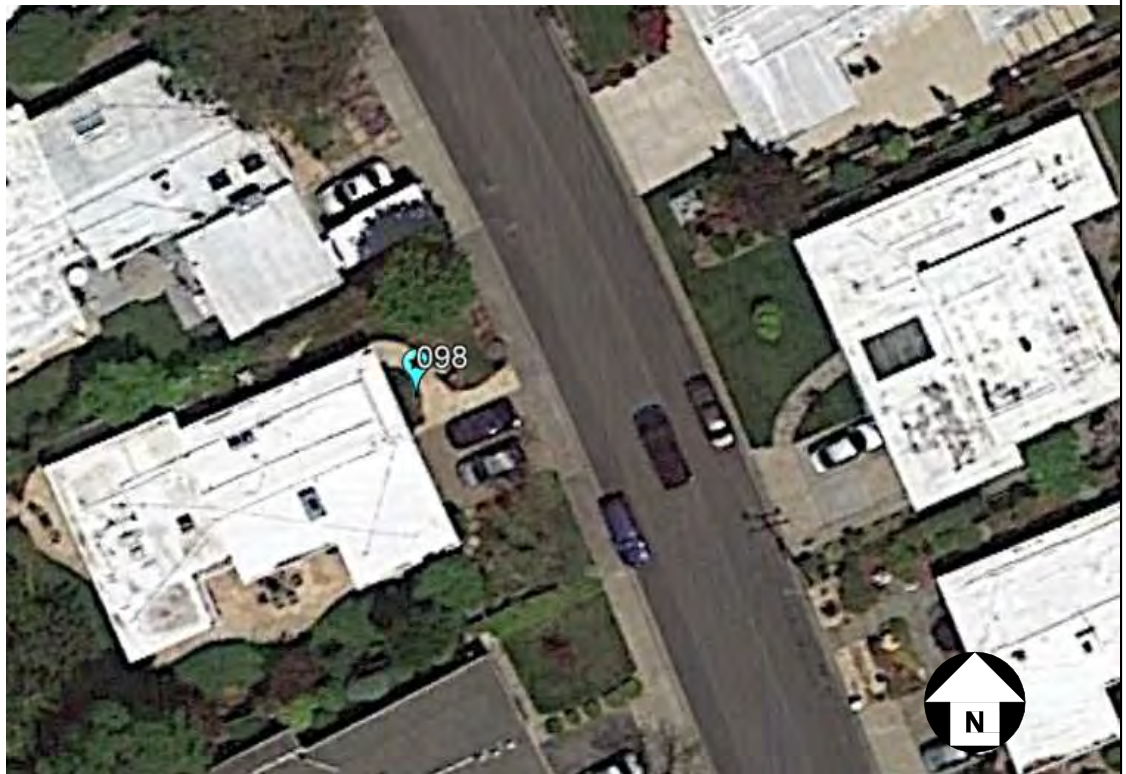
Comments: Cleanout could not be located. Low point near walkway

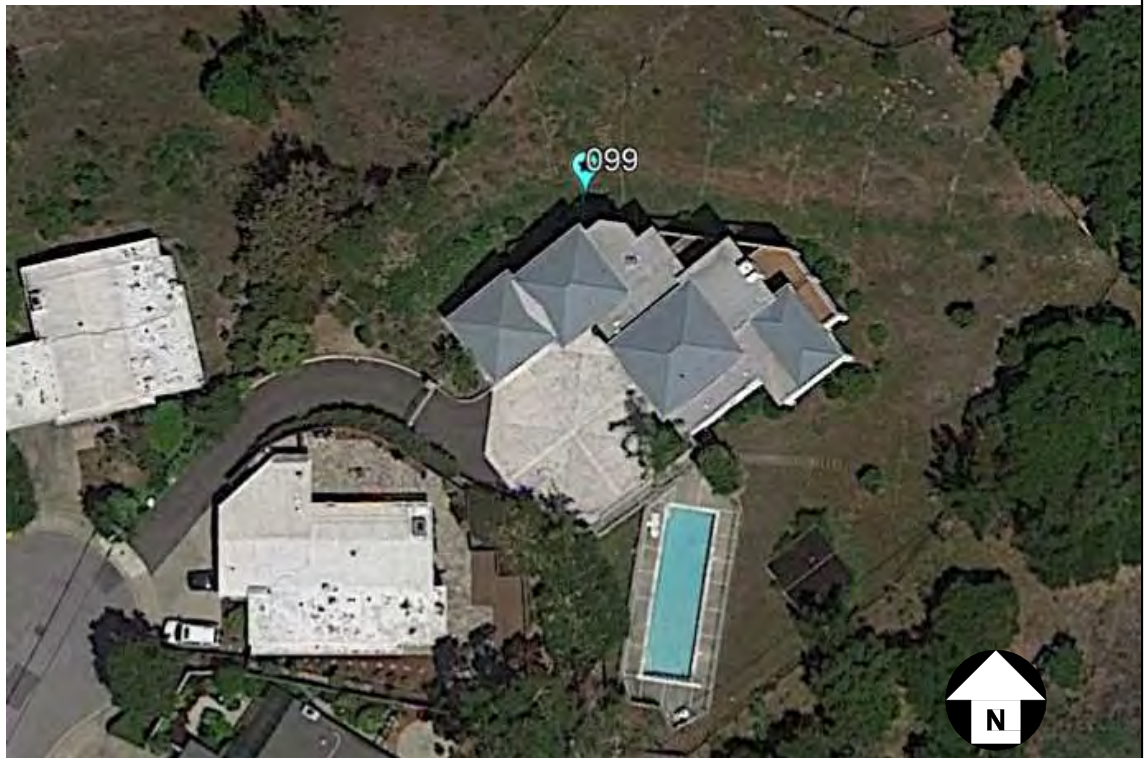
Comments: Sewer manhole lid low point on hill; infiltration disk recommended

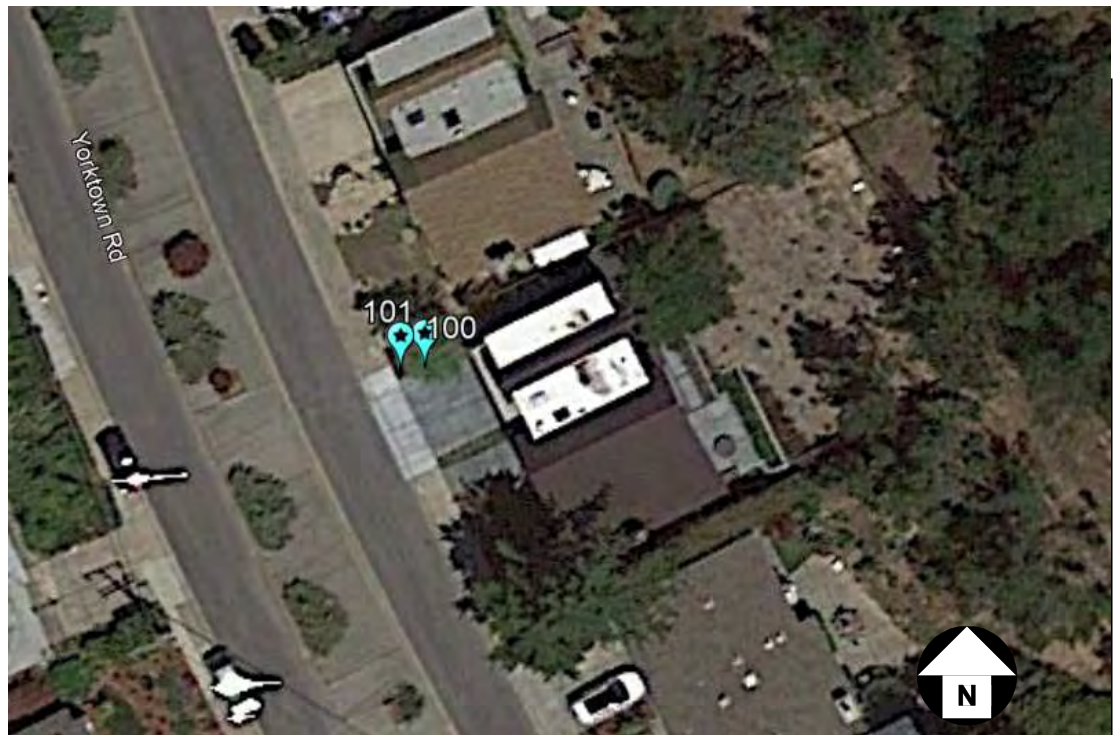
Comments: 100: Smoke coming from edge of pavement. 101: Area drain maybe cleanout

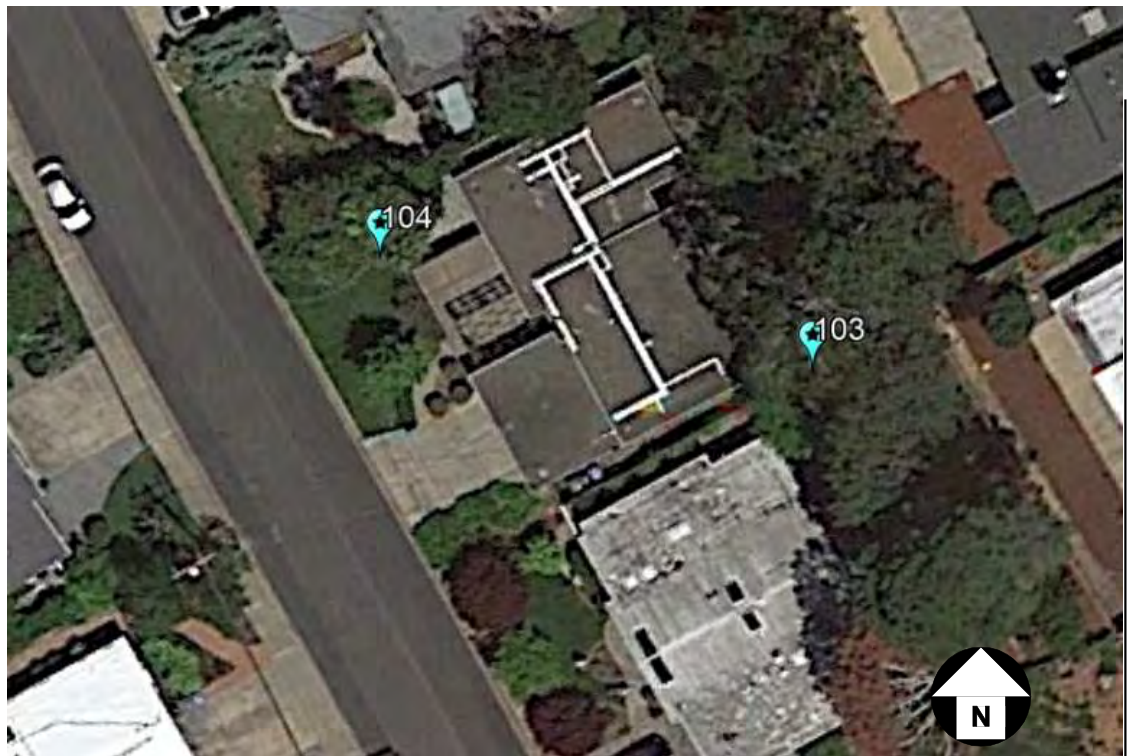
Comments: 103: Sewer manhole lid low point on hill; infiltration disk recommended.
 104: Rusty/ deteriorated cap

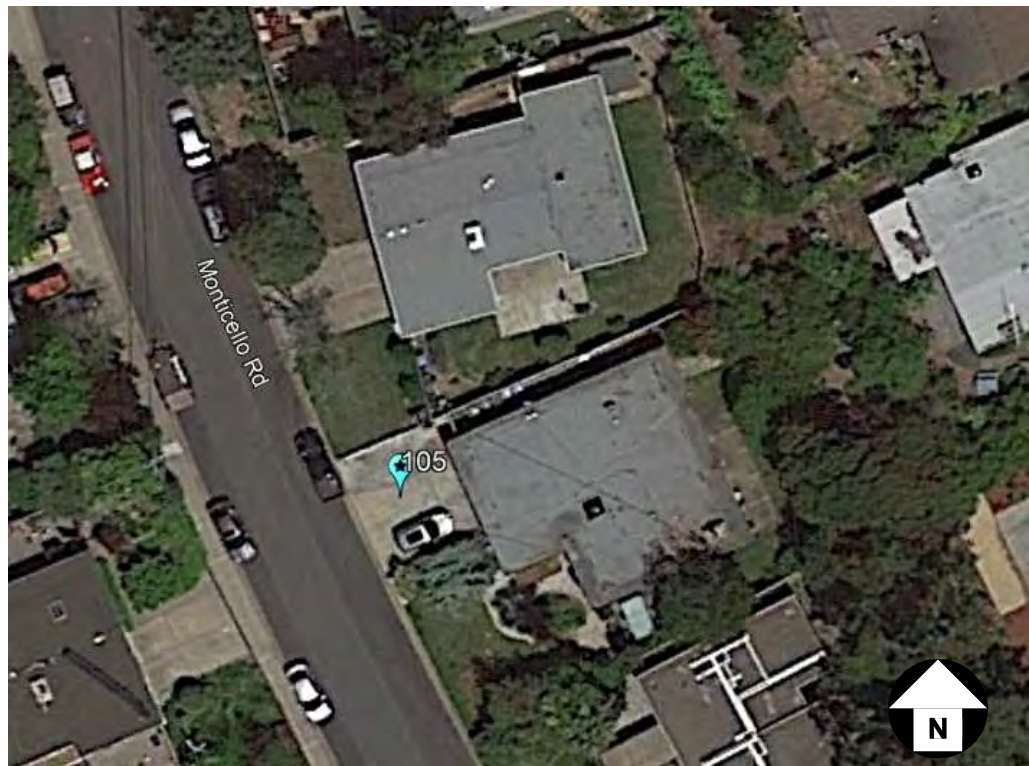
Comments: Smoke coming from cracks in driveway and cleanout. Included part of the roof since downspout drains here. Probably crack lateral

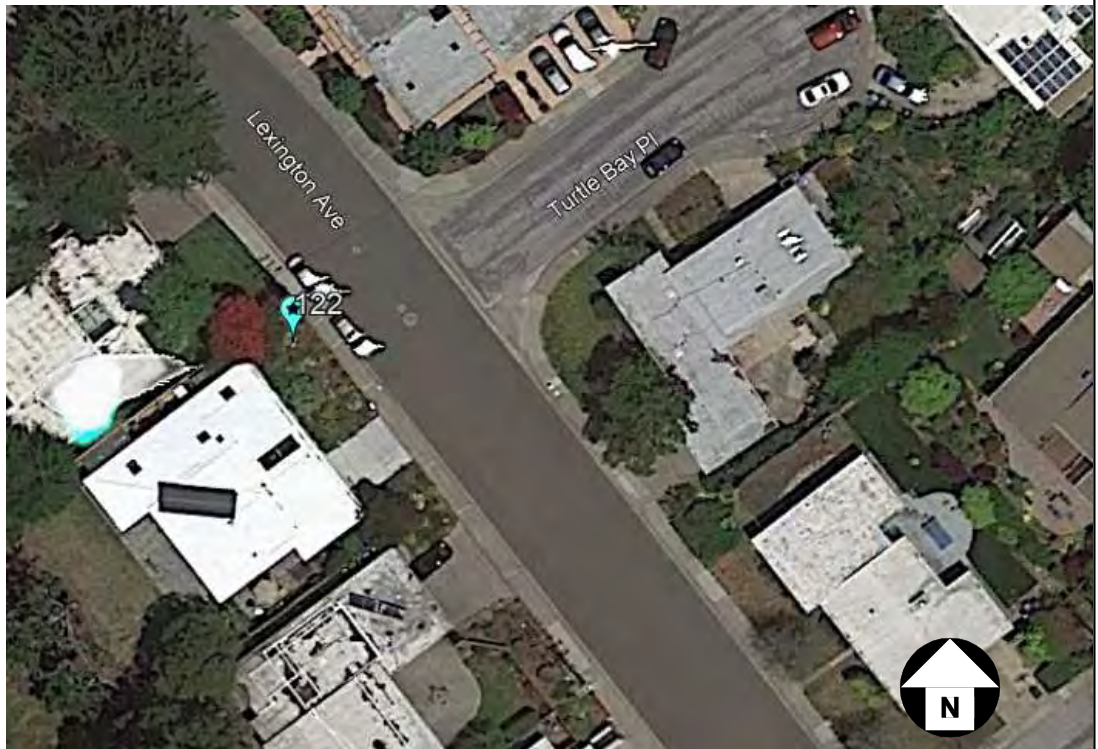
Comments: Work being done to lateral line

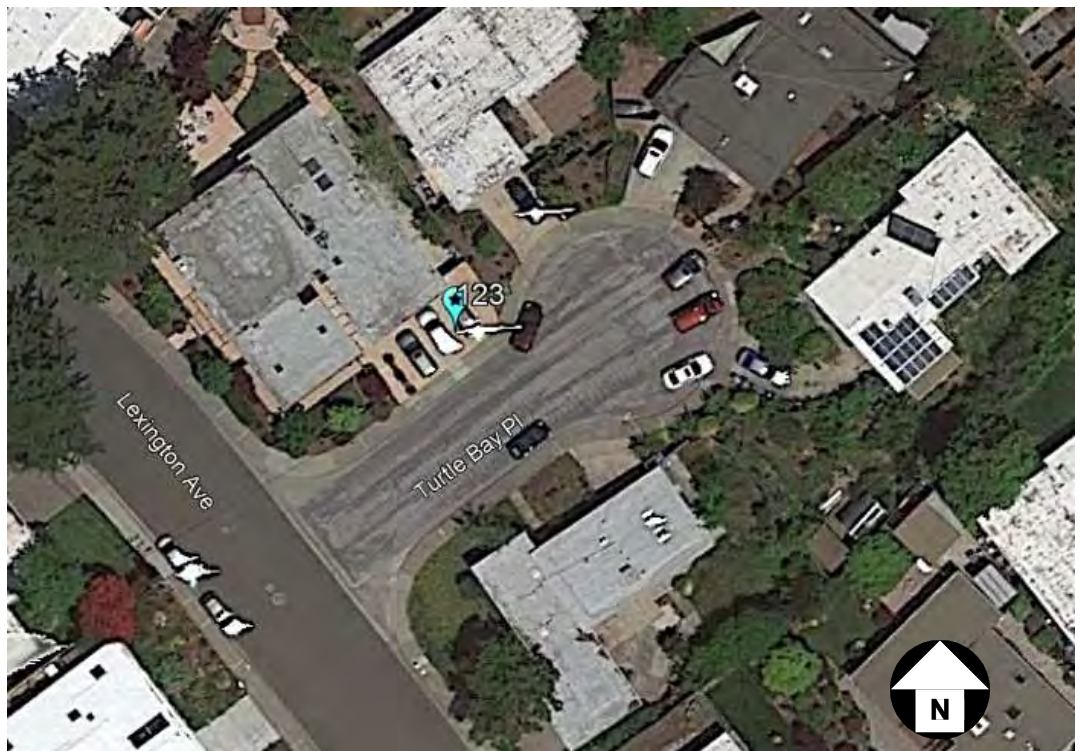
Comments: No cap.

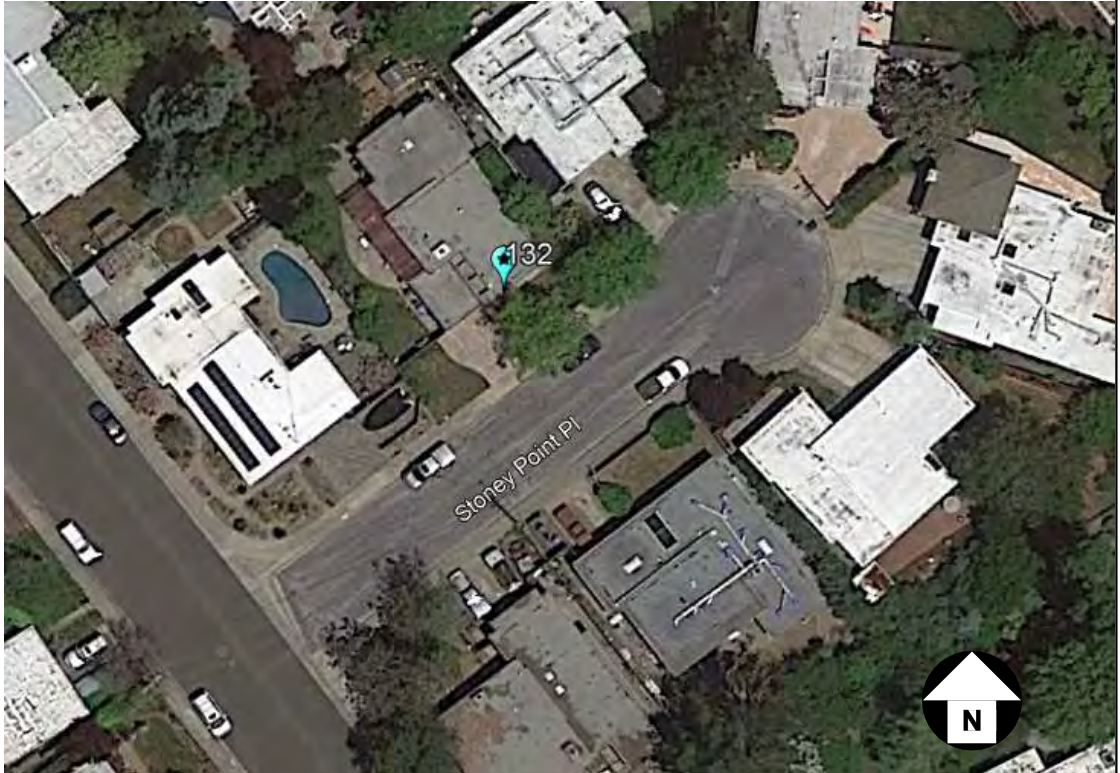
Comments: Cannot access due to debris. Most likely cleanout.

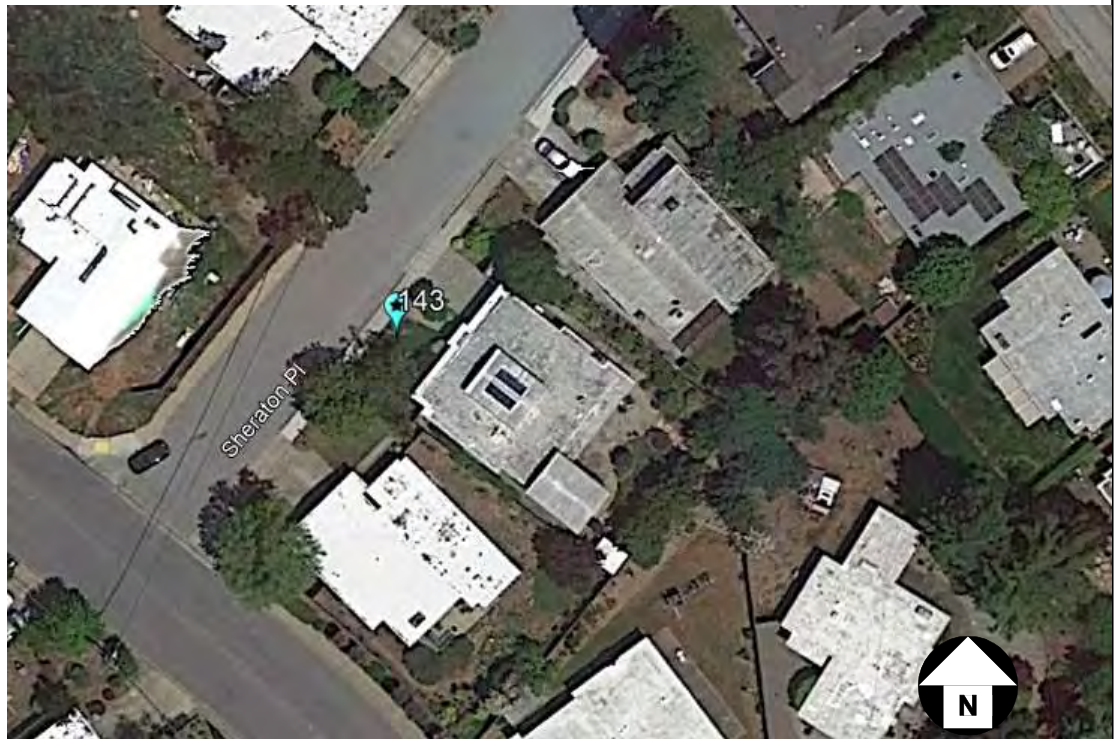
Comments: No cap. Flows funnel here. Damaged pipe?

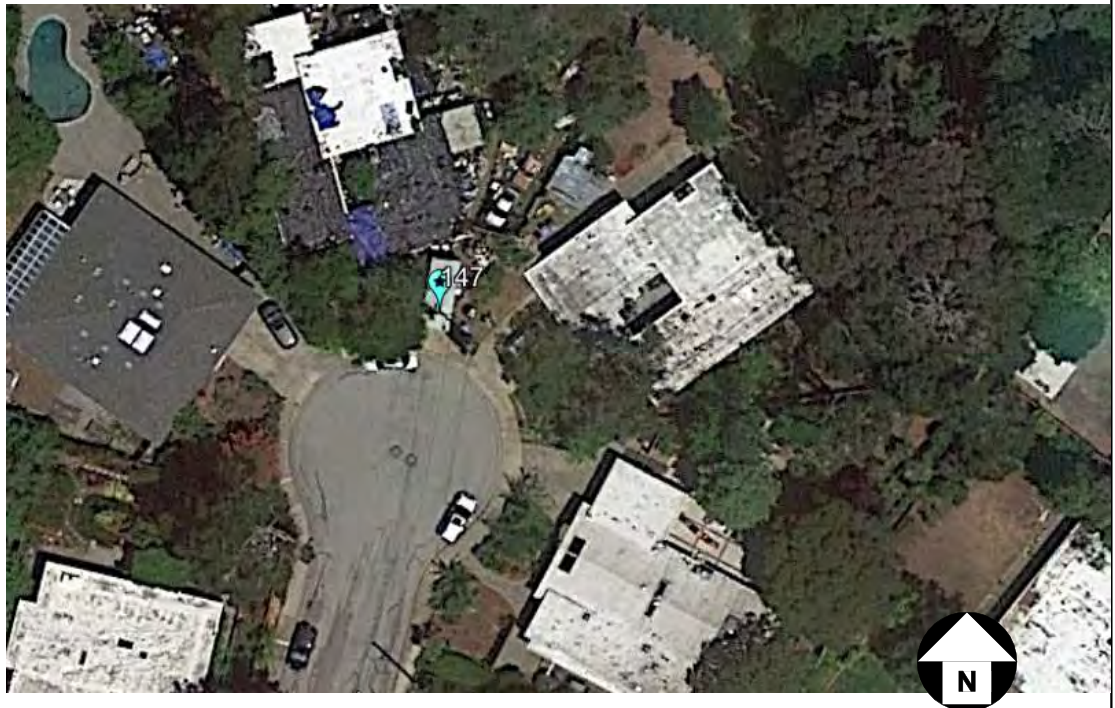
Comments: Could not tell source. Under container car
