MEMORANDUM

DATE: January 19, 2024
TO: Mark Chow, County of San Mateo
FROM: Ben Shick, PE
SUBJECT: Crystal Springs County Sanitation District – Pipe
and Manhole Assessment and Recommendations

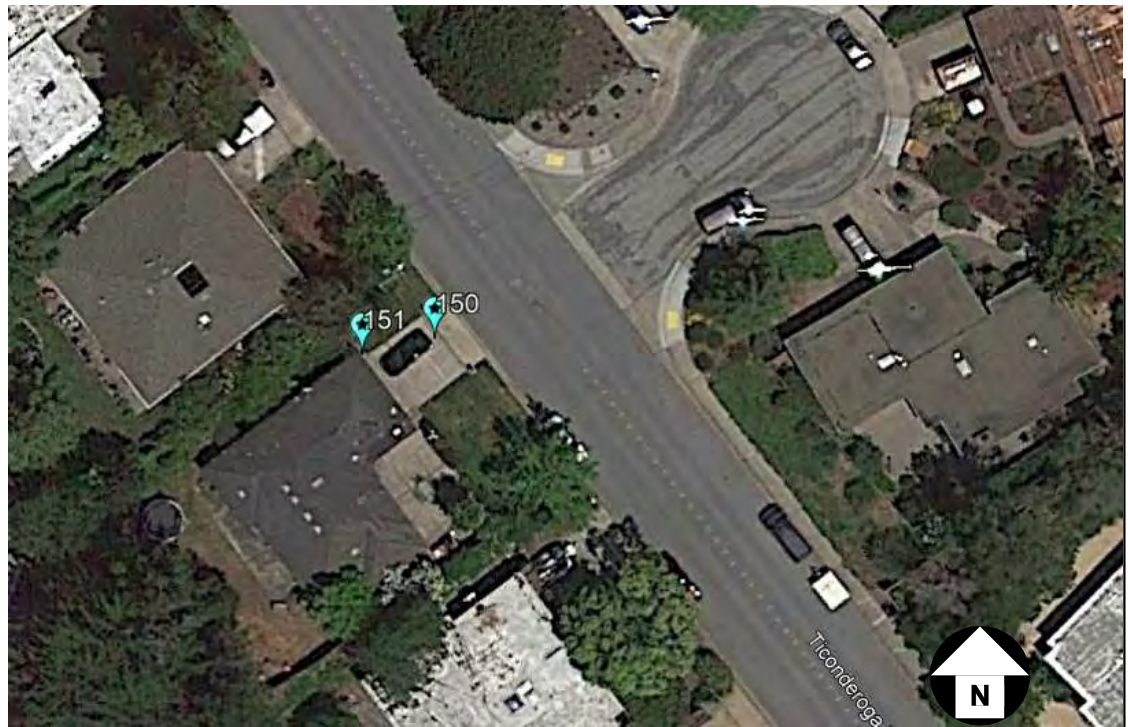
Comments: 150: Rusty/ deteriorated cap

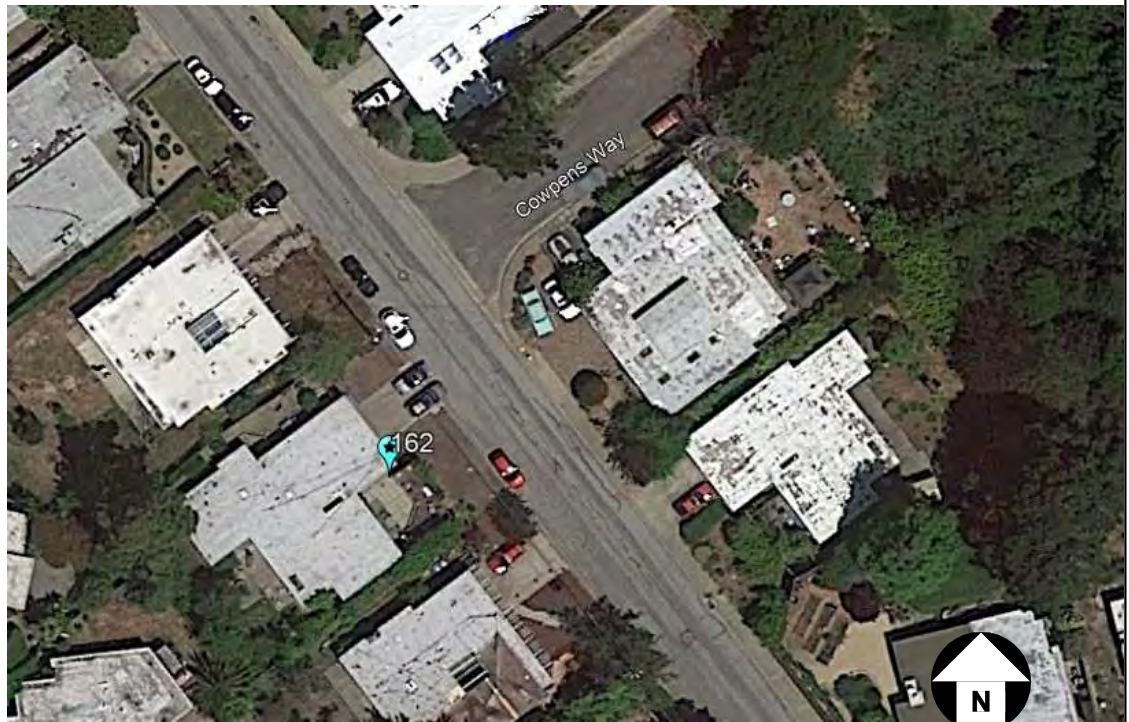
Comments: No cap. Downspout drains here

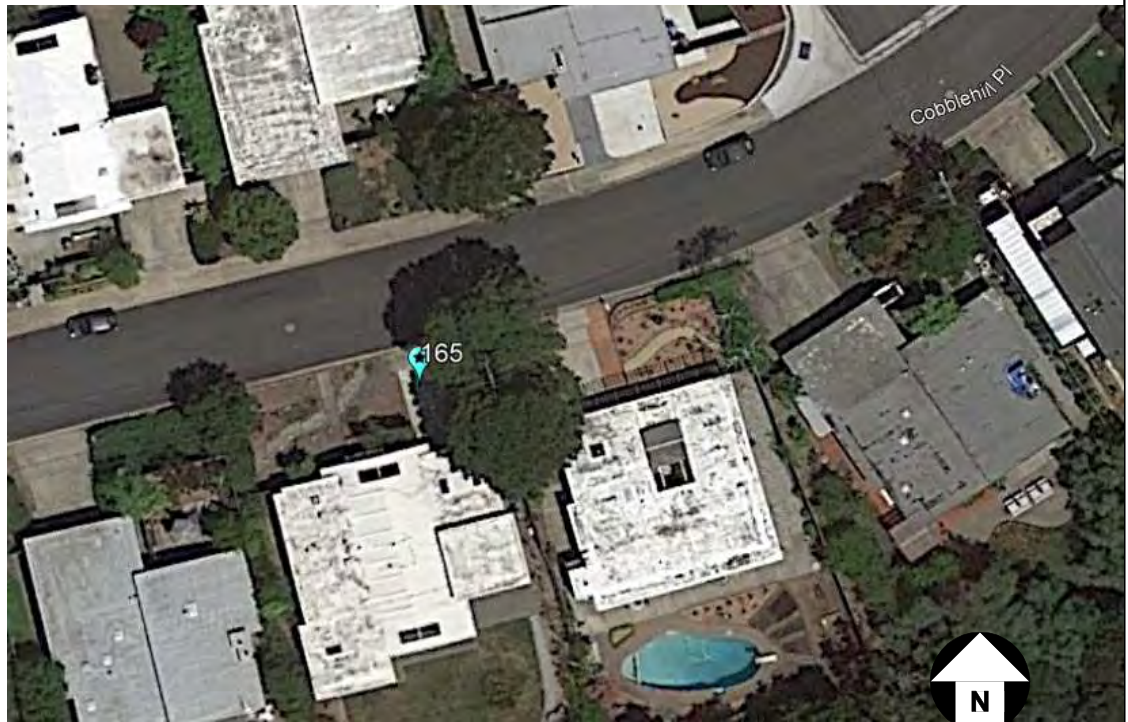
Comments: Cap loose. Water flows over top.

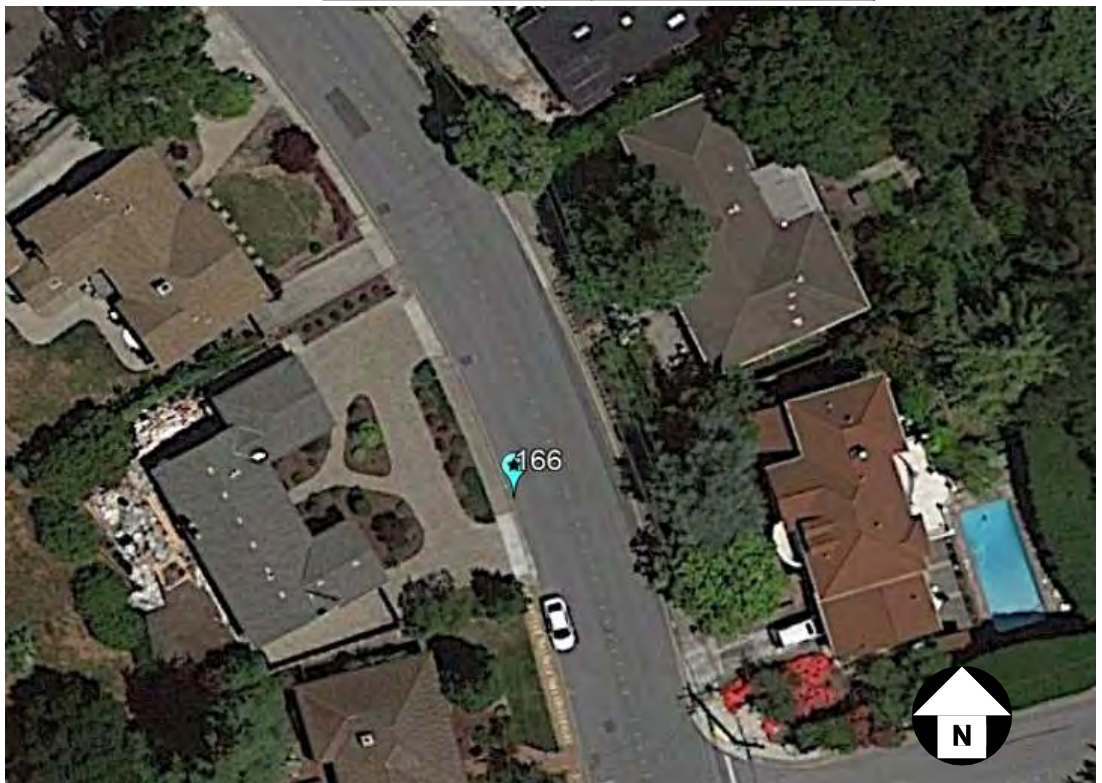
Comments: Crack in road/ sidewalk. Could be lateral or main sewer line. On hill and flow will drain over crack. Might have root infiltration .

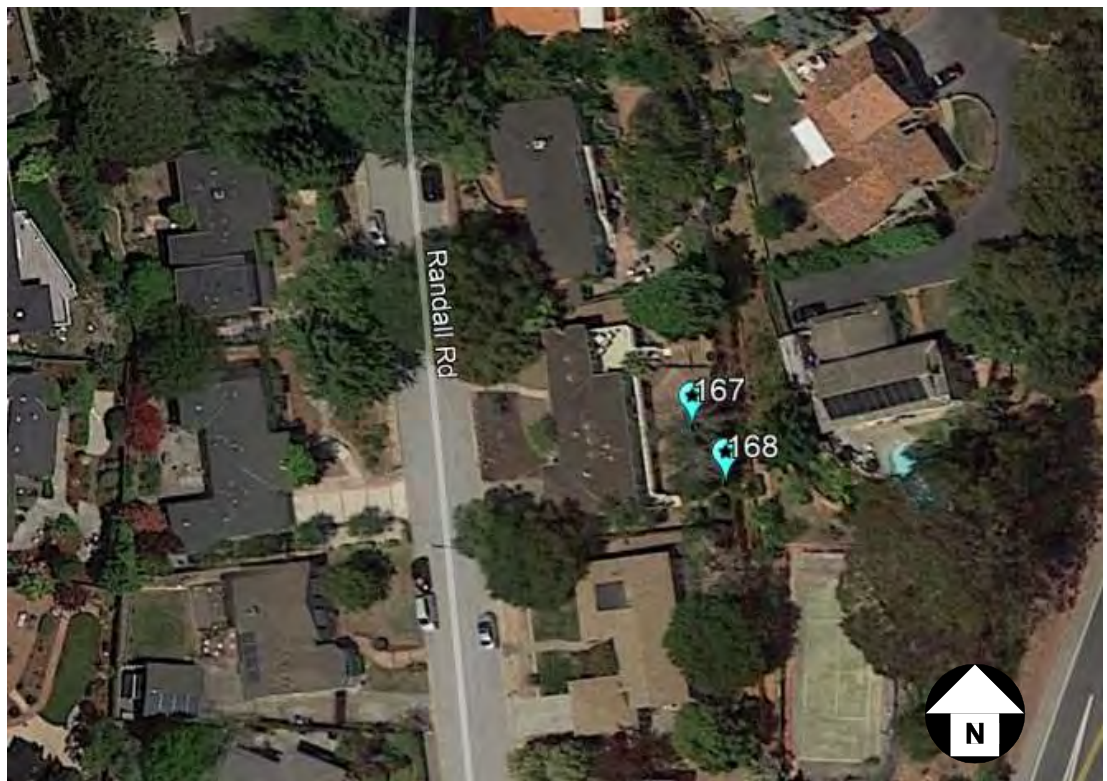
Comments: 167: Cannot open

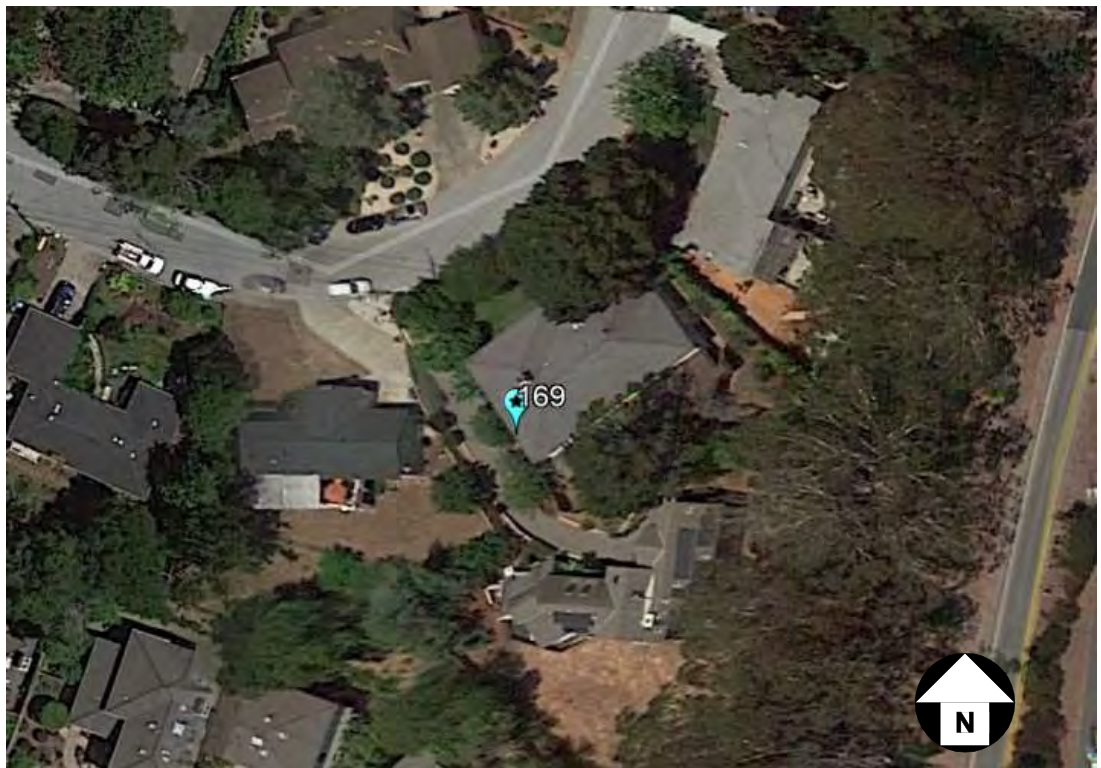
Comments: Smoke from small crack in walkway
