Fair Oaks Sewer Master Plan

Fair Oaks

SEWER MASTER PLAN

Prepared by:
Brown and Caldwell
September 2000

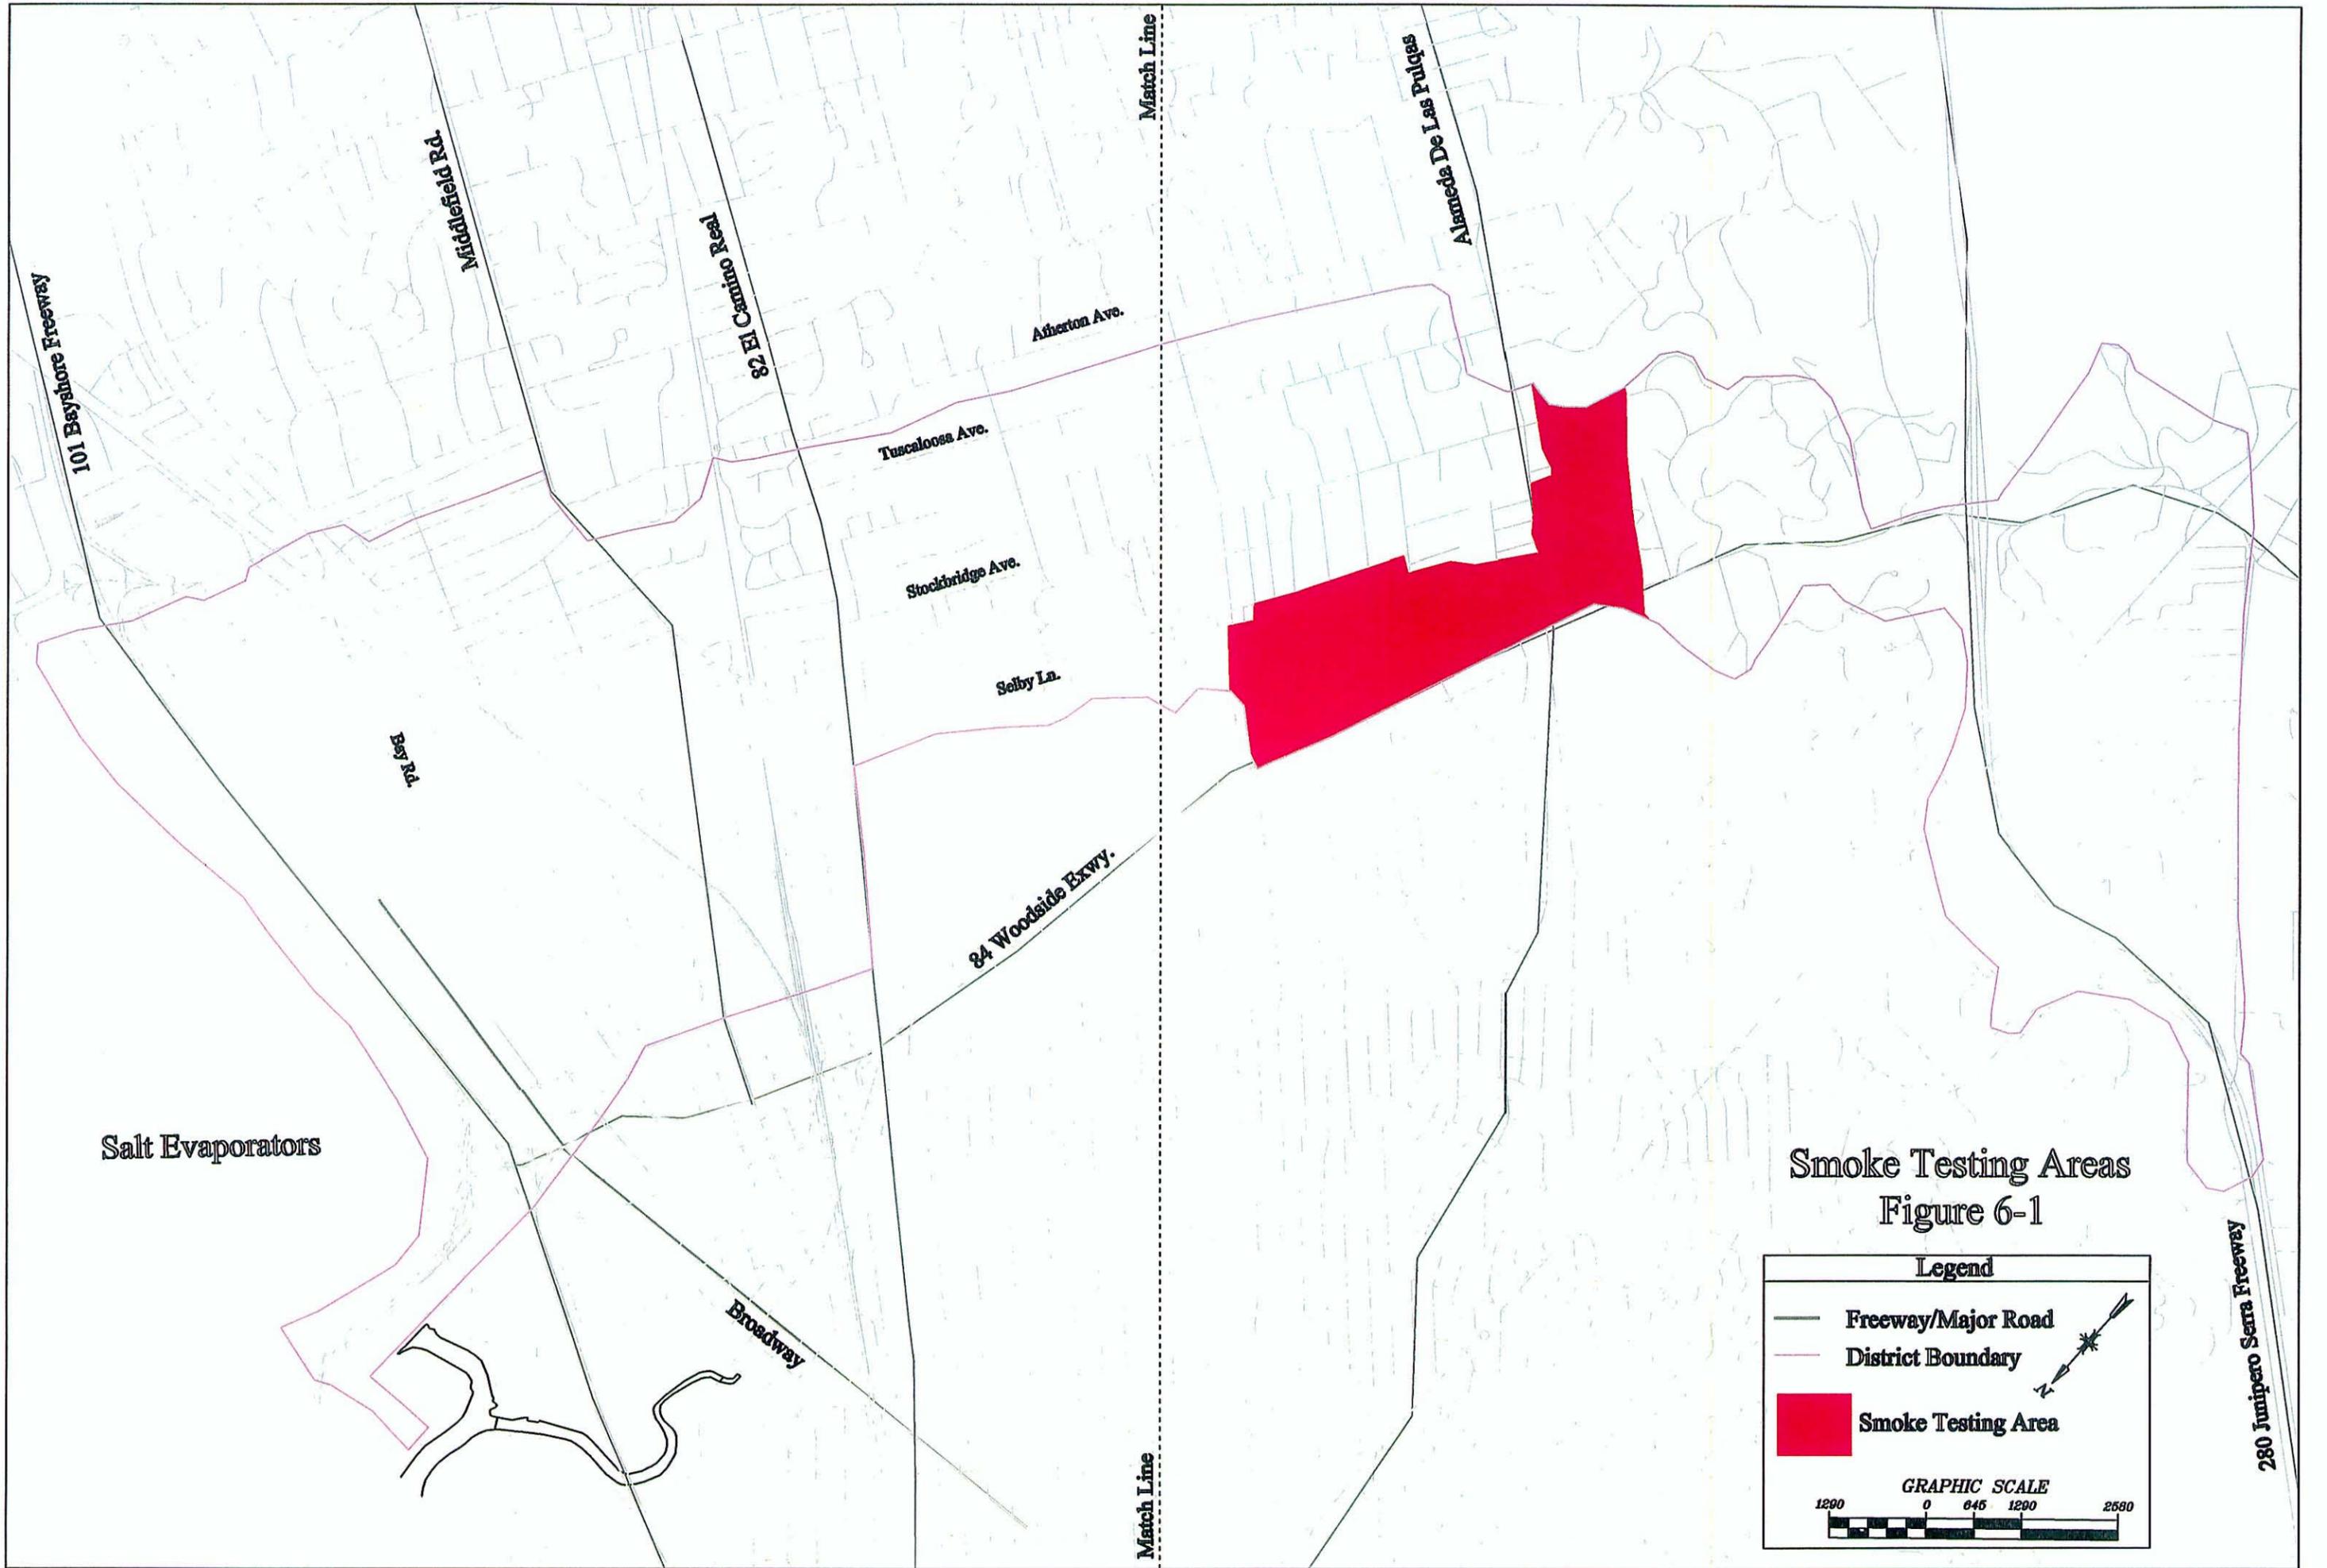
Smoke Testing Areas
Figure 6-1

Table 6-1. Smoke Testing Defect Summary

Defect type	Number of defects
Cleanout	45
Lateral	4
Illegal drain	4
Storm drain cross connection	1
Manhole leaks	3
Pavement cracks	1
Other	1
Total footage tested: 27,501

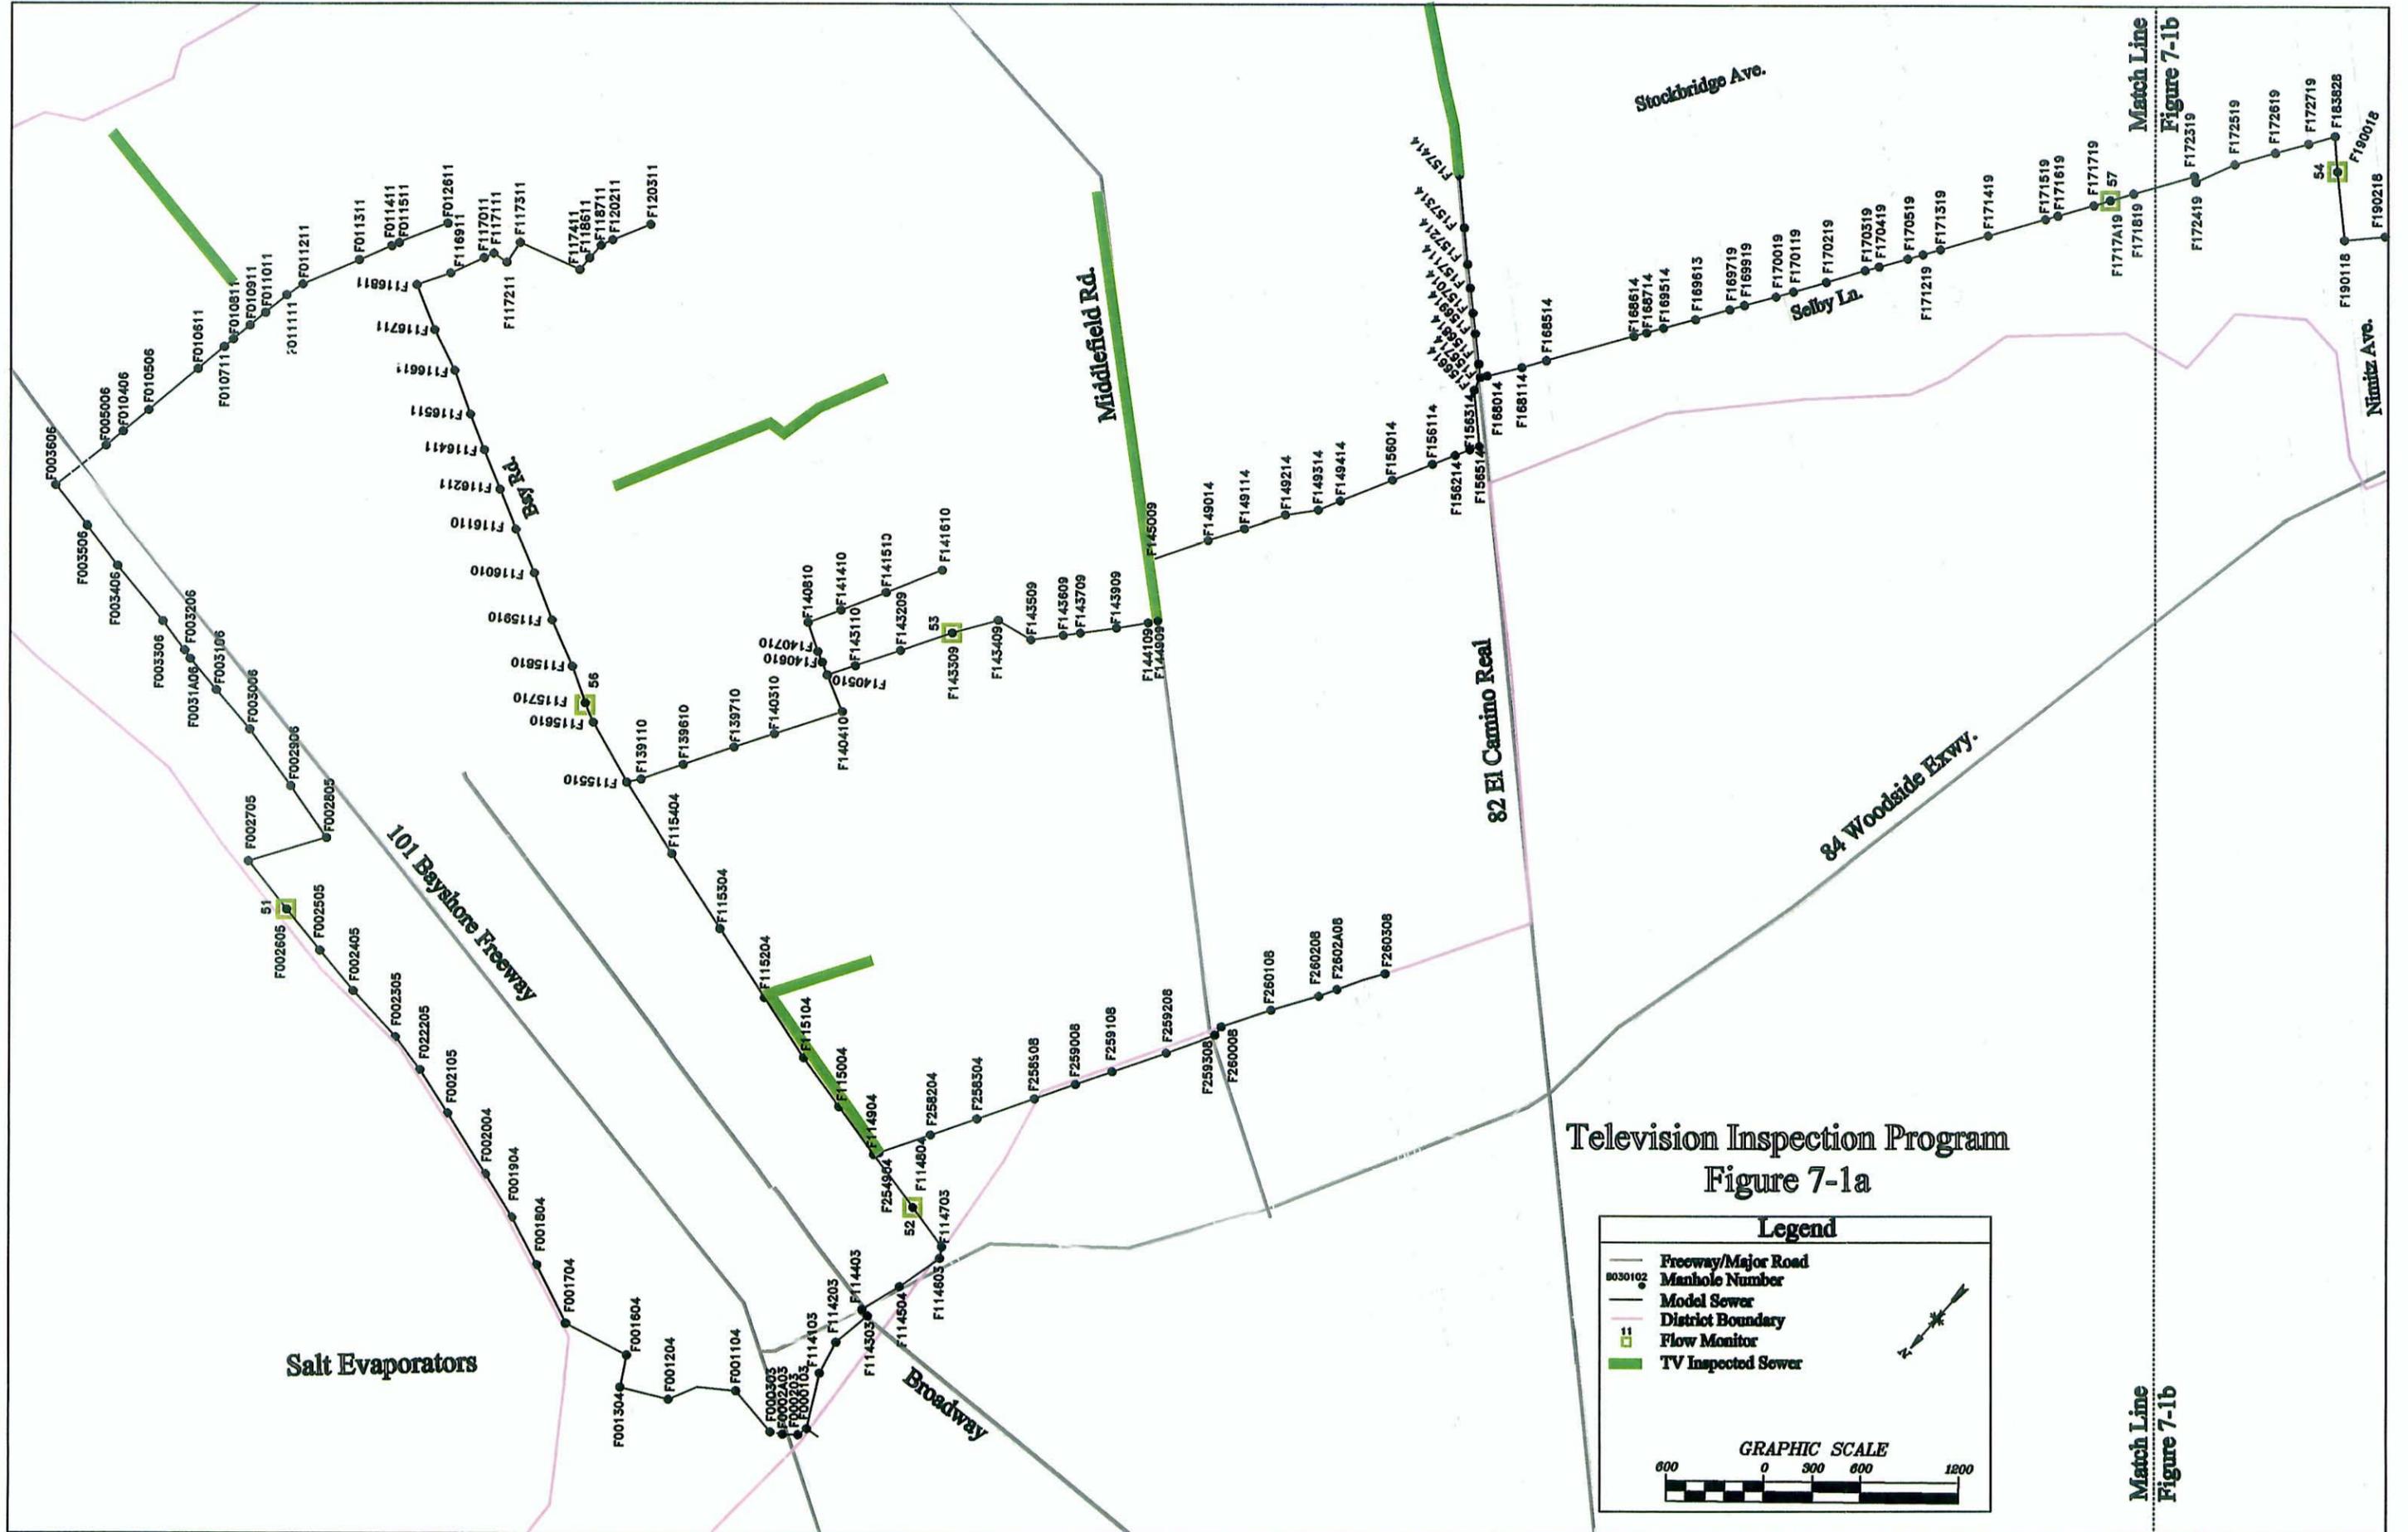
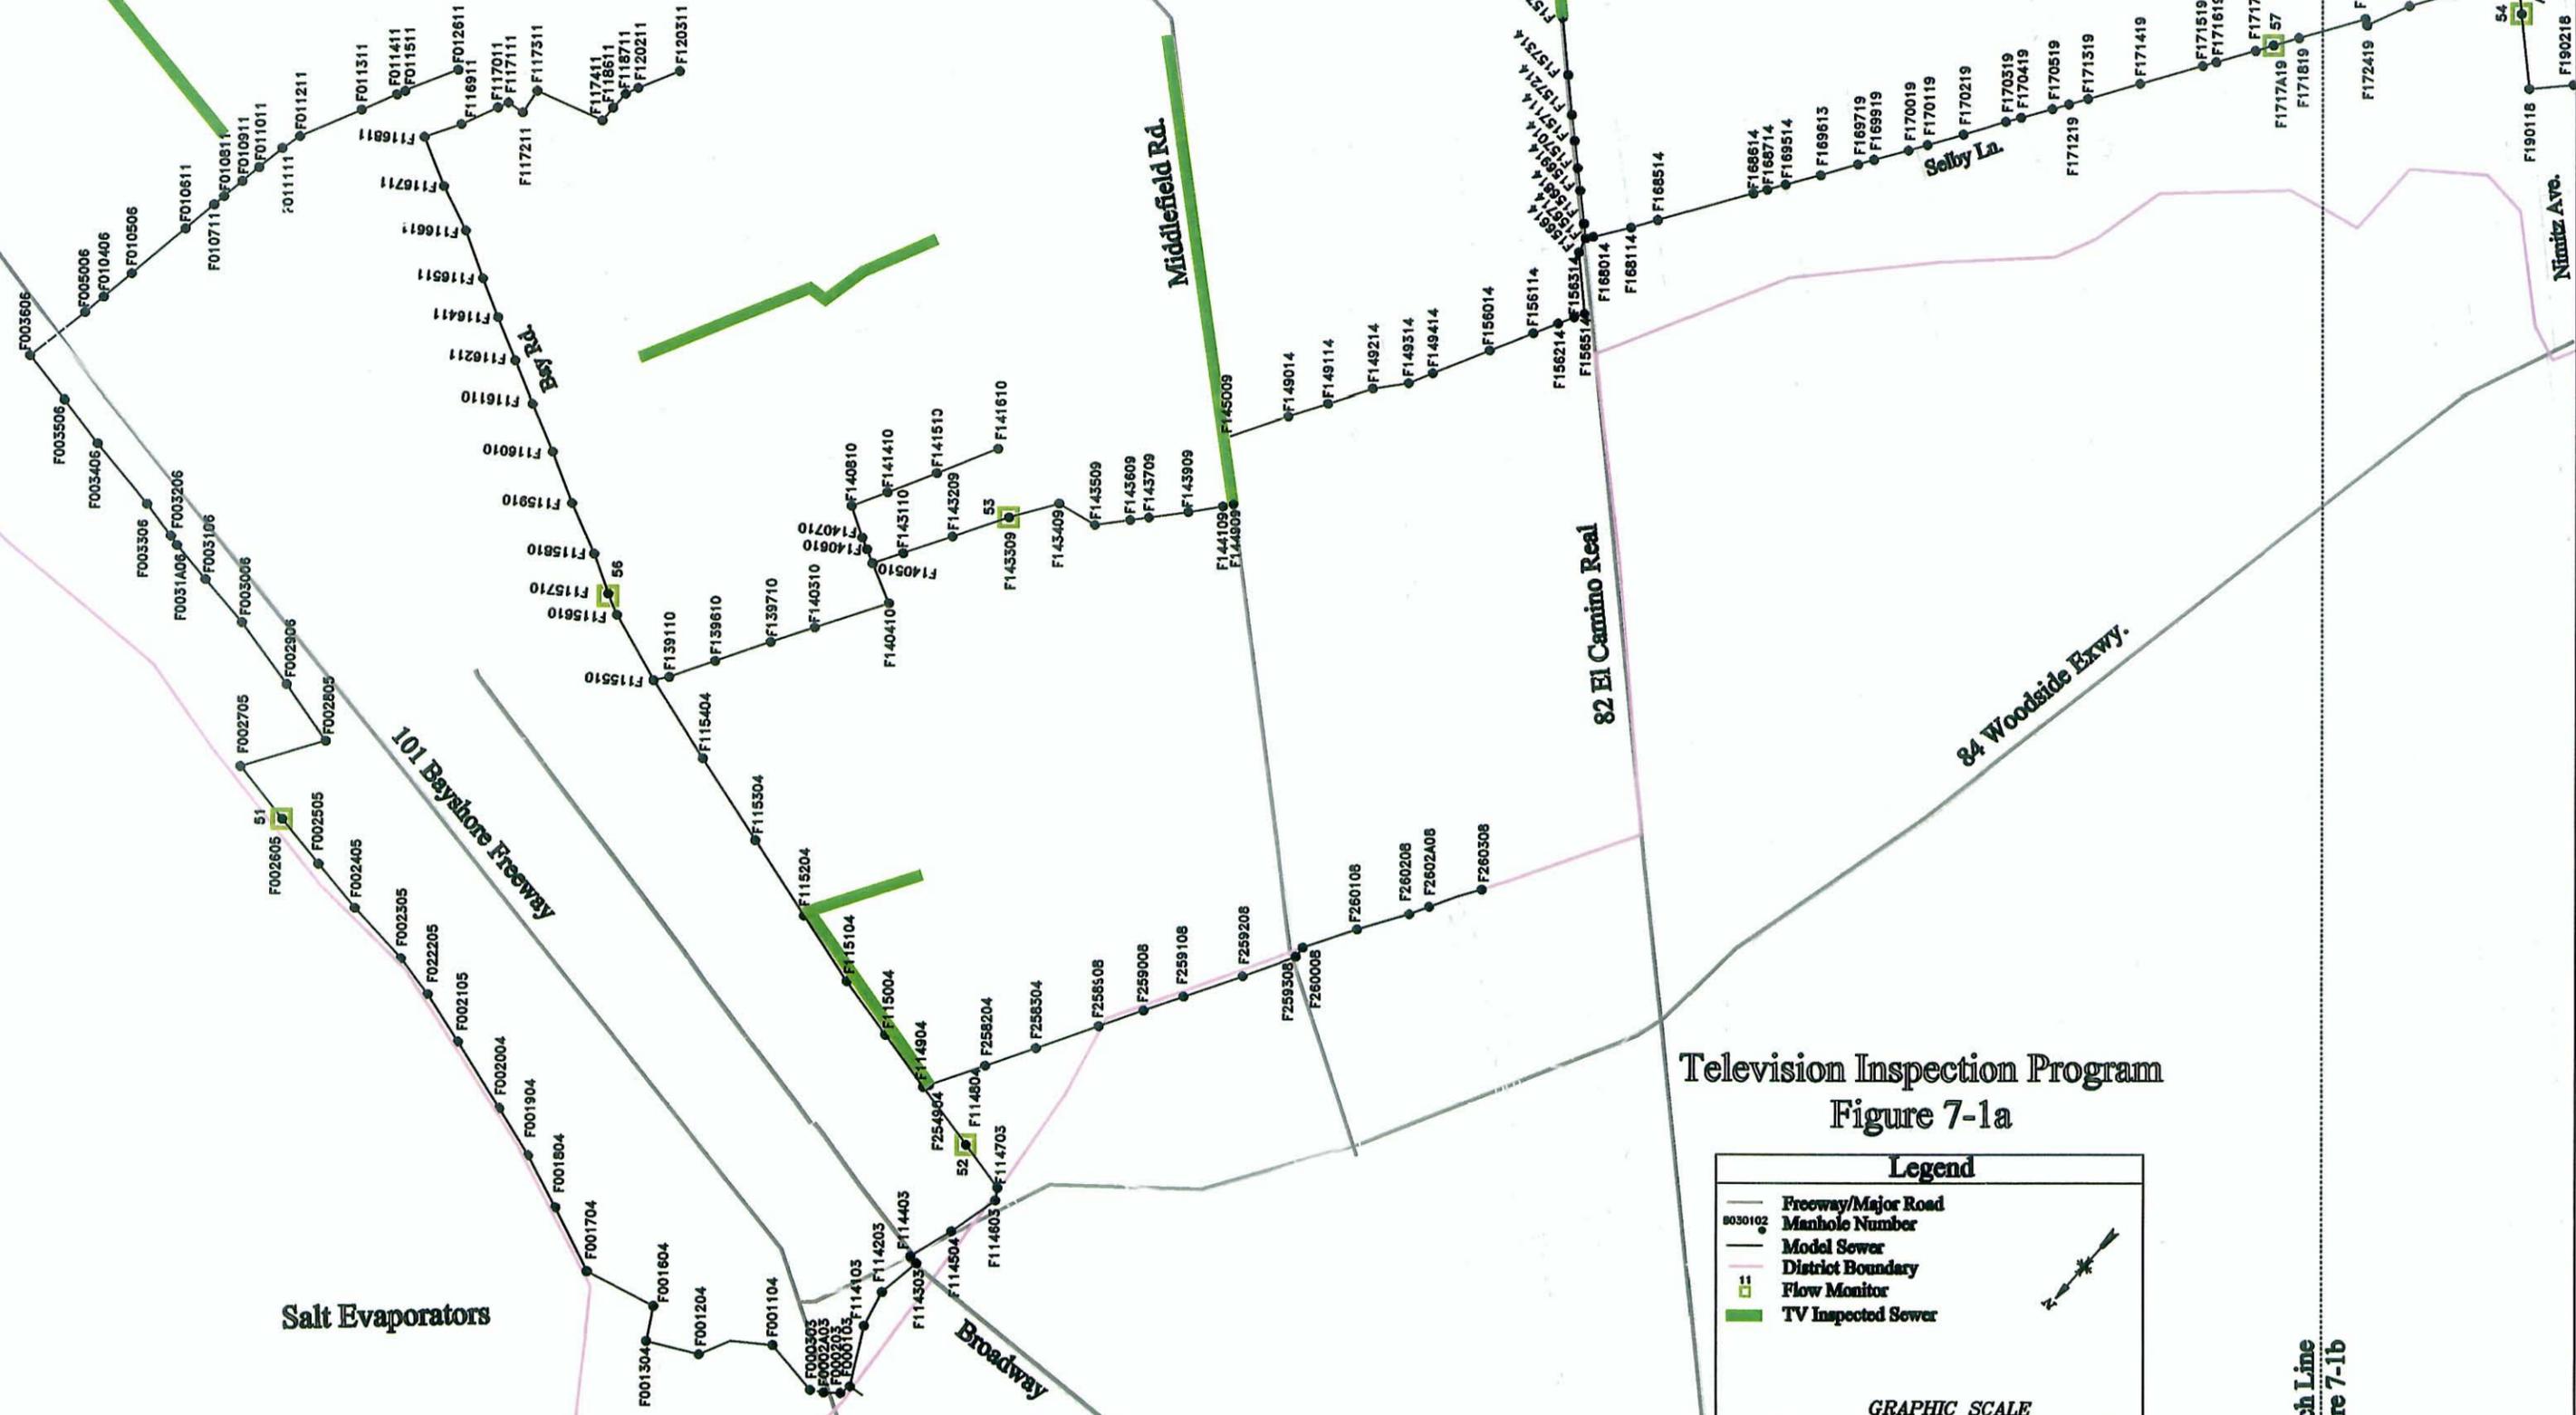
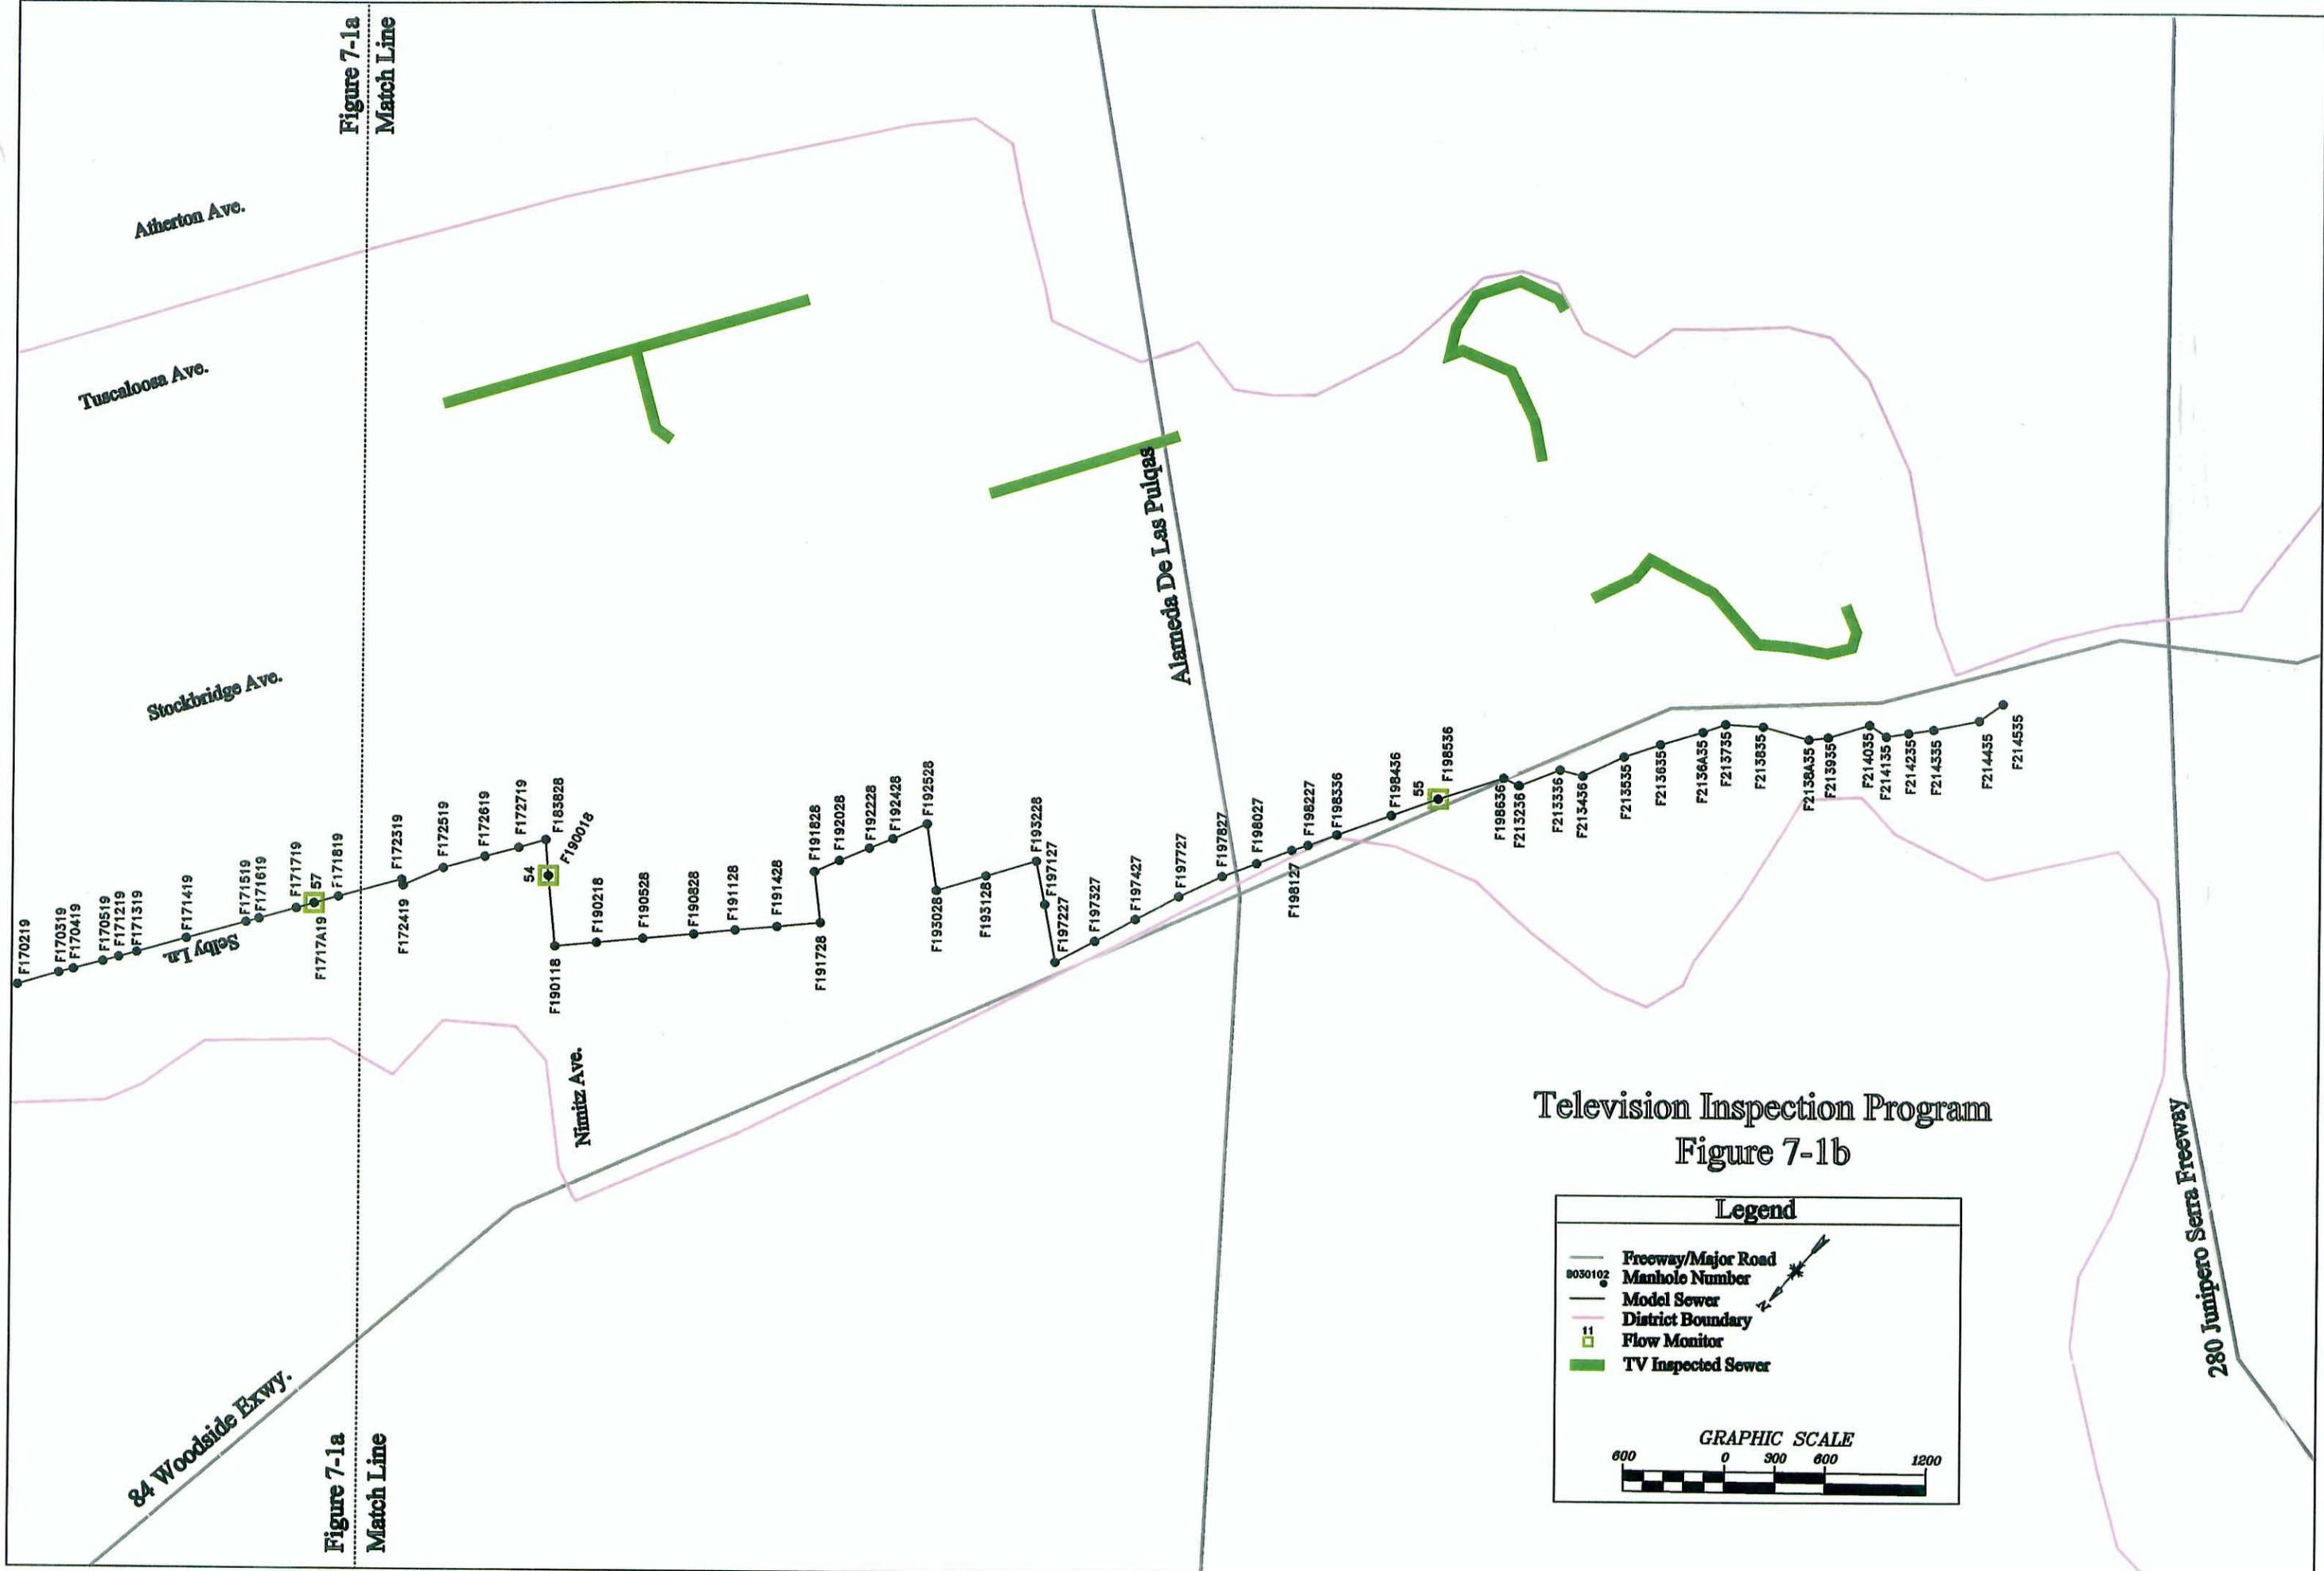
Television Inspection Program
Figure 7-1b

Table 7-1. Television Inspection Summary

Description	Total
Footage Attempted	15,707
Footage Completed	15,025
Cracks	
Radial	330
Longitudinal	1
Joints	
Minor Offset Joint	12
Major Offset Joint	0
Laterals	
Protruding Lateral	0
Defect at Connection	0
Dead Connection	47
Roots	
Roots at Joint	167
Roots at Lateral	15
Infiltration/Inflow	
At Joint	0
At Crack	0
At Roots	0
At Inside Lateral	0
At Lateral Connection	1
At Inside Lateral and at Connection	0
Alignment	
Sag in Line	25
Pipe Out of Round	0
Structural	
Piece Missing	31
Shattered/Broken	28
Crushed or Collapsed	1
Mineral Stains	
At Joint	0
At Cracks	0
Sulfide Corrosion	
Minor	0
Severe	0

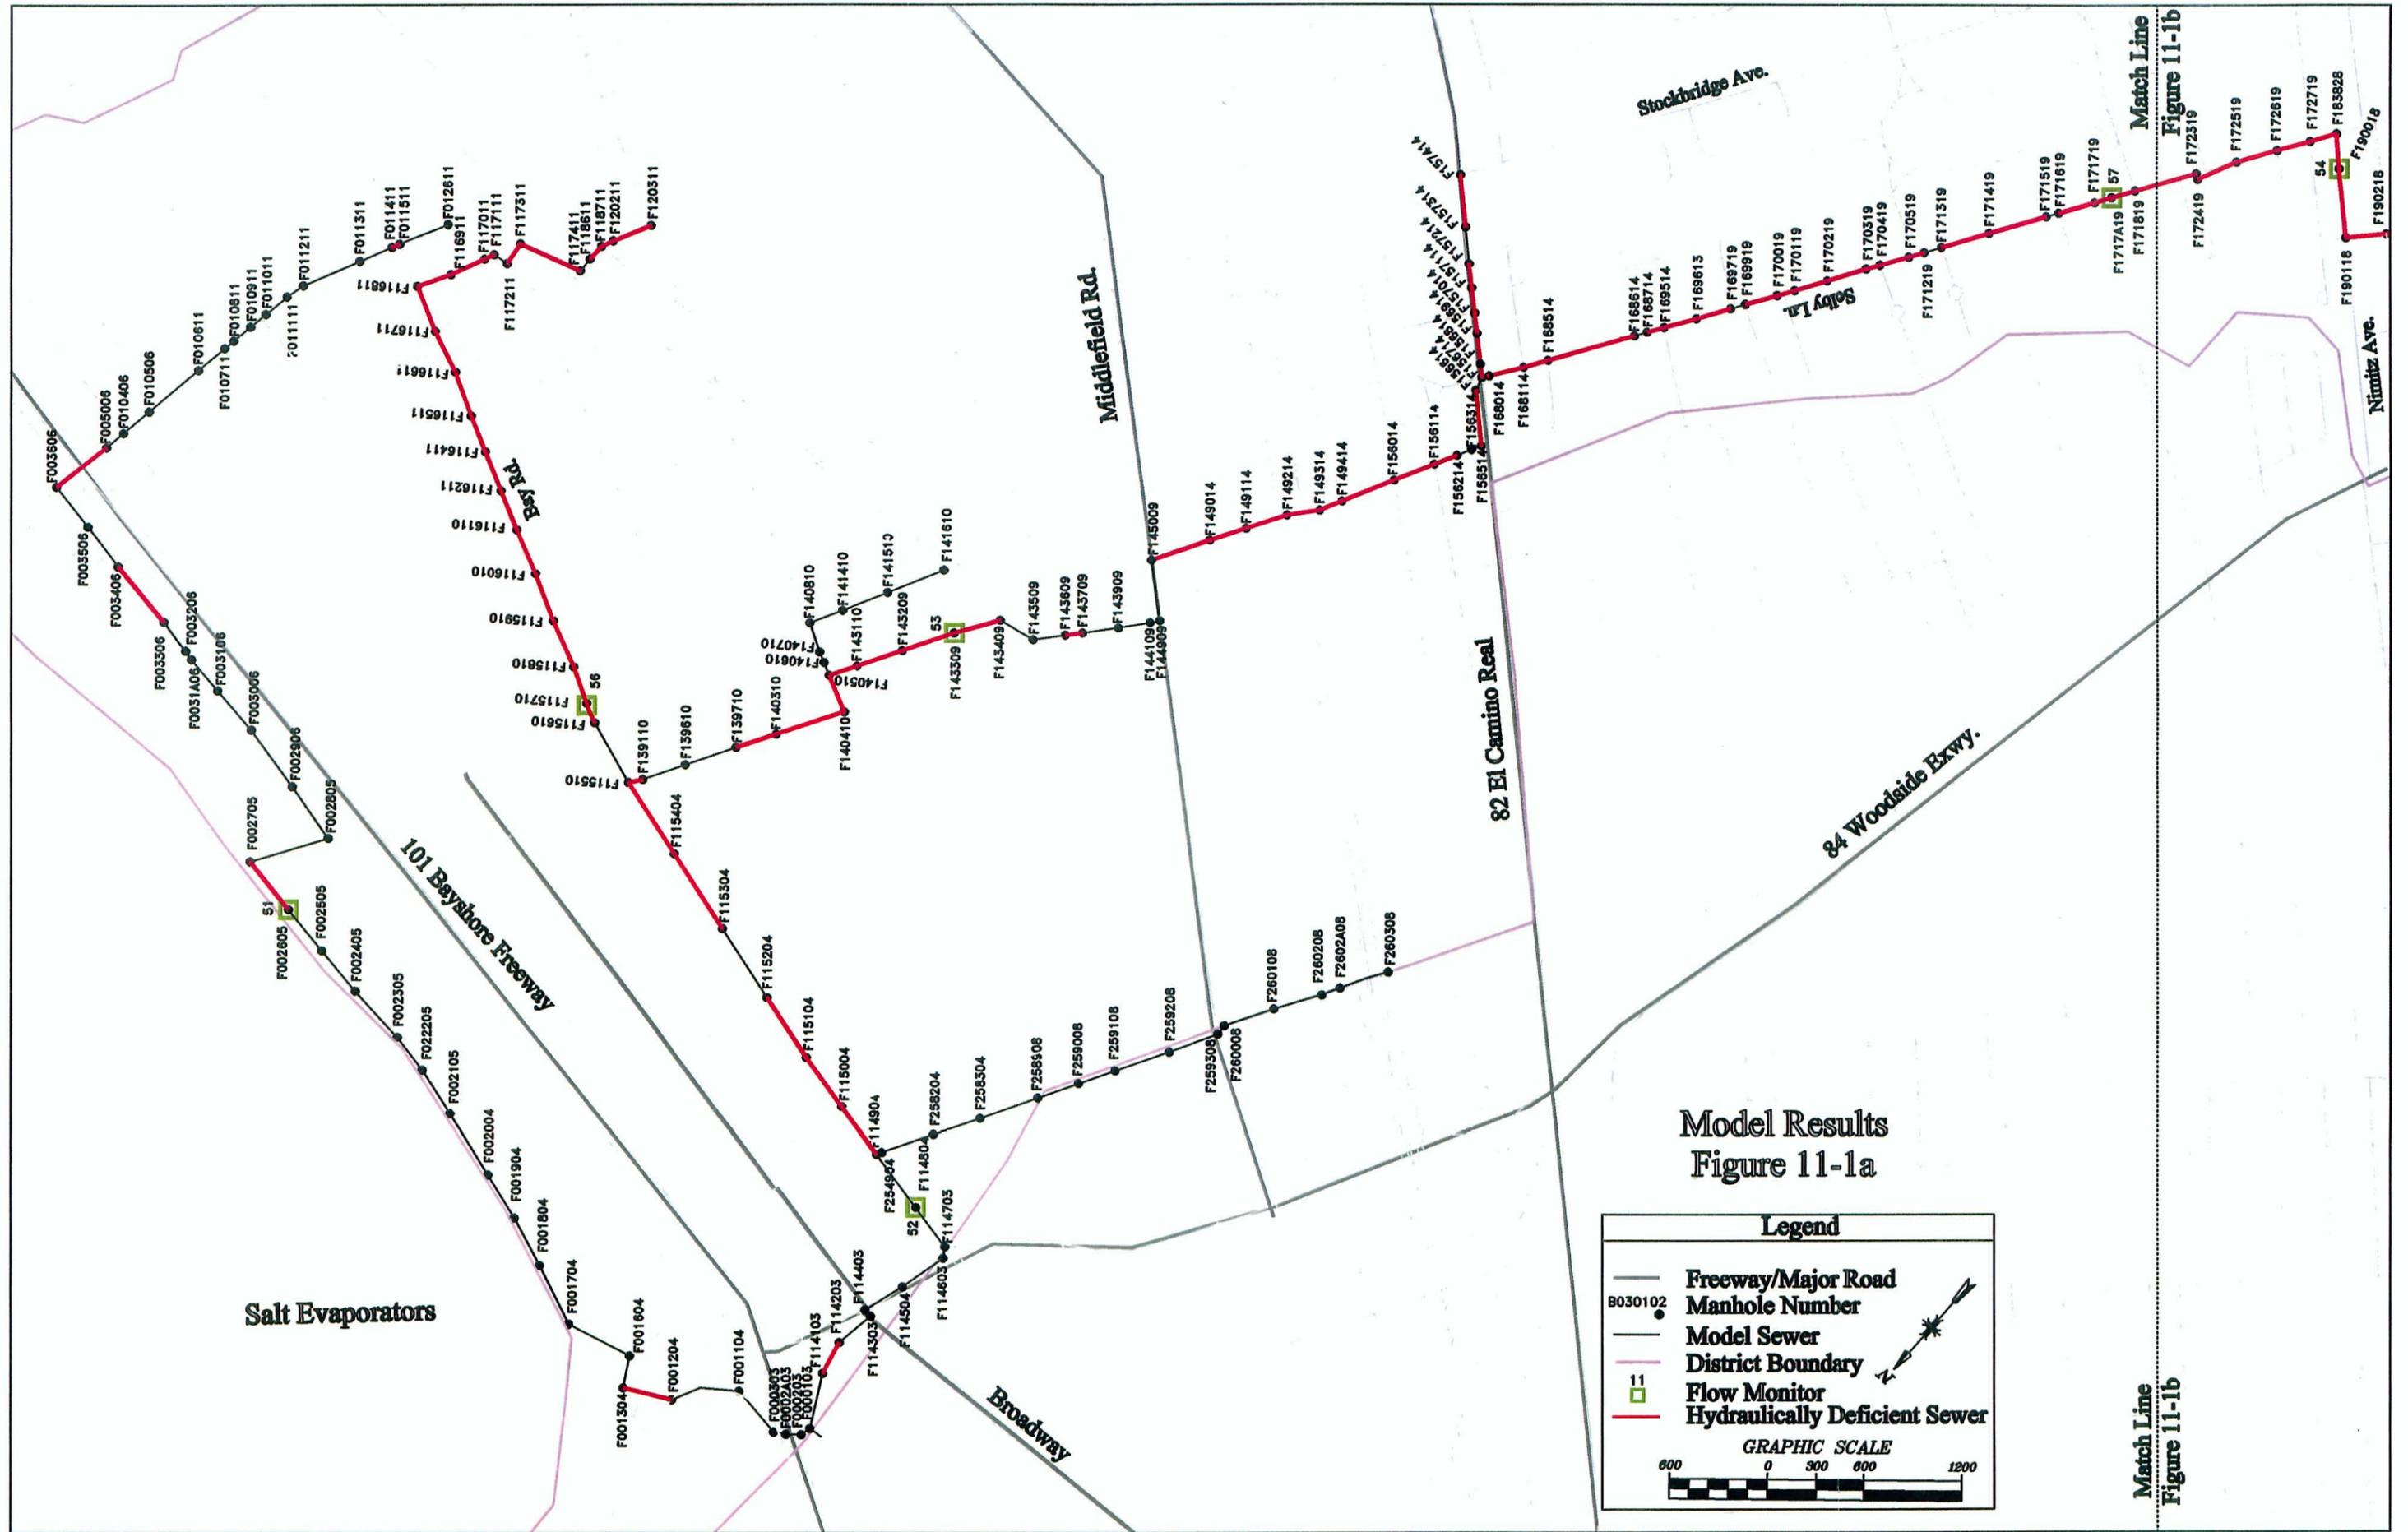
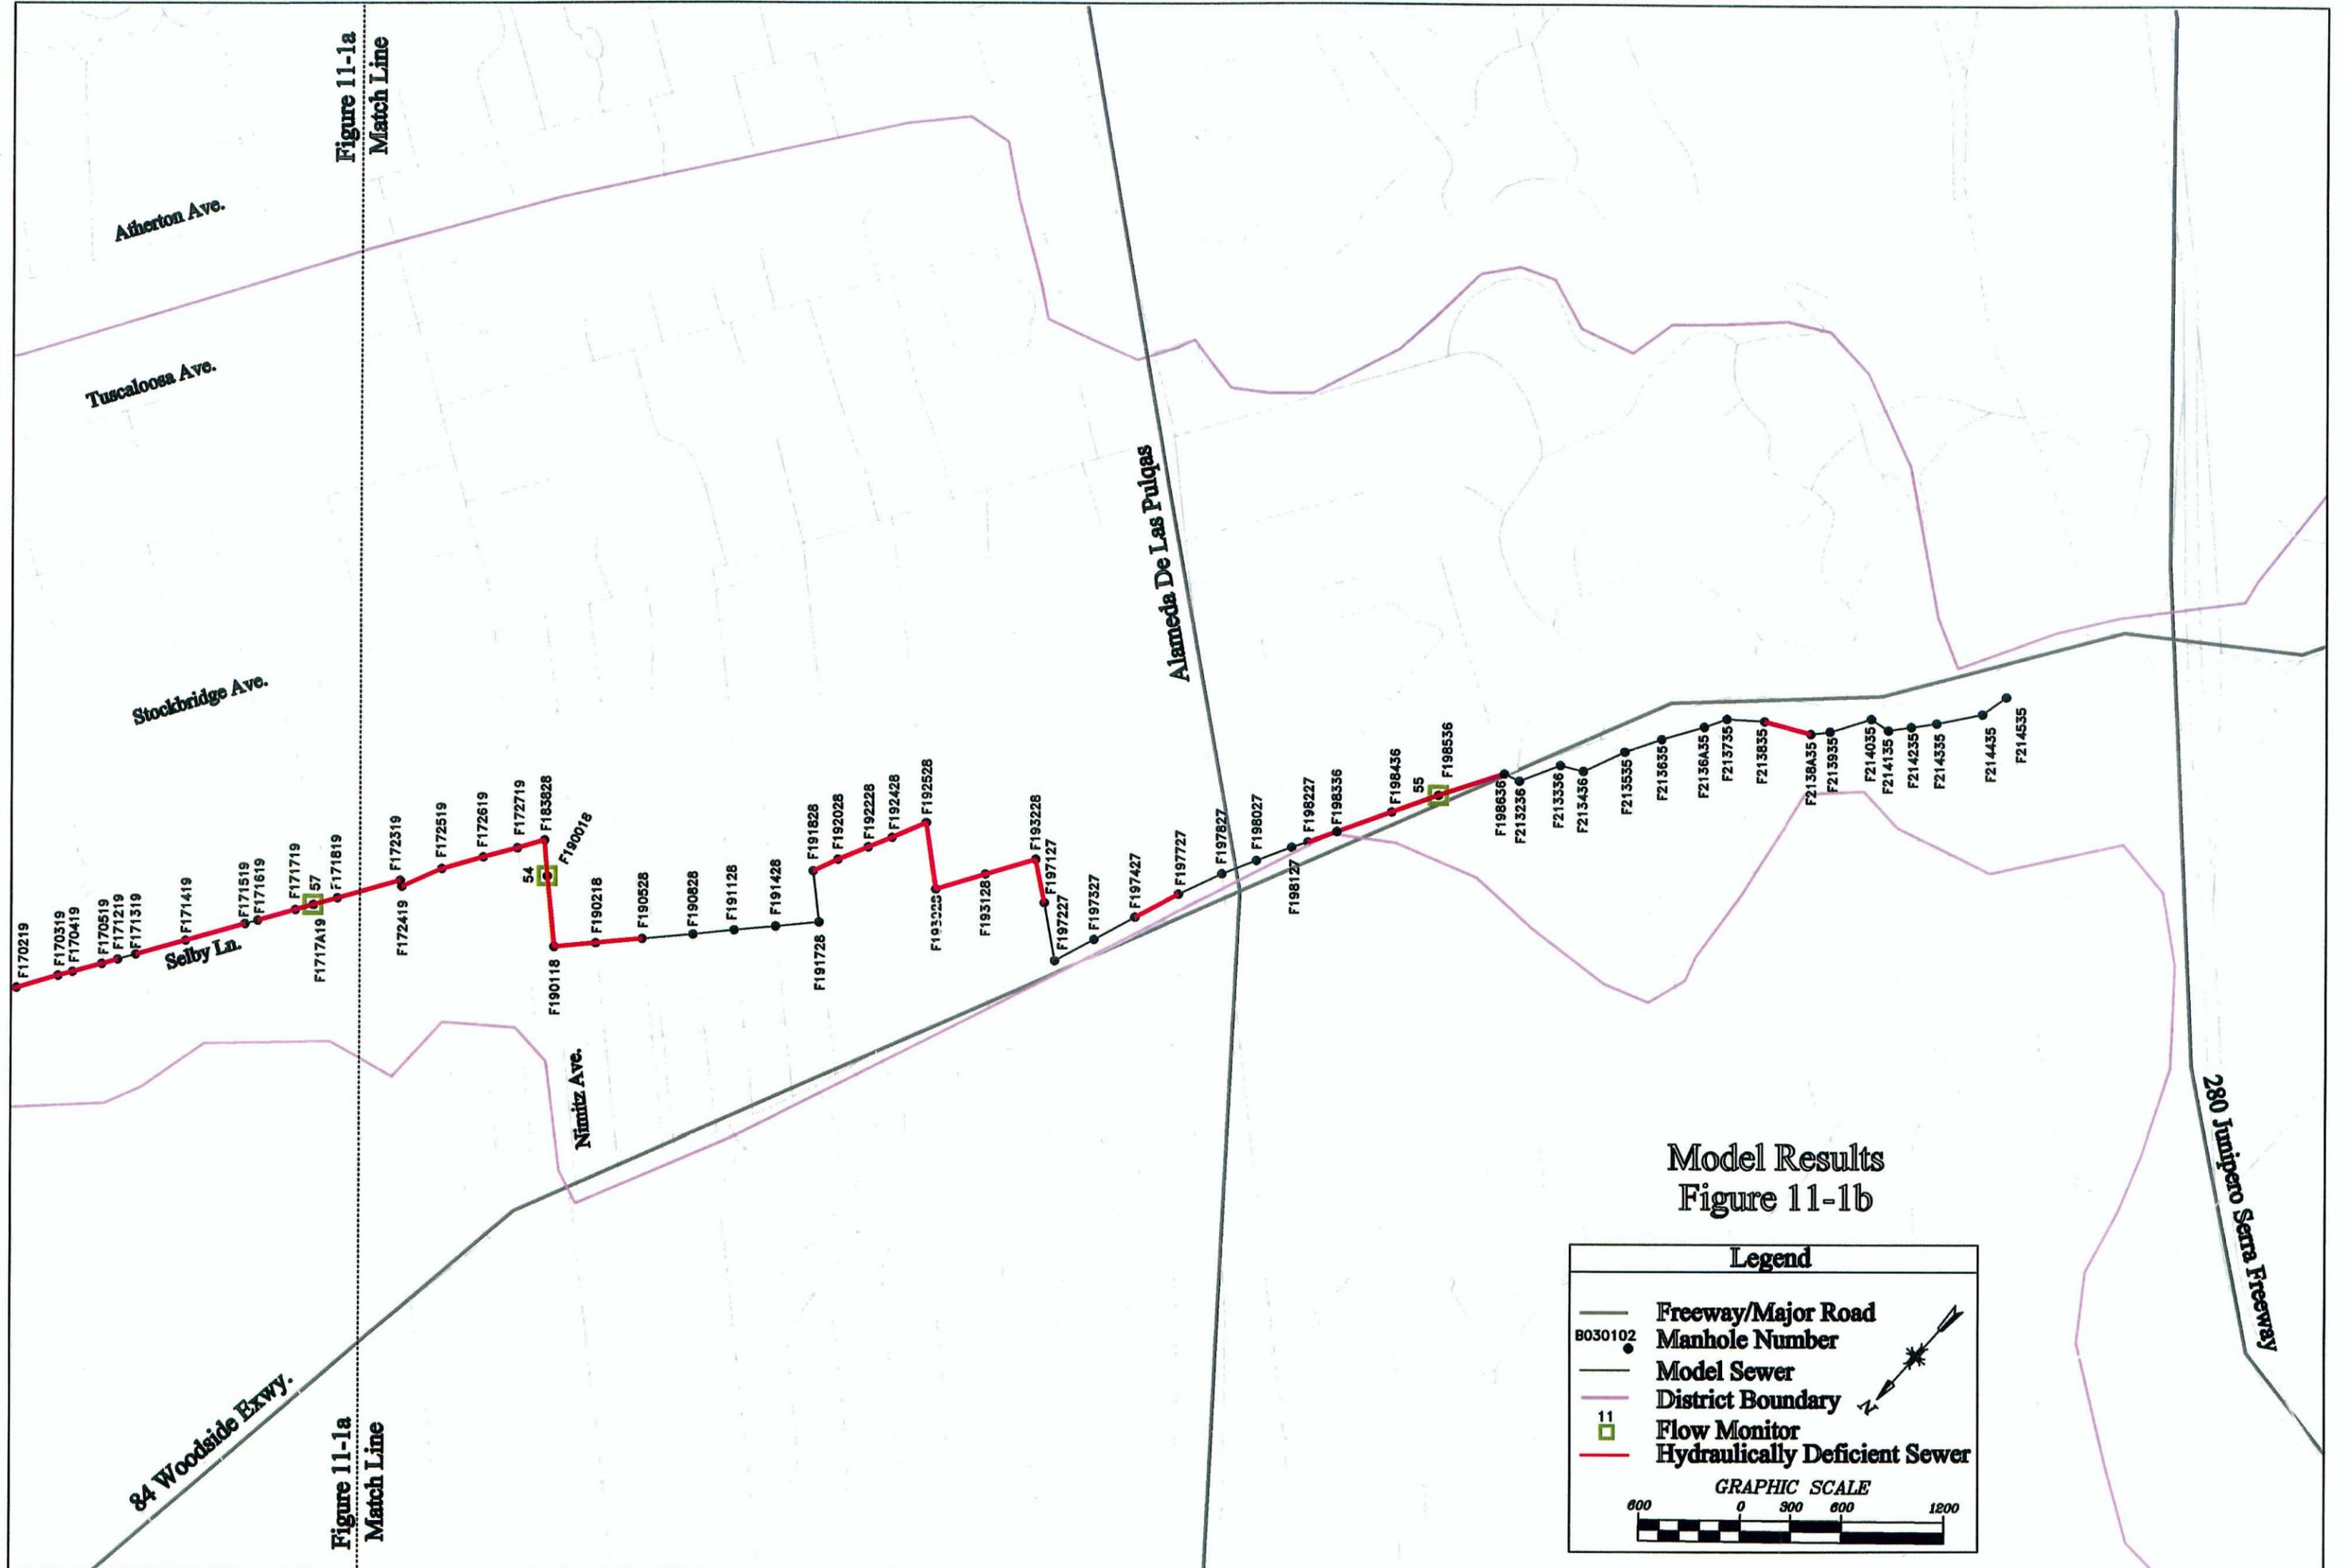
Model Results
Figure 11-1a

The results of the model indicate nearly five miles of sewer pipelines with insufficient capacity to convey peak wet weather flow without surcharging. Peak wet weather flow in the trunk sewers along Selby Lane and Nimitz Avenue are at nearly 300 percent of the pipeline capacity. Model results are shown on Figures 11-1a and 11-1b. The technical memorandum describing the flow development and modeling is provided in Appendix E. Additionally, the complete HYDRA modeling results are provided in Appendix E.
