Site: Chesham Ave., San Carlos

At your request I visited the above site for the purpose of inspecting and commenting on the regulated trees around the property. A new home is planned, prompting the need for this tree protection report.

## Tree Survey

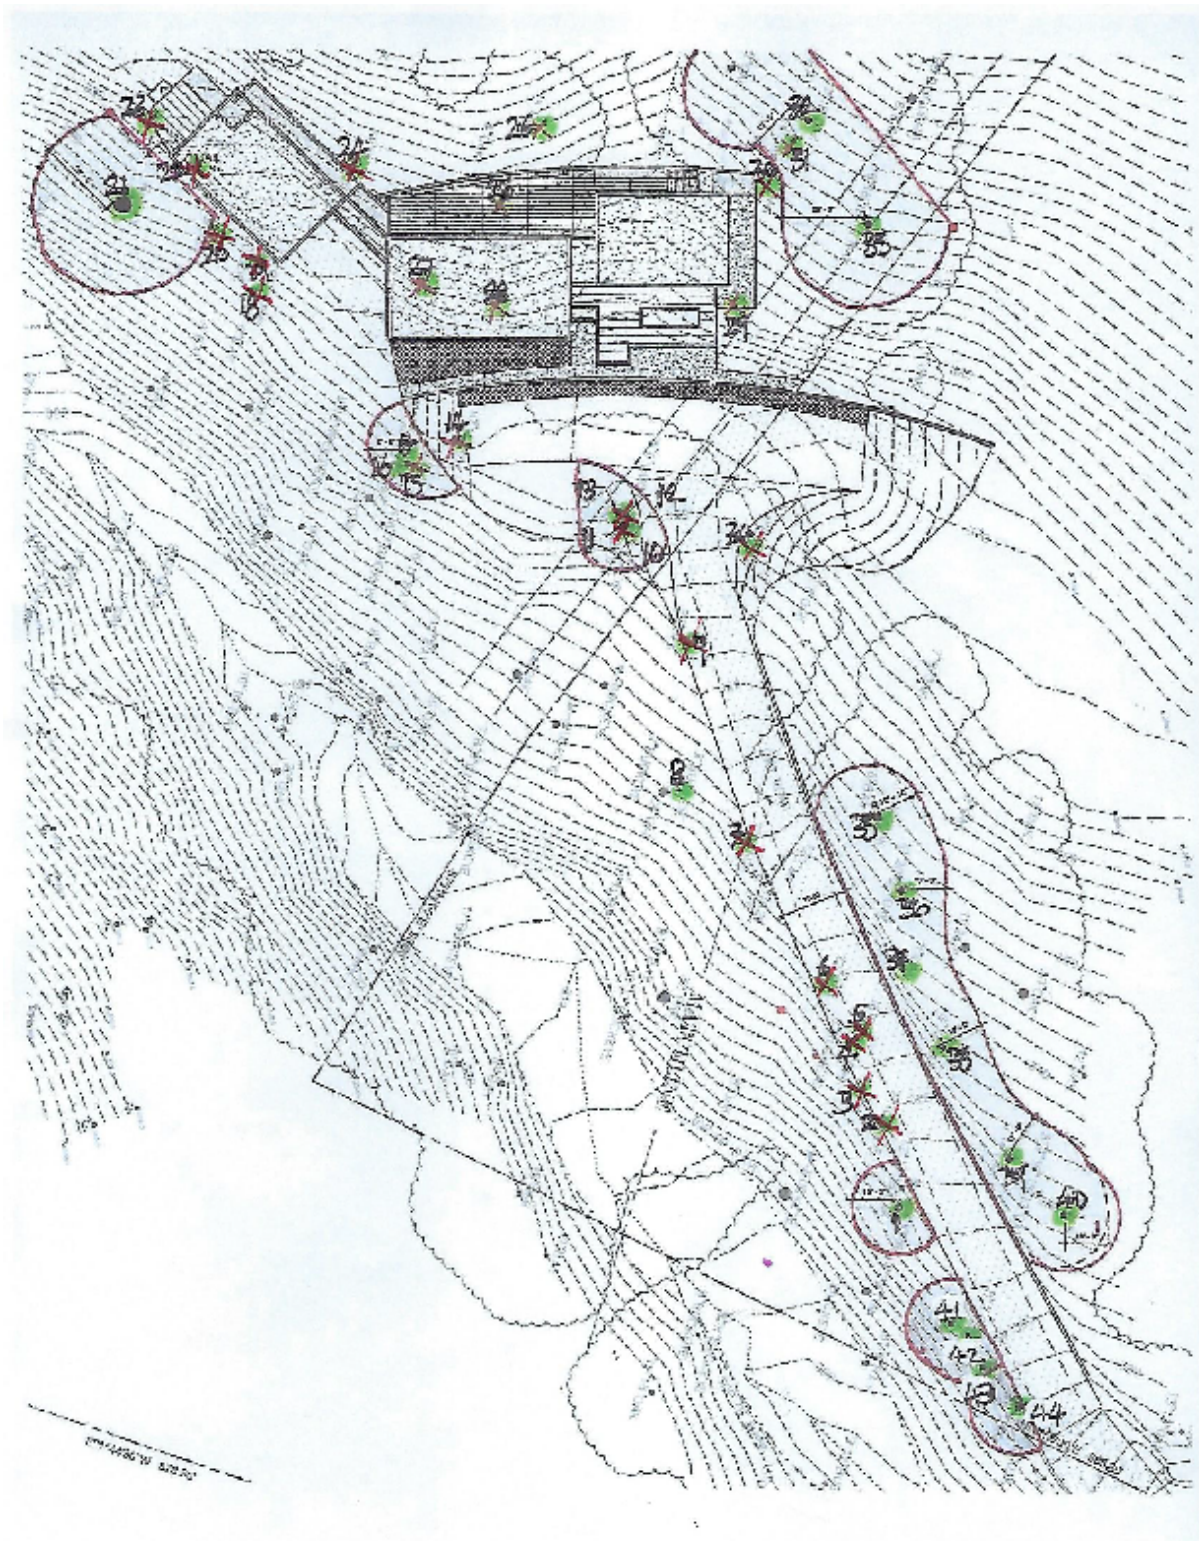
Tree #s 1, 11, 13, 17, 21, 32, 33, 35, 36, 38, 39, 40, 41, 42 and 44 should be protected during construction.

Location of proposed new house, protected trees and their Tree Protection Zones

Tree #s 1, 11, 13, 41, 42 and 44 are along the east side of the driveway up to the proposed house. The TPZ fencing should follow the edge of the driveway and extend out to 10 feet from the trunk of the tree where possible.

Tree #s 35, 36, 38, 39 and 40 are along the west side of the driveway up to the proposed house. The TPZ fencing should follow the edge of the driveway and extend out to 10 feet from the trunk of the tree where possible.

Tree # 17: TPZ should be at 8 feet from the trunk closing on the fence line in accordance with Type I Tree Protection as outlined and illustrated in image 2.15-1 and 2<sup>(6)</sup>.

Tree # 21: TPZ should be at 20 feet from the trunk closing on the fence line in accordance with Type I Tree Protection as outlined and illustrated in image 2.15-1 and 2<sup>(6)</sup>.

Tree # 32: TPZ should be at 20 feet from the trunk closing on the fence line in accordance with Type I Tree Protection as outlined and illustrated in image 2.15-1 and 2<sup>(6)</sup>.

Tree # 33: TPZ should be at 20 feet from the trunk closing on the fence line in accordance with Type I Tree Protection as outlined and illustrated in image 2.15-1 and 2<sup>(6)</sup>.

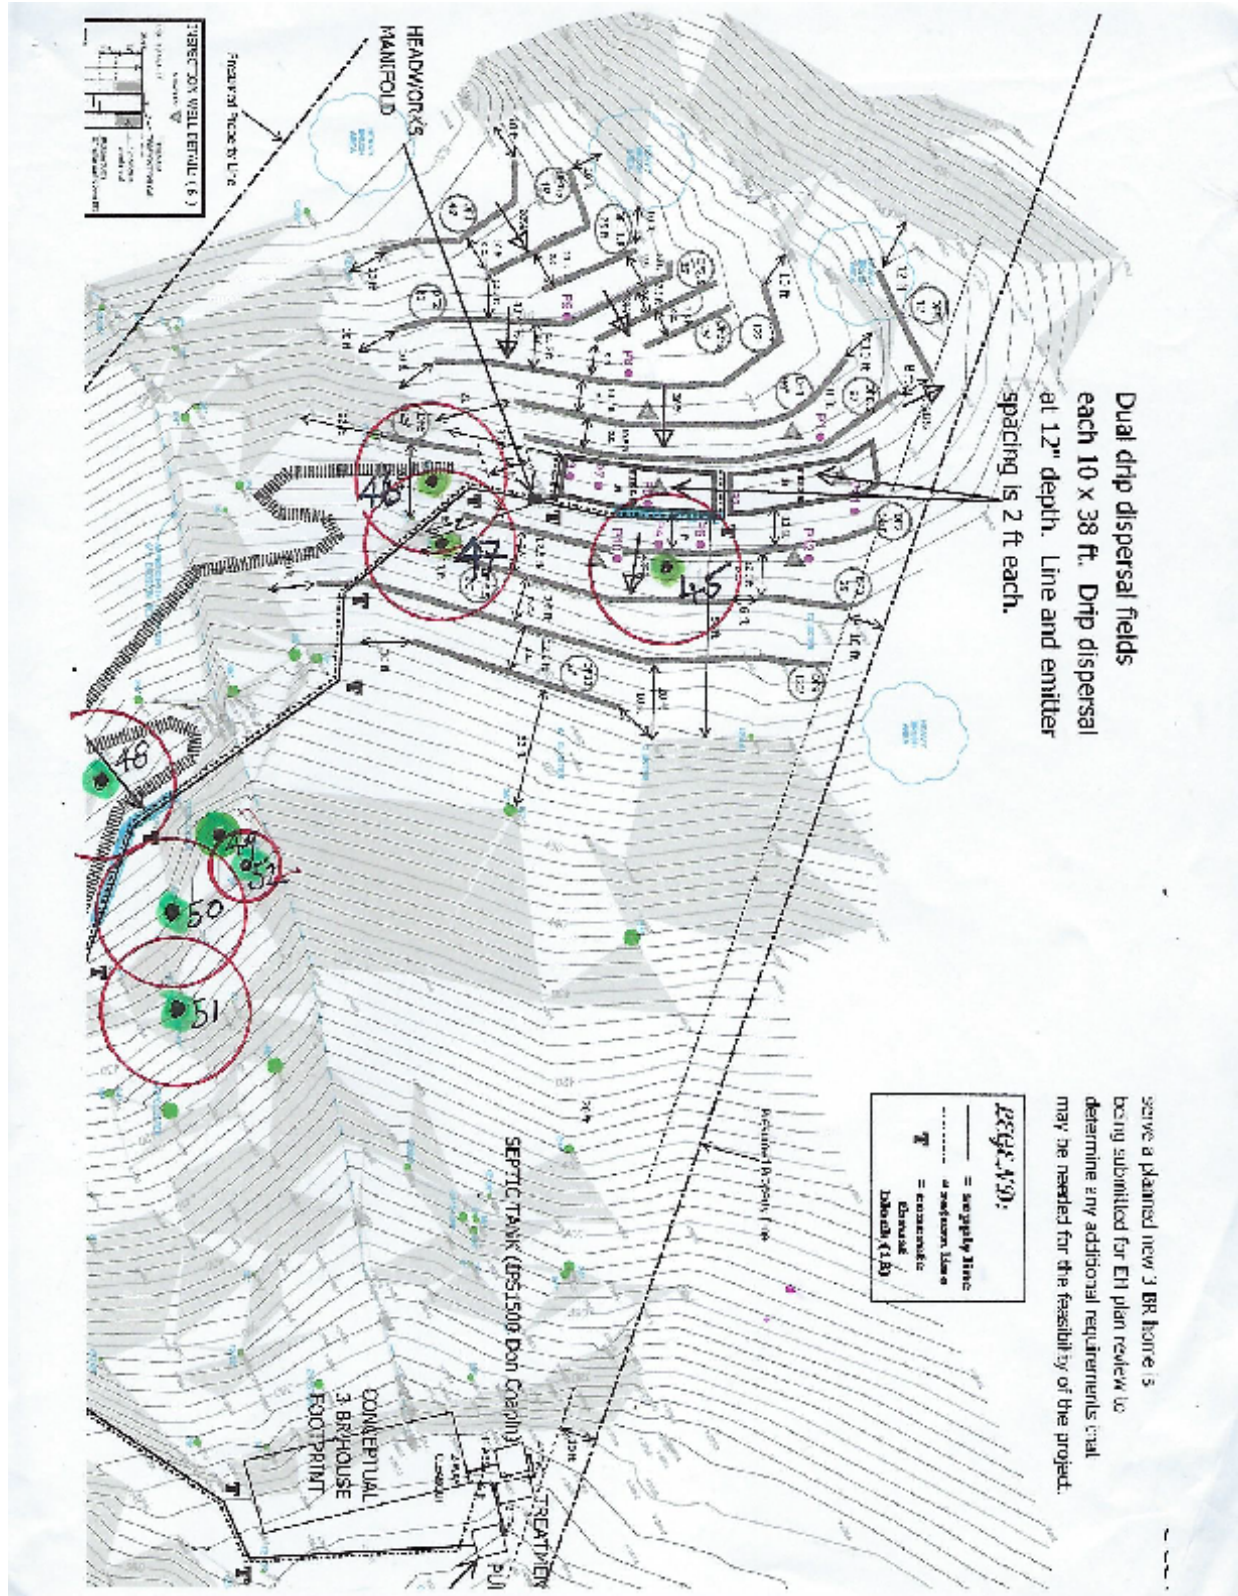
A septic system is planned for the property that may impact further Significant trees. The location of the trees can be found on the following plan. The trees are numbered continuing from the original inventory.

TPZs for Tree #s 45, 46, 47, 48, 50, and 51 should be at 20 radius feet from the trunk of each tree. This is shown as a red line. I do not think it is necessary to install Type I Tree Protection fencing around those trees however the TPZ should be observed and noted

TPZ for Tree # 52 should be at 10 radius feet from the trunk of each tree. This is shown as a red line. I do not think it is necessary to install Type I Tree Protection fencing around those trees however the TPZ should be observed and noted

Excavation of the leach field within the TPZ of Tree # 45, 48 and 50 should be dug by hand with no roots greater than 2" in diameter being cut. Shown in blue.
