TUNITAS CREEK BEACH IMPROVEMENT PROJECT

EXISTING CONDITIONS

April 2020

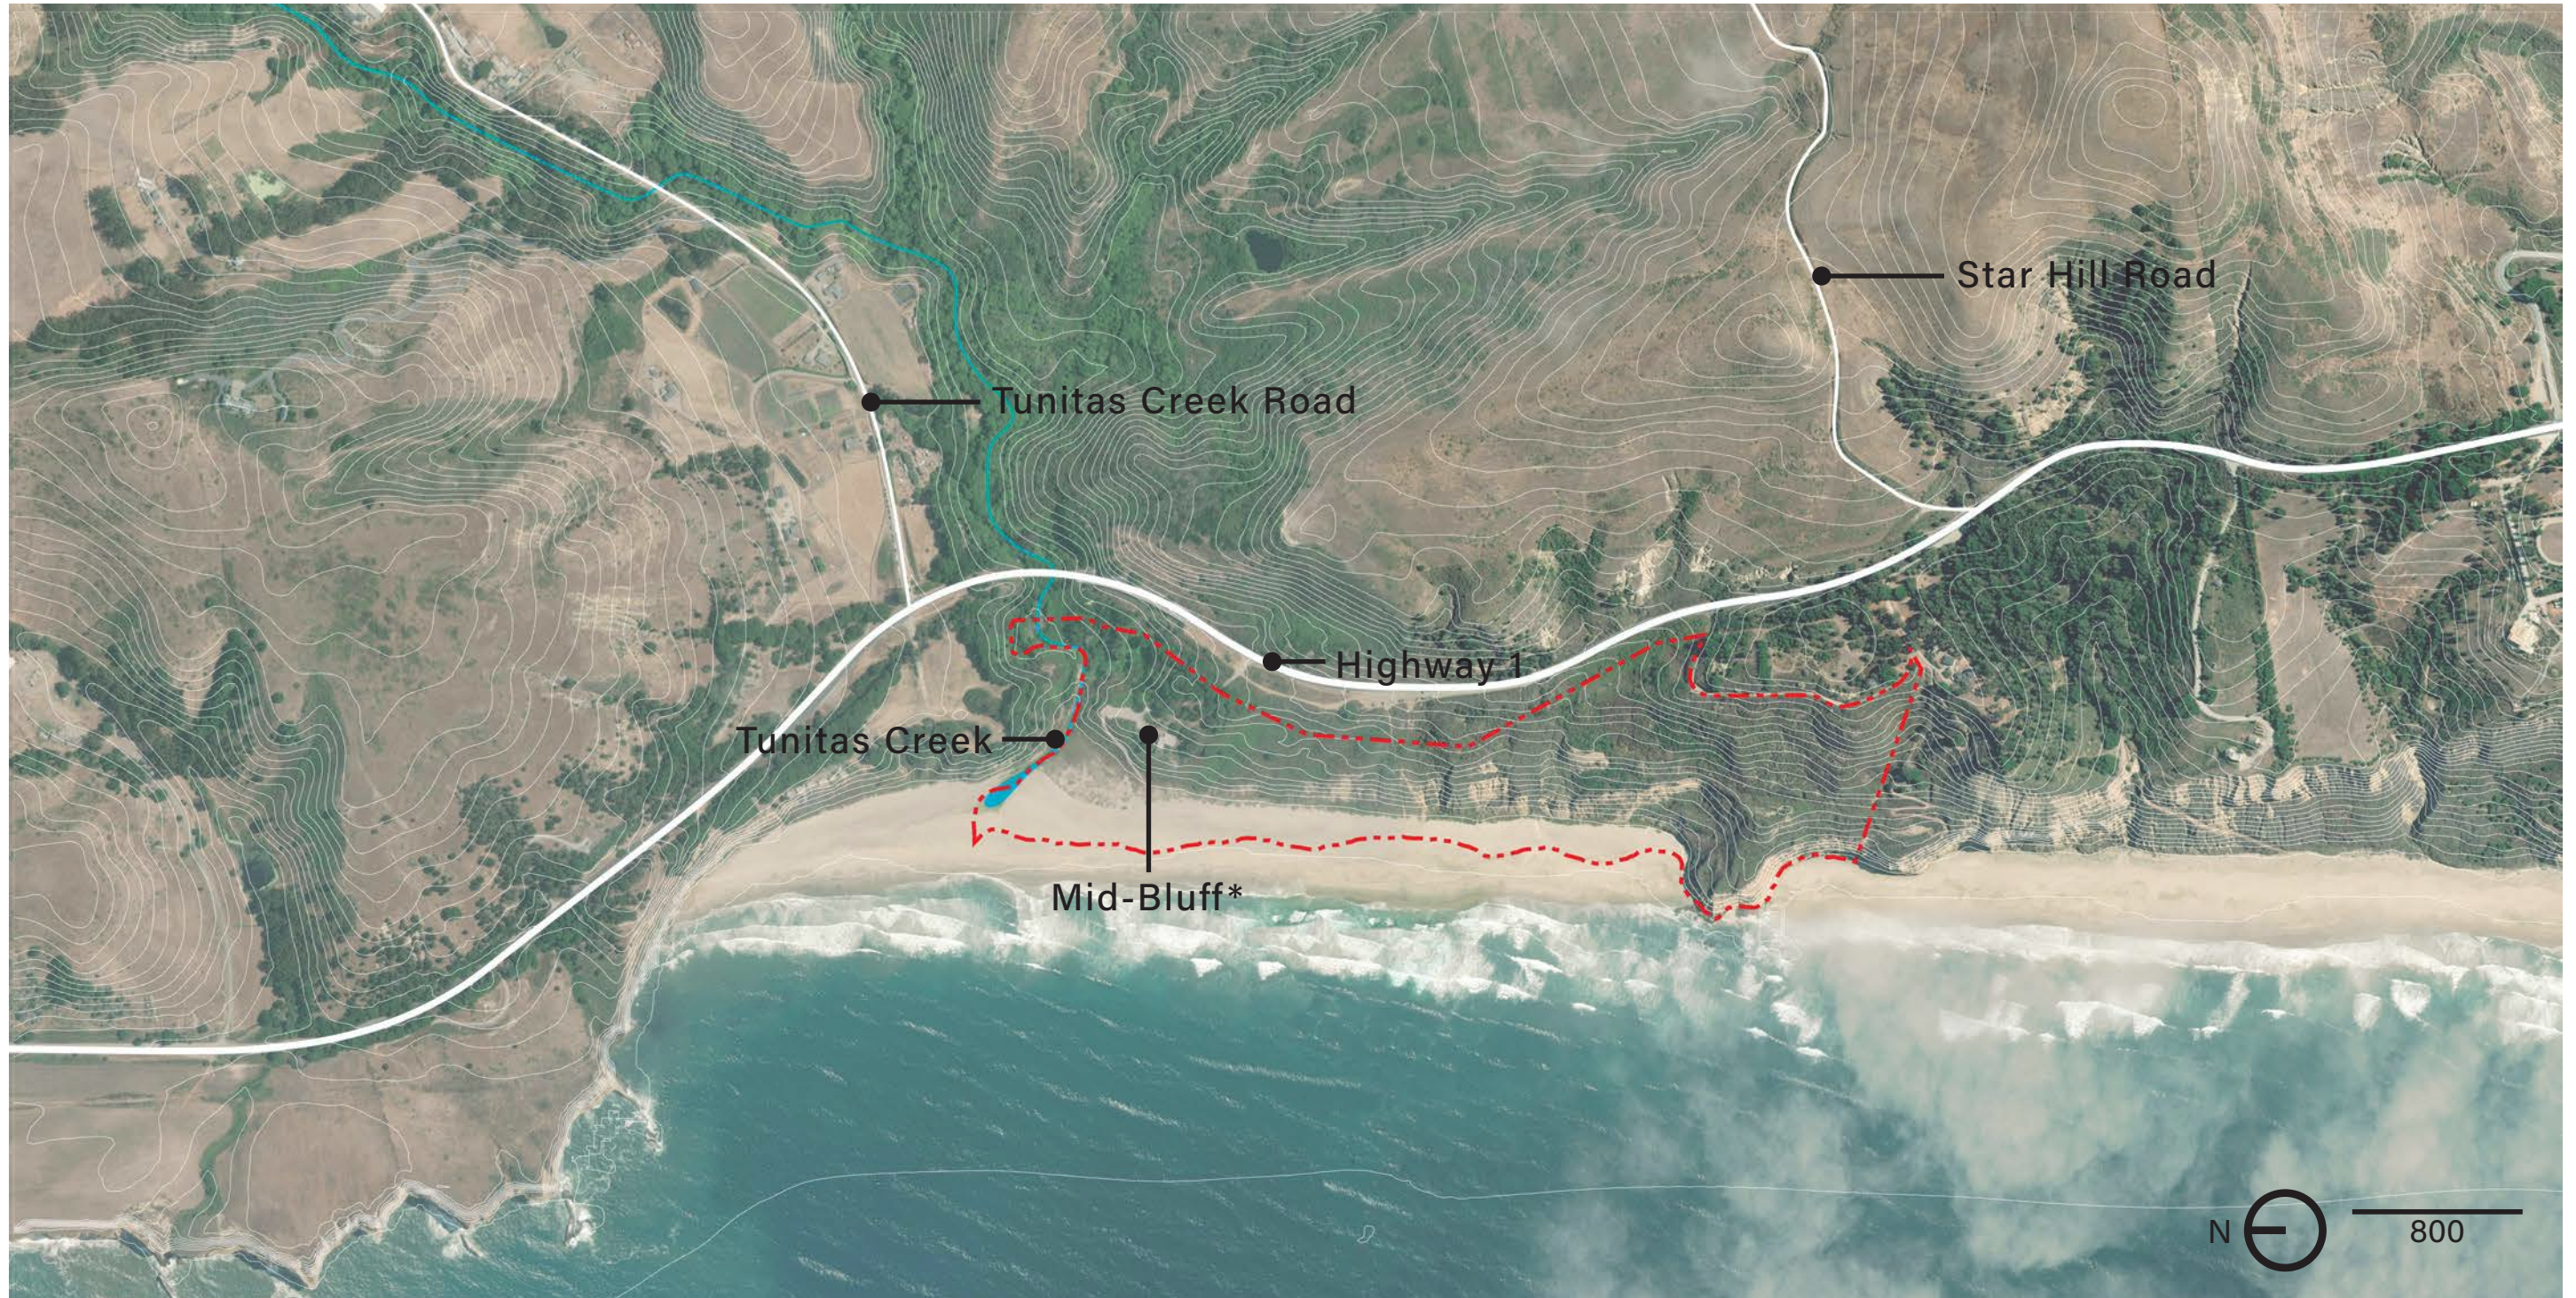
*Throughout the presentation, we will be using the term "mid-bluff" to refer to the relatively flat area near the existing residence

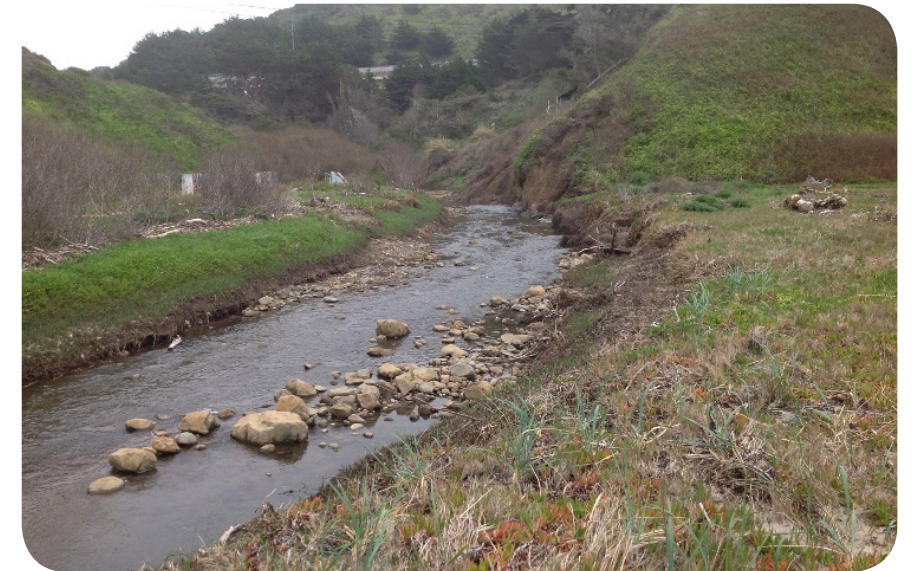
PERENNIAL STREAM HABITAT

Tunitas Creek is a 6.6-mile fast-flowing perennial stream that runs from King's Mountain to Tunitas Beach. The active wetted channel is approximately 20 ft wide and ranges from several inches to several feet deep.

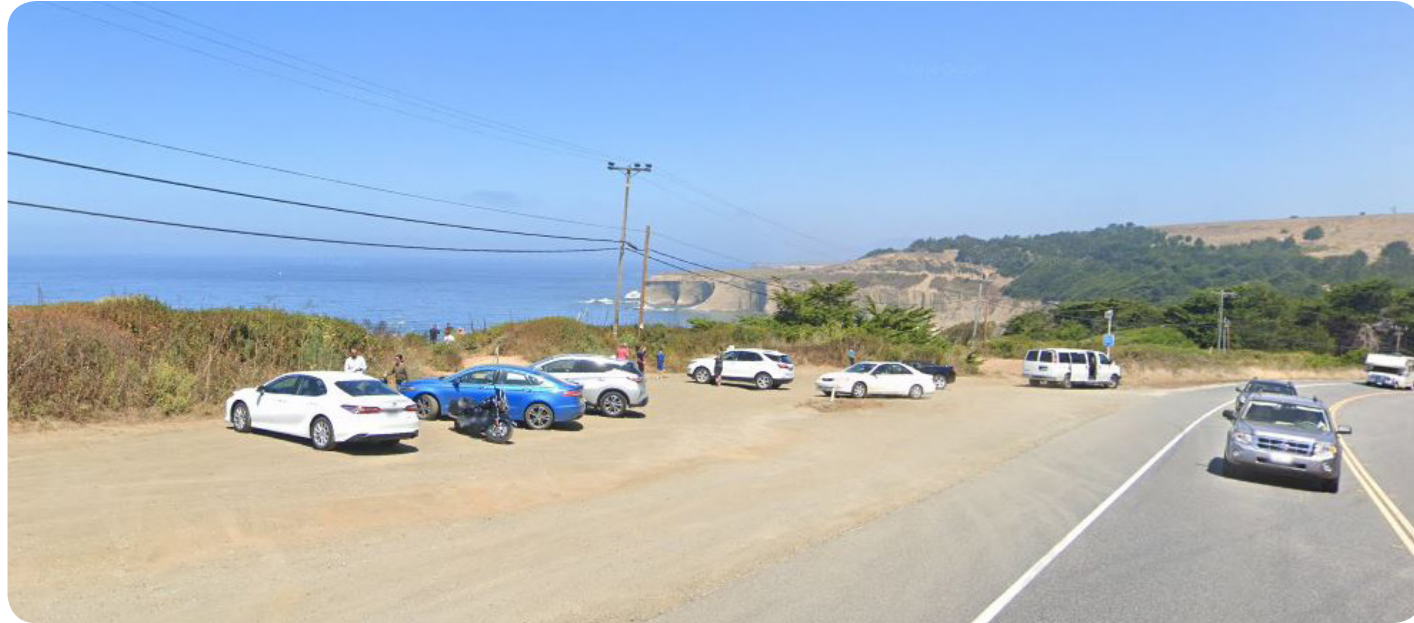
EXISTING INFORMAL DIRT PARKING

Currently, most cars park in the informal roadside dirt lot at the top of the bluff. Up to 60 cars park here at a time on the busiest days of the week.

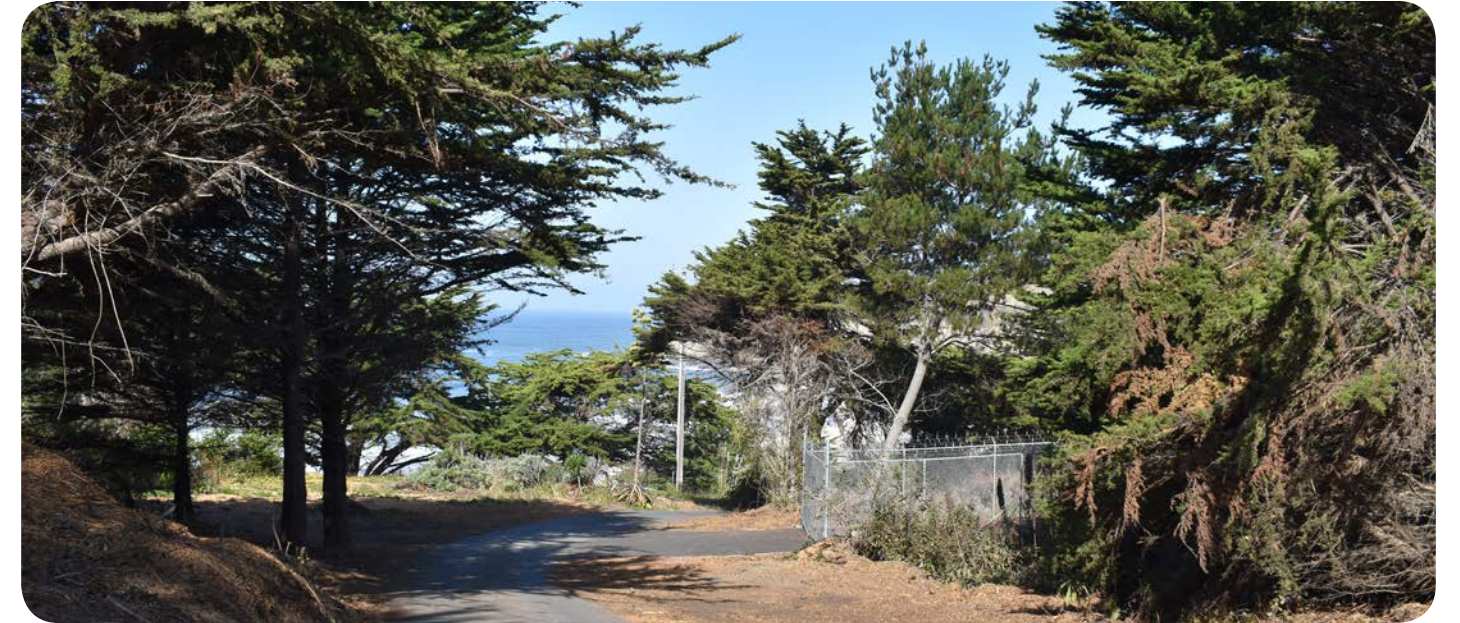
EXISTING ACCESS ROAD

An existing closed-off access road currently allows rangers and emergency vehicles to get down to the site of the existing residence and the beach.

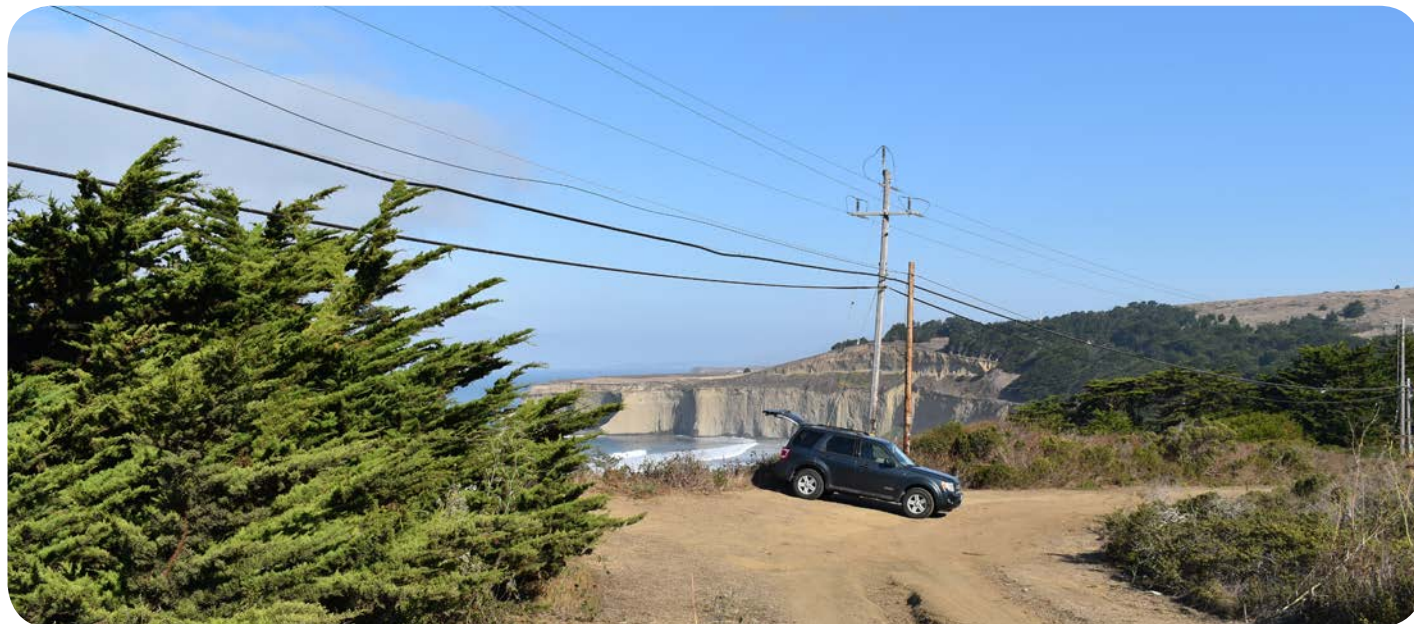
OTHER INFORMAL PARKING AREAS

Some cars will park on the dirt trail leading from the access road to the informal dirt parking area and pull close to the edge of the bluff.

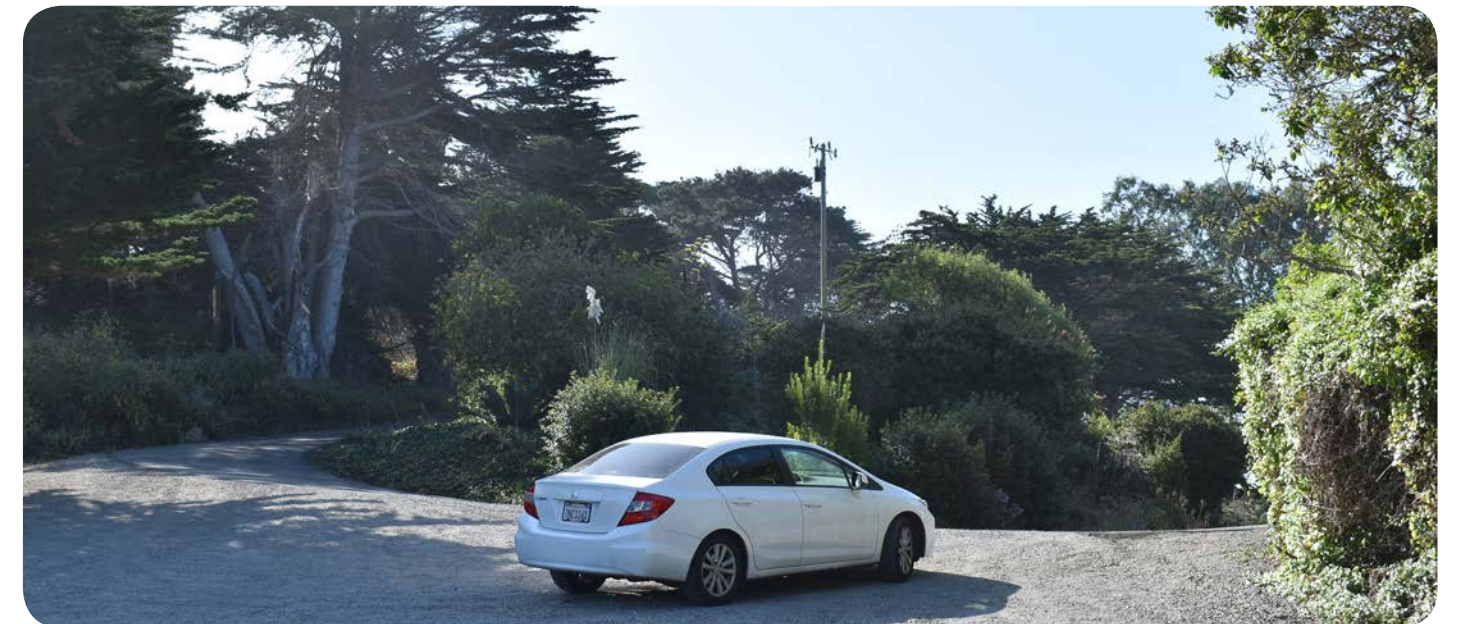
GRAVEL PARKING AT MID-BLUFF

The existing closed-off access road leads to an informal gravel parking area near the site of the existing residence.

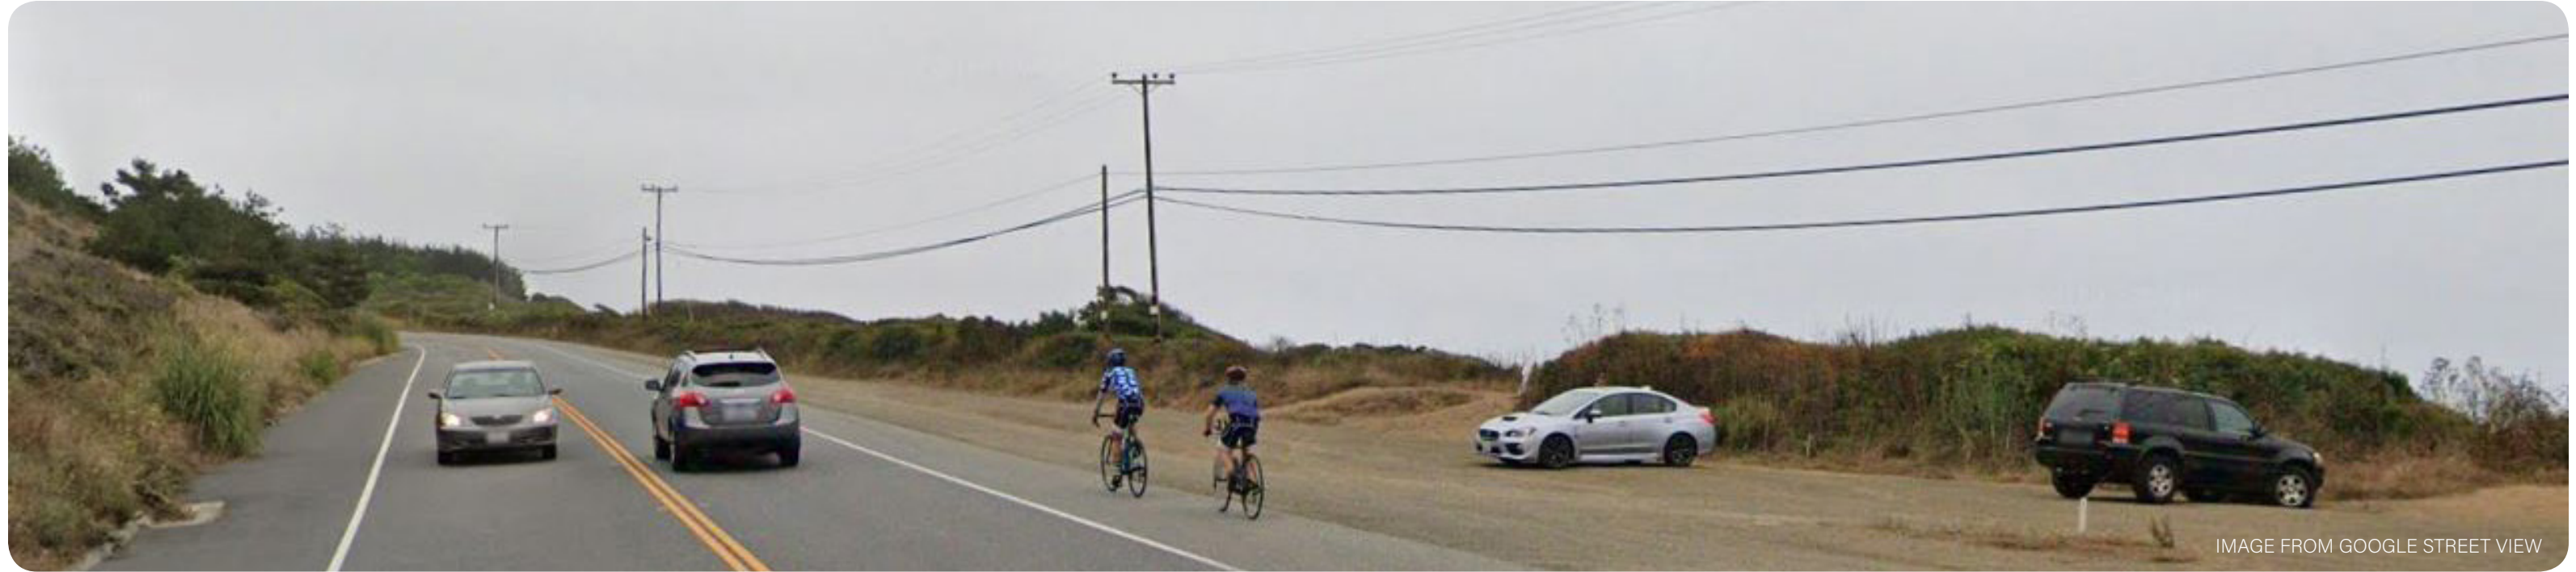
BIKING AT TUNITAS CREEK BEACH

No formal biking trails exist at Tunitas Creek Beach today. Some bikers bike alongside Highway 1 down the peninsula and pass by Tunitas Creek Beach.

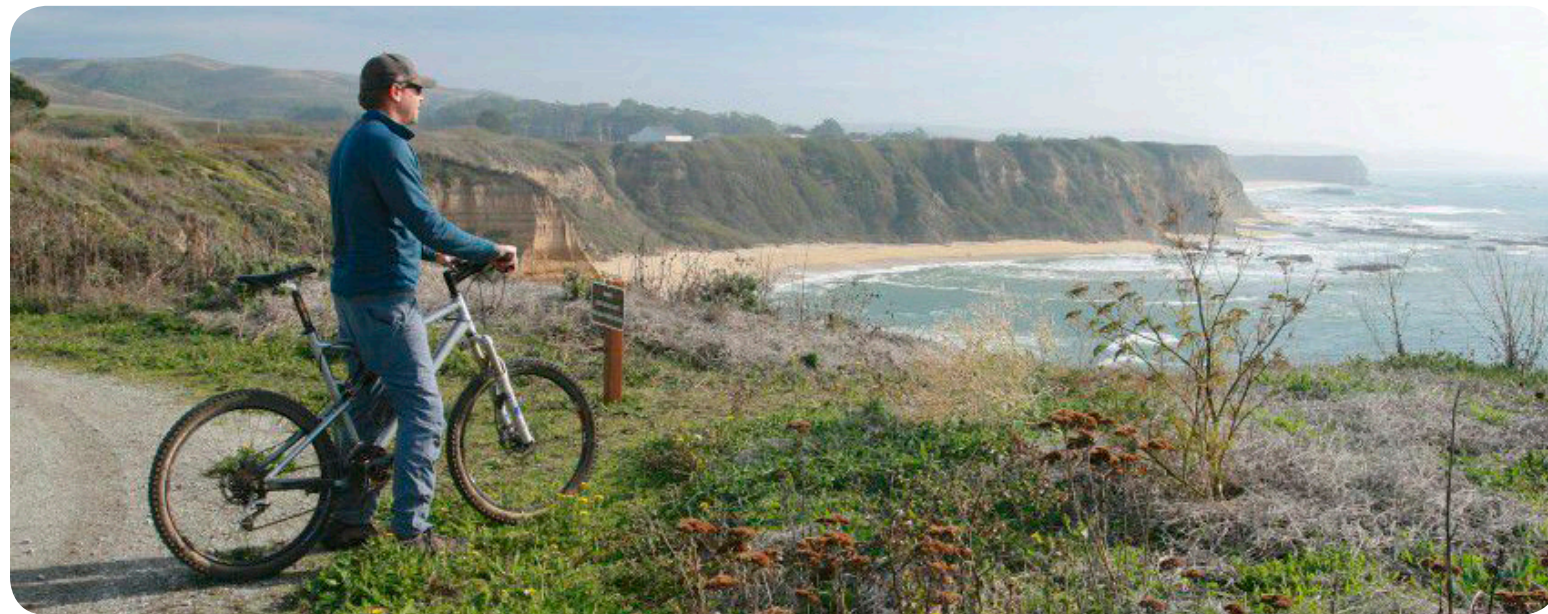
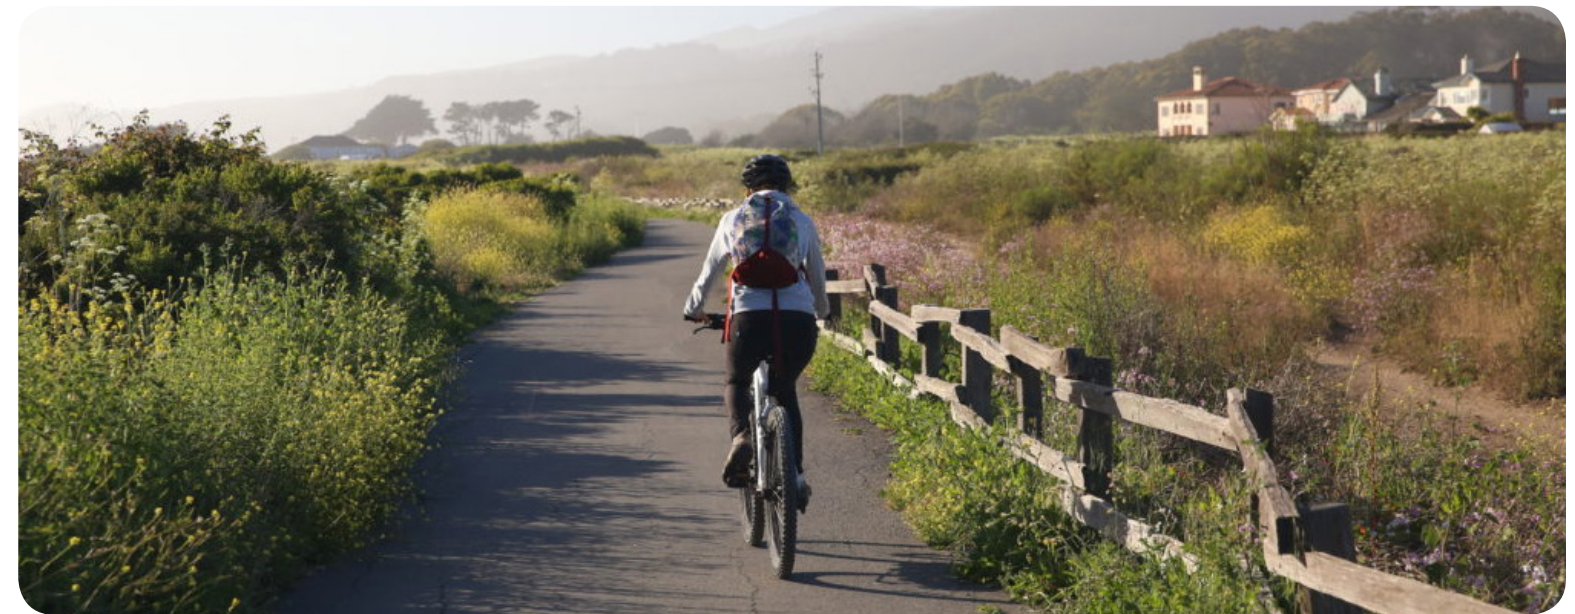
REGIONAL COASTAL TRAILS

While no bike trail exists at Tunitas Creek Beach, there are several nearby bike-friendly trails, such as the Cowell-Purisima Coastal Trail (left) and the Half Moon Bay Coastal Trail (right). Some of these trails have the potential to be connected to Tunitas as part of the Ohlone-Portola heritage trail.

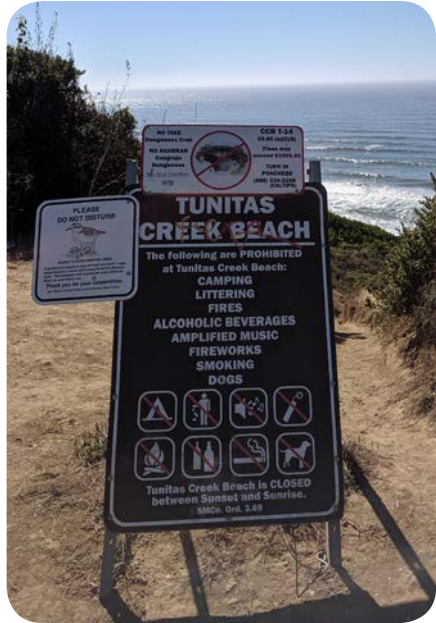
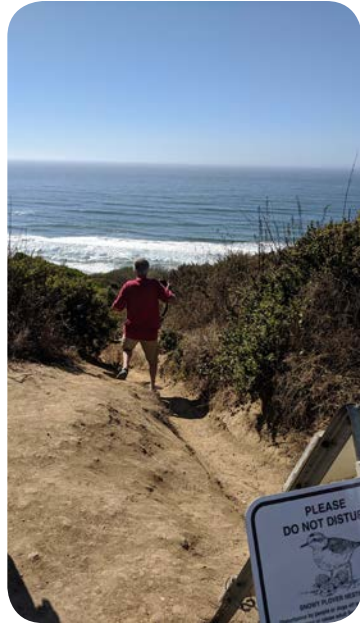
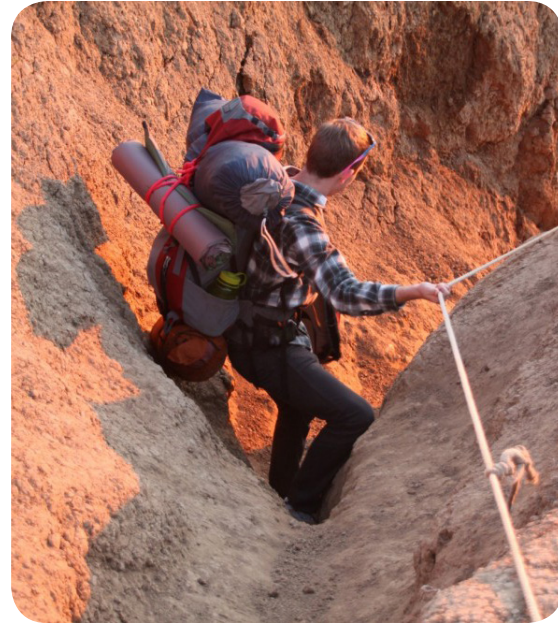
EXISTING PEDESTRIAN ACCESS TO THE BEACH

Currently, the only paths to Tunitas Creek Beach from the parking area at the top of the bluff are unsanctioned, eroding, and unsafe footpaths.

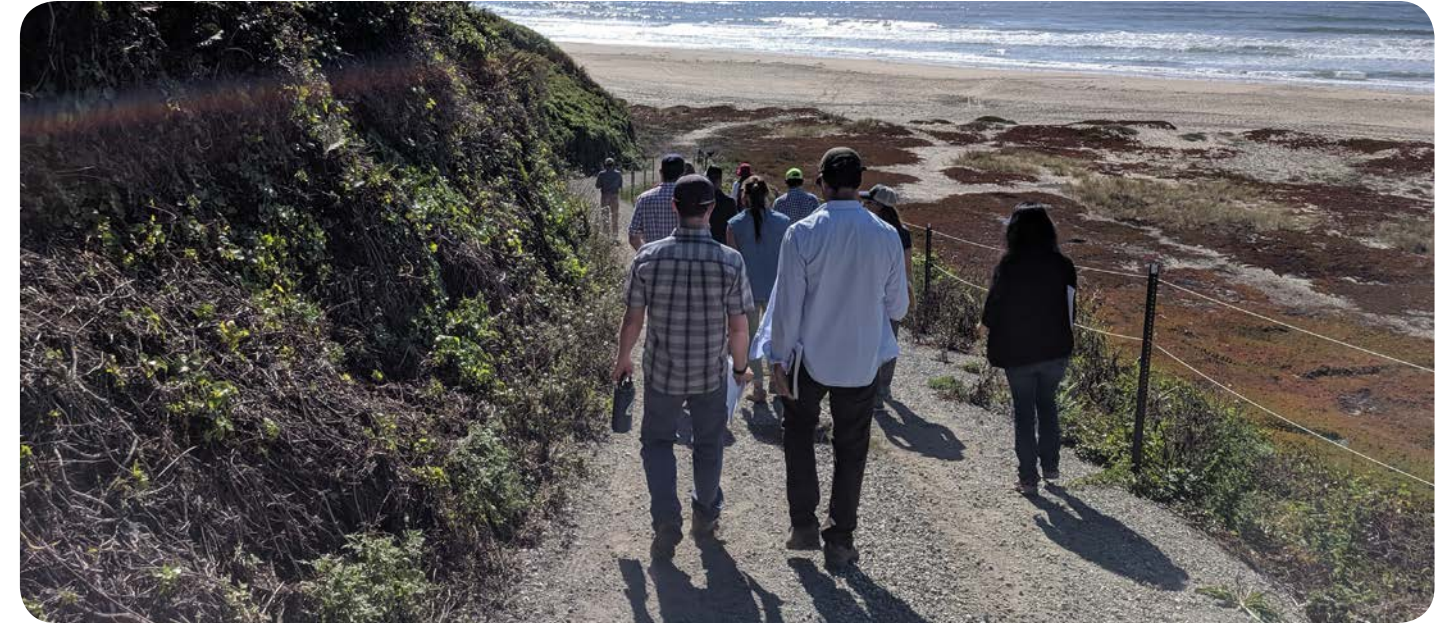
ACCESS ROAD TO THE BEACH

While not open to the public, an access road created for emergency vehicles to get to the beach currently exists and will become a pedestrian trail when the park opens.

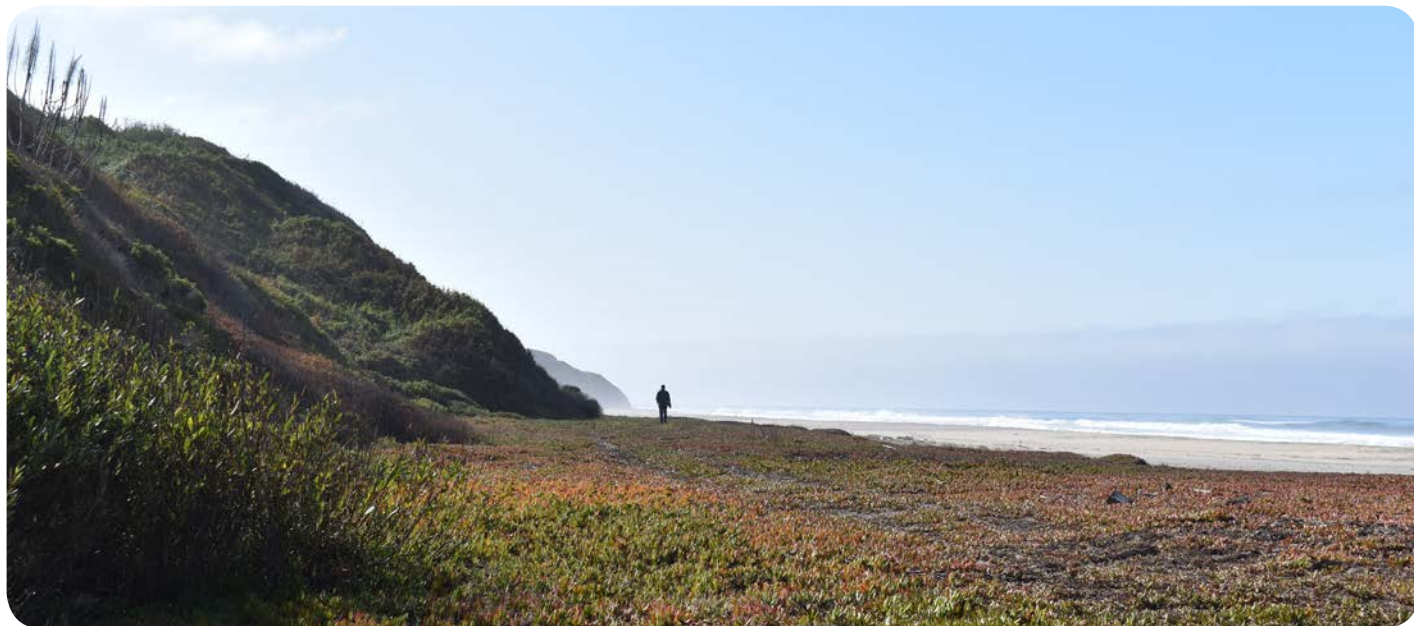
PEDESTRIAN ACCESS ALONG THE BEACH

There are currently no formal access paths along the beach, but people often walk along the beach to get to the southern bluffs.

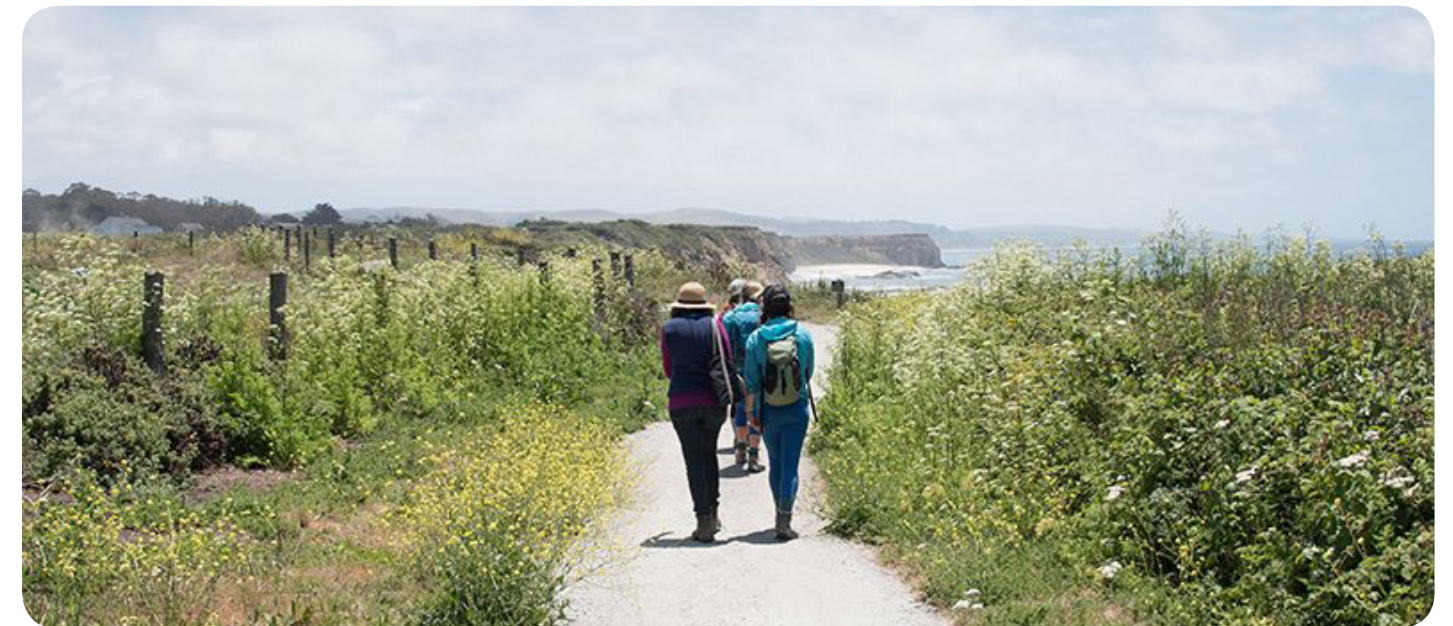
REGIONAL COASTAL TRAILS

The nearby Cowell-Purisima coastal trail features walking and biking paths and may potentially be connected to a pedestrian trail at Tunitas Creek Beach.

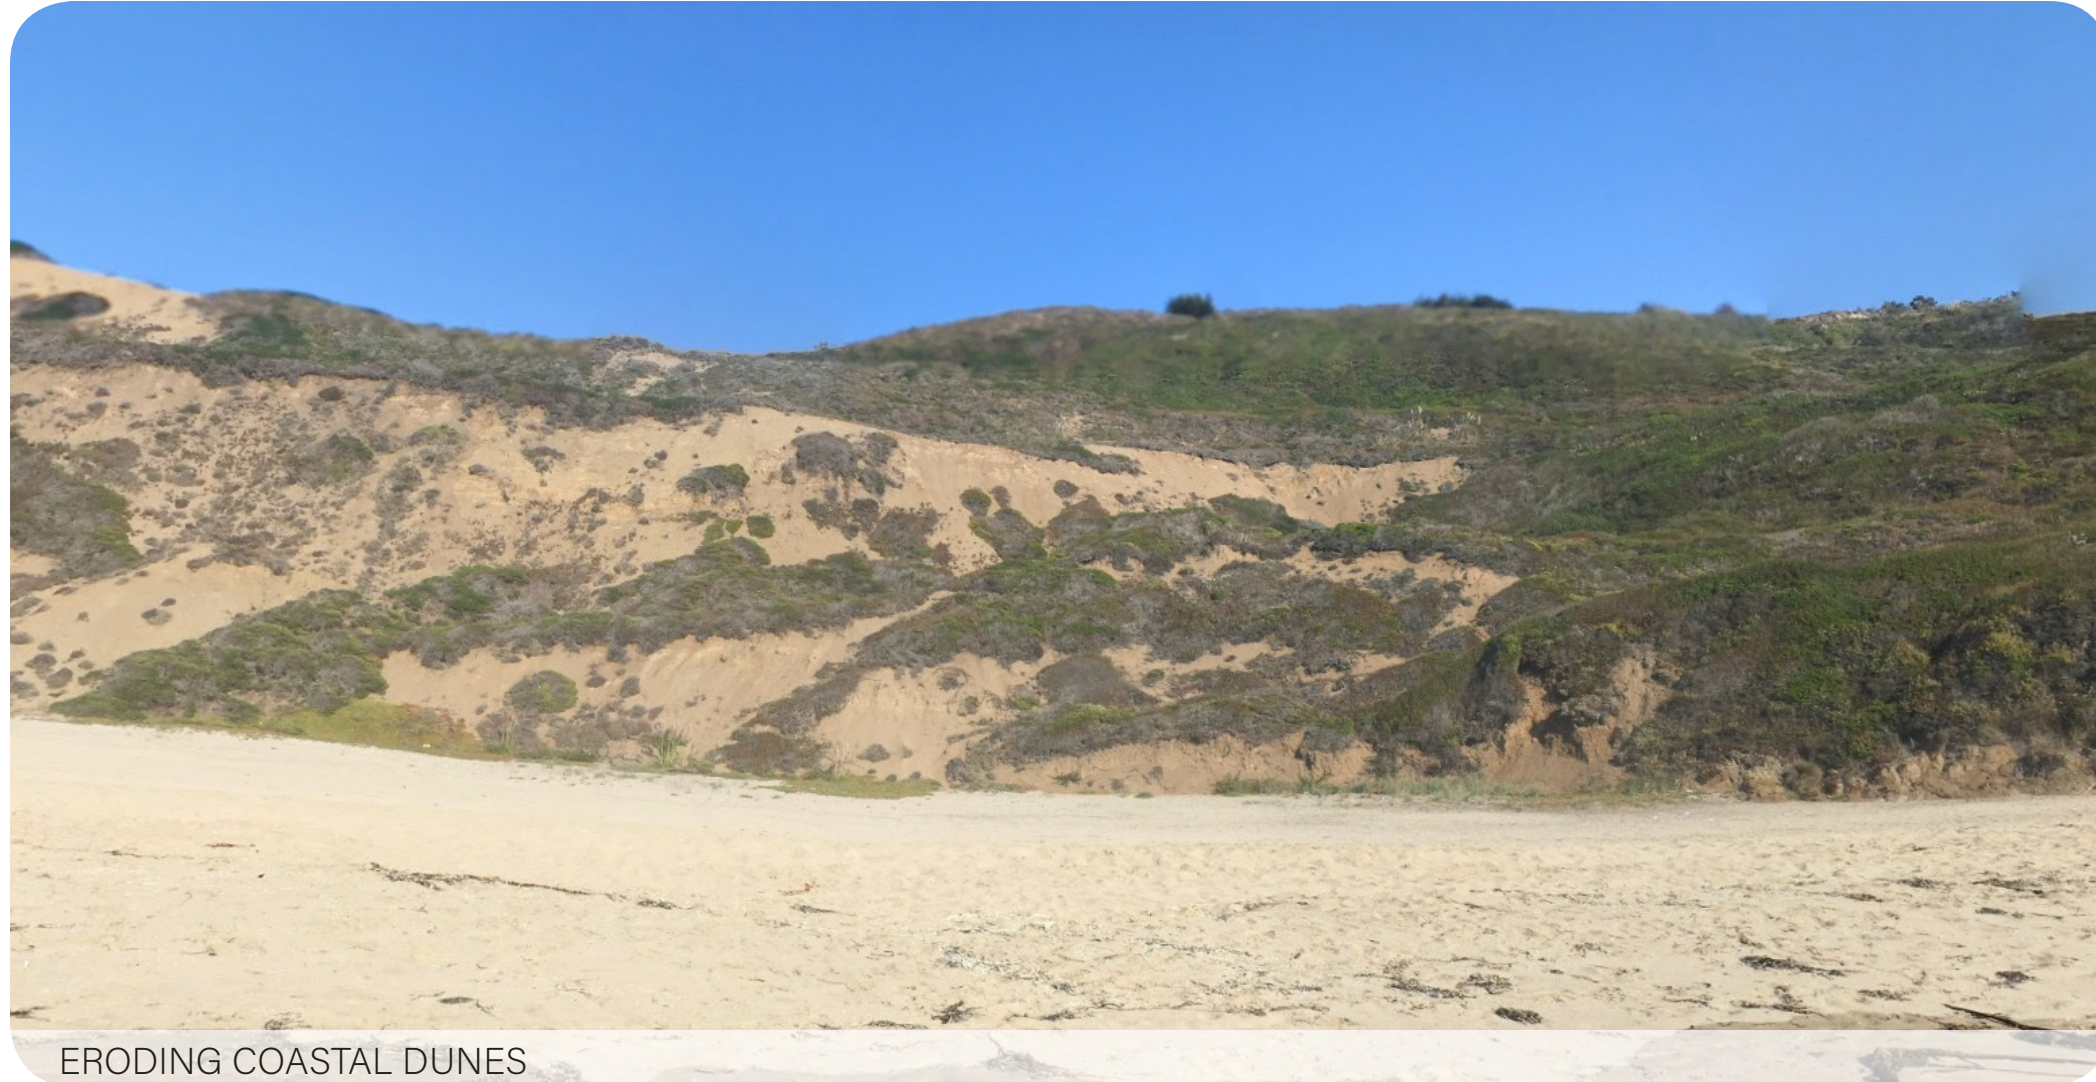
ERODING COASTAL DUNES

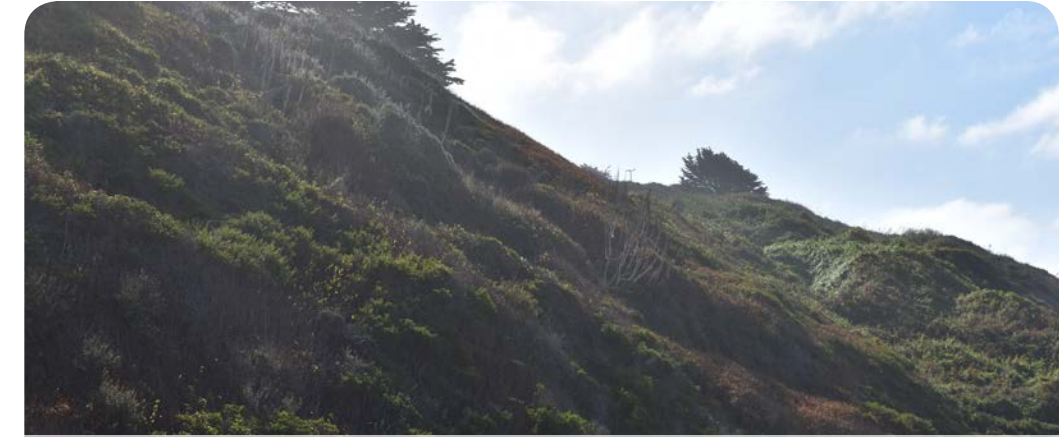
STEEP SLOPE TO BEACH

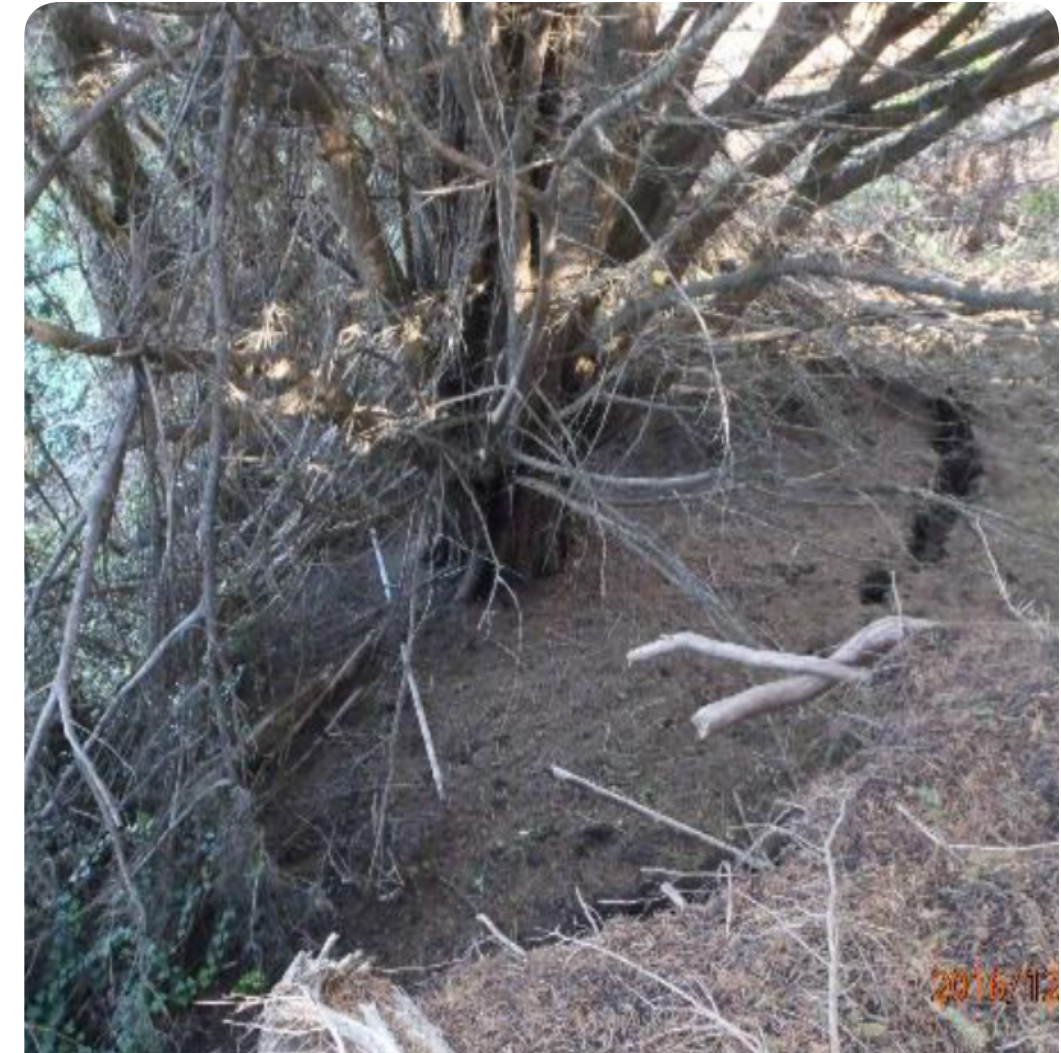
ACTIVE LANDSLIDE IN NORTHEAST AREA OF SITE

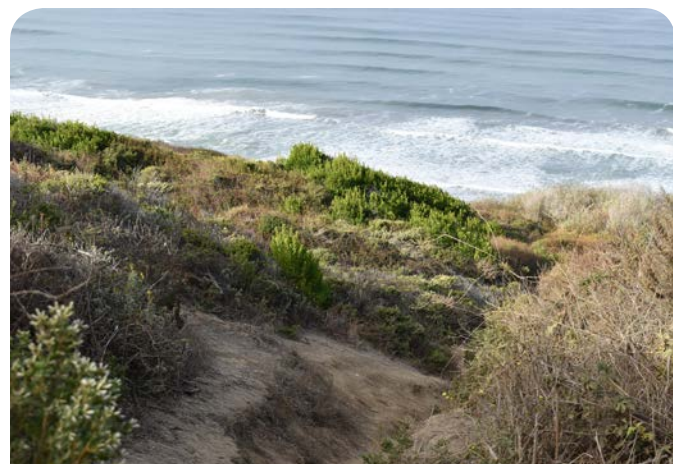
ERODED FOOTPATH TO BEACH

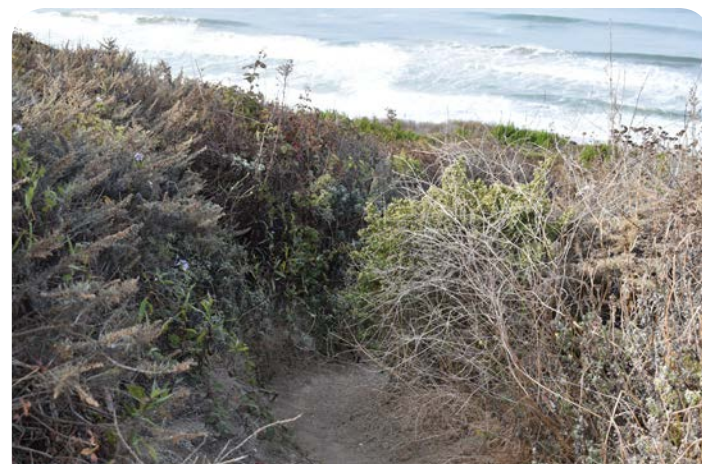
ERODED FOOTPATH TO BEACH

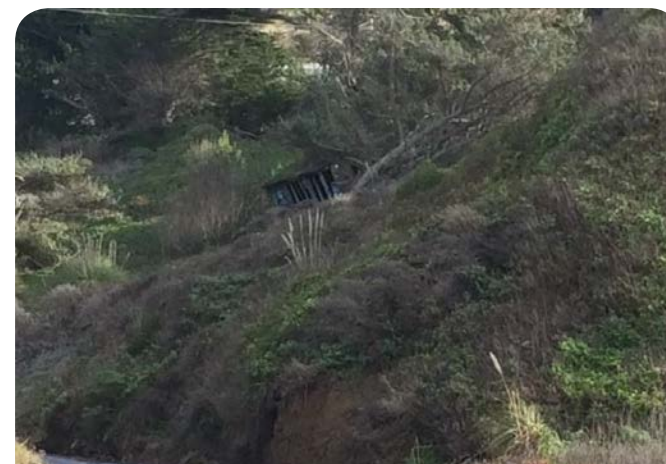
EROSION NEAR TUNITAS CREEK
