Project SM10391.1
24 April 2015

Subject: Coastal Bluff Recession Study

Reference: Juliana Avenue and Vallemar Street
Moss Beach, California
San Mateo County APN's 37-08-23, 24, 25, 26, 27, 28 and 29

HARO, KASUNICH AND ASSOCIATES, INC.

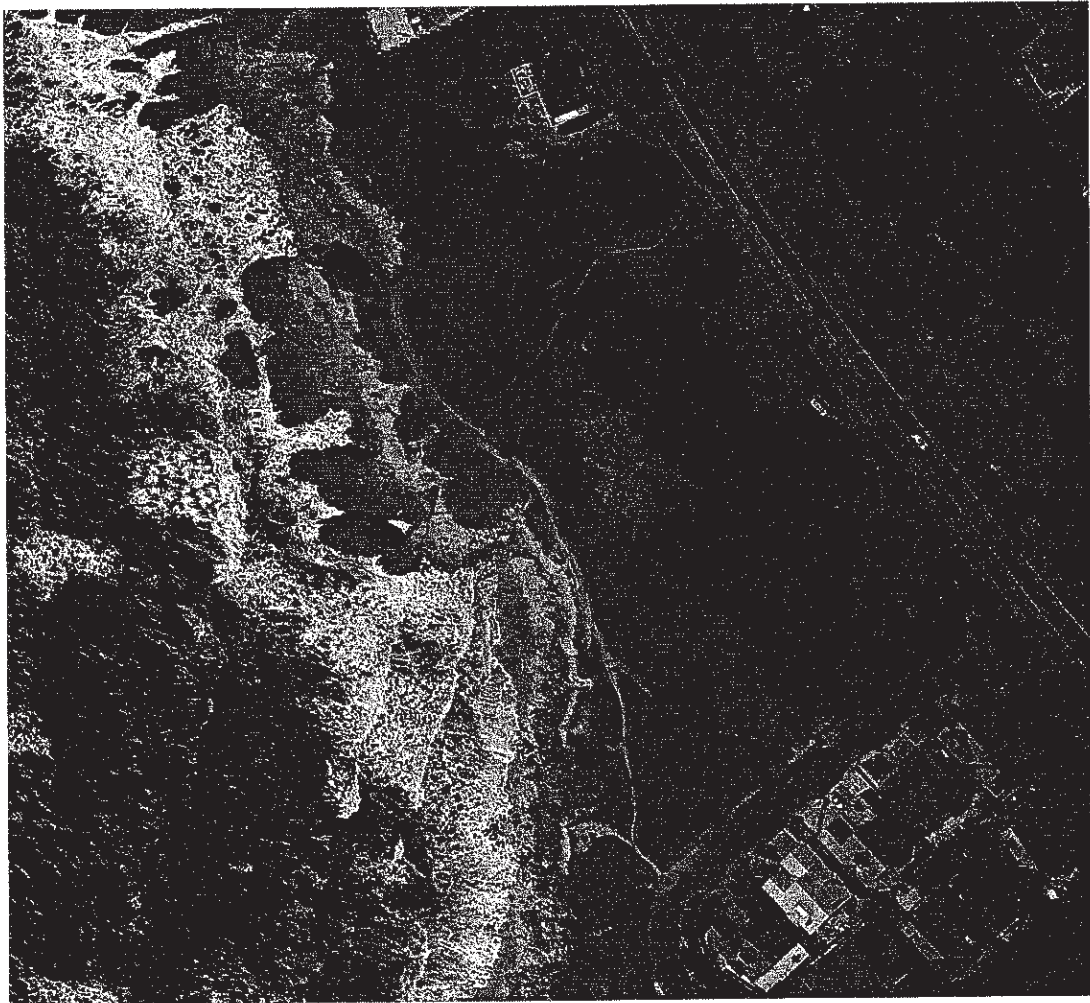
**April 15, 2013 Vertical Image of Site
Copyright Google Earth**

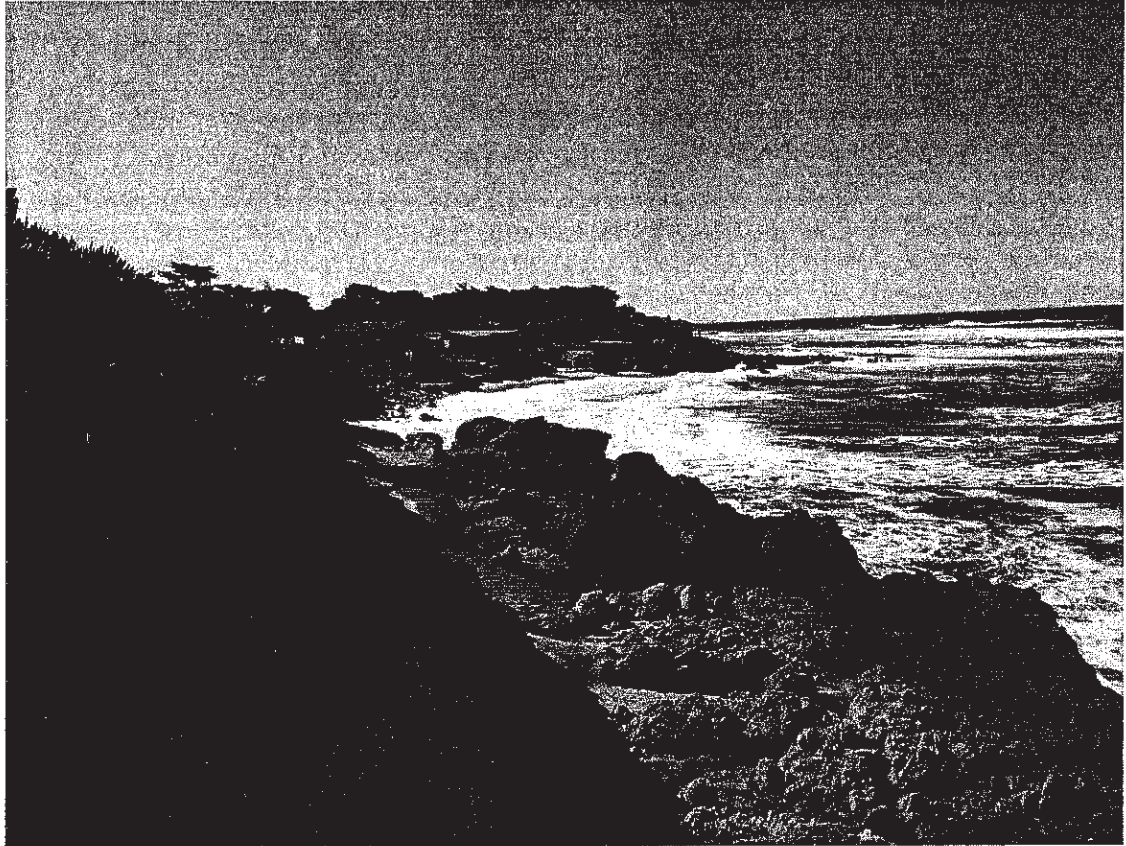
Bluff Face Looking Downcoast

We observed the bluff from the ocean to the building site. The level bluff top area where the oceanfront homes will be located is 42 to 55 feet above sea level. The upper bluff face is steeply inclined downward and is composed of marine terrace deposits (Qmt), which are approximately 22 to 26 feet thick where exposed in the bluff face. Below the terrace deposits, the lower bluff below approximately elevation 20 is composed of hard erosion resistant bedrock, which is nearly vertical, consisting of granitic rock (Kgr). The bedrock is erosion resistant and therefore the upper bedrock surface forms an exposed rough horizontal bench where the more erodible upper terrace deposits have receded more than the bedrock. Along the downcoast half of the site, seaward of the base of the bluff is a thin deposit of cobbles and beach sand that is often covered by ocean water or wave runup. The beach width varies significantly based on tidal conditions and ocean wave runup.

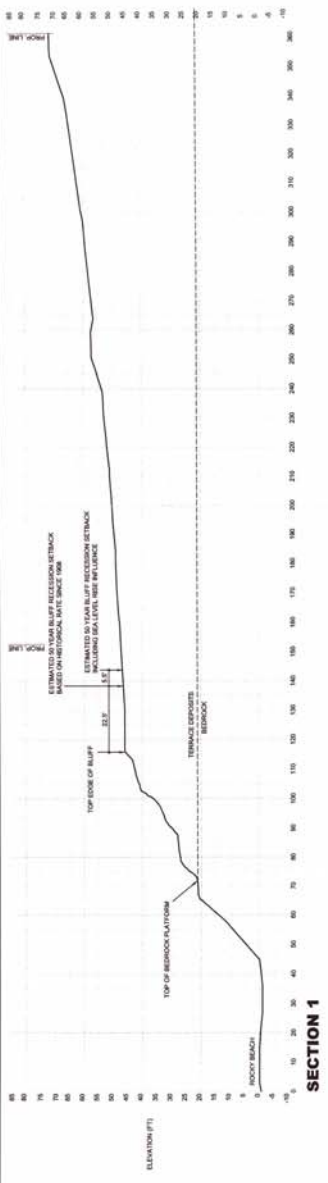
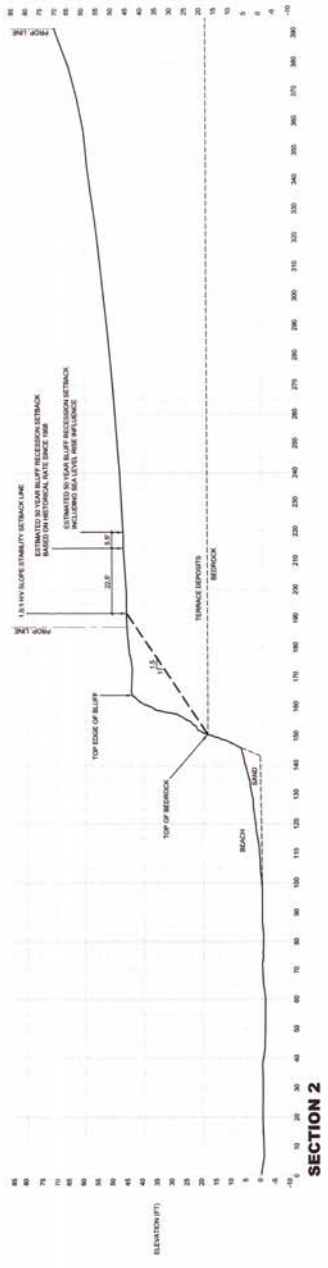
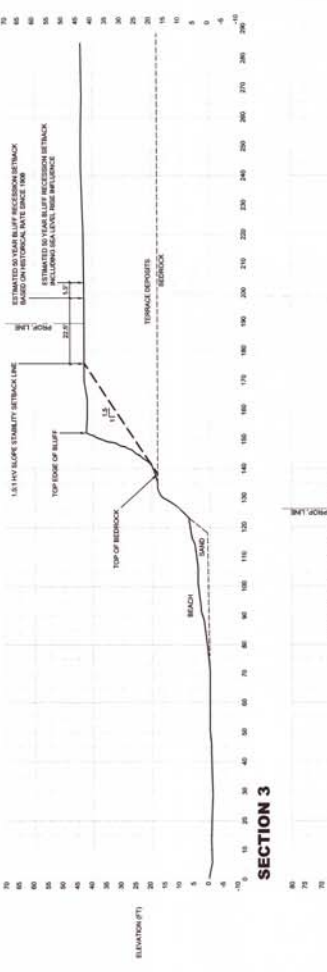
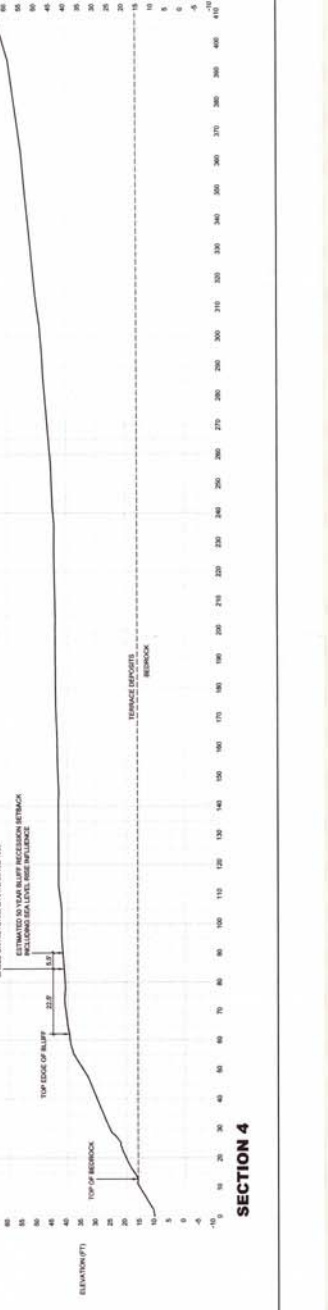
COASTAL BLUFF RECESSION CROSS SECTIONS
 MOSS BEACH ASSOCIATES, LLC
 VALLEMAR STREET & JULIANA AVENUE, MOSS BEACH, CA
 SAN MATEO COUNTY A.P.N.'S: 037-086-023, 024, 025, 026, 027, 028 & 029

2014 Topographic Base Map and Cross Sections by Ifland Surveys Showing Estimated 50 Year Future Coastal Bluff Recession Setback

We have prepared a drawing that shows an Estimated 50 Year Future Coastal Bluff Recession Setback that depicts the setback in plan view on a 2014 topographic base map prepared by Iland Surveys (Appendix C). The Setback was developed based on where an estimated projected failure of the bluff face to a 1.5 to 1.0 (H to V) stable gradient would come to (varying from 0 to about 25 feet back from the existing bluff edge; depending on existing bluff face gradient), then an additional 22.5 feet of recession to account for 50 years of future coastal erosion at the historical rate that recession has occurred at since 1908, plus an additional 5.5 feet of recession to account for accelerating bluff recession resulting from accelerating sea level rise. The 5.5 feet represents a 25% acceleration in the long term historical recession rate at this site. As a result the total Estimated 50 Year Future Coastal Bluff Recession Setback is predicted to be 28 feet landward of where the bluff would be stable based on the 1.5 to 1 (H to V) gradients discussed above. This results in a total Estimated 50 Year Future Coastal Bluff Recession Setback line 28 to 56 feet inland of the existing top edge of the bluff, as shown on the 2014 topographic base map prepared by Iland Surveys in Appendix C.

We note that our analysis considers the influence of both slope instability and coastal recession. It accounts for 50 years of recession that causes the bluff face to recede landward uniformly, then an episode of slope instability in the 50th year that flattens the bluff face to a 1.5 to 1 (H:V) gradient in areas that have been oversteepened by active recent erosion. It is statistically unlikely that an episode of slope instability will occur exactly in the 50th year; this makes the analysis conservative. Because the historical recession rates used herein were calculated using the position of the top edge of the bluff, those calculated rates include the influence of both slope instability and coastal erosion. This adds a second degree of conservatism to the setback line we have presented, since it considers the influence of slope instability and coastal erosion in an additive manner.
