2023 Slip-Out Repair Project Higgins Canyon Road

Department of Public Works

April 13, 2023

Higgins Canyon Road Failure and Closure

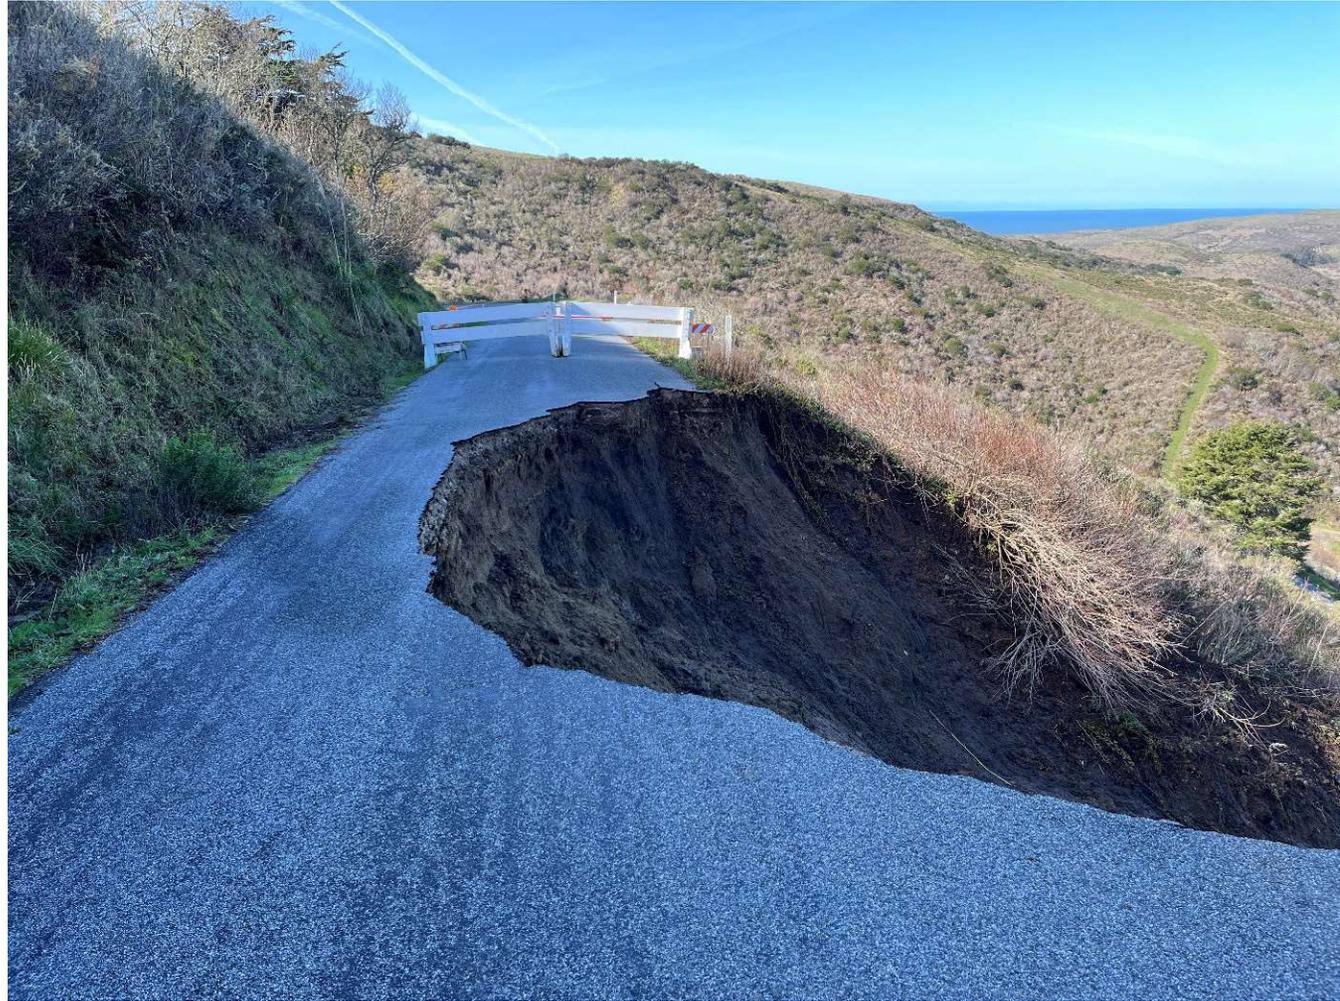
Stage Road – Roadway Closed

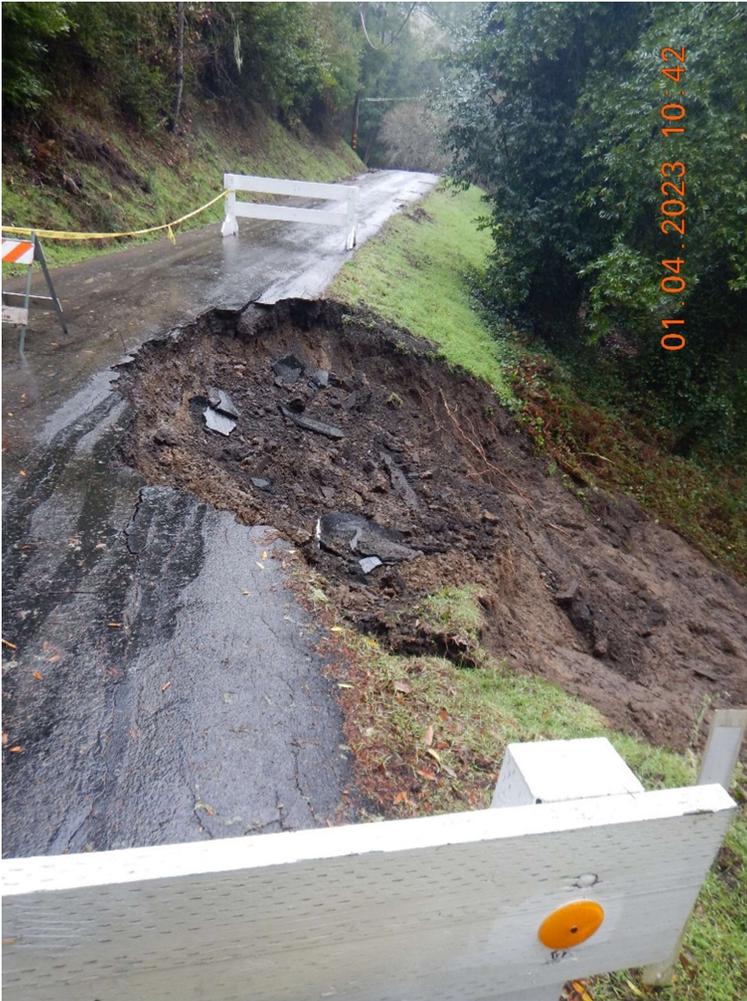
Laguna Drive – Roadway Closed

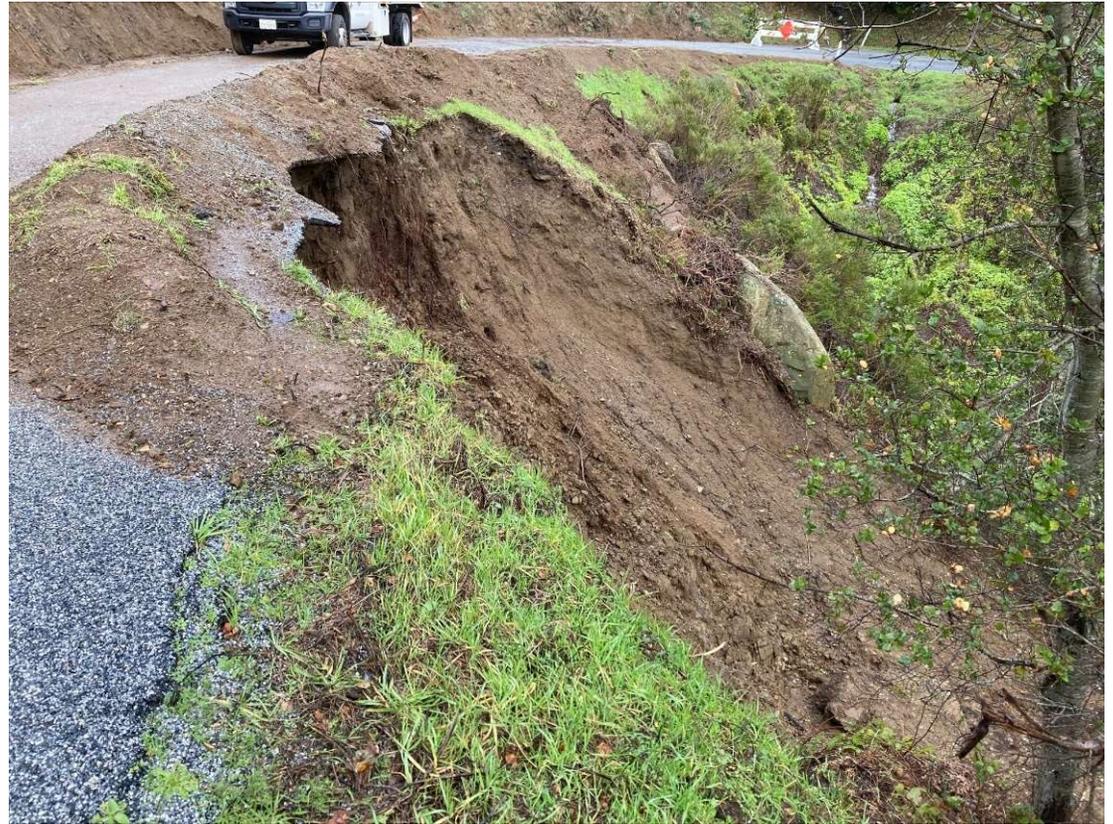
Old La Honda Road – Roadway Closed

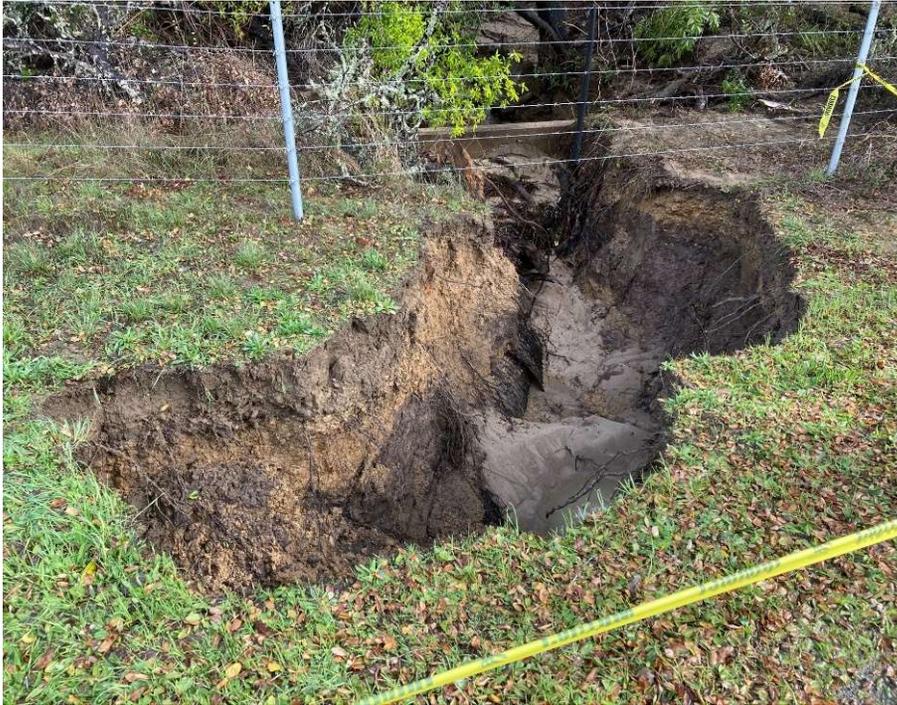
Canada Road – Culvert/Sink Hole

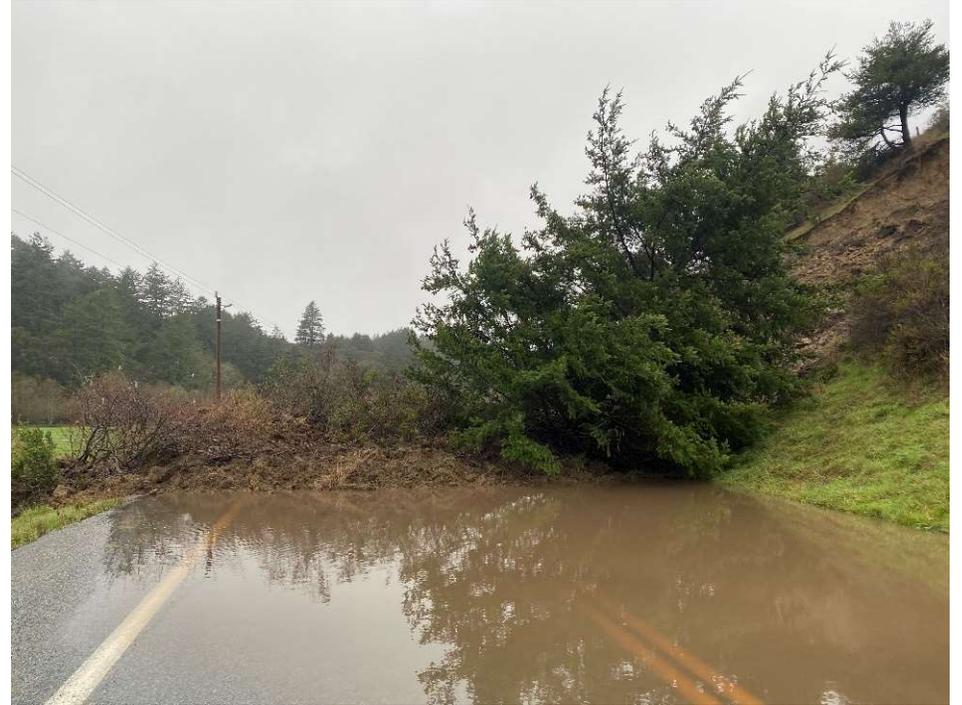
Cloverdale Road – Slide/Debris Removal

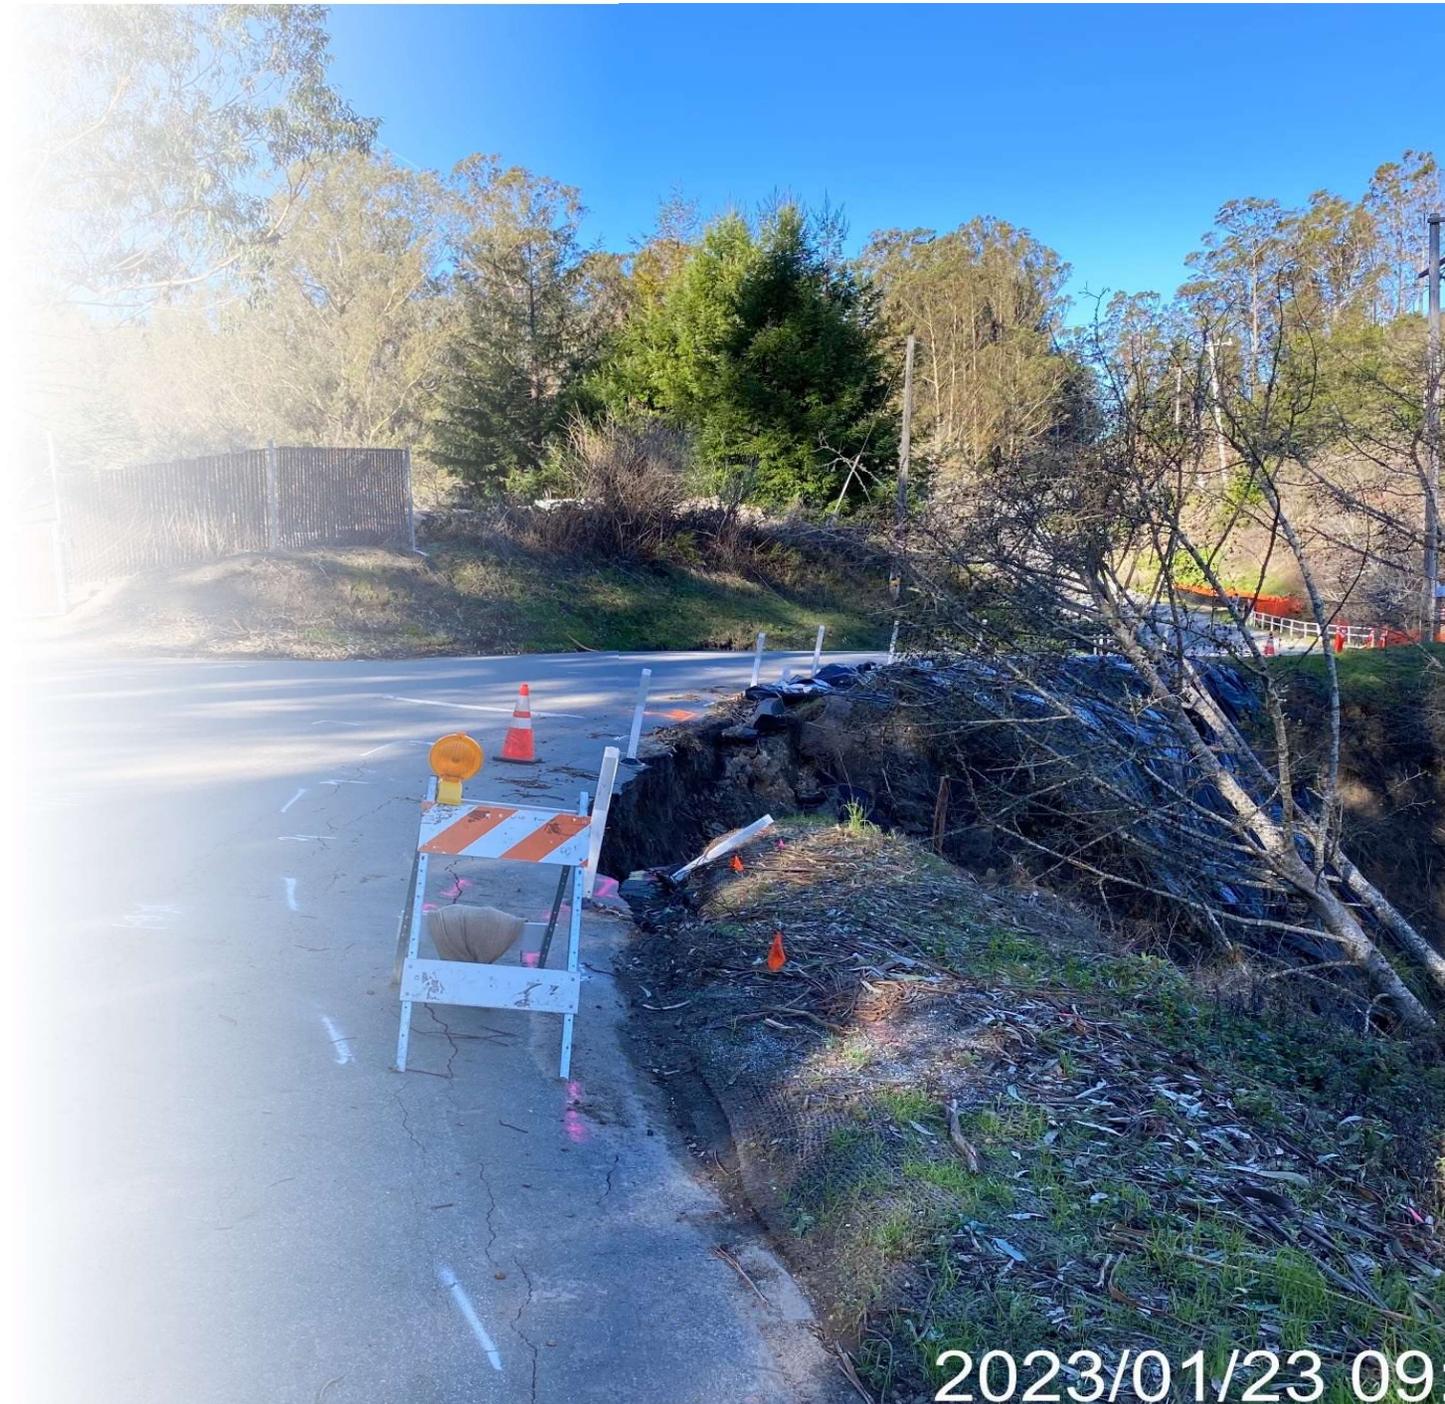
Slope Failure Near 1780 Higgins Canyon Rd

- Slope failure first occurred in Fall 2021
- County road maintenance crew repaired the slope in November 2021, with an emergency permit
- Slope failed again in the 2021/2022 winter storm events. Conditions worsened in the 2022/2023 winter storm events

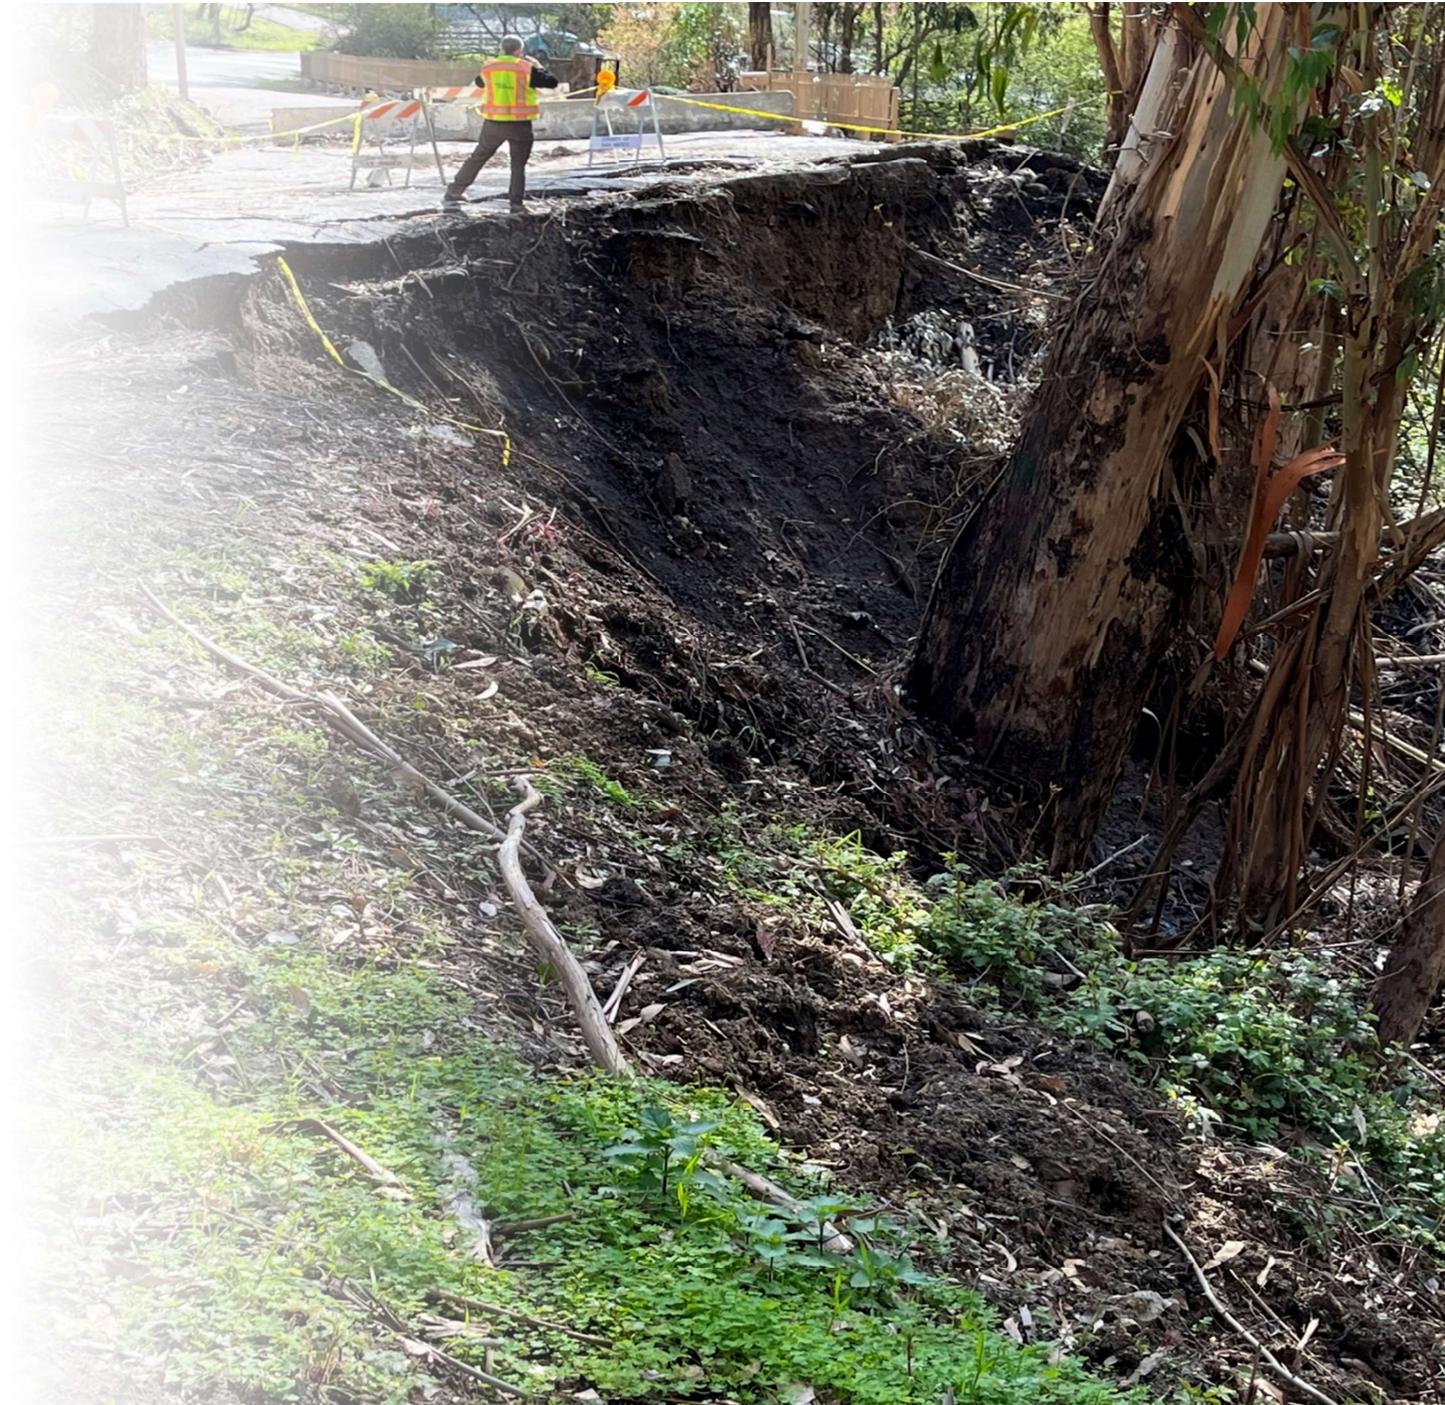
Slope Failure Near 2180 Higgins Canyon Rd

- Slope failure first occurred in January 2023 due to the 2022/2023 winter storm events
- Large eucalyptus trees had fallen
- Pavement on the road buckled and continues to deteriorate
- Road is currently closed for safety concerns
- Vehicles are detoured to use Purisima Creek Rd

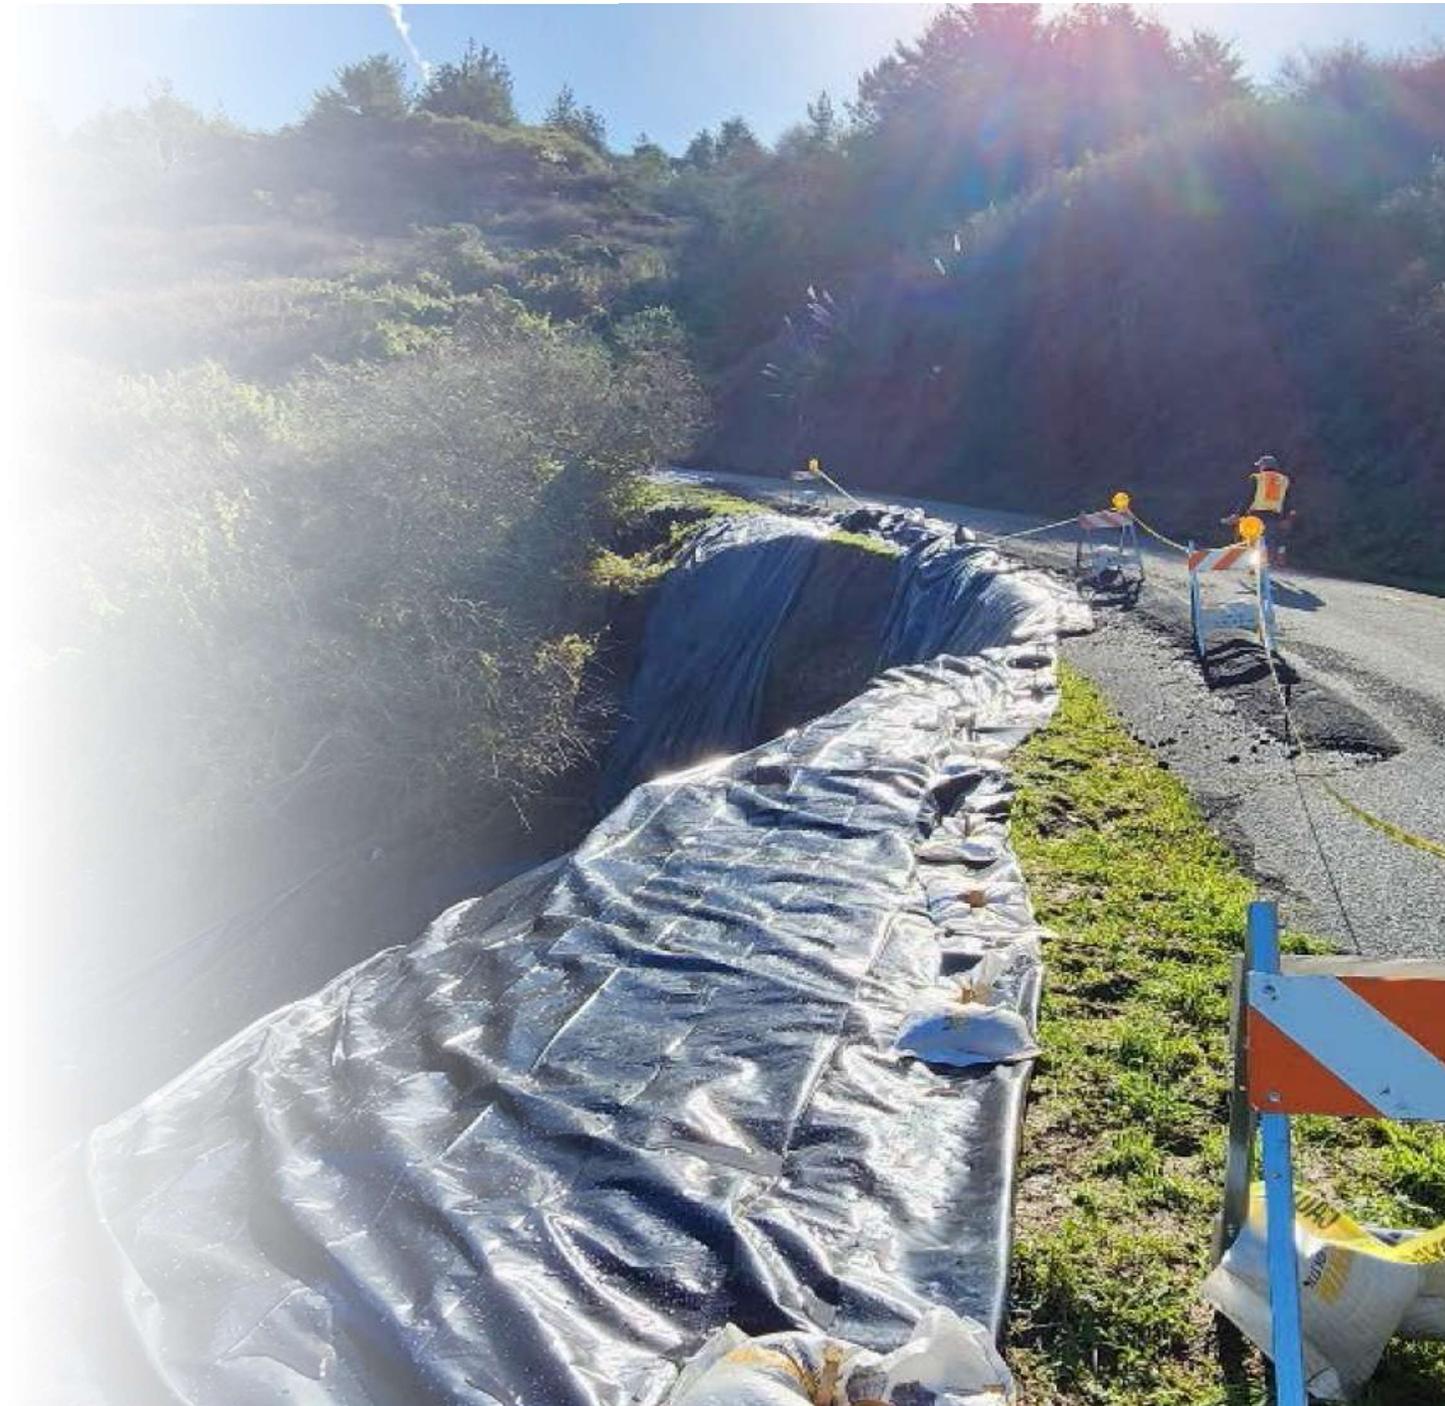
Slope Failure Near 2665 Higgins Canyon Rd

- Two roadside slip-outs have occurred within the area.
- Slope failures occurred in January 2023 due to the 2022/2023 winter storm events
- Larger failure is approximately 200 feet in length
- Smaller failure is approximately 25 feet in length.

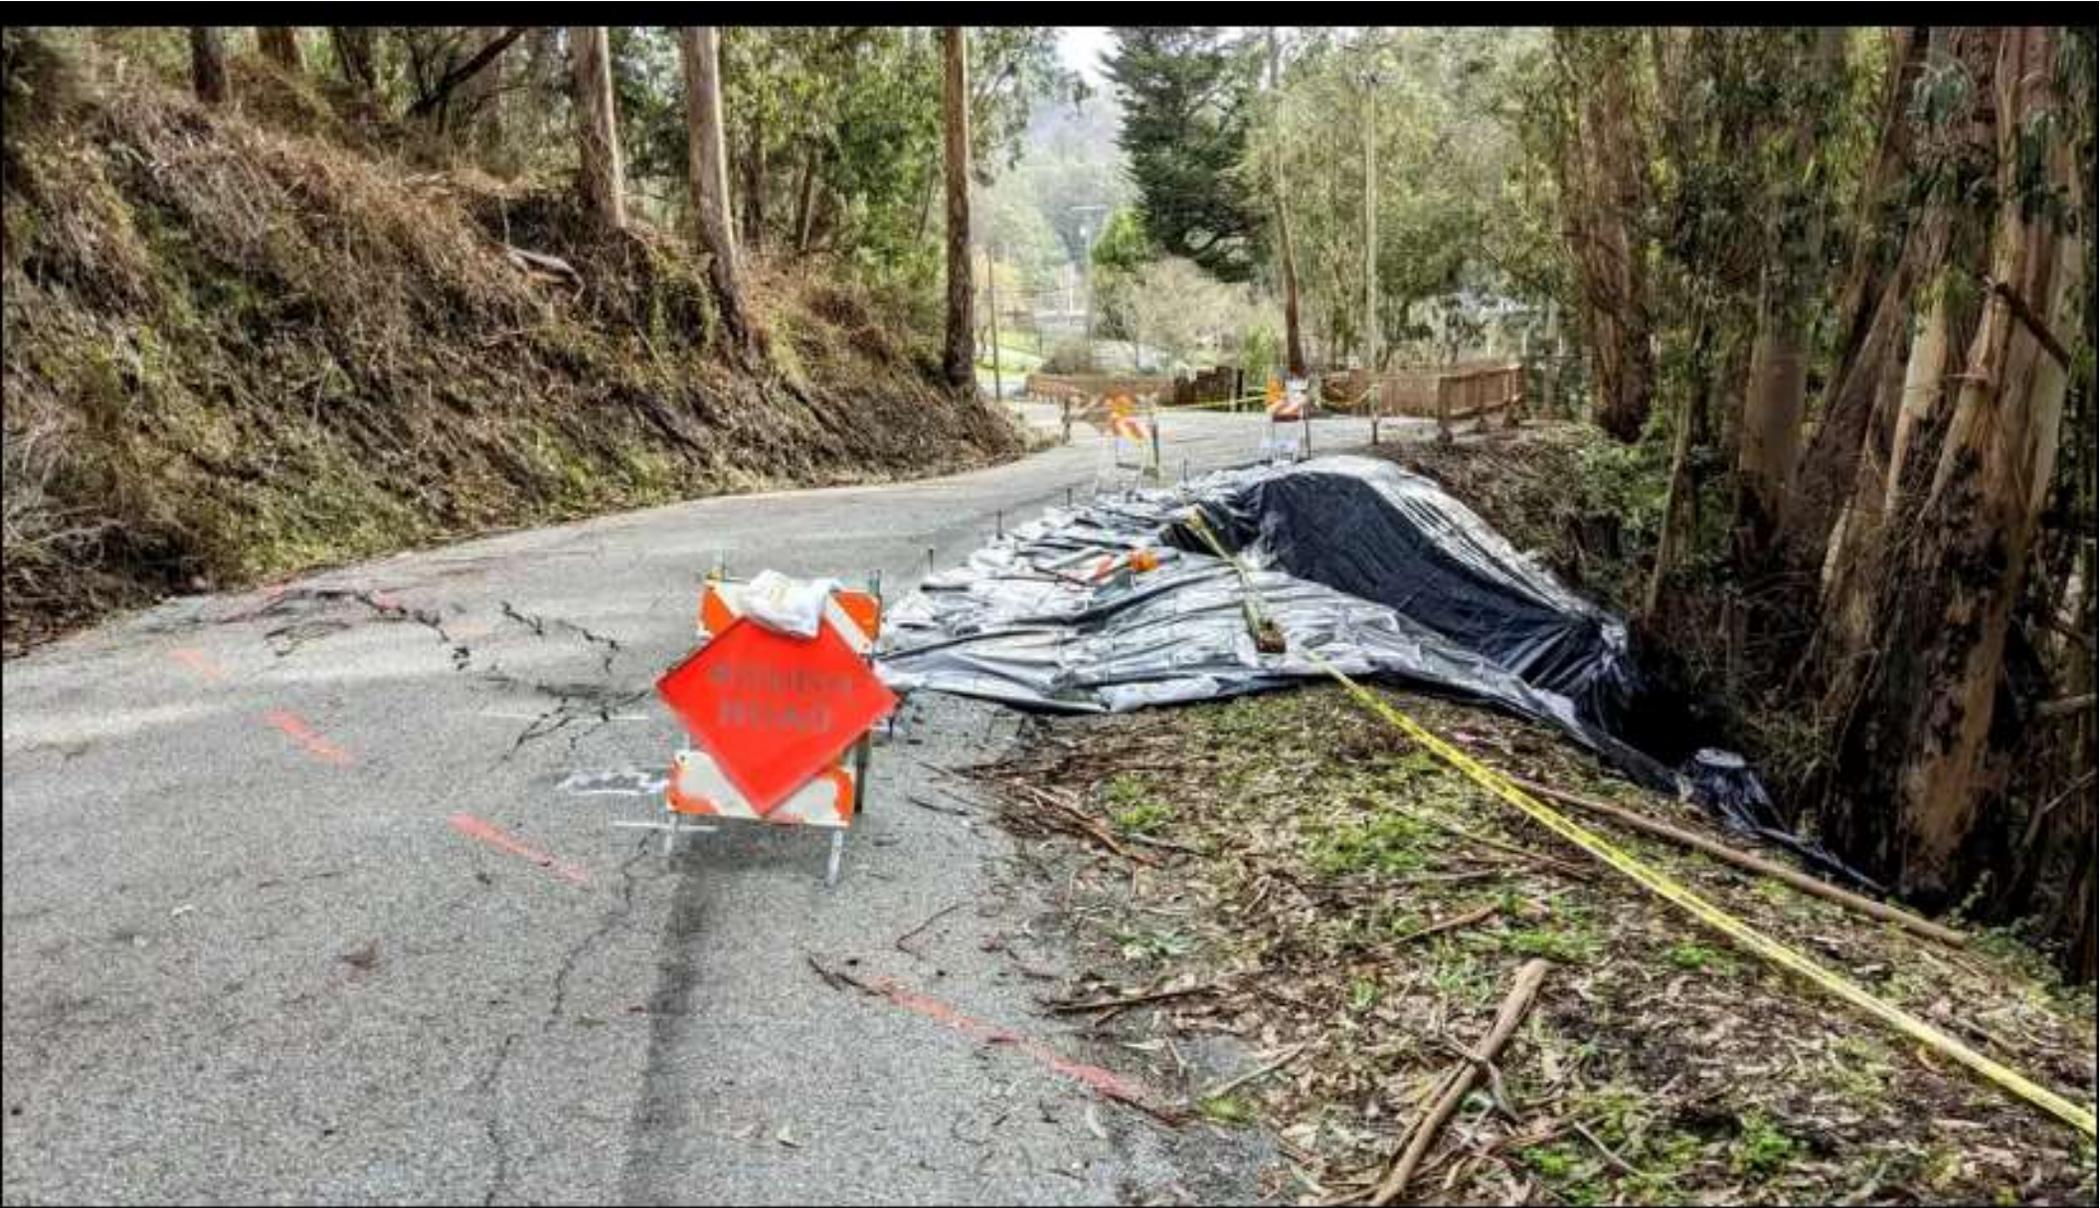
January 11, 2023

January Slide Movement

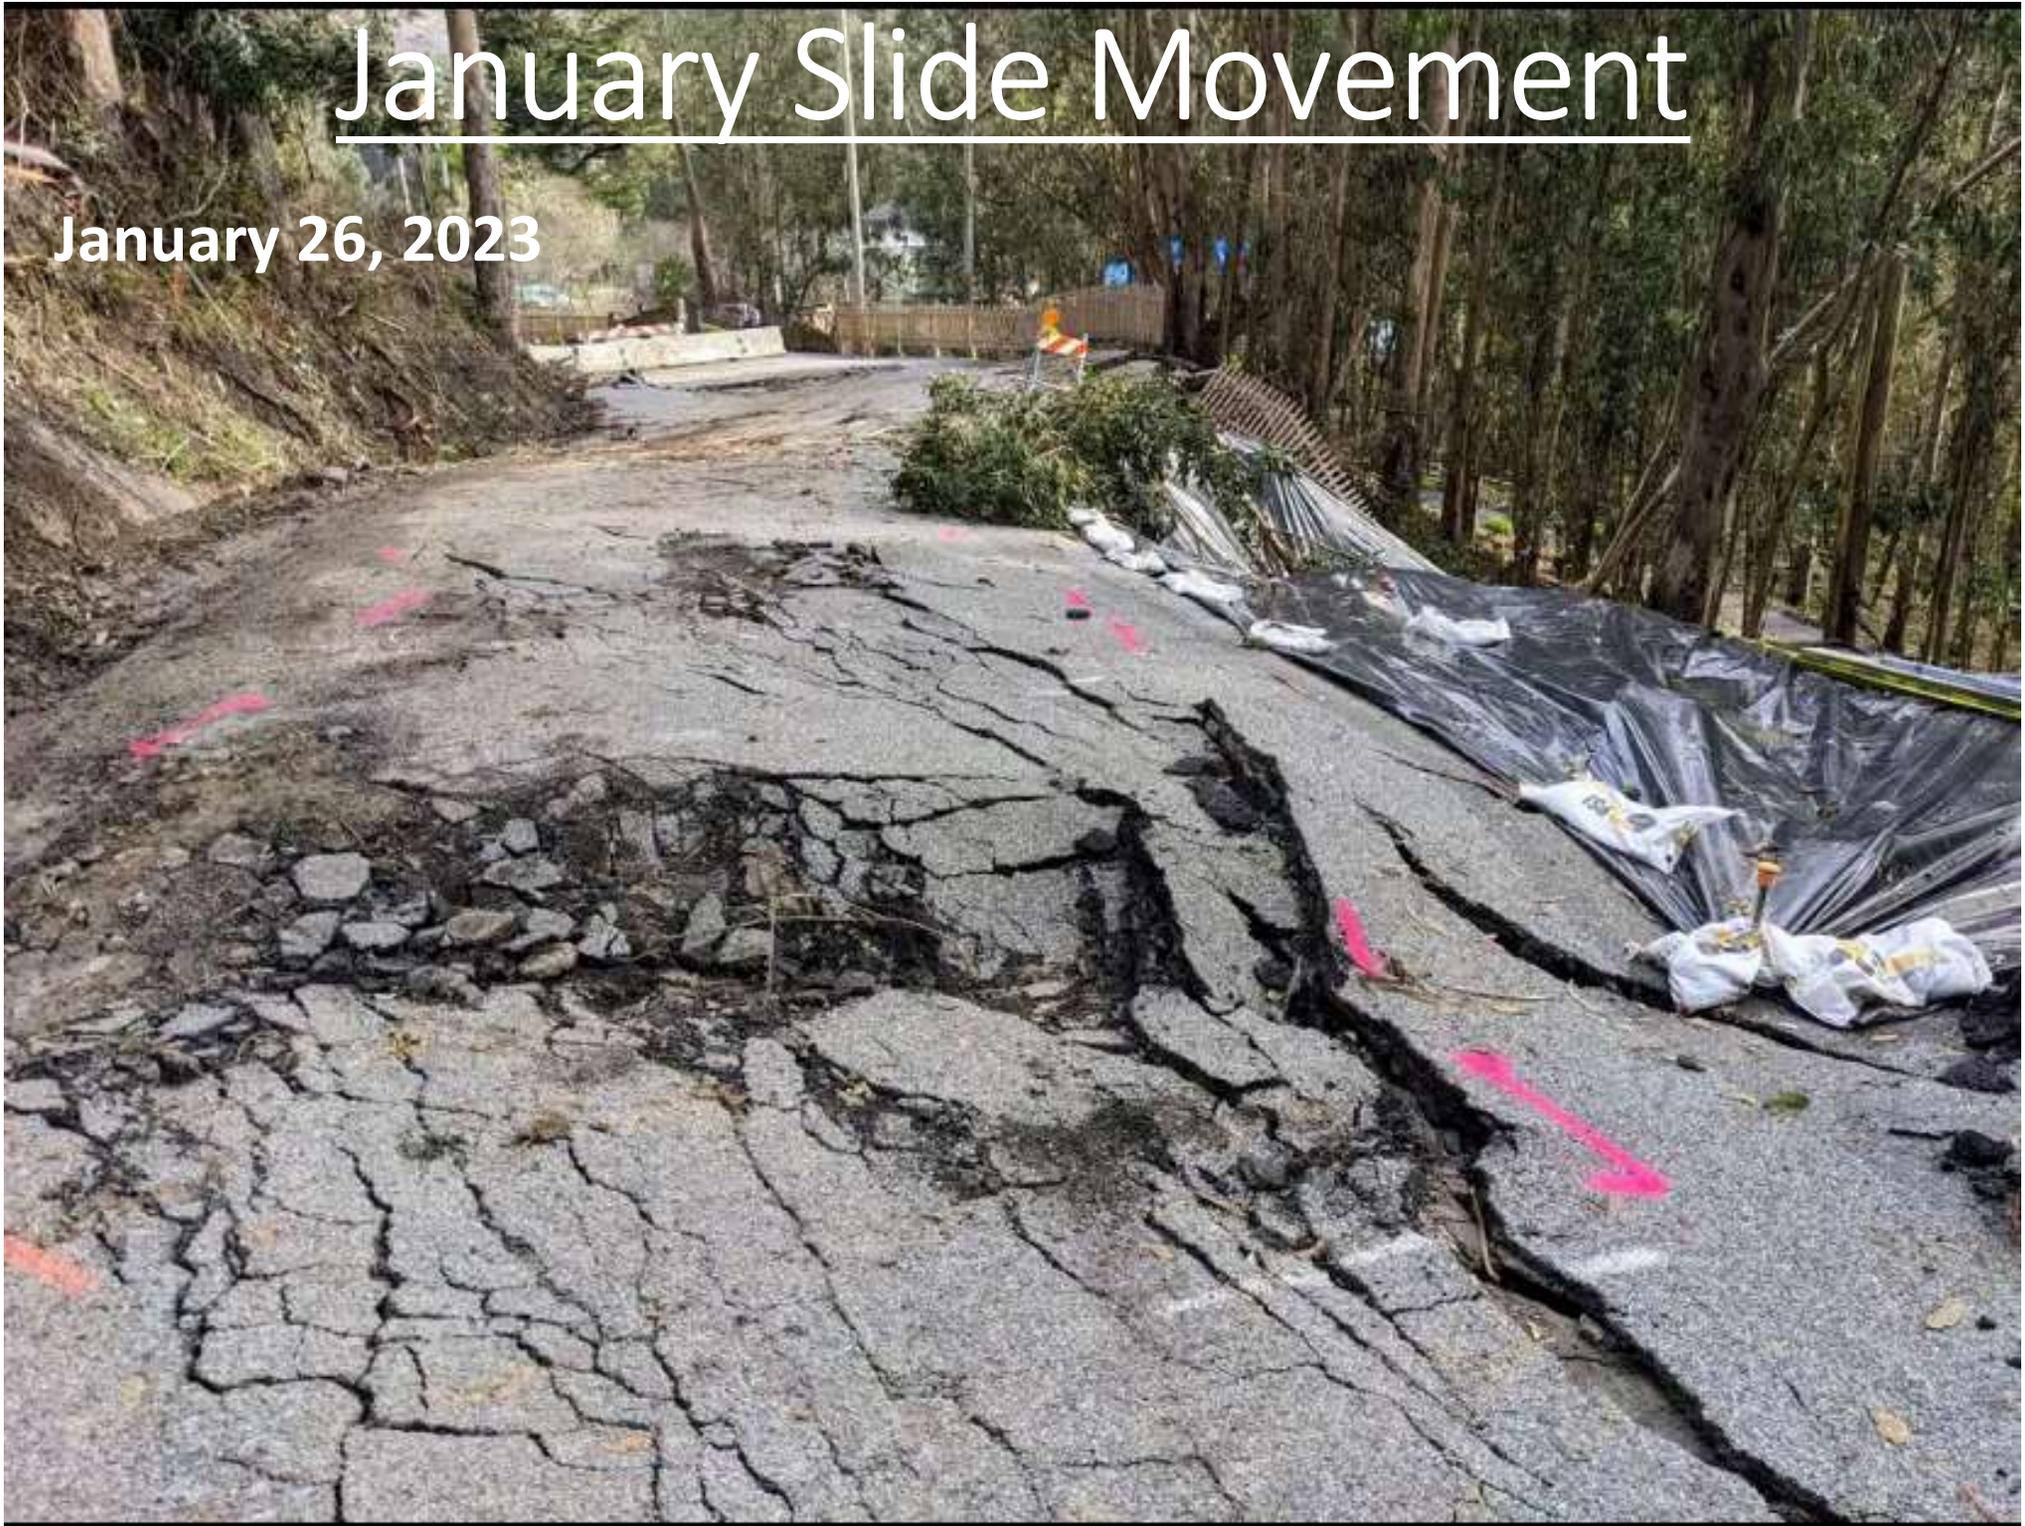
January 26, 2023

January Slide Movement

- The Slide is Still MOVING!!
- Greater Than 75% of the Slide's Mass is Above Higgins Canyon Road.
- Saturation Allowed the Previously Static Soil Mass to Move. The Soil Mass is Still Wet and Therefore Remains Unstable.
- The Roadway Repair Requires Structural Protection of Higgins Canyon Road From the Slide Mass Above the Roadway.
- Slip Plane is Twenty (20) Feet, or Greater Beneath Higgins Canyon Road.

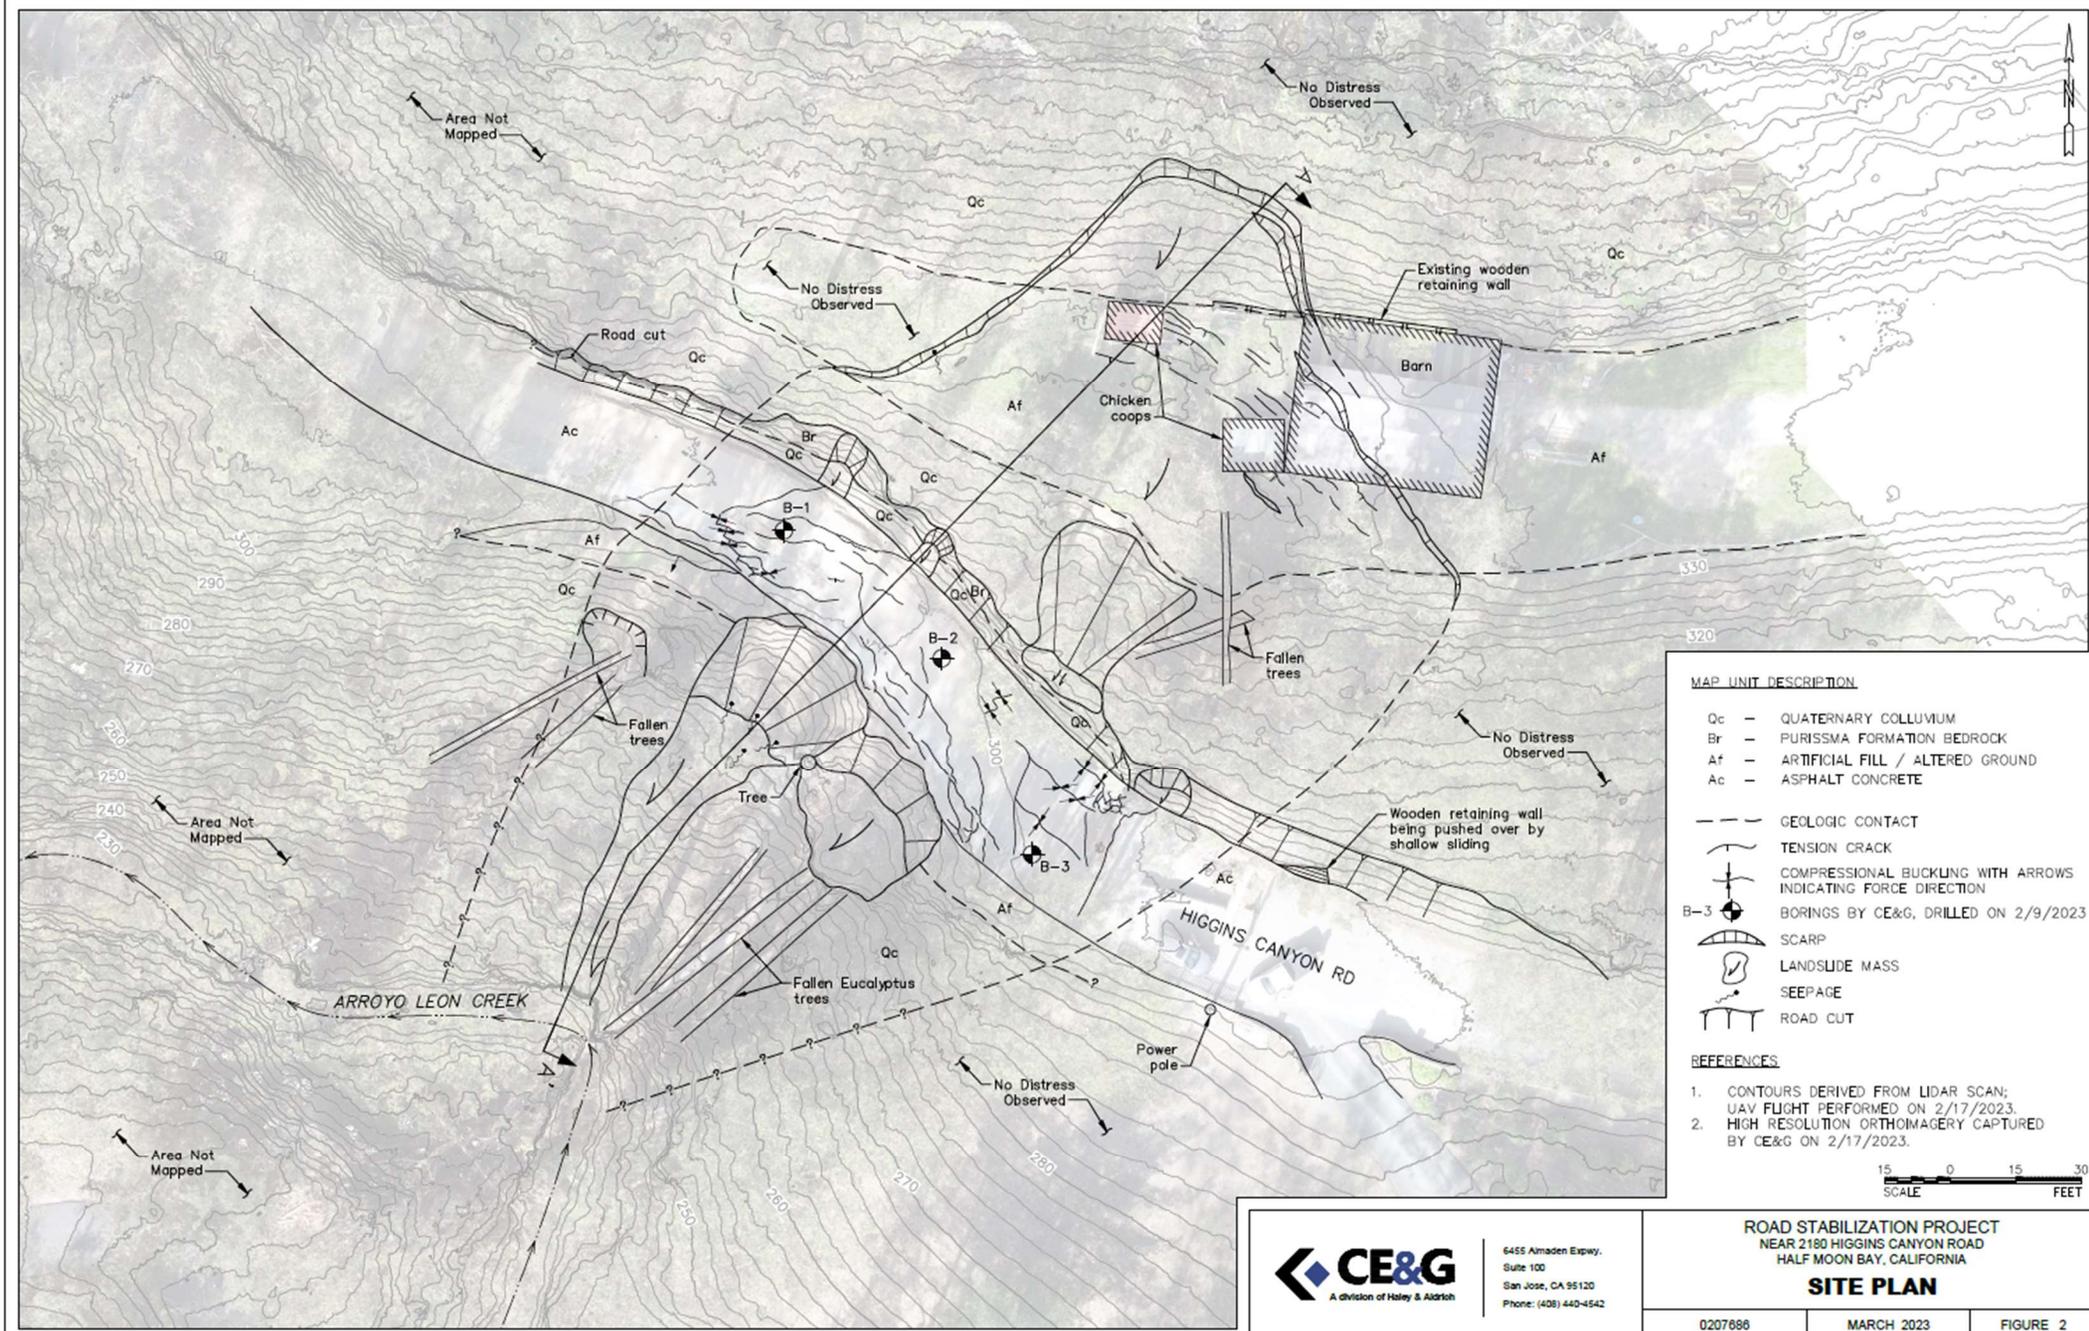
- Site Plan of existing conditions (as of March 20, 2023) near 2180 Higgins Canyon Rd developed by CE&G.

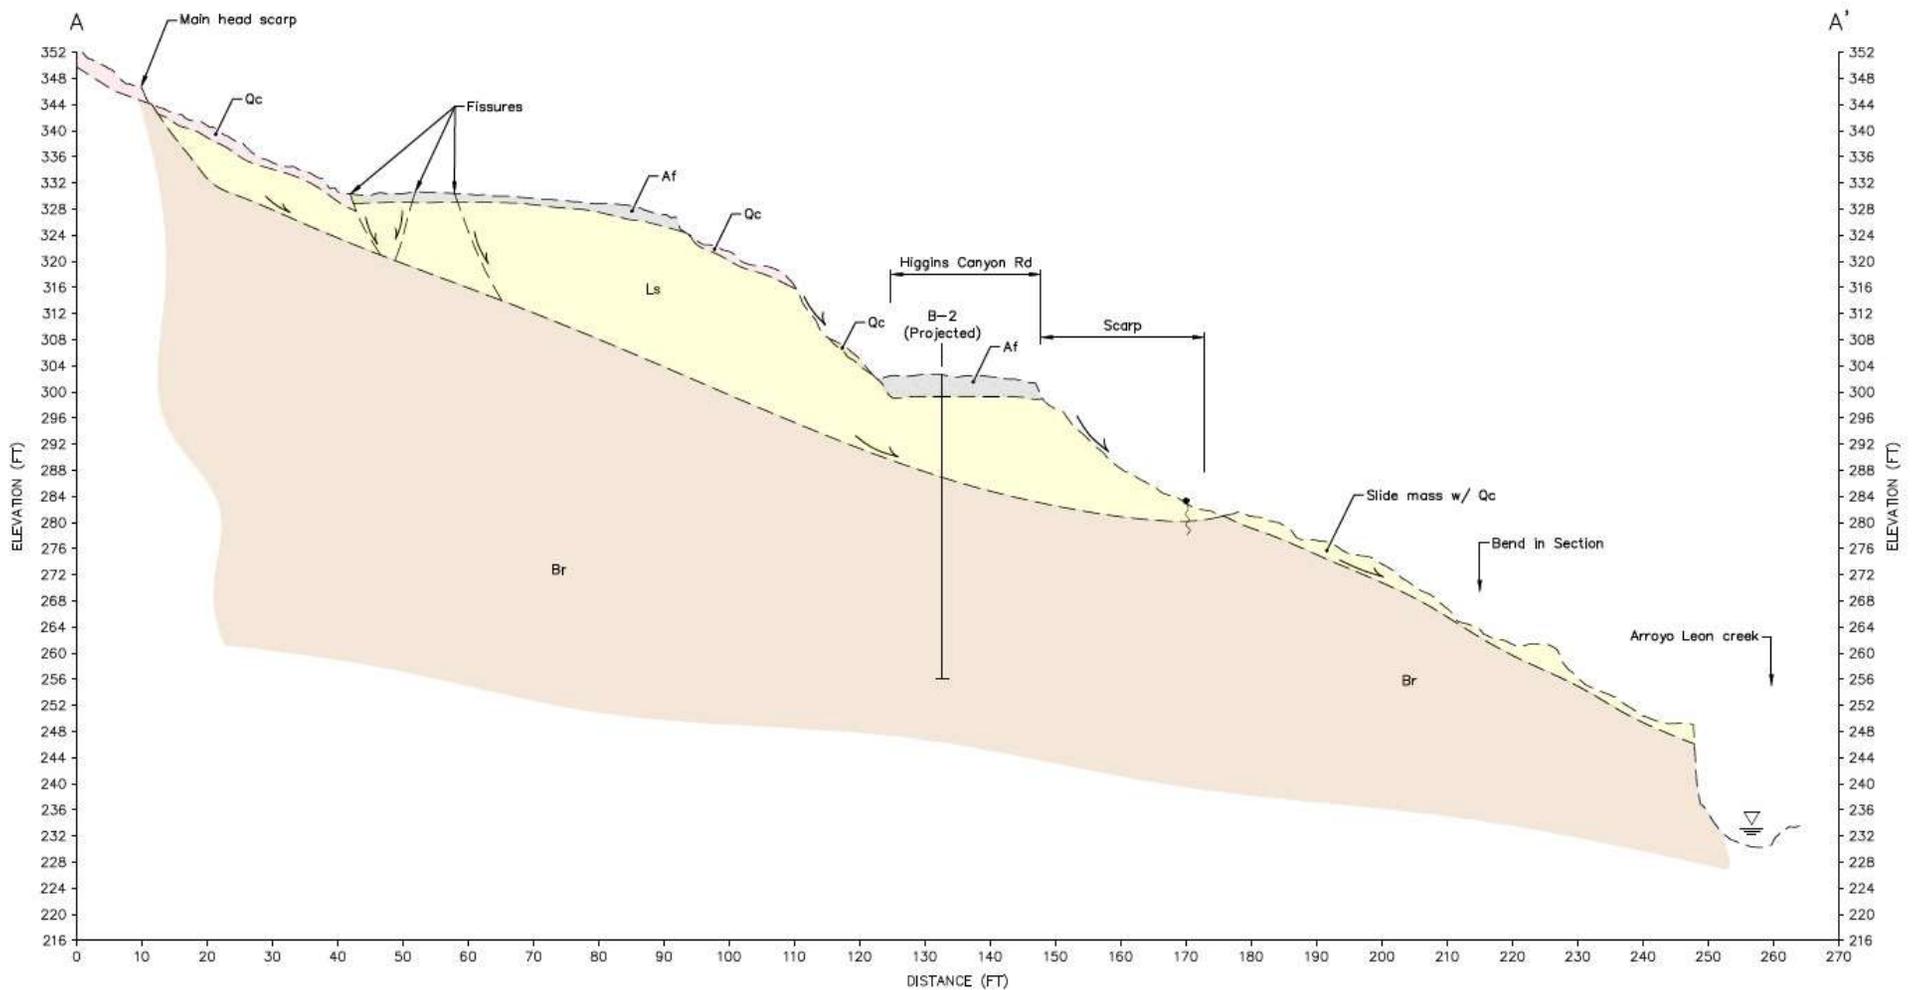
FIGURE 6

- Qc - QUATERNARY COLLUVIUM
- Br - PURISSIMA FORMATION BEDROCK
- Af - ARTIFICIAL FILL
- Ac - ASPHALT CONCRETE
- SEEPAGE

- Cross section of existing conditions (as of March 20, 2023) near 2180 Higgins Canyon Rd developed by CE&G.
