2023 Slip-Out Repair Project Higgins Canyon Road

Department of Public Works

April 13, 2023

Higgins Canyon Road Failure and Closure

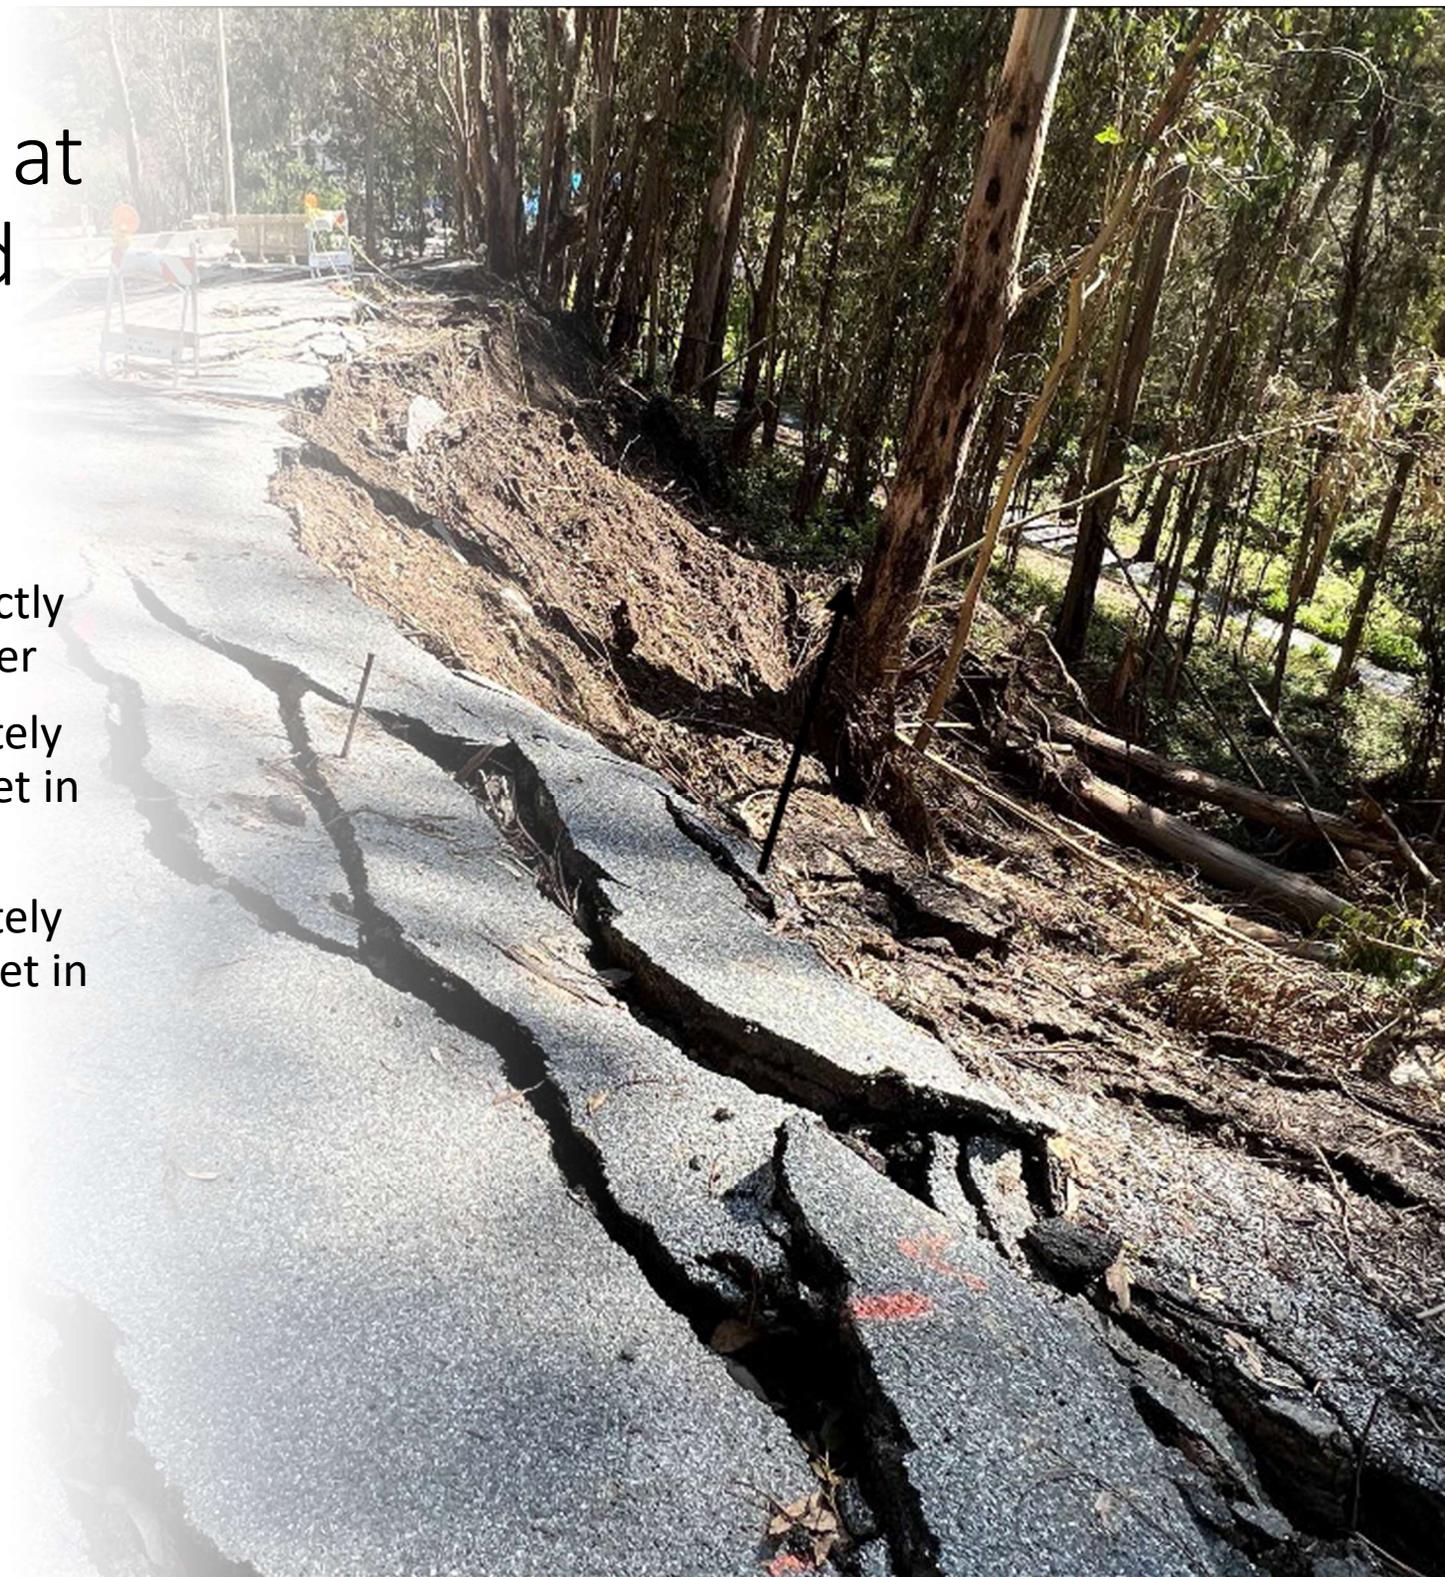
Slope Failure at the Outboard Edge of the Road

- 2 landslide scarps directly adjacent to one another
- Scarp #1 is approximately 37 feet wide, 20-25 feet in length
- Scarp #2 is approximately 33 feet wide and 12 feet in length

- Reinforced Earth Slope Repair
- Soldier Pile Retaining Wall
- Mechanically Stabilized Earth (MSE) Retaining Wall

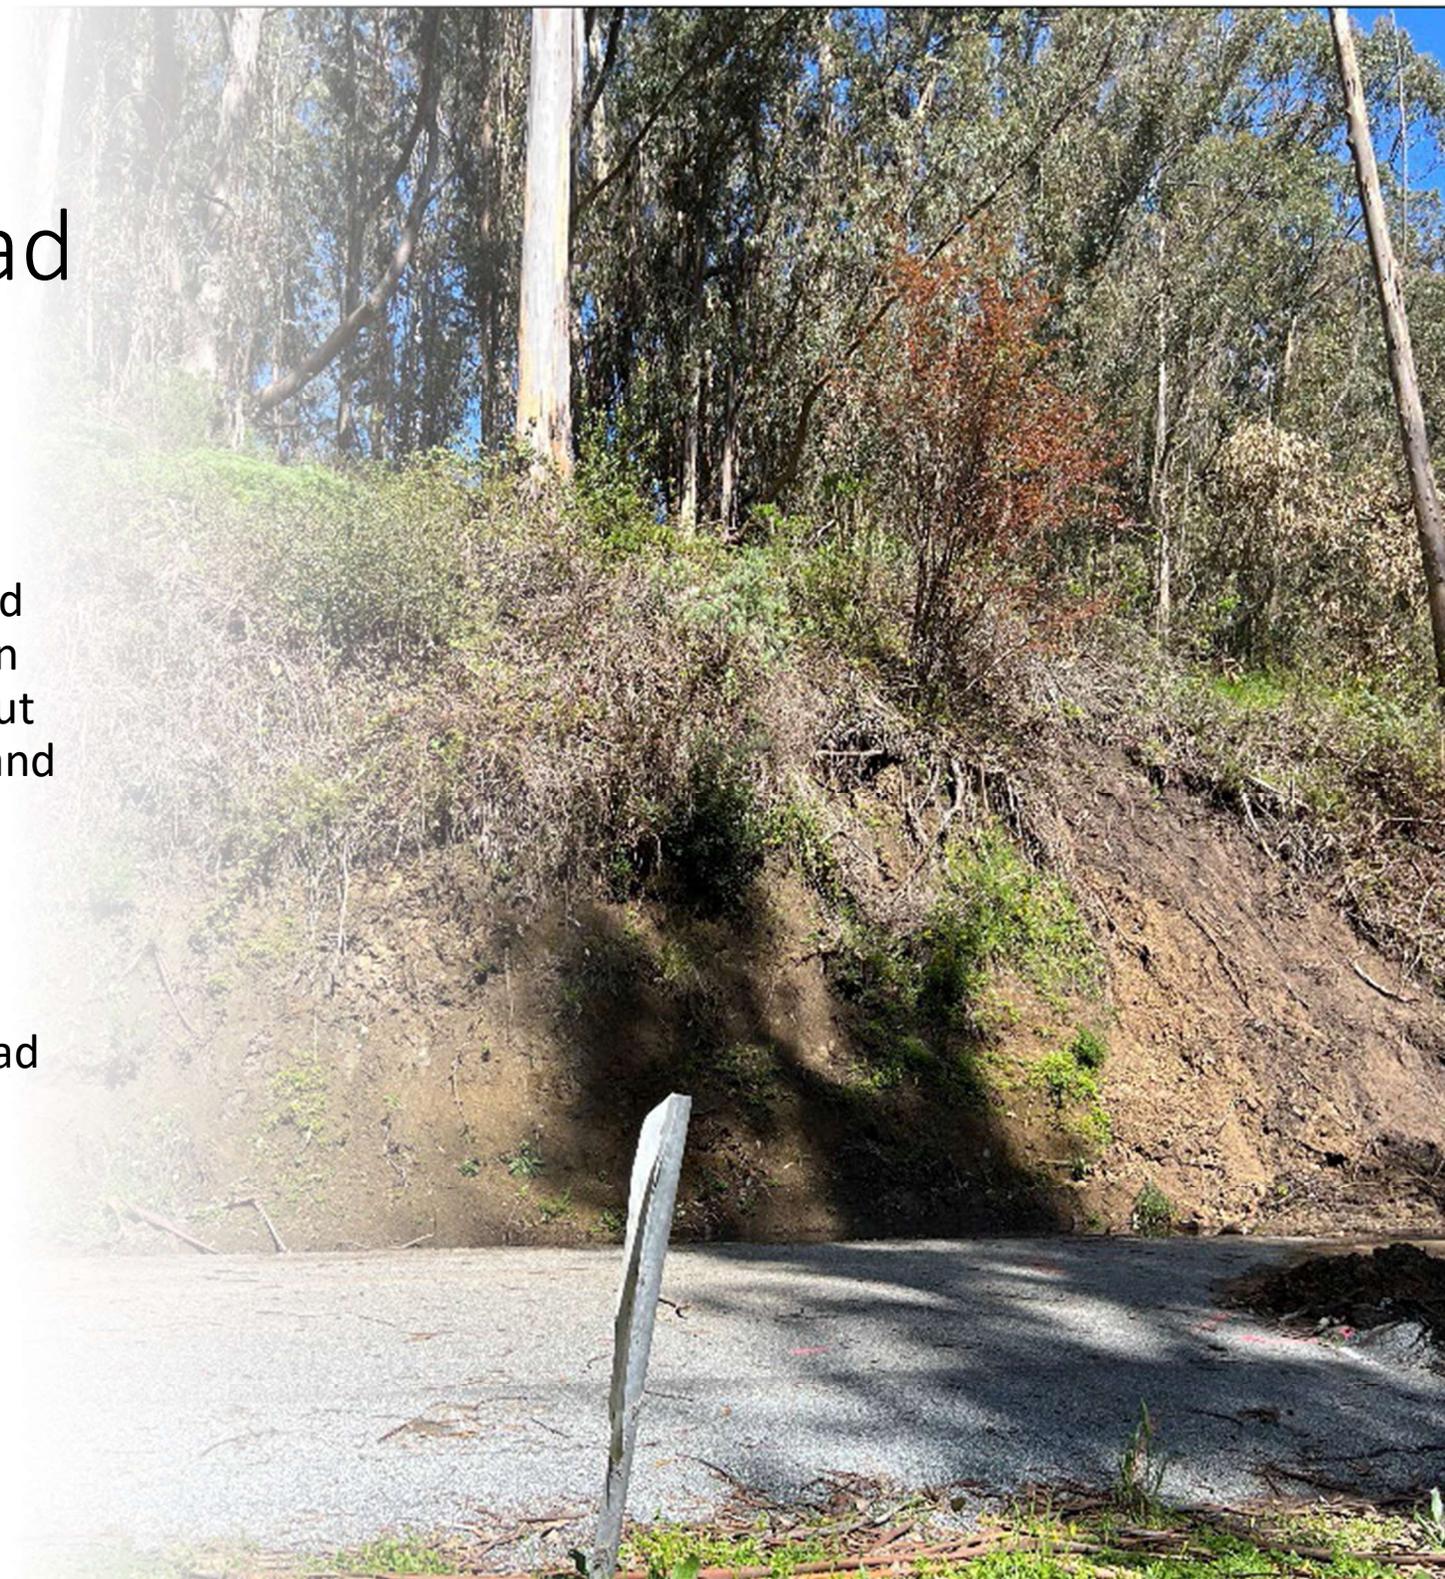
Inboard Road Cut

- Road cut at the inboard edge of Higgins Canyon Road ranges from about 6 to 15 feet in height and is inclined at about 55 degrees.
- Multiple shallow landslides were observed along the road cut

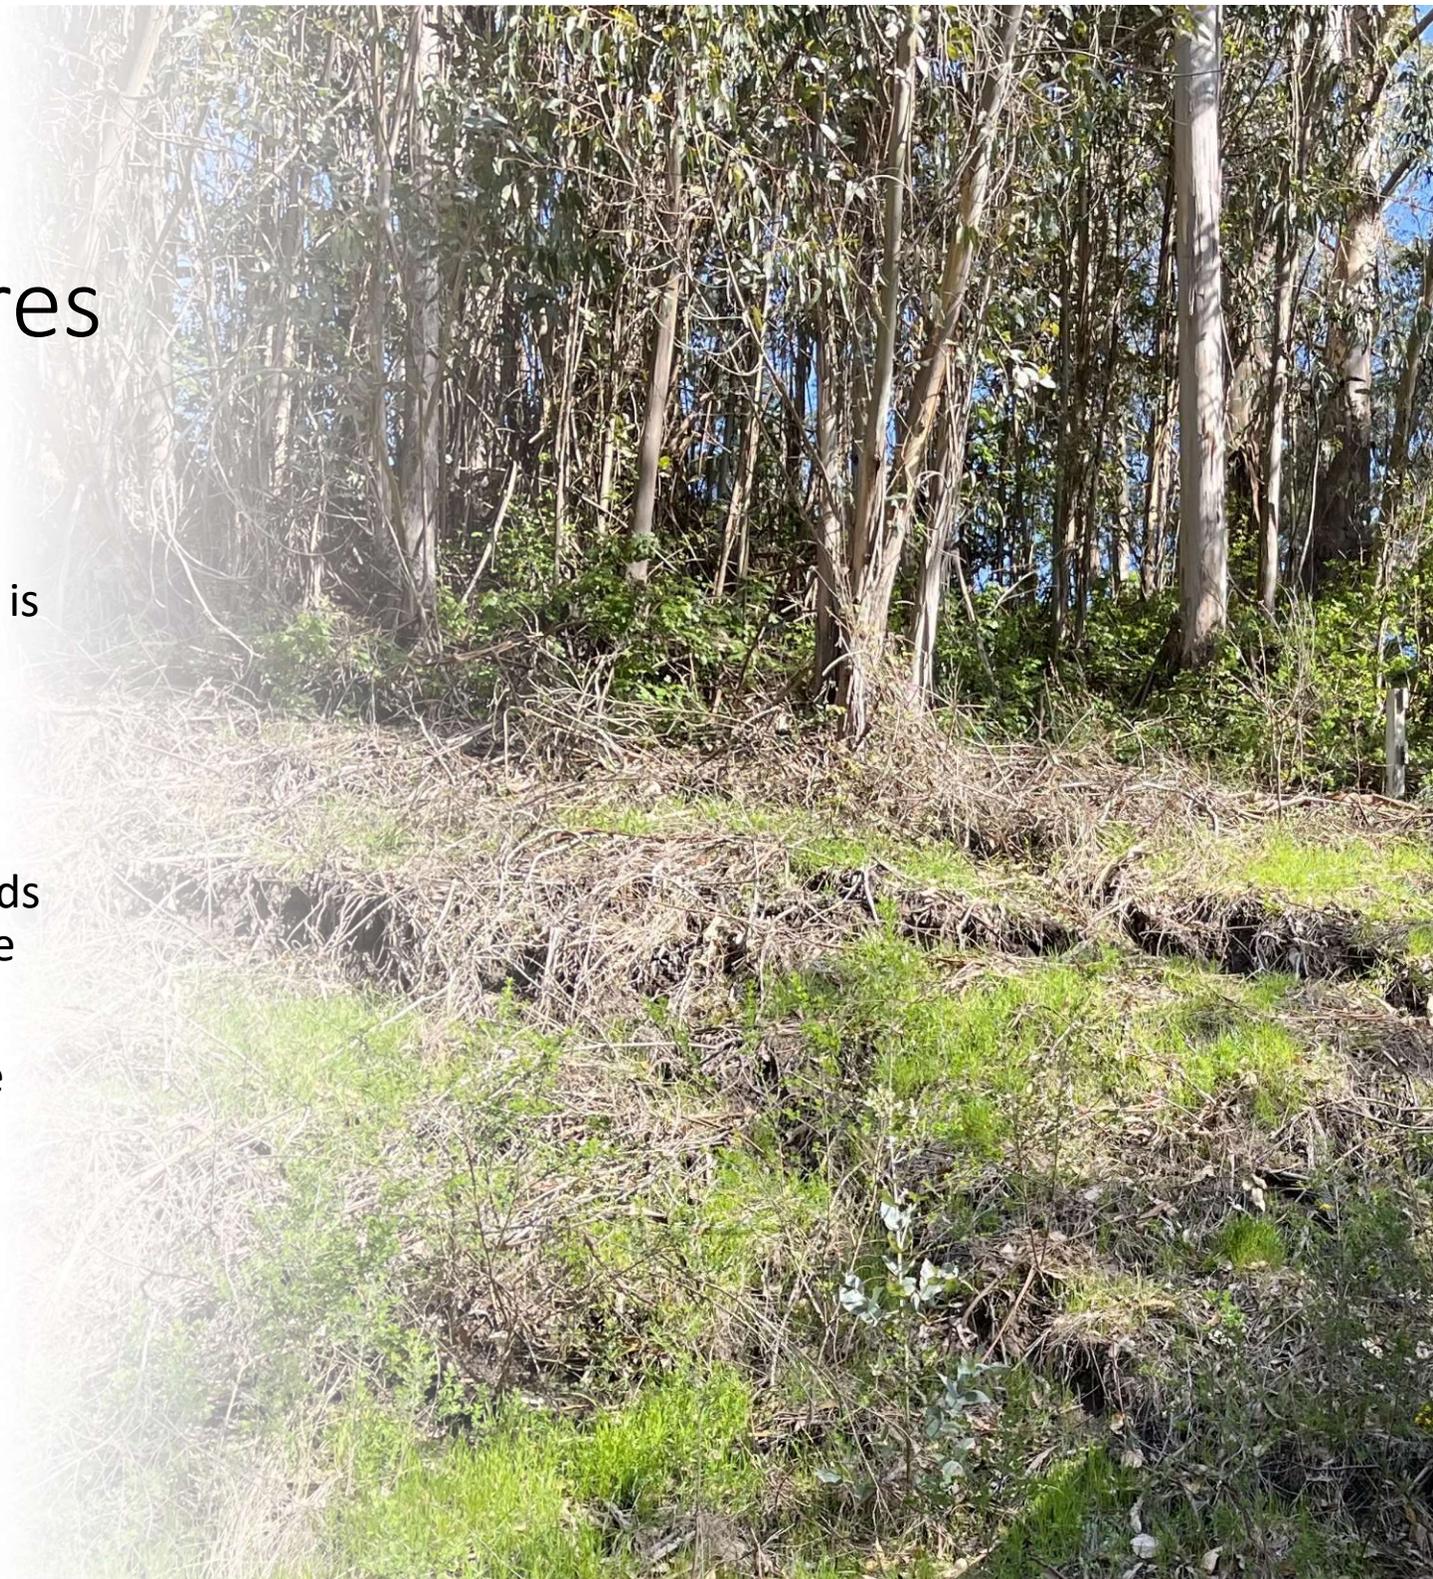
Uphill Fissures

- The upslope of the site is also experiencing displacement of the ground
- Multiple fissures were observed on the grounds on the uphill side of the road
- Lateral supports will be required

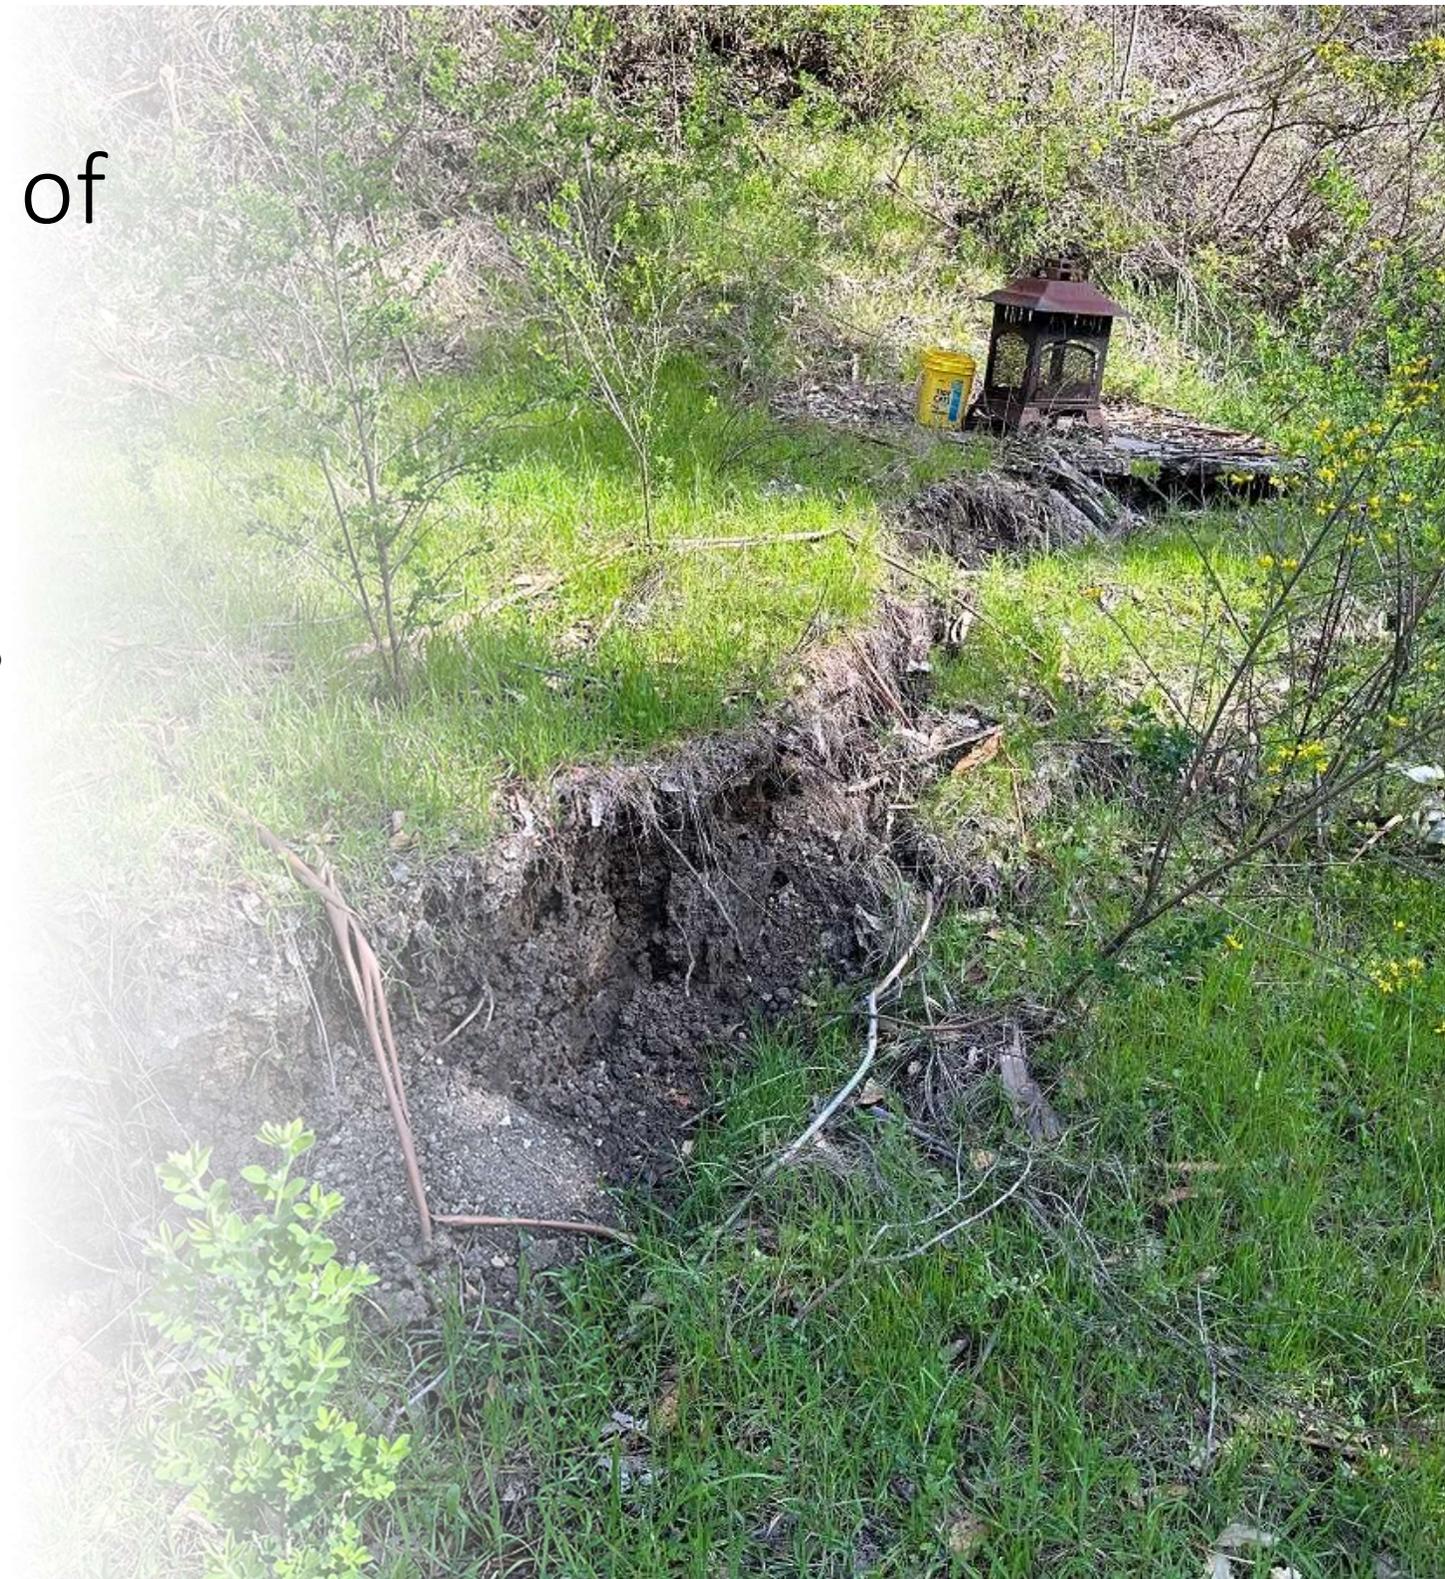
Closer Look of Uphill Movement

- Uphill movement at
property address 2175
Higgins Canyon Rd

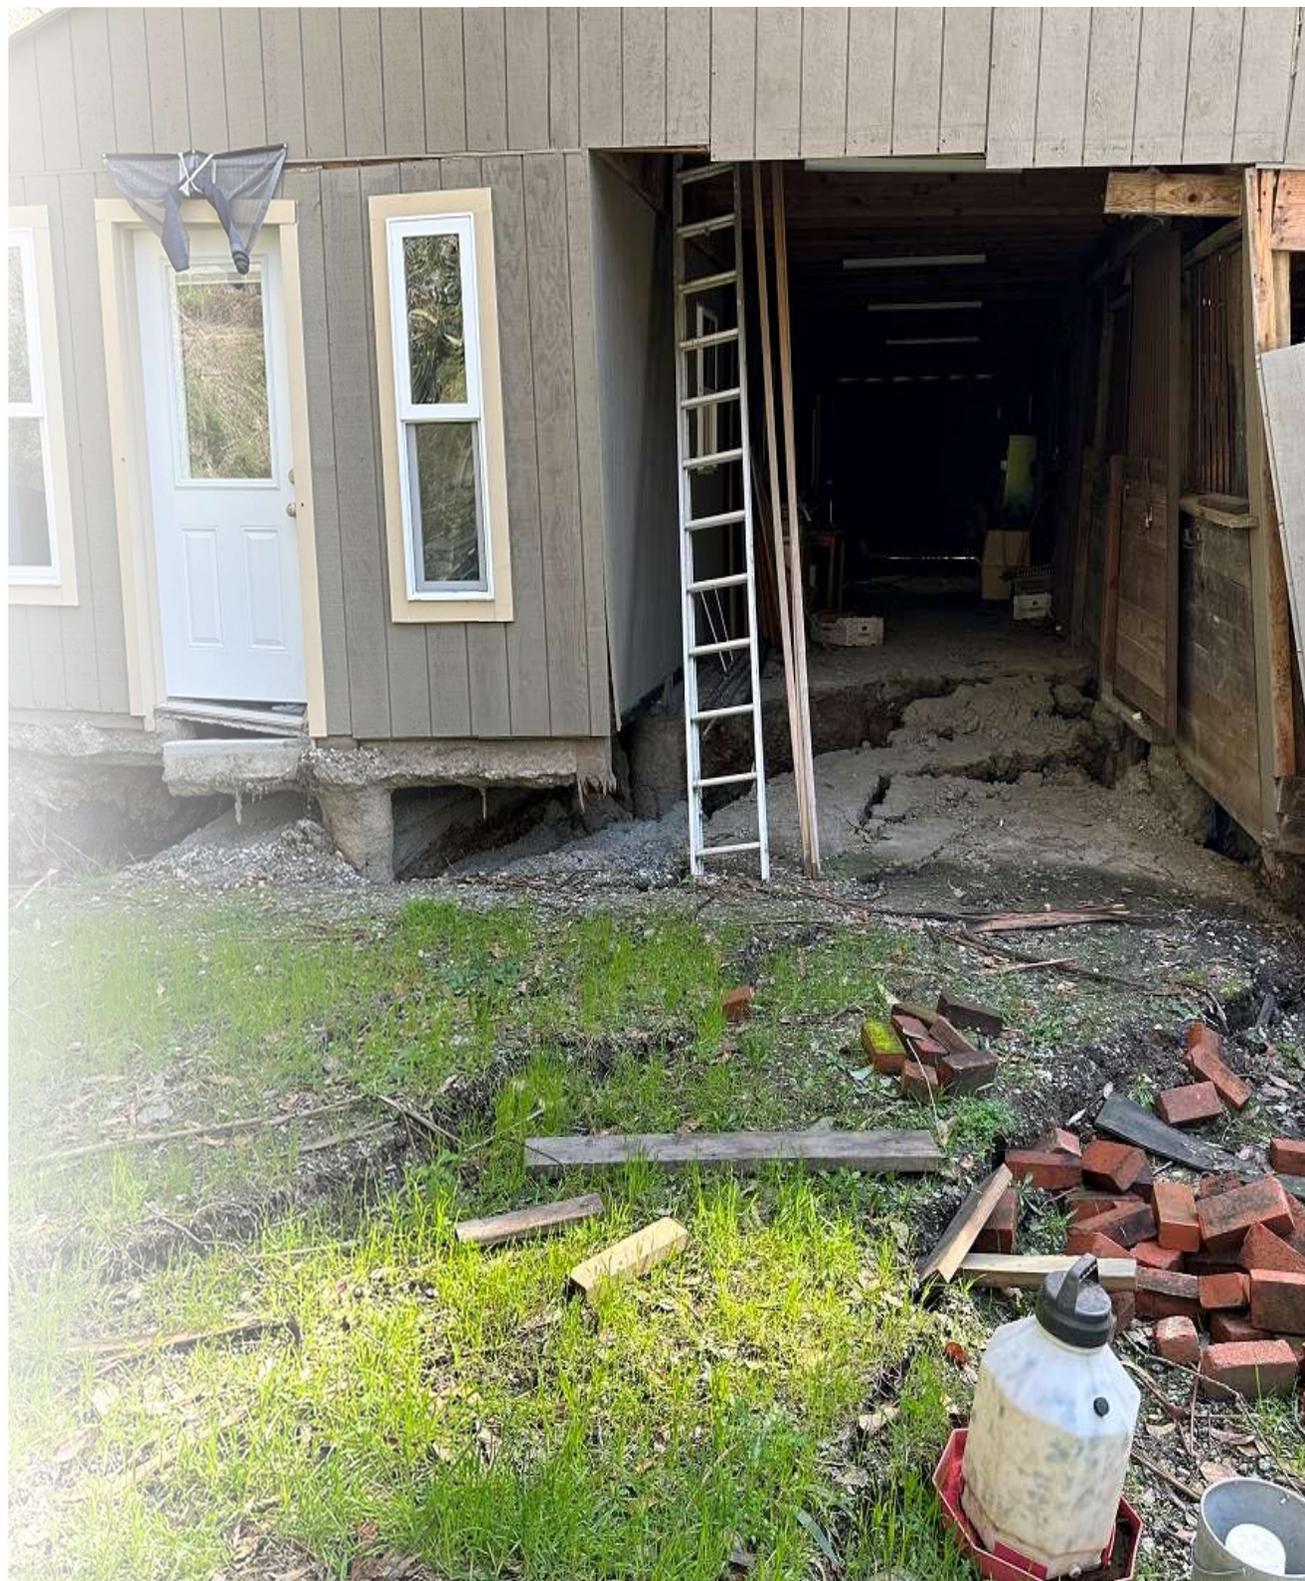
Closer Look of Uphill Movement

- Uphill movement at property address 2175 Higgins Canyon Rd
