**COUNTY OF SAN MATEO
PLANNING AND BUILDING DEPARTMENT**

SUBJECT: EXECUTIVE SUMMARY: Consideration of a Coastal Development Permit to allow the replacement or reattachment of road culverts and the repairing of road slip-outs at various locations on Higgins Canyon Road, Seaside School Road, Bear Gulch Road, and Stage Road in the unincorporated areas of San Gregorio and the Rural Midcoast.

County File Number: PLN 2014-00199
(SMCo. Department of Public Works)

**COASTAL CULVERT REPLACEMENT, REATTACHMENT, AND SLIP-OUT REPAIRS PROJECT
BIOLOGICAL IMPACT FORM**

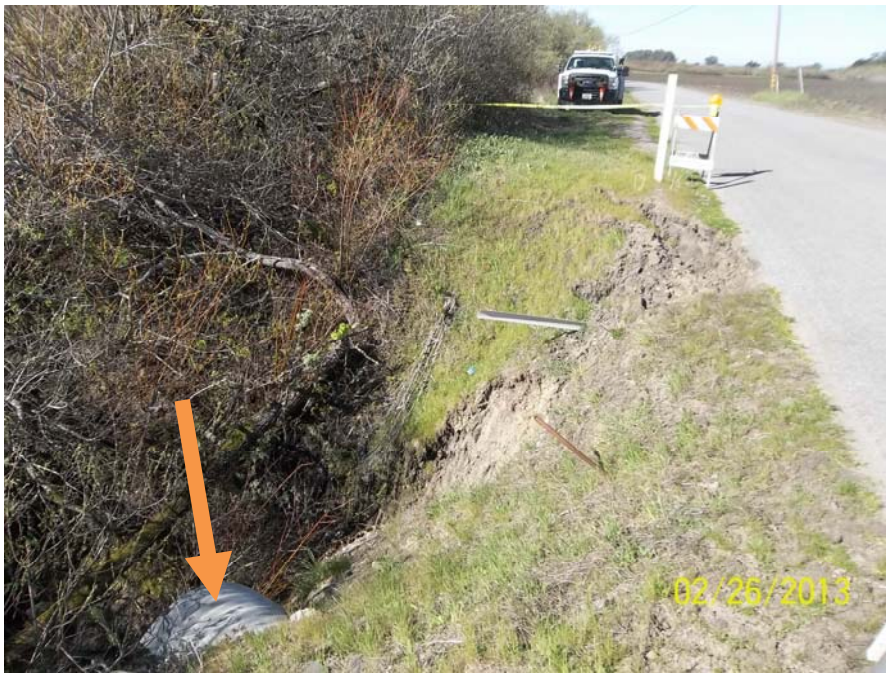
A slip-out (15'L x 10'W x 10'H) has developed on the roadway shoulder immediately adjacent to the culvert outlet (Photo 1 & 2). The slip-out eroded from the edge of the pavement and into the drainage channel. When comparing photos from a visit in February 2013 to the most recent visit in December 2013, the slip-out appears to have worsened slightly (Photos 1 & 2). Approximately, 74.52 cubic yards of imported soil and 1- to 4-foot diameter rock will be used to rebuild the shoulder and provide energy dissipation for the culvert outlet. One 3-inch DBH arroyo willow (*Salix lasiolepis*) exists in the immediate work area and will need to be removed in order to excavate the bench for the placement of boulders used to form the toe of the slope, and provide energy dissipation for the culvert outlet. (Appendix A, Figures 11 & 12). The rest of the embankment will be repaired using brushlayering in conjunction with the placement of rock and imported soil. Arroyo willow stands are readily available near the culvert and can be used for harvesting stakes during the brushlayering process. The upper two feet of the revetment is considered the roadway shoulder and will be free of woody vegetation which might otherwise reduce visibility along the road.

Photo 1 - Photo of slip-out dated February 26, 2013. Several shallow-rooted annual grasses visible on shoulder and in slipped area. The 36-inch culvert outlet is visible on bottom left corner of picture as indicated by the arrow.

The majority of the roadway shoulder extending beyond the slip-out and culvert has extensive signs of damage from voles (*Microtus spp.*). Following the slip-out repair, the shoulder will be seeded with native grasses and covered with an erosion control blanket. Disturbances are not expected to take place beyond the dashed lines in Photo 3. Out of the six SFDW nests detected during the December 10, 2013 survey, only one nest exists within 25 feet of the immediate work area (Appendix A, Figure 4). The SFDW nest exists at the base of an arroyo willow tree beyond 10 feet of the immediate construction area and will be marked for avoidance using high visibility flagging. The slip-out repair will take place when the site is dry and once completed, will reduce erosion contributions to Arroyo Leon Creek.

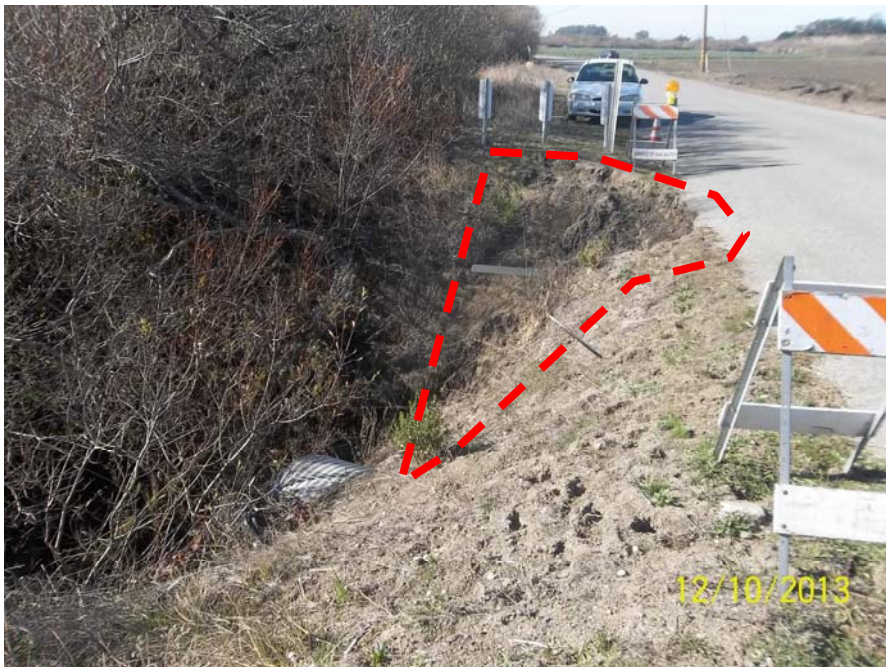
Photo 2 - Photo of slip-out dated December 10, 2013. Most of the annual grasses have died or eroded into the drainage revealing more of the damaged shoulder. Three reflector posts have been installed to reduce the possibility of motorists inadvertently driving into drainage. Dashed lines indicate the location of the slip-out. Note the erosion has reached the edge of pavement; whereas the edge of pavement in Photo 1 is still protected by a sliver of dirt.

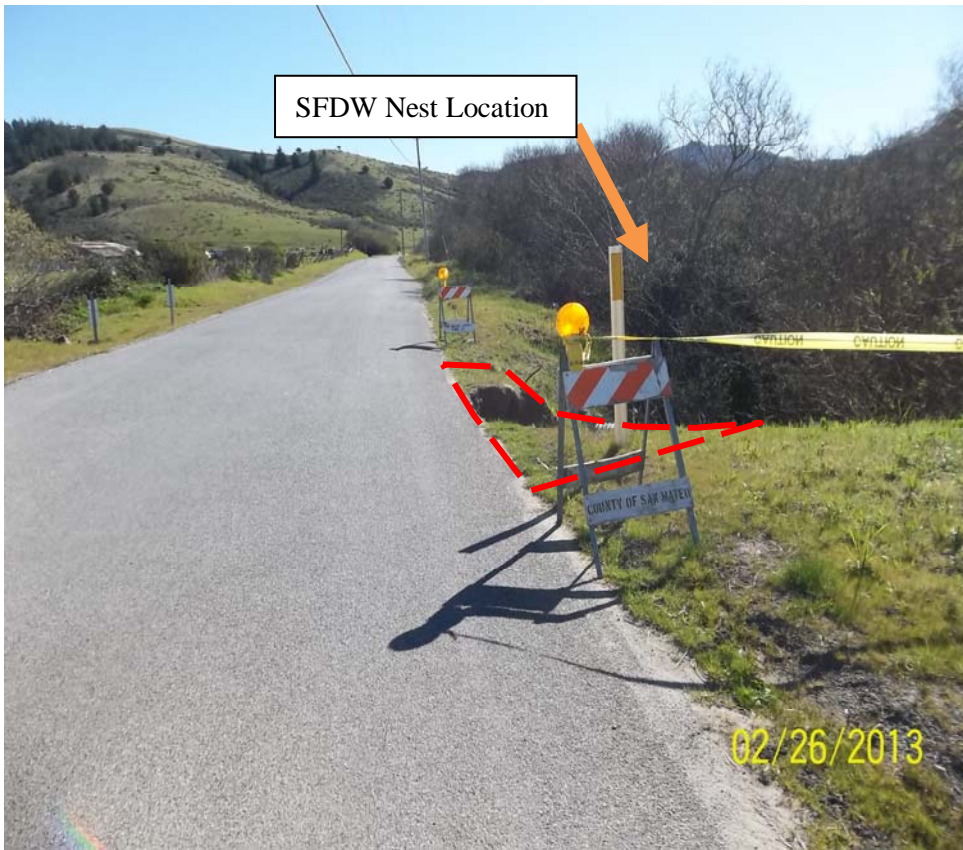
Photo 3 - Photo of slip-out looking east on Higgins Canyon Road. Dashed lines indicate immediate construction area. Slip-out deteriorated from the edge of pavement and eroded into the channel. Location of San Francisco dusky-footed woodrat nest location indicated by arrow.

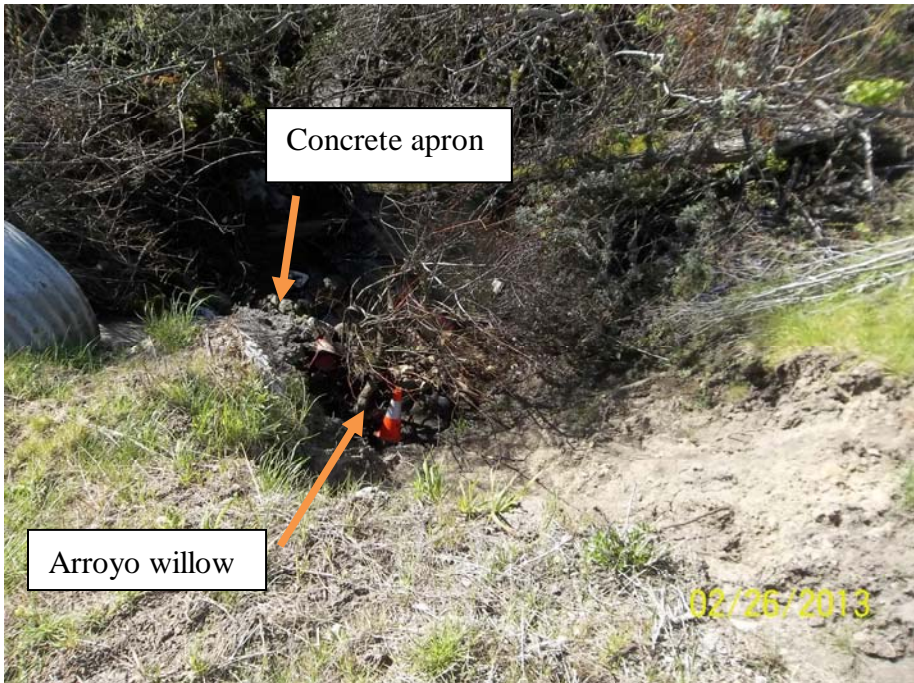
Photo 4 - Photo of the 36-inch CMP culvert outfall and the unnamed drainage. Slip-

out is visible on lower right of the picture. The 3-inch DBH arroyo willow will need to be removed in order to excavate the bench for fill placement. Energy dissipating boulders will be placed at the toe of the slope and concrete apron.

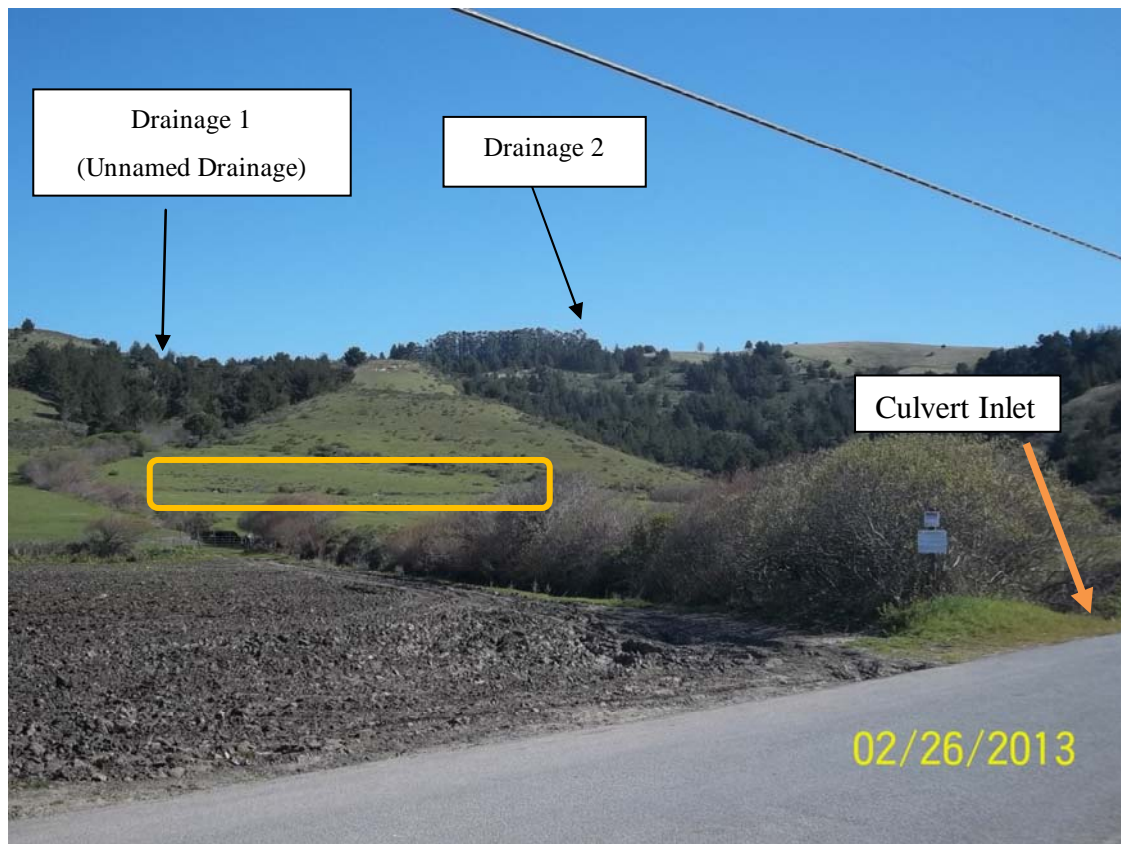
Photo 5 – Photo showing the upstream extent of the unnamed drainage. Runoff accumulates into the unnamed drainage from the surrounding agriculture and ranching operations as well as the drainage to the east (Drainage 2). Off-channel ponds have been created on the drainage to the east and flows have been diverted into the drainage as indicated by the rectangle.

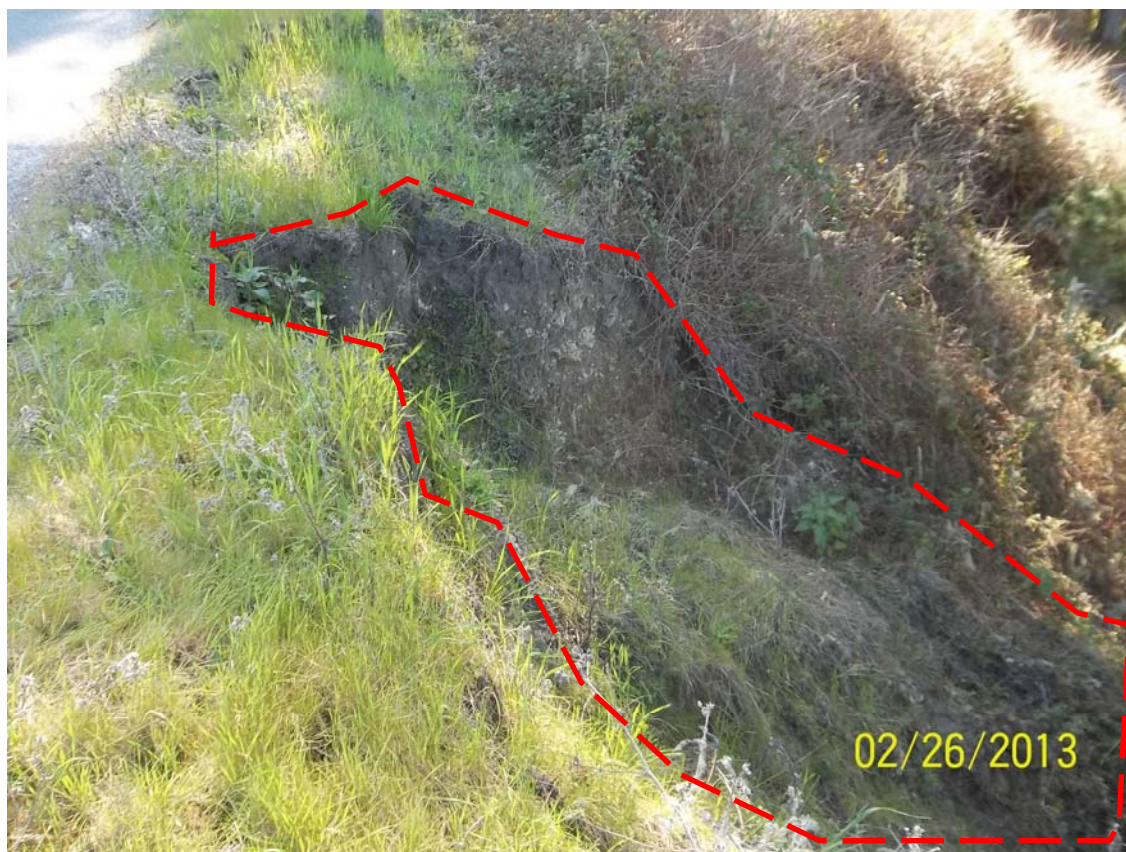
Photo 6 – Photo showing the extent of the slip-out indicated by the dashed lines. Damage caused by voles is prevalent throughout the shoulder. Cause of slippage might be due to a combination of factors including but not limited to vole burrows, unnatural consolidation of water run-off, and roadside vegetation management.

In order to avoid further incision of the gully, a 30-foot-long flex pipe of equal diameter will be bolted onto the existing 15-inch CMP culvert. At the end of the flex pipe, a flume of equal diameter will be mounted to direct water onto existing boulders for energy dissipation. No excavation or heavy equipment will be required for the flex pipe and flume installation as it will be done by hand. Two SFDW nests were detected in the coastal scrub habitat on the upslope side of the road. Construction activities will not impact the two SFDW nests as they are outside of the work footprint. A 10-foot exclusion buffer identified using high visibility flagging will be established around all active SFDW nests near the project site. No SFDW nests were found within 10-feet of the immediate construction area. Repair work will be preceded by a preconstruction survey for special status species and construction will take place when the site is dry.

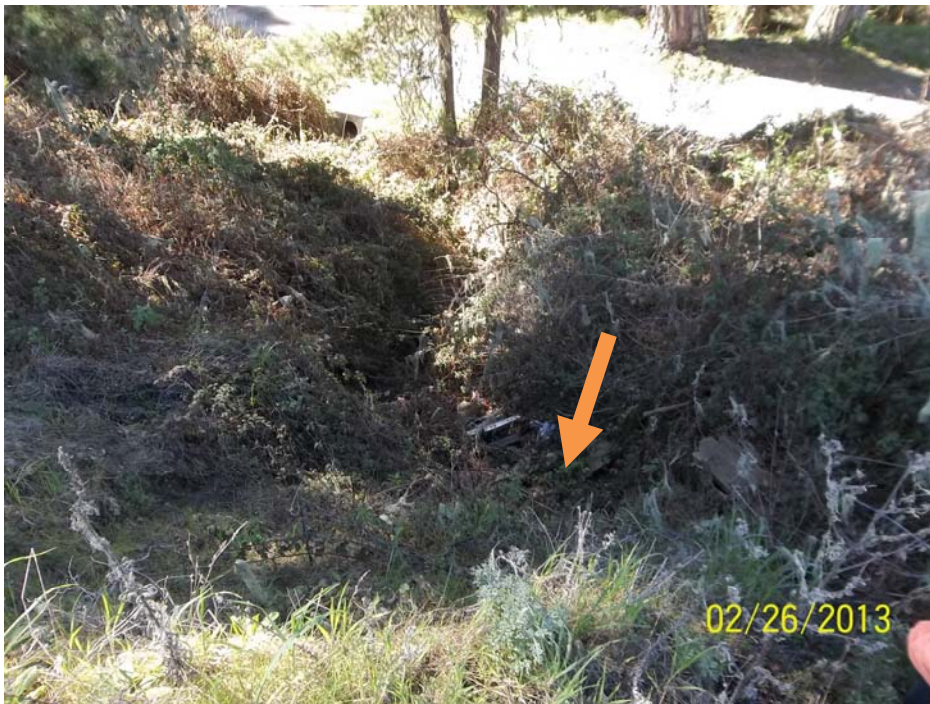
Photo 7 – Photo of gully leading to private driveway culvert. Arroyo Leon Creek exists approximately 150ft below Higgins Canyon Road at this location. Arrow indicates approximate location of proposed flume and extent of flex pipe.

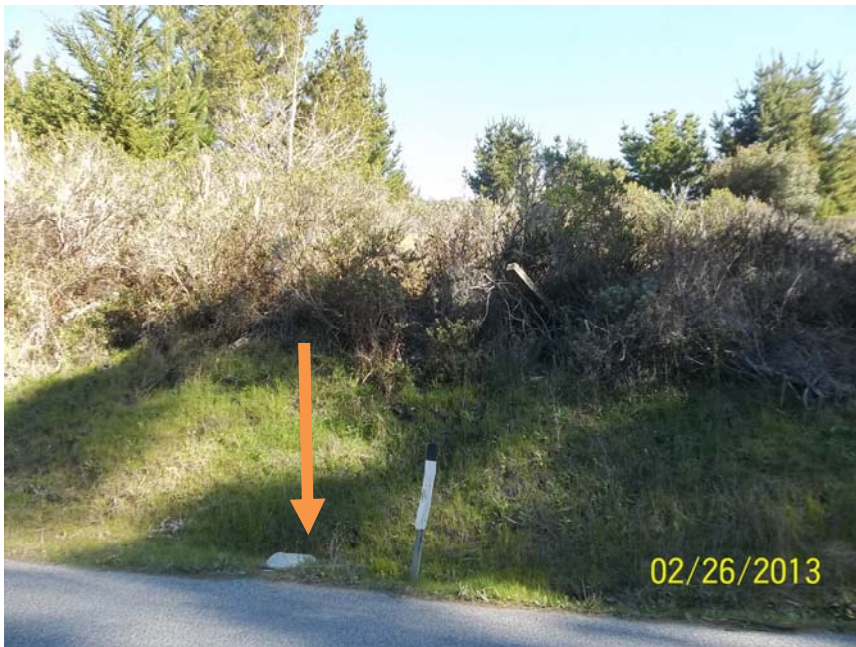
Photo 8 – Photo of 15-inch CMP culvert inlet along Higgins Canyon Road. The inlet drains the surrounding hillside and an earthen ditch. Parcel on upslope side of the road is part of Burleigh Murray Ranch State Park.

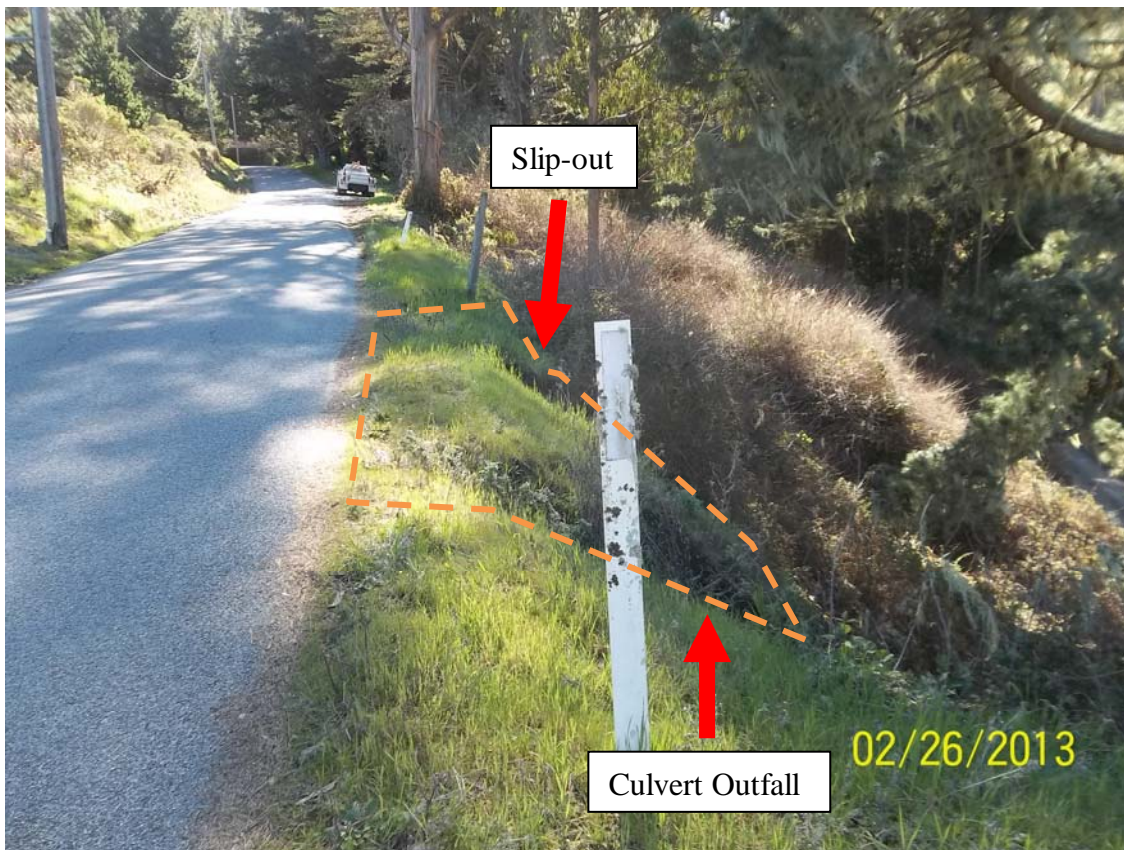
Photo 9 – Photo of work area on Higgins Canyon Road. Dashed lines indicate area of potential disturbance. Several Monterey pine (*Pinus radiata*) and eucalyptus (*Eucalyptus spp.*) trees exist in the area. No raptors or raptor nests were observed during the biological assessment survey in December 2013.

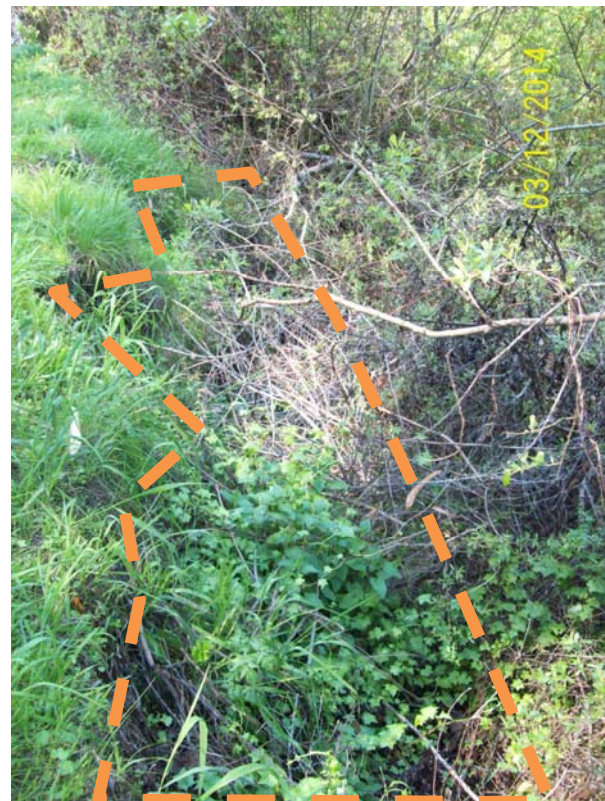
Photo 11 – Photo of slip-out looking west from Seaside School Road. Only herbaceous vegetation (cape ivy, miner's lettuce, milk thistle, bed straw) exists in the slipped material. The overhanging vegetation will need to be thinned to provide construction access and visibility of the slipped area. Dashed lines indicate slip-out location and previous extent of

shoulder.

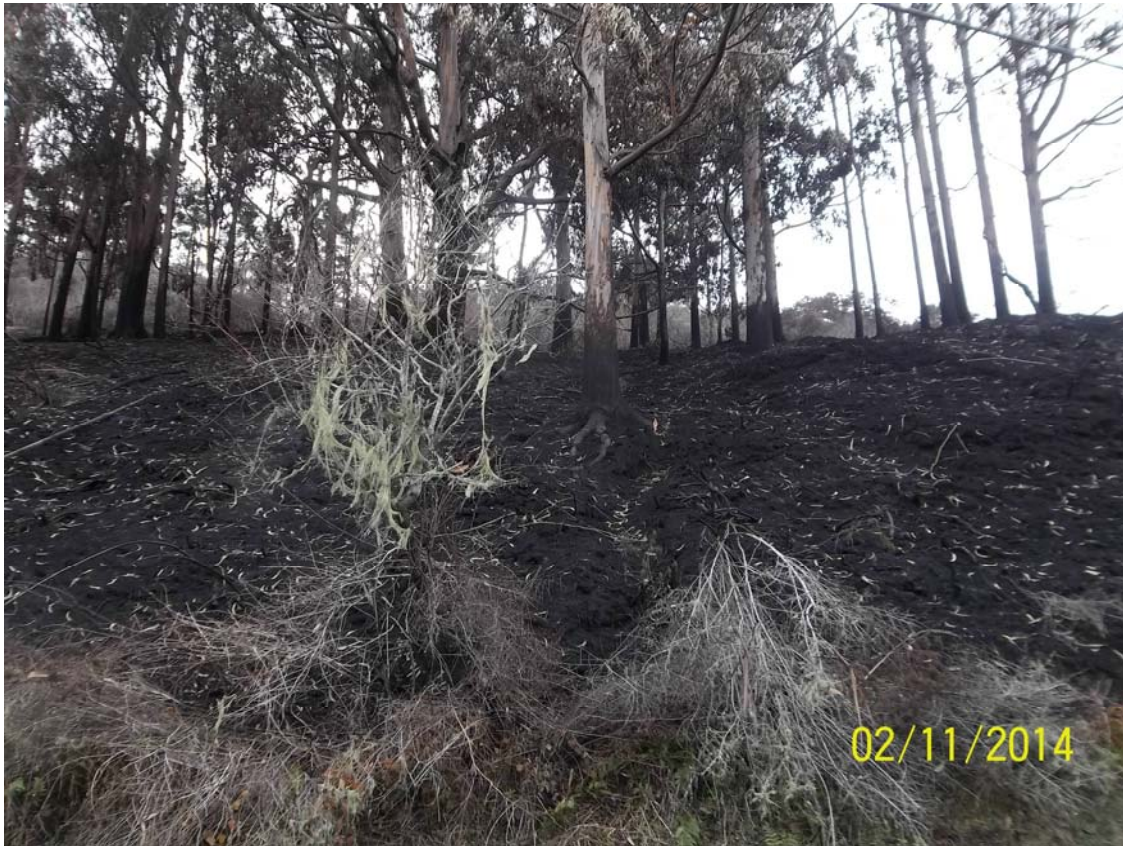
Photo 12 – Photo of upland area on south side of Seaside School Road immediately adjacent to the two slip-outs. Although the fire scorched most of the understory coastal scrub vegetation, most of the eucalyptus trees in the background of the picture survived.

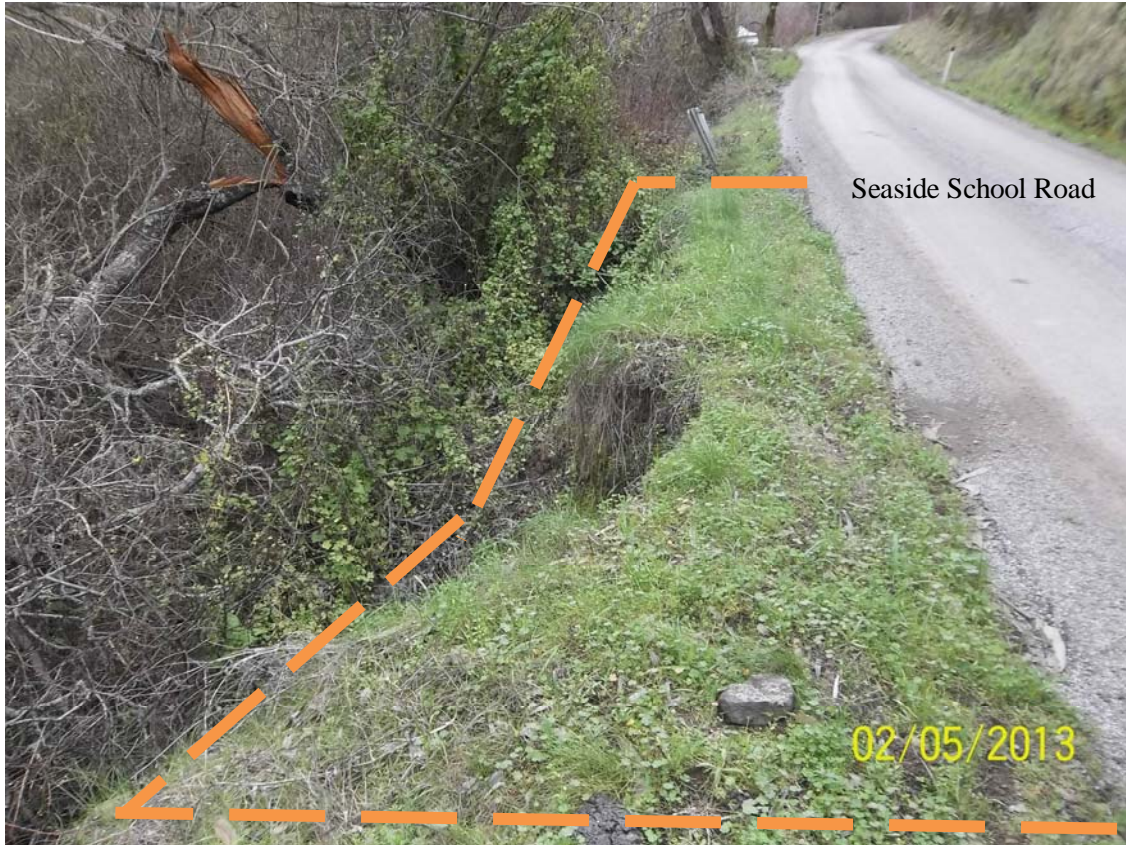
Photo 13– Photo of slip-out location in relation to Seaside School Road. In the past, emergency repairs were completed to repair a slip-out at the same location. Recently an undermined willow tree fell from the road shoulder and caused another slip-out. Dashed lines indicate expected area of disturbance and previous extent of shoulder.

repair to assist with stabilizing the revetment and discourage recruitment of invasive plant species. Disturbed areas will be seeded with a native seed mix, covered with an erosion control blanket, and mulched with sterile rice straw. Construction work will only take place when the site is dry. Disturbances are not expected to exceed beyond the boundaries shown in Photo 13.

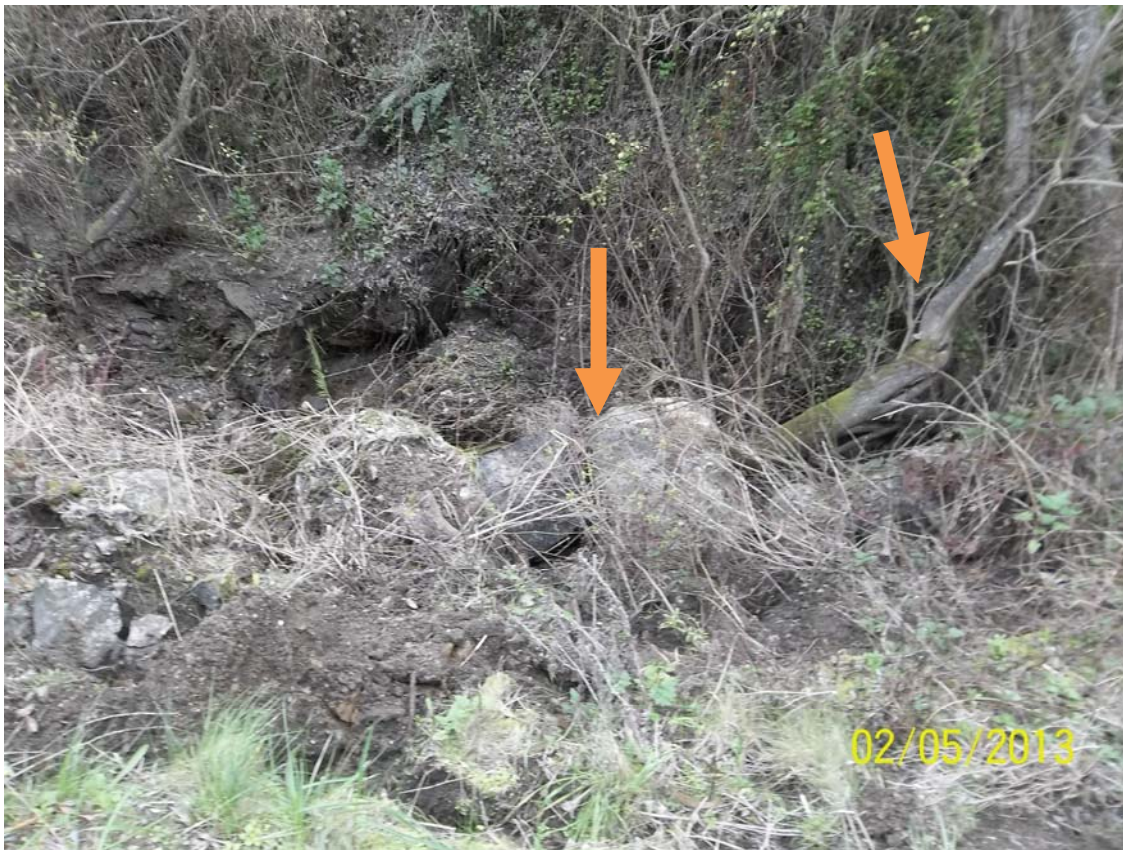
Photo 14 – Photo of slipped materials in the unnamed tributary channel. Arrows indicate location of slipped boulders and the undermined willow. The boulder and tree were removed from the entrenched channel to prevent flooding from upcoming rain events. The stream’s confluence with San Gregorio Creek is approximately 100 feet downstream of the slip-out #2 and 50 feet downstream of slip-out #1.

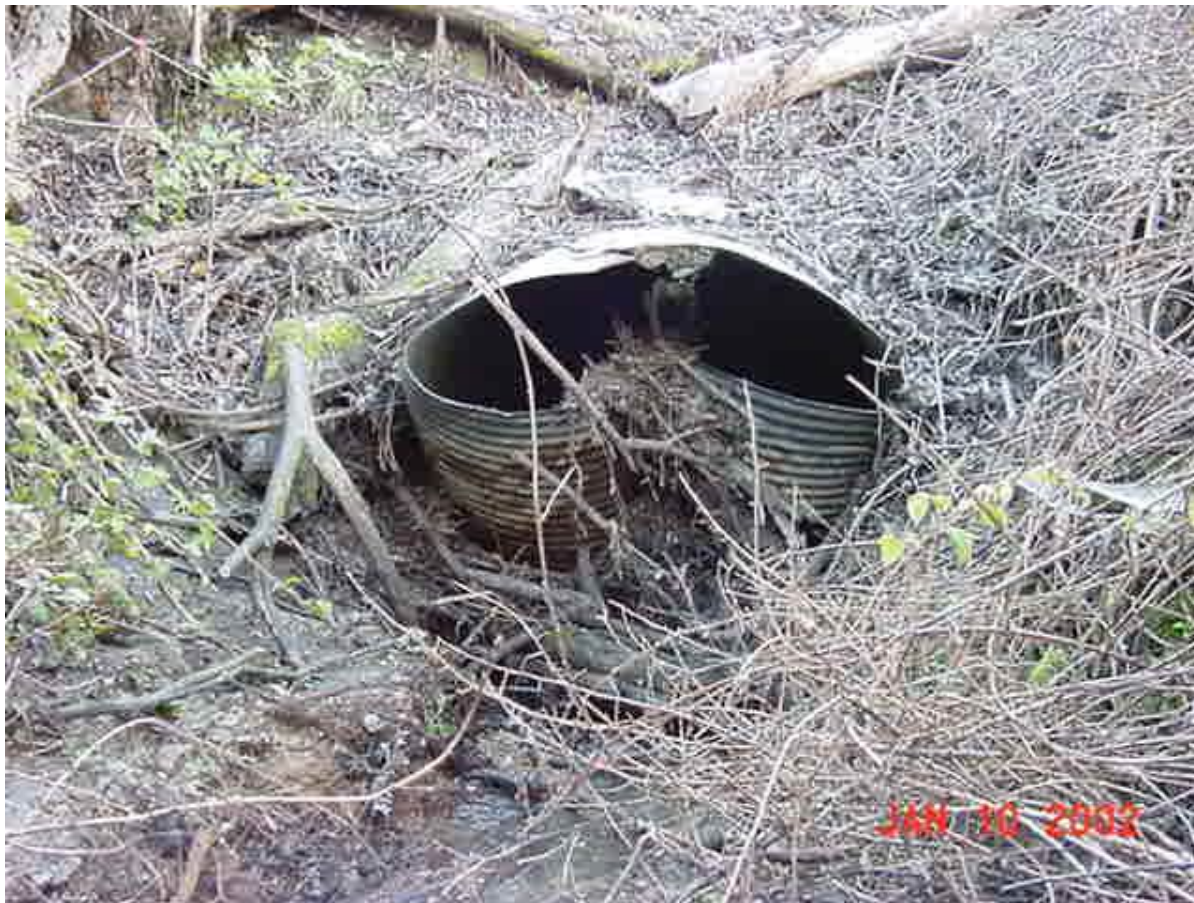
Photo 15 – Photo of 60-inch CMP culvert inlet at the Bear Gulch Road project site. Storm events in 1998 along with natural wearing resulted in a partially crushed inlet and damages throughout the pipe. Picture was taken in January 10, 2002. Clear Creek stream flows have navigated around the inlet and flooring and have gradually dissolved the road fill material. Natural woody debris and substrate movement within the stream is greatly hindered by the condition of the existing culvert. Note the woody debris accumulation on and around the culvert.

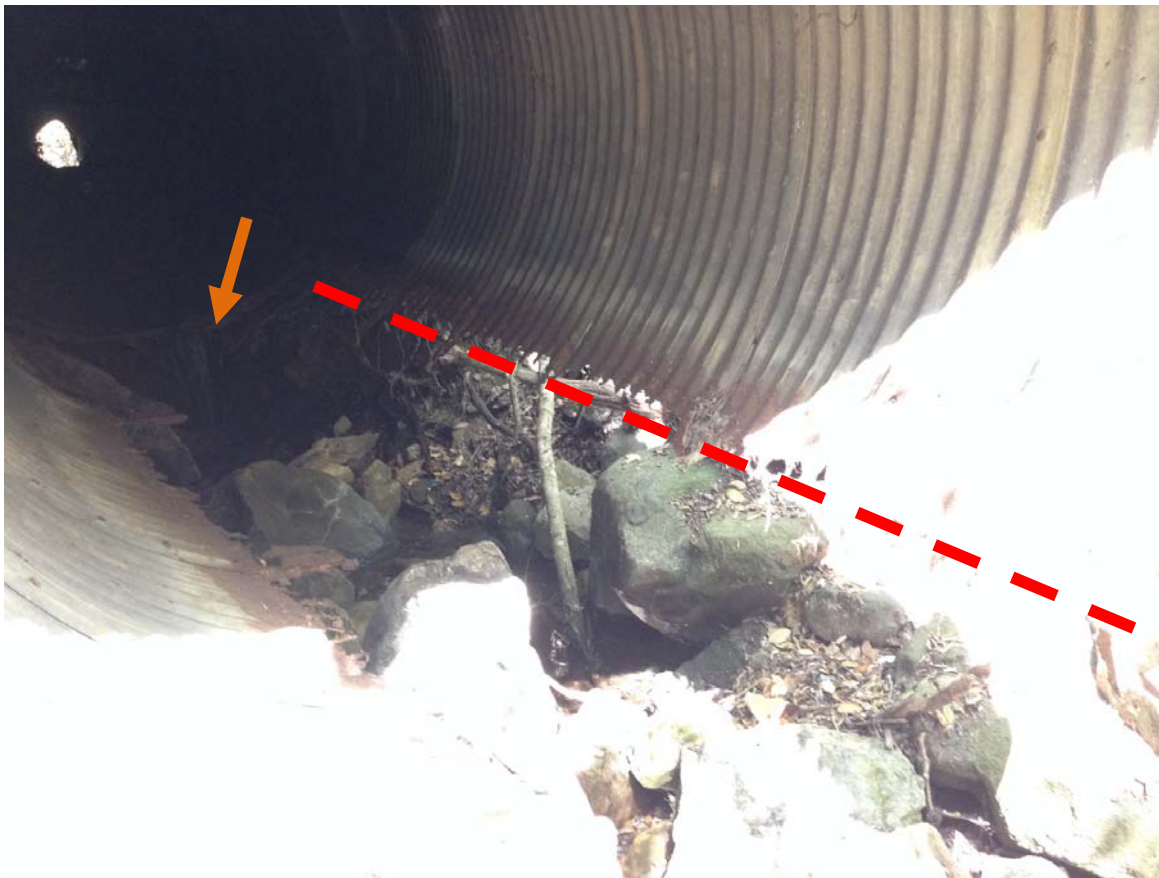
Photo 16 – Photo of 60-inch CMP culvert outlet showing fully deteriorated culvert flooring. Dashed line indicates downstream extent of culvert flooring loss. Arrow indicates downstream extent of remaining but deteriorated culvert flooring. Culvert outlet is perched at least 3 feet from the streambed. Moreover, the deteriorated flooring and stream flow around the pipe has resulted in loss of road fill at the outlet and inlet. Surface flow was absent during the December 2013 and February 2014 visits but minor surface flow was present during the March 2014 visit. Construction will take place when surface flow is absent and the appropriate permits have been obtained.

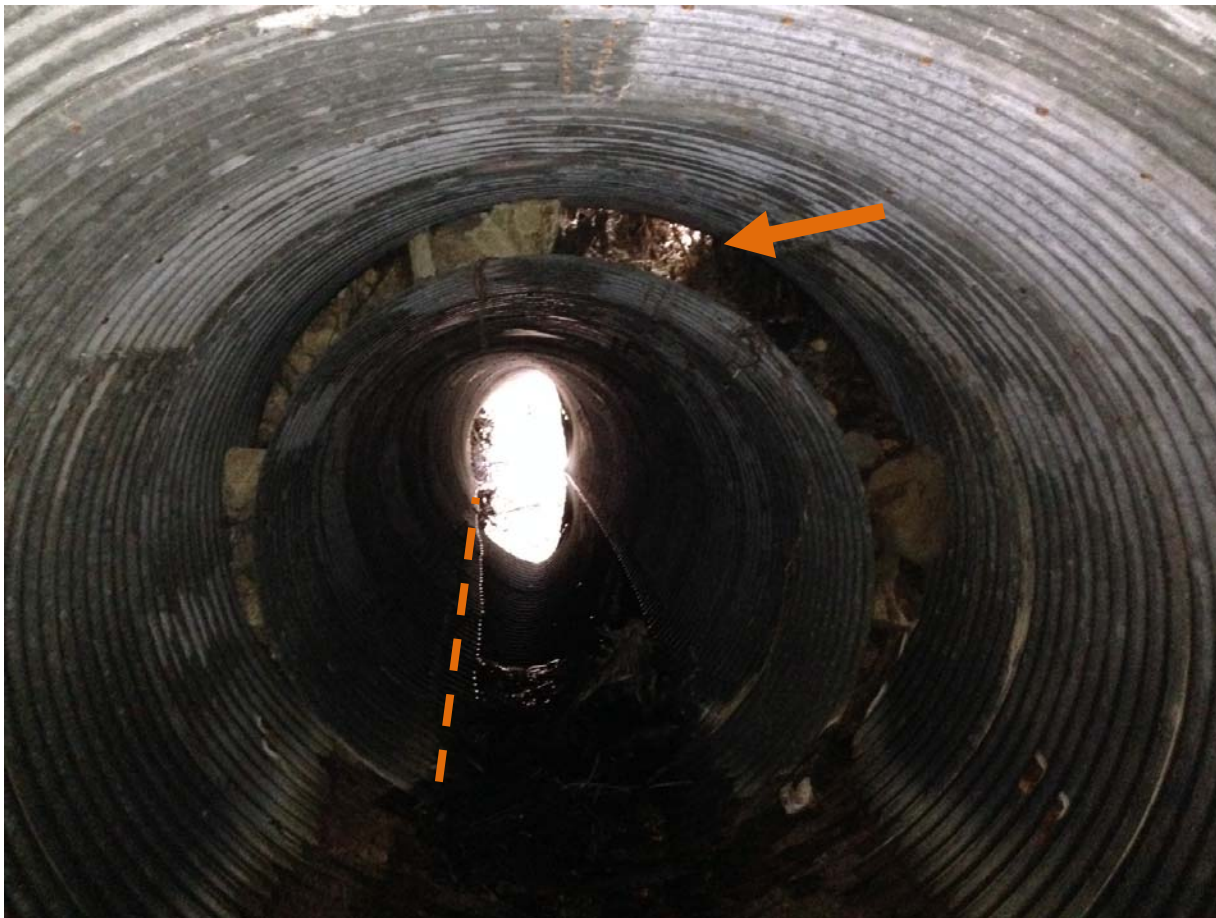
Photo 17 – Photo of culvert inlet showing disconnection of a 20-foot section of culvert inlet from the remaining pipe. Total loss of culvert flooring within this 20-foot section has caused the pipe to fully disconnect from the remaining pipe, reducing the volume carrying capacity of the pipe and causing the fill around the pipe to sink. Dashed line indicates location of the 20-foot section of pipe. Note the light entering the culvert from the earth fill as indicated by the arrow. The sinkhole is situated on top of the fill around the disconnected section of pipe.

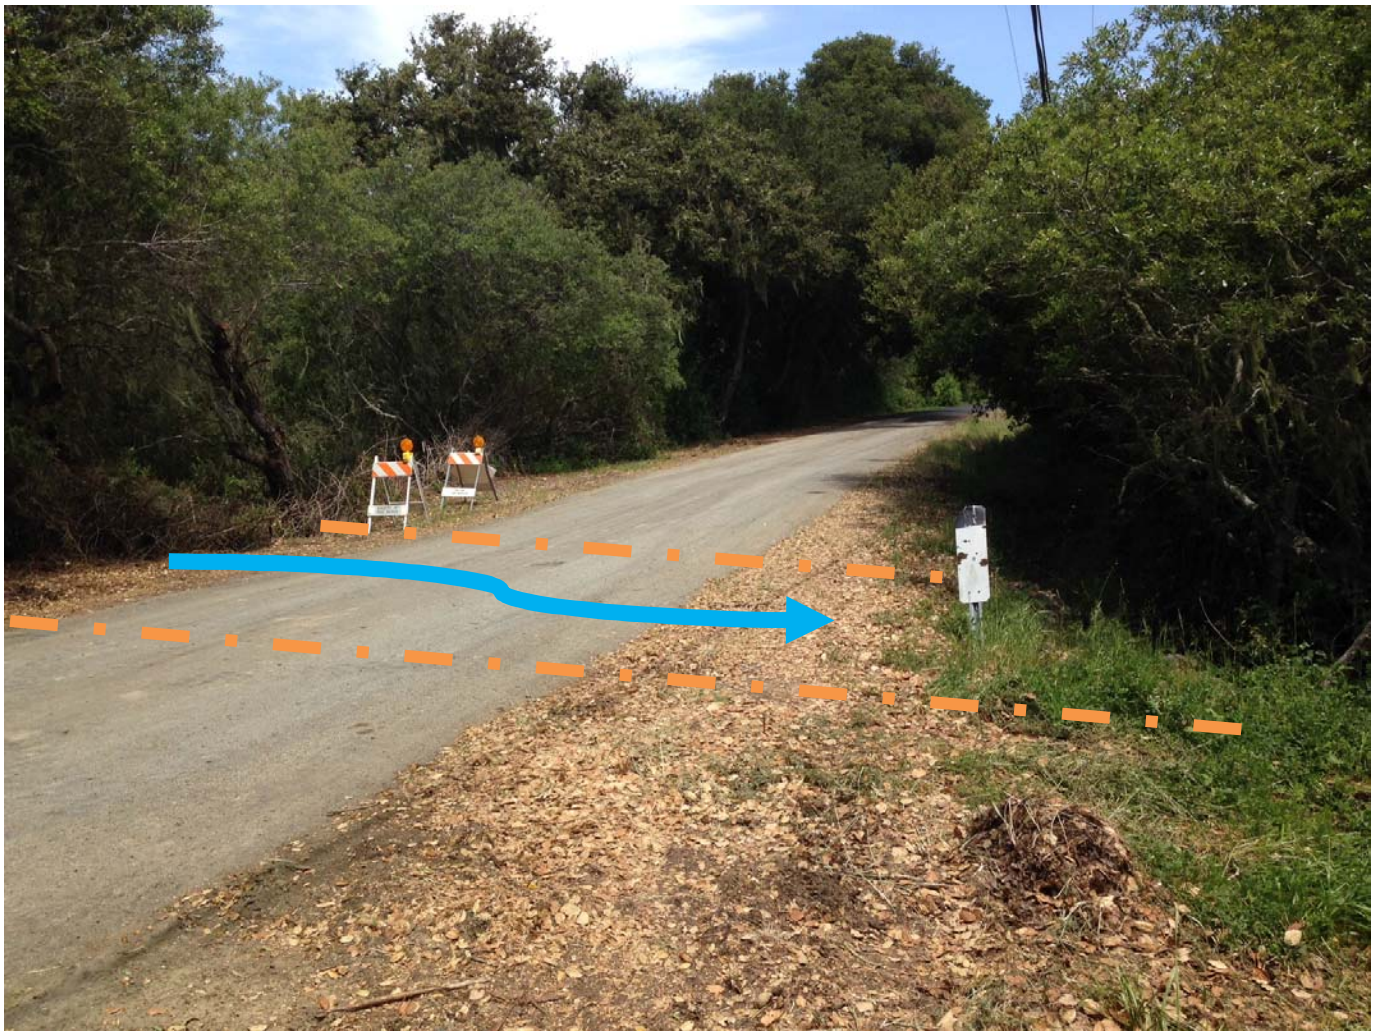
Photo 18 – Photo of Bear Gulch Road project site. Dashed lines indicate anticipated limits of project site activities. Traffic barricades identify sinkhole location. Roadside ditch exists on the east side of the road and drains into the culvert outlet plunge pool. Arrow indicates direction of stream flow. Construction will only take place when the site is dry and occur on one half of the road at a given time, leaving the other half of the road available for public egress and ingress.

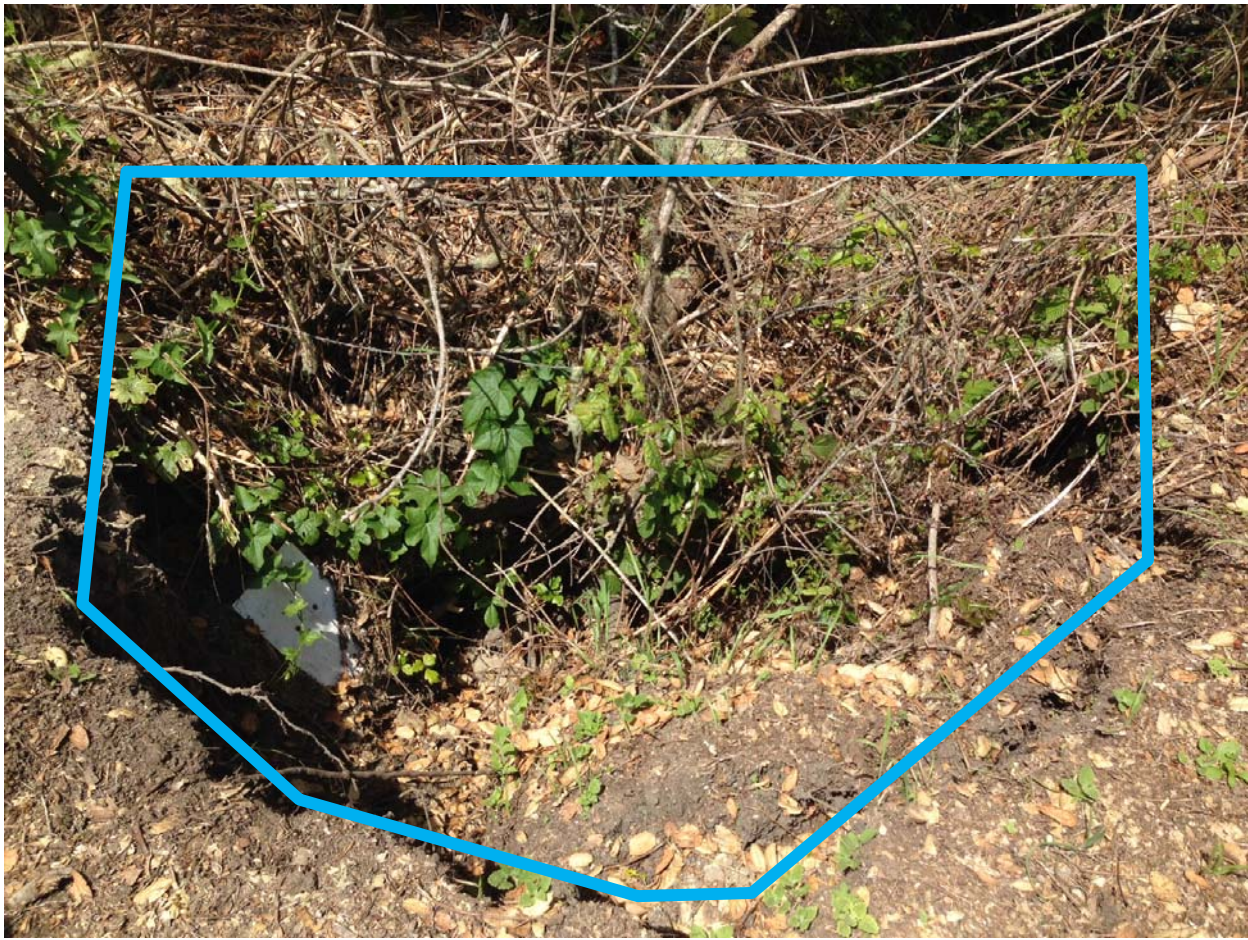
Photo 19 – Photo of sinkhole at culvert inlet caused by culvert disconnection. The hole is approximately 4 feet deep and 6 feet wide and is identified by the blue line.

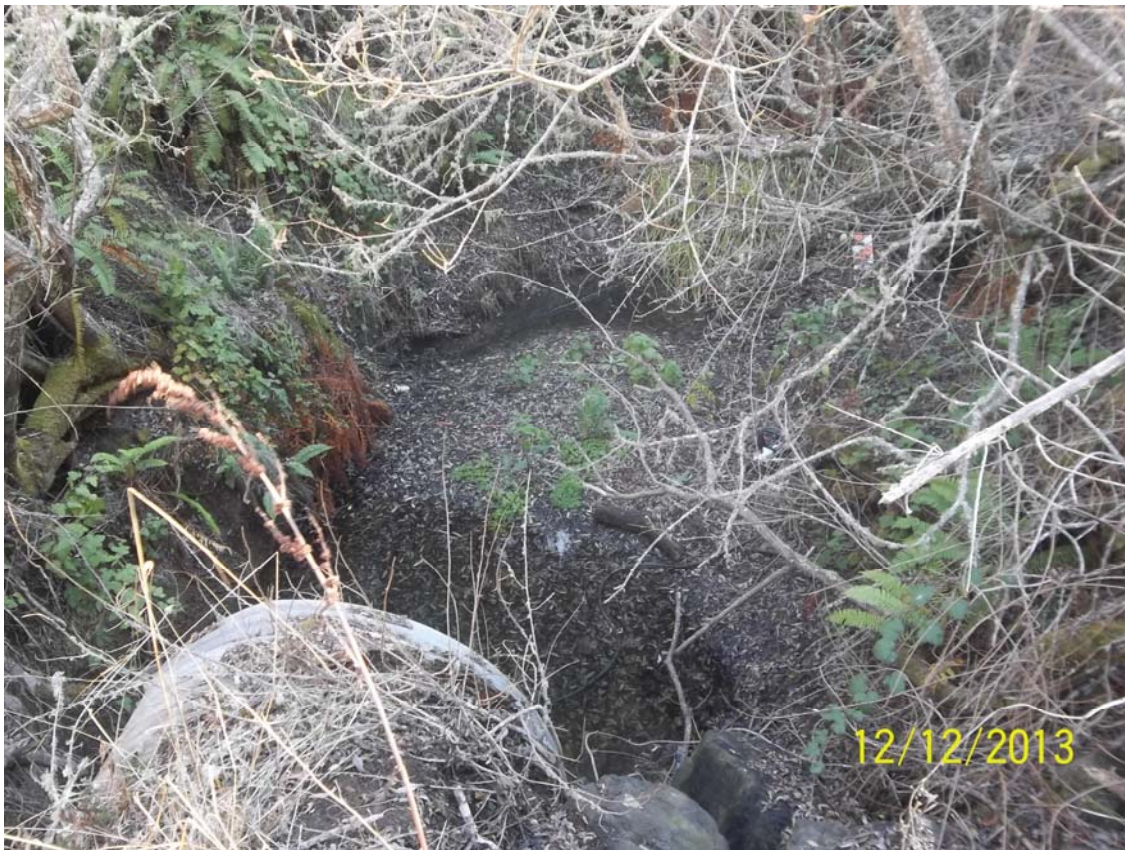
Photo 20 – Photo of culvert outlet pool and channel. The pool is expected to have negligible depth during the culvert replacement which will occur during the dry season. Substrate within the pool is mostly sand and silt with a heavy accumulation of leaf debris. No fish or wildlife were seen utilizing the pool during the site visits. Maximum pool depth at the time of the 12/12/2013 visit was approximately 1 foot.

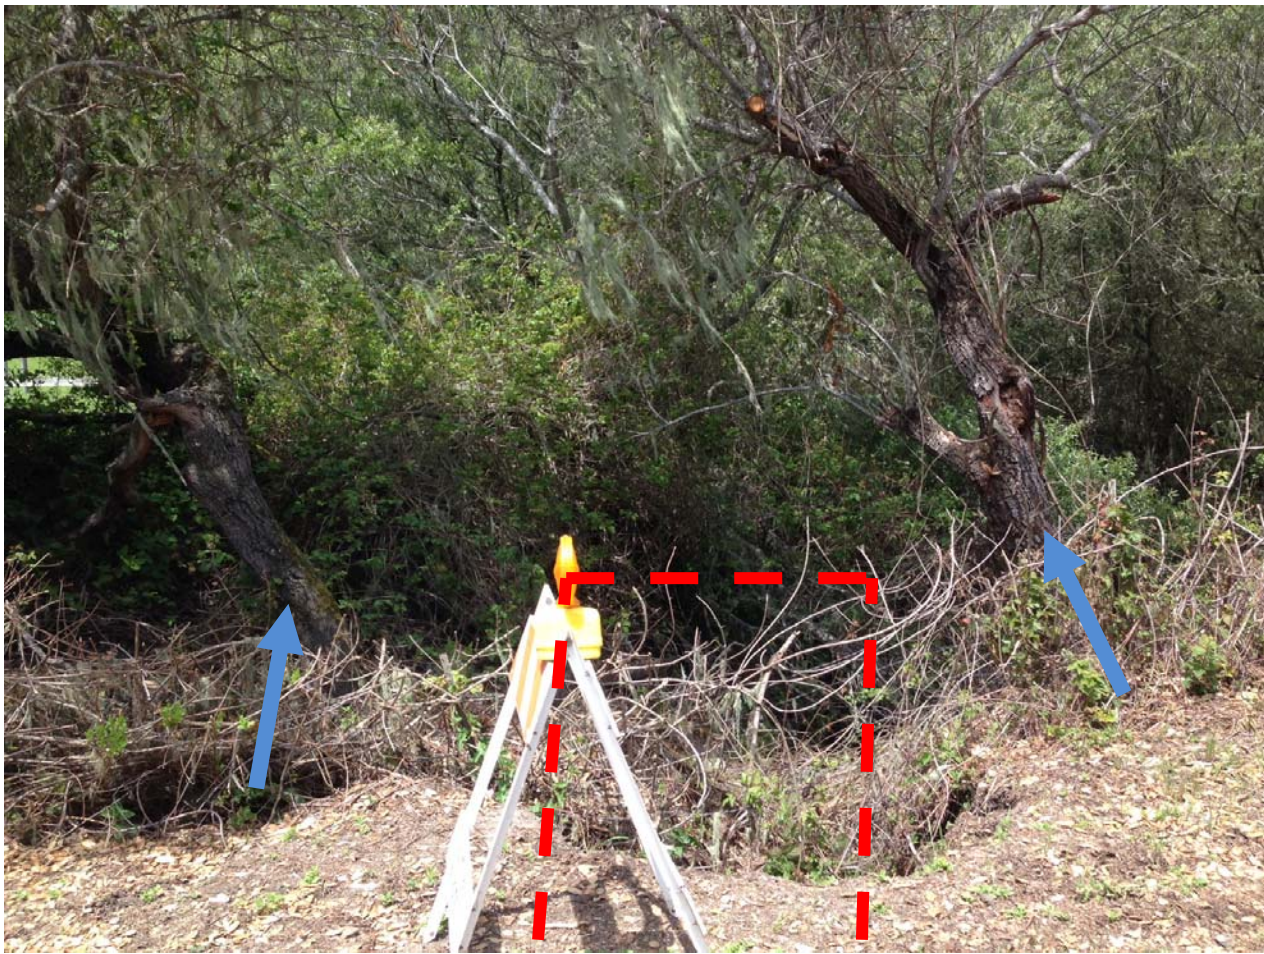
Photo 21 – Photo of culvert inlet with the two arroyo willow trees proposed for removal. Tree diameters are approximately 12- to 13-inch at breast height. Removal of the trees is necessary to extract the failing culvert as their trunks and roots exist within directly over and adjacent to the culvert. Trees will not be removed if determined unnecessary during the construction process. Dashed lines indicate approximate location of culvert in relation to the arroyo willow trees.

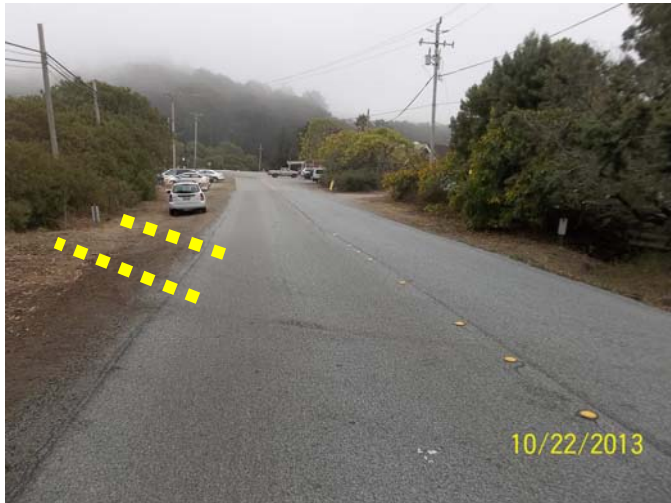
Photo 22 – Photo of Stage #1 project site. Dashed lines denote area of impact from construction activities. Excavation of culvert will begin at edge of pavement. Culvert drains neighboring property and roadside ditch into Palmer Gulch. A small sinkhole has developed at the point of culvert disconnection.

The Stage #1 project site is located on Stage Road, approximately 300 feet north of State Route 84 (see Appendix A, Figures 1 & 9). The lower section of an 18-inch diameter HDPE culvert outlet disconnected underground causing a small sink hole to form on the roadside shoulder (Photo 23). The culvert drains an earthen ditch along Stage Road. An existing HDPE flume attached to the culvert outlet drains the ditch into Palmer Gulch, approximately 50 feet downslope from the culvert outlet. No stream flow was observed in Palmer Gulch or the culvert ditch during the December 2013 biological assessment survey; stagnant pools with filamentous algae accumulations were sporadically distributed along the gulch. The confluence between Palmer Gulch and San Gregorio Creek is approximately 1000 feet south of the project site. The area receives a high amount of traffic from motorists and pedestrians.

The lower 15-foot section of pipe will be excavated from the shoulder and reattached to the upper section of culvert (Appendix A, Figure 18). The excavation area will be approximately 8’L x 15’W x 2’D and will require no removal of vegetation. The culvert exists above the ordinary high water mark and top of bank

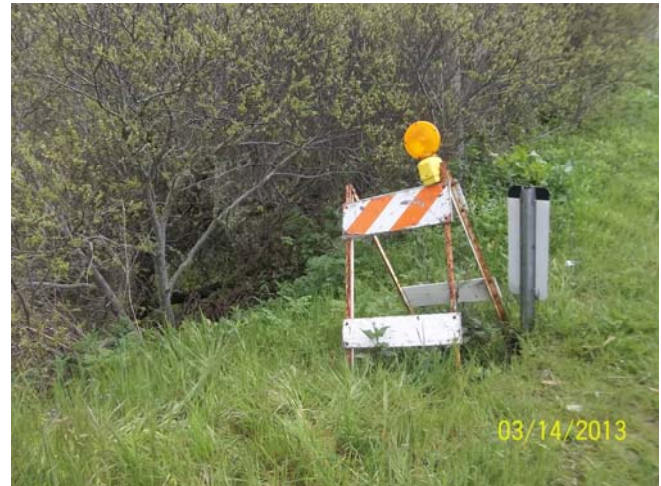
Photo 23 – Photo of traffic barricade directly over sinkhole and culvert disconnection point.
