**COUNTY OF SAN MATEO
PLANNING AND BUILDING DEPARTMENT**

SUBJECT: EXECUTIVE SUMMARY: Consideration of a Coastal Development Permit to allow the replacement or reattachment of road culverts and the repairing of road slip-outs at various locations on Higgins Canyon Road, Seaside School Road, Bear Gulch Road, and Stage Road in the unincorporated areas of San Gregorio and the Rural Midcoast.

County File Number: PLN 2014-00199
(SMCo. Department of Public Works)

**COASTAL CULVERT REPLACEMENT, REATTACHMENT, AND SLIP-OUT REPAIRS PROJECT
BIOLOGICAL IMPACT FORM**

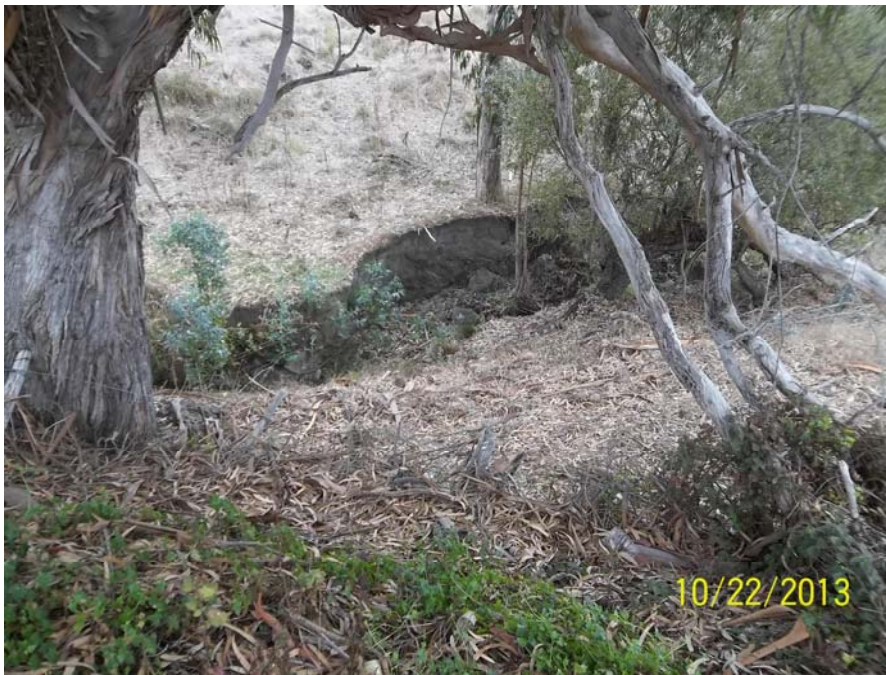
Photo 24 – Photo of Palmer Gulch adjacent to project site. Palmer Gulch joins San Gregorio Creek approximately 1000 feet south of the project location. Although CNDDDB records show steelhead and tidewater goby occurrences in San Gregorio Creek, no occurrences have been documented in Palmer Gulch and the two species are not expected to occur in Palmer Gulch due to lack of habitat. Most of the San Gregorio Watershed is designated as critical habitat for California red-legged frog. No CRLF are expected to be within the immediate construction area as there is no understory cover or suitable habitat.

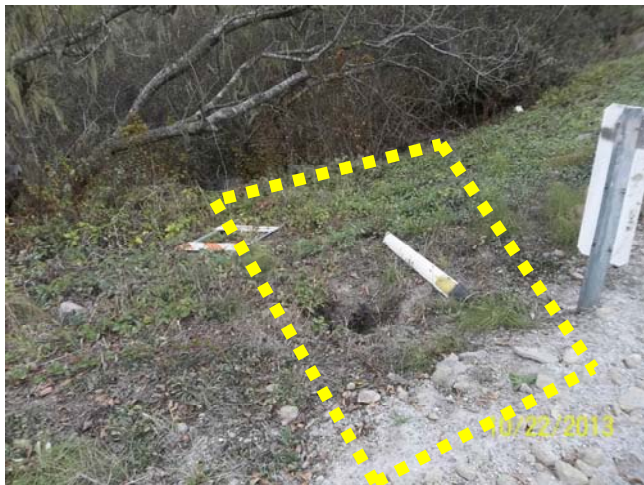
Photo 25 – Photo of culvert disconnection point and sinkhole. Sinkhole exists approximately 2 feet from the edge of pavement. Culvert outfall has a HDPE flume which directs water into the low gradient valley.

Similar to the HDPE culvert mentioned in the project site description for Stage #1, the culvert for this project site was constructed under emergency conditions. The lower section of the culvert has disconnected underground allowing water to drain around the pipe and causing a (2'W x 3'H) sinkhole to form on the roadway shoulder (Photo 25 & 27). The lower 10-foot section of the culvert will be excavated from the shoulder and reattached to the upper section of pipe (Appendix A, Figure 19). Culvert alignment will remain the same. The roadside shoulder will then be rebuilt with native soil and, if necessary, imported rock. Disturbances are not expected to extend beyond the dashed lines in Photo 24. Once construction is complete, the disturbed areas will be seeded with a native seed mix, covered with erosion control blankets and mulched with sterile rice straw. Excavation area will measure approximately 10'L x 8'W x 3'D and approximately 8.89 cubic yards of fill will be required to complete the repair.

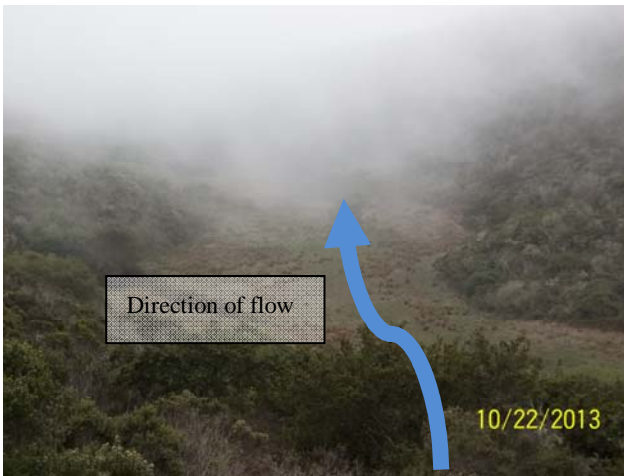
Photo 26– Photo of low gradient valley carrying flows from the unnamed gulch to Pomponio Creek. Based on aerial imagery and observations from the road, flows from the gulch are not significant enough to create well-defined channels within the valley.

The Stage #2 project site is located on Stage Road, approximately 3.2 miles south of State Route 84 (Appendix A, Figures 1 & 9). A small gully exists at the site and carries runoff from the nearby hillside through a 24-inch HDPE culvert. Runoff from the culvert flows down a flume and north through an undefined channel into a low gradient valley before reaching Pomponio Creek approximately 1/3 mile from the Project location (Photo 26).

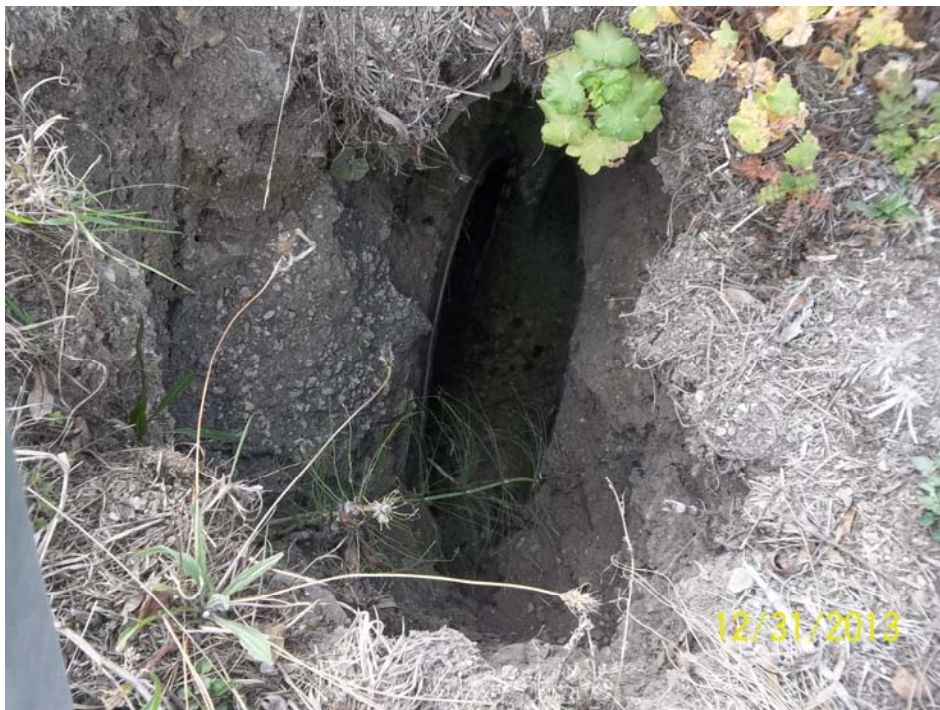
Photo 27 – Photo of culvert disconnection area and the resulting sinkhole. The hole is 2 feet wide and 3 feet deep including the depth of the culvert. Picture was taken on December 31, 2013. The surrounding area and culvert segments will be inspected for special status species prior to and during the construction activities.

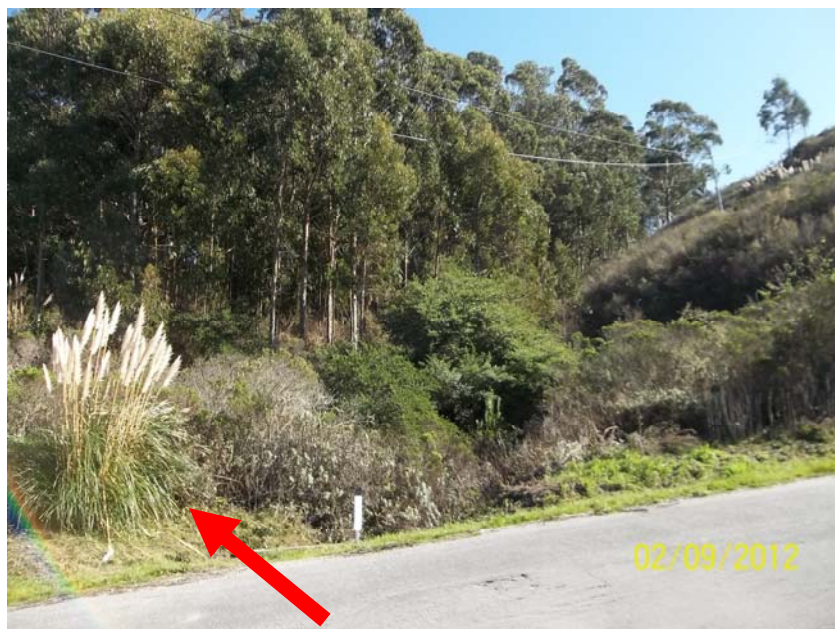
Photo 28 – Photo of drainage and eucalyptus grove on culvert inlet. Pampas grass individual to the left of the white culvert marker will be removed.

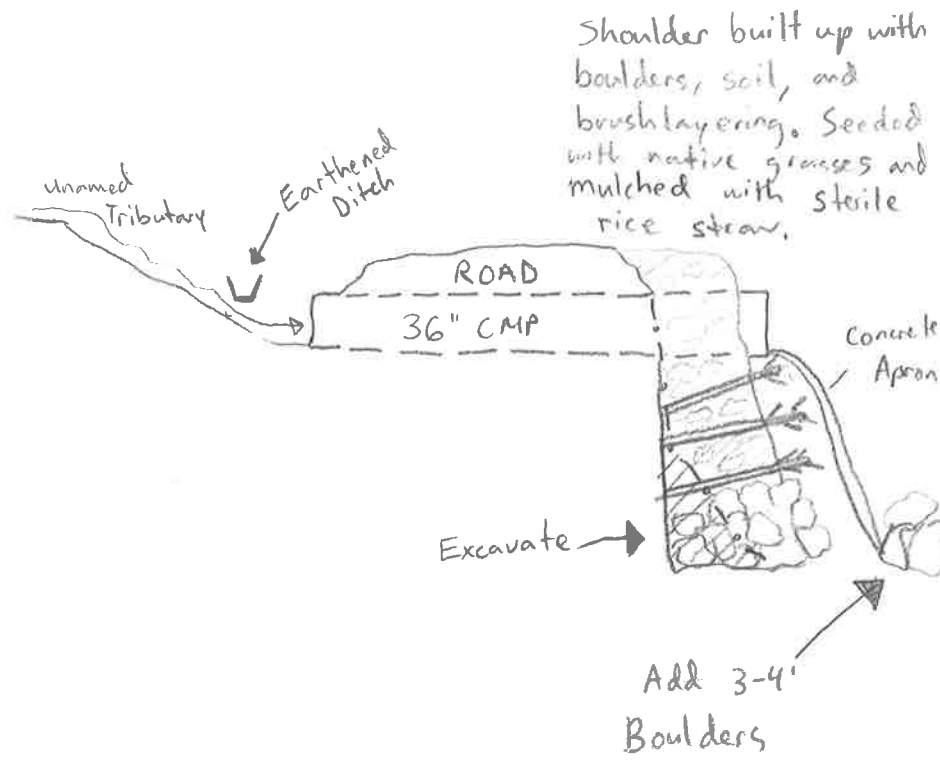
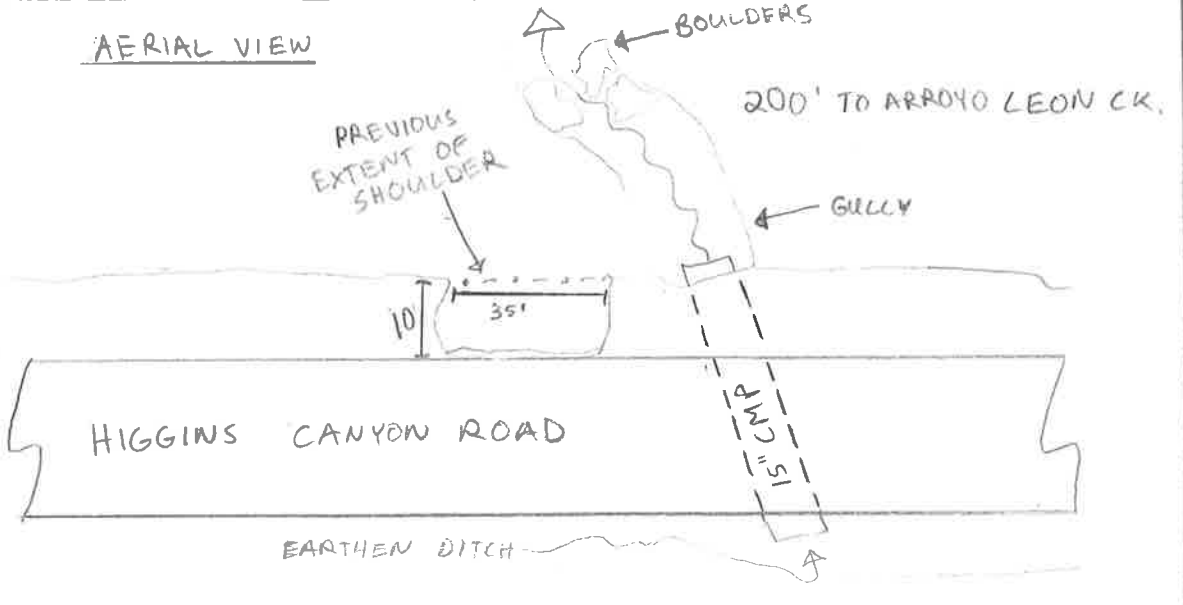
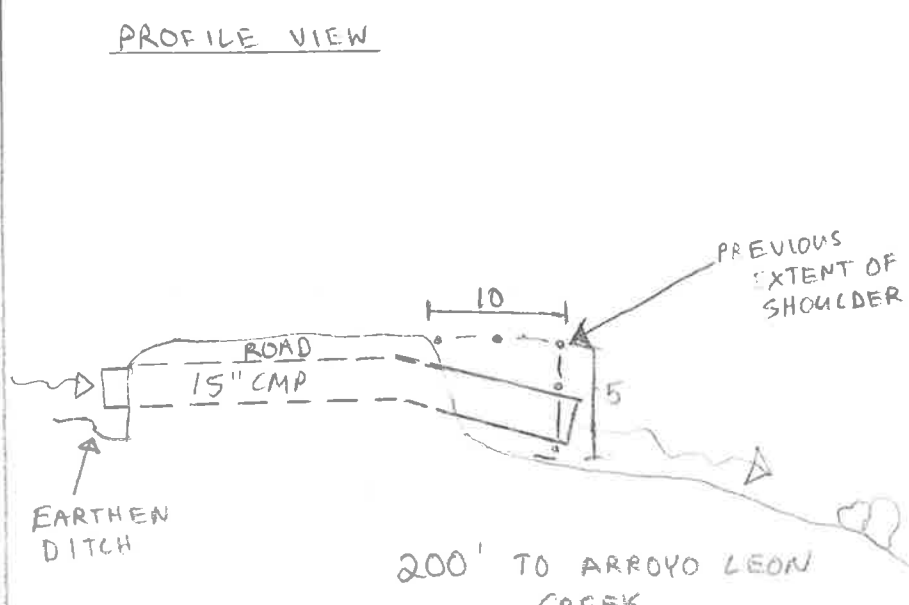
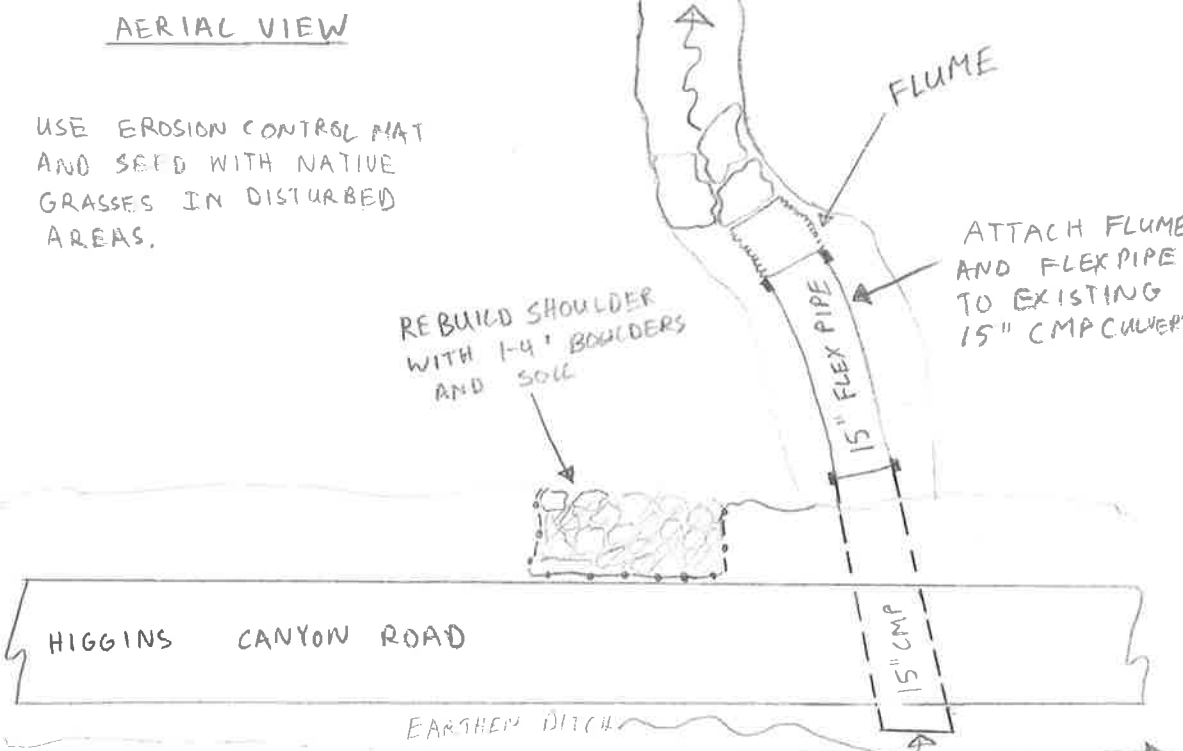
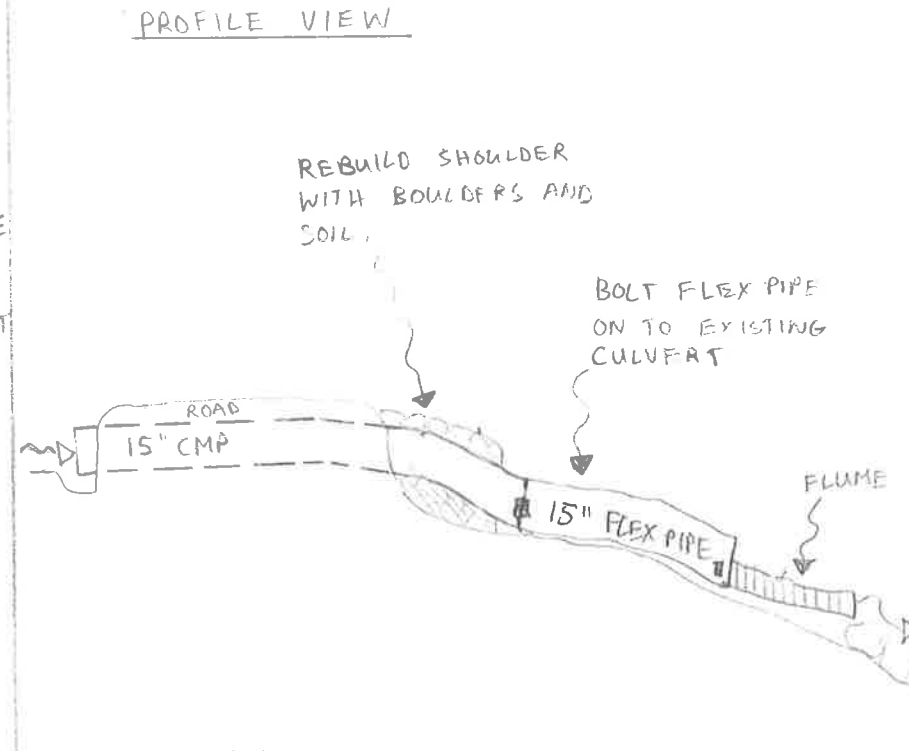
FIGURE 3. HIGGINS CANYON #2 PROJECT SITE - SLIP-OUT REPAIR AND FLEX PIPE ATTACHMENT (1.8 MILES EAST OF HIGHWAY 1)

Note: Excavated shoulders will be seeded with native grasses and mulched with sterile rice straw.
