MEMORANDUM

DATE: January 19, 2024
TO: Mark Chow, County of San Mateo
FROM: Ben Shick, PE
SUBJECT: Crystal Springs County Sanitation District – Pipe
and Manhole Assessment and Recommendations

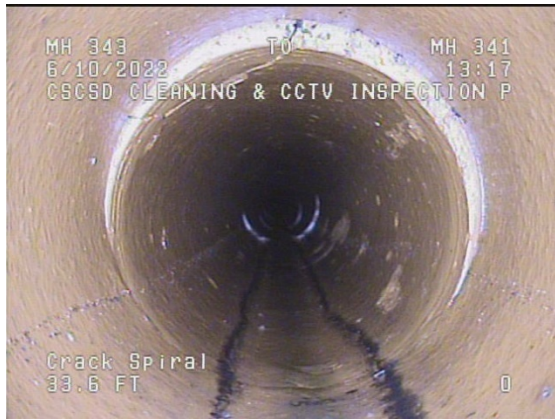
Example 1: Spiral Crack

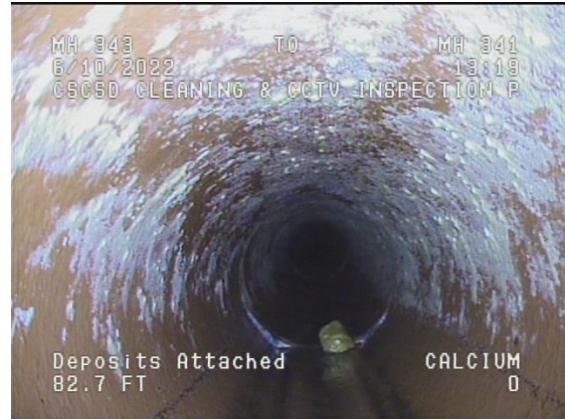
Example 2: Calcium Deposits

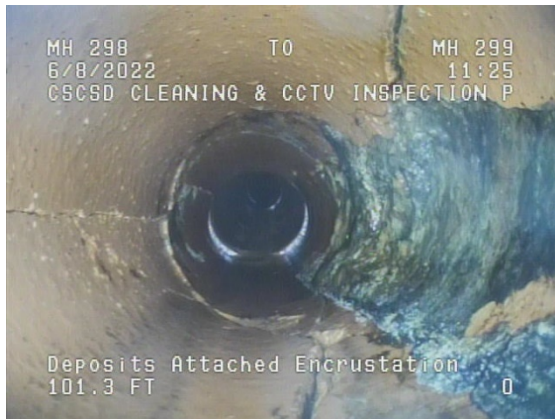
Example 3: Encrustation Deposits/Infiltration Stain

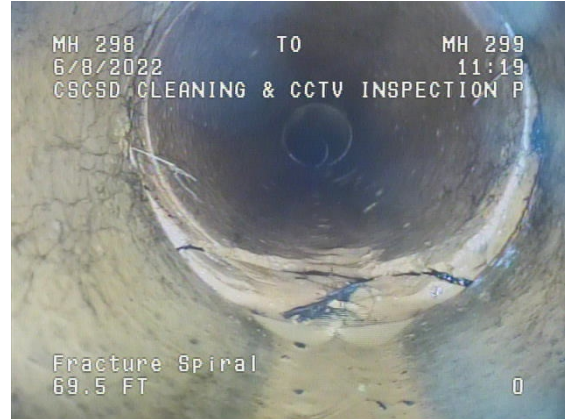
Example 4: Spiral Crack

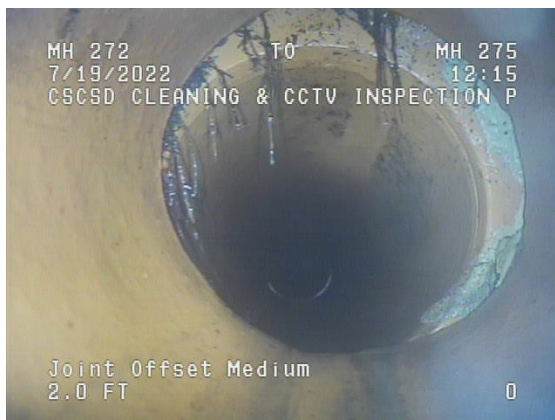
Example 5: Medium Offset Joint

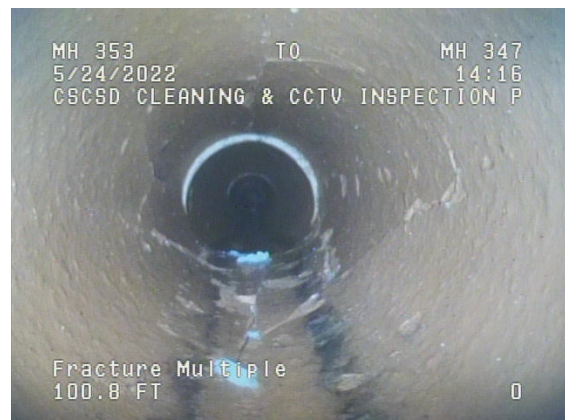
Example 6: Multiple Fractures

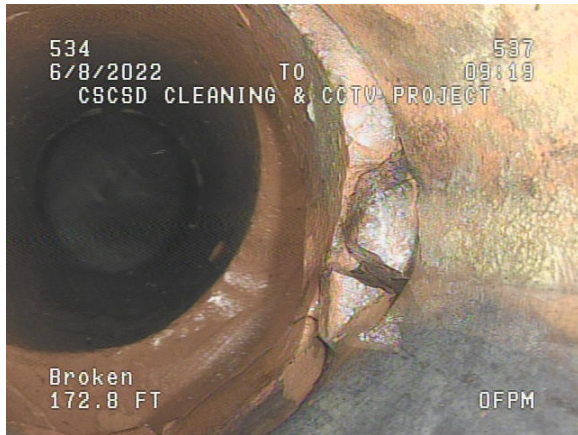
Example 7: Broken Pipe

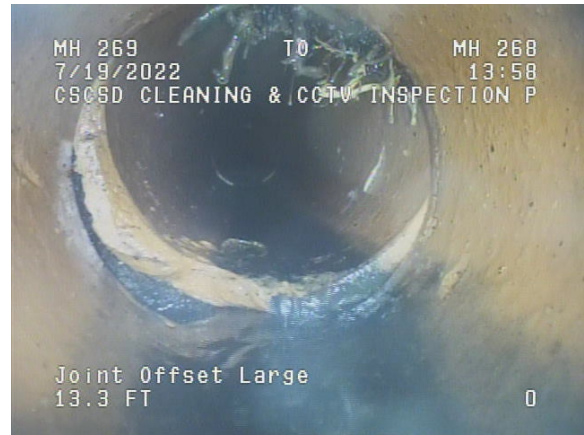
Example 8: Large Offset Joint

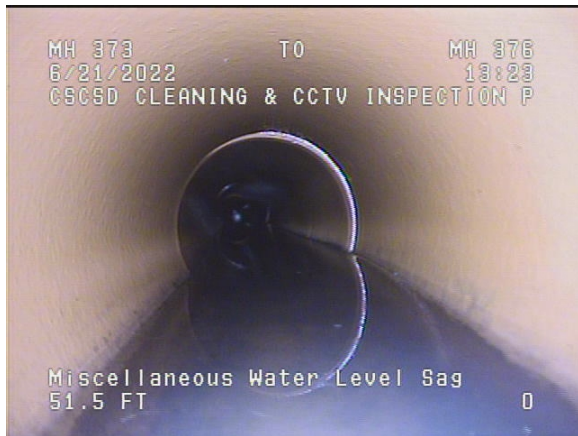
Example 9: Pipe Sag

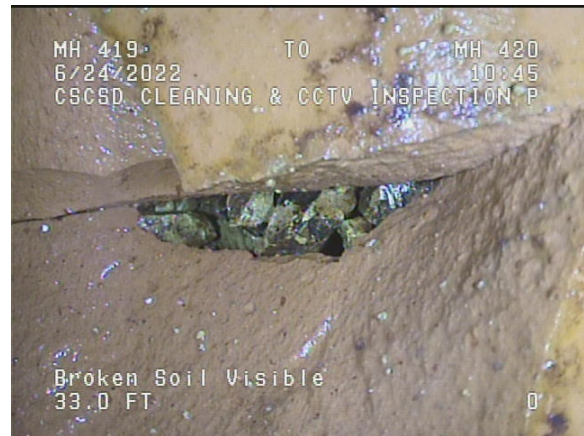
Example 10: Broken Pipe Soil Visible

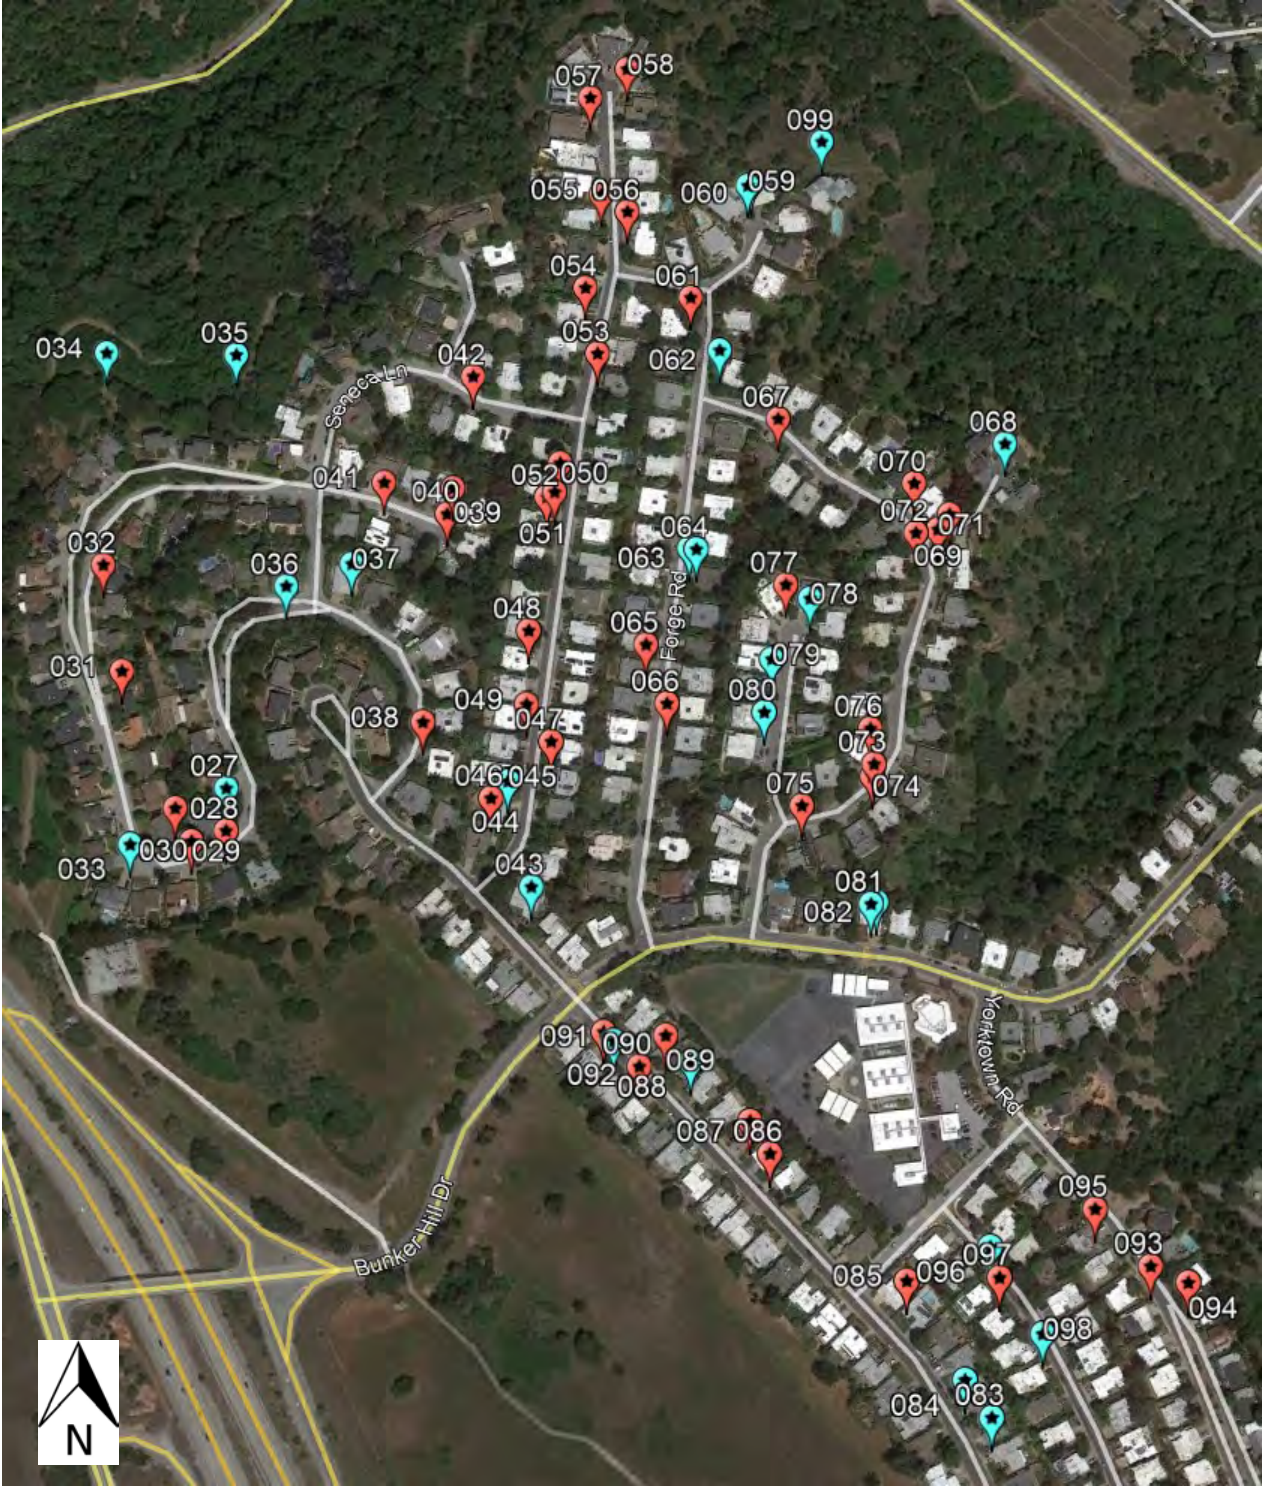
Figure 1: Basin CS-2 Area Defects
(Blue star: Smoke testing form pages 1 & 2 completed. Red star: Standard cleanout.
Smoke testing form page 2 completed)

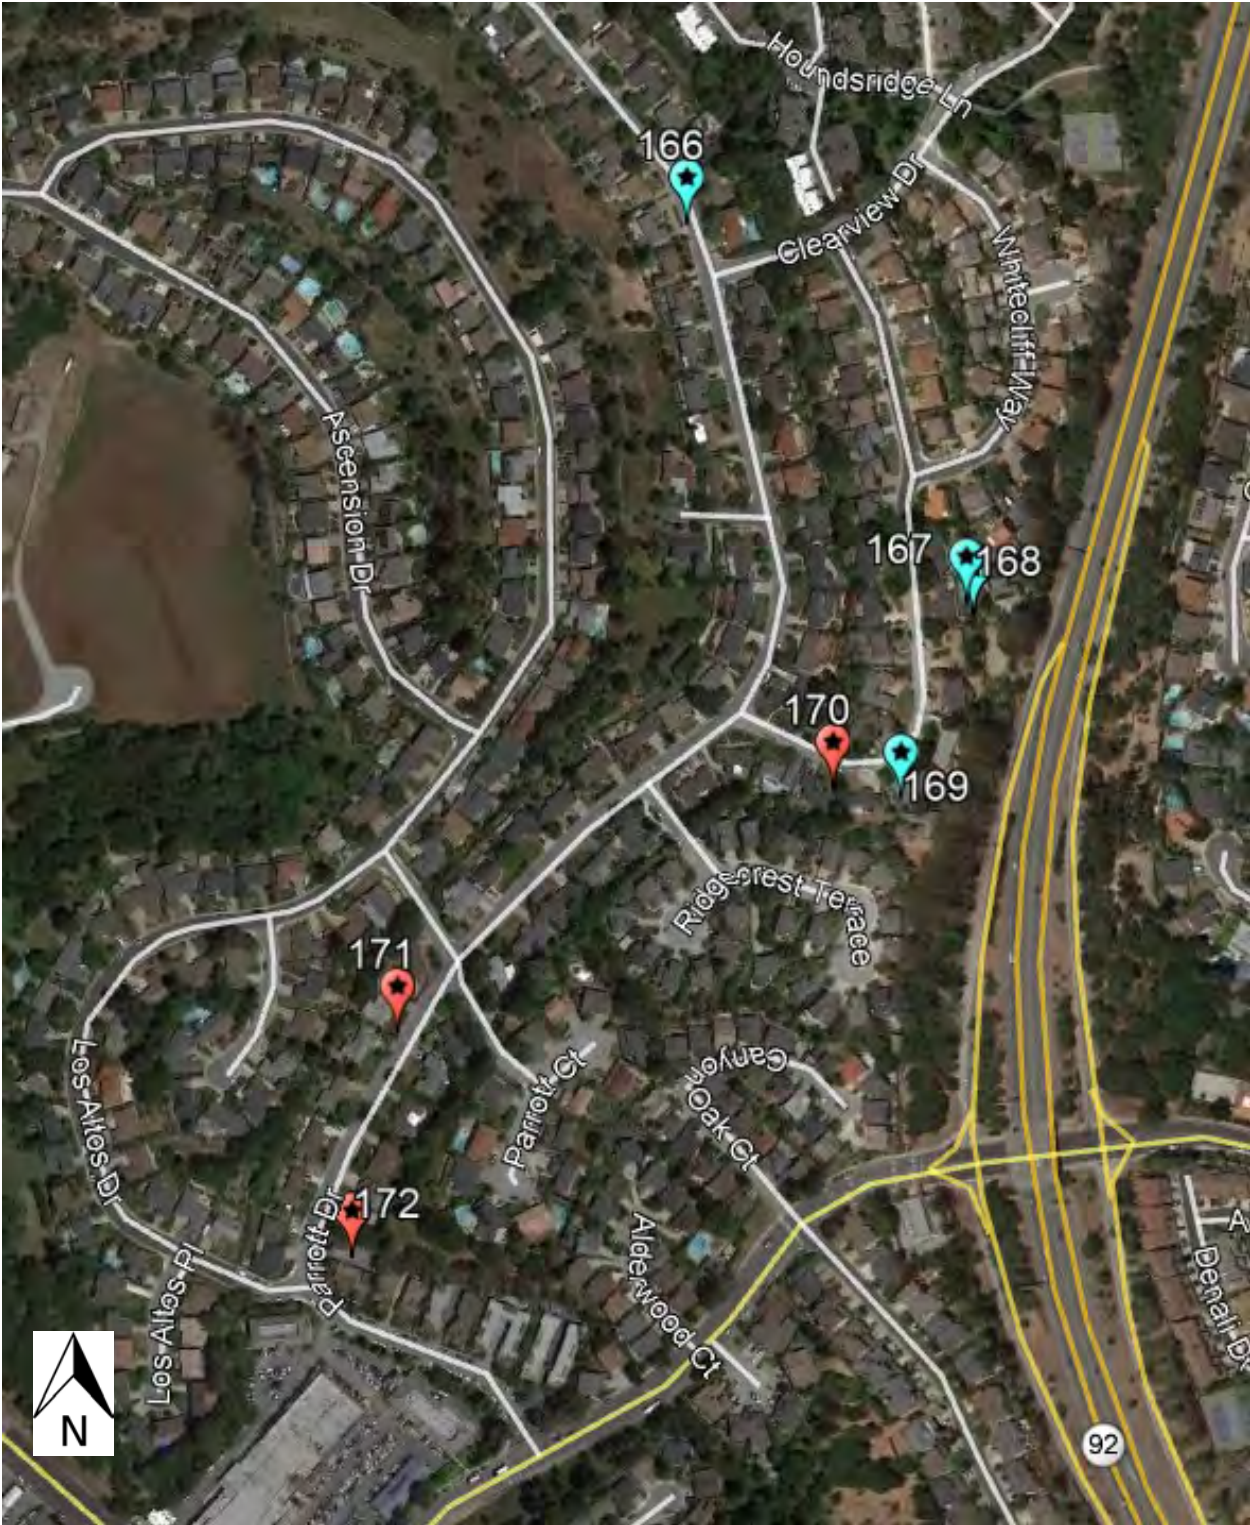
Figure 2: Basin CS-6 Area Defects
(Blue star: Smoke testing form pages 1 & 2 completed. Red star: Standard cleanout. Smoke testing form page 2 completed)

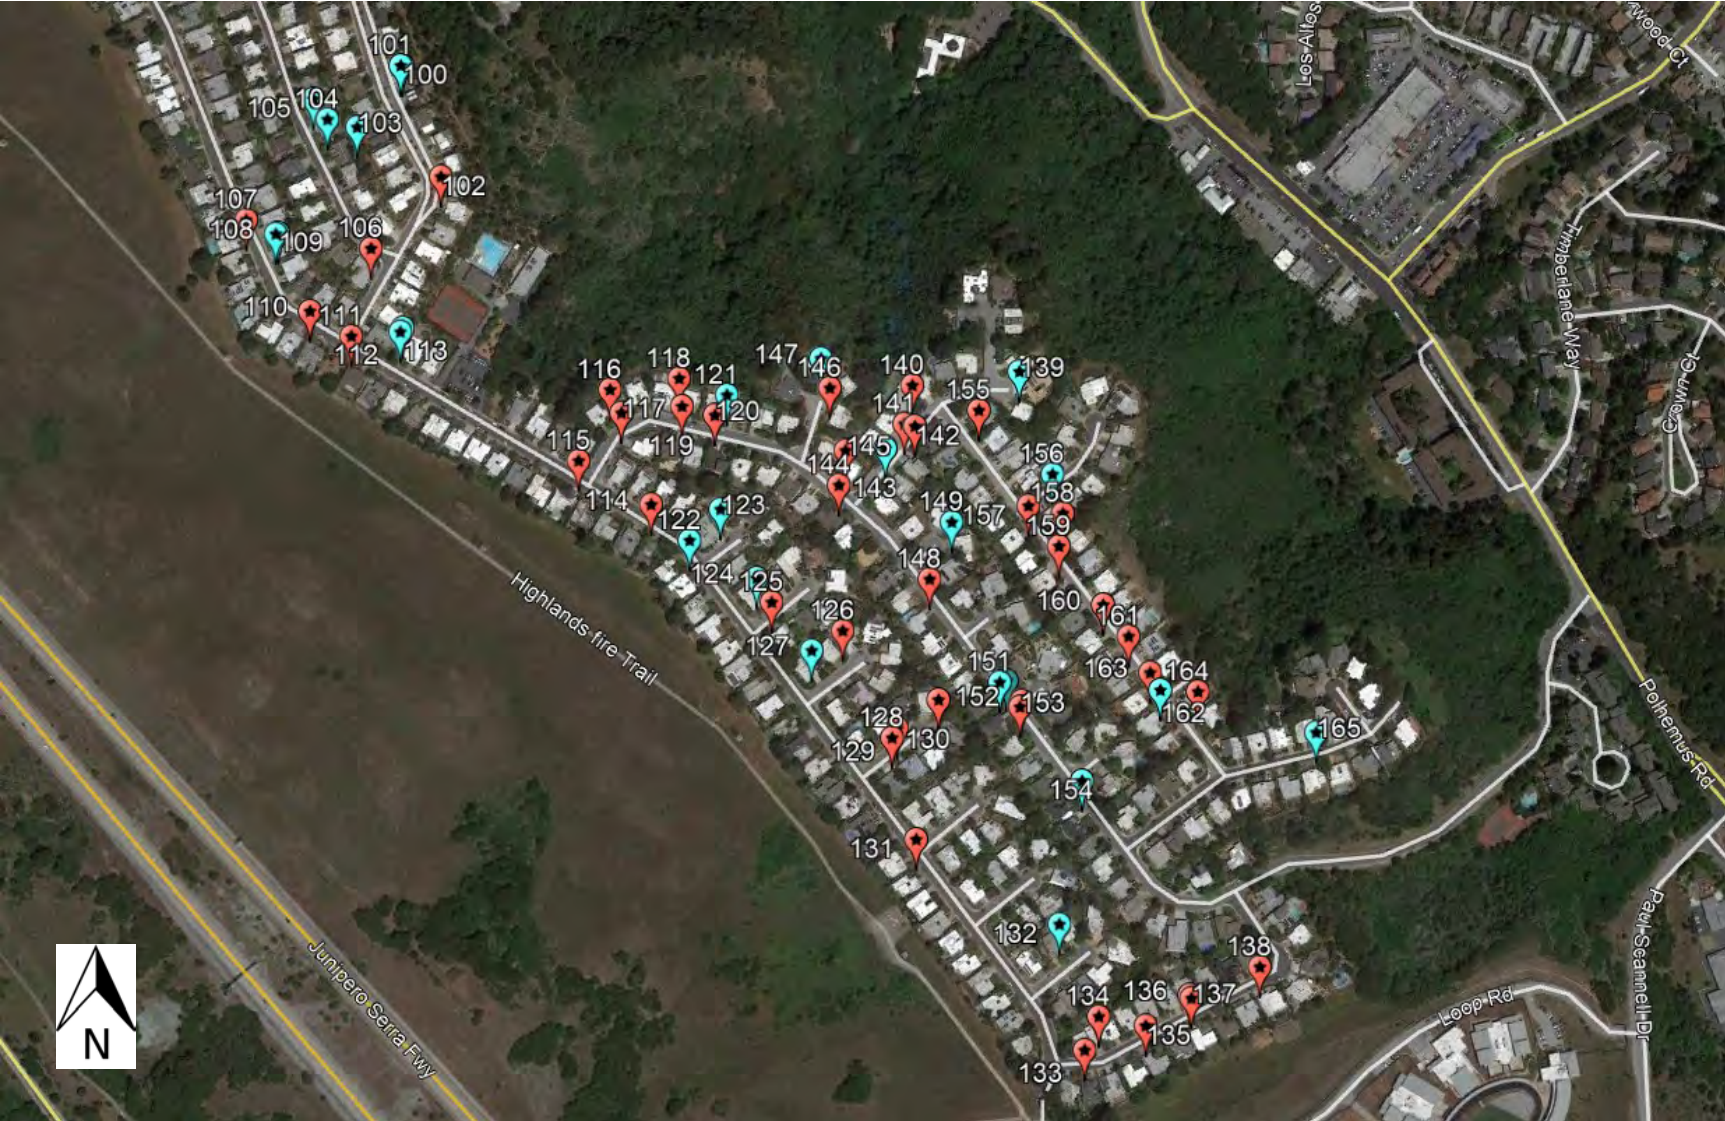
Figure 3: Basin CS-7 Area Defects
(Blue star: Smoke testing form pages 1 & 2 completed. Red star: Standard cleanout. Smoke testing form page 2 completed)

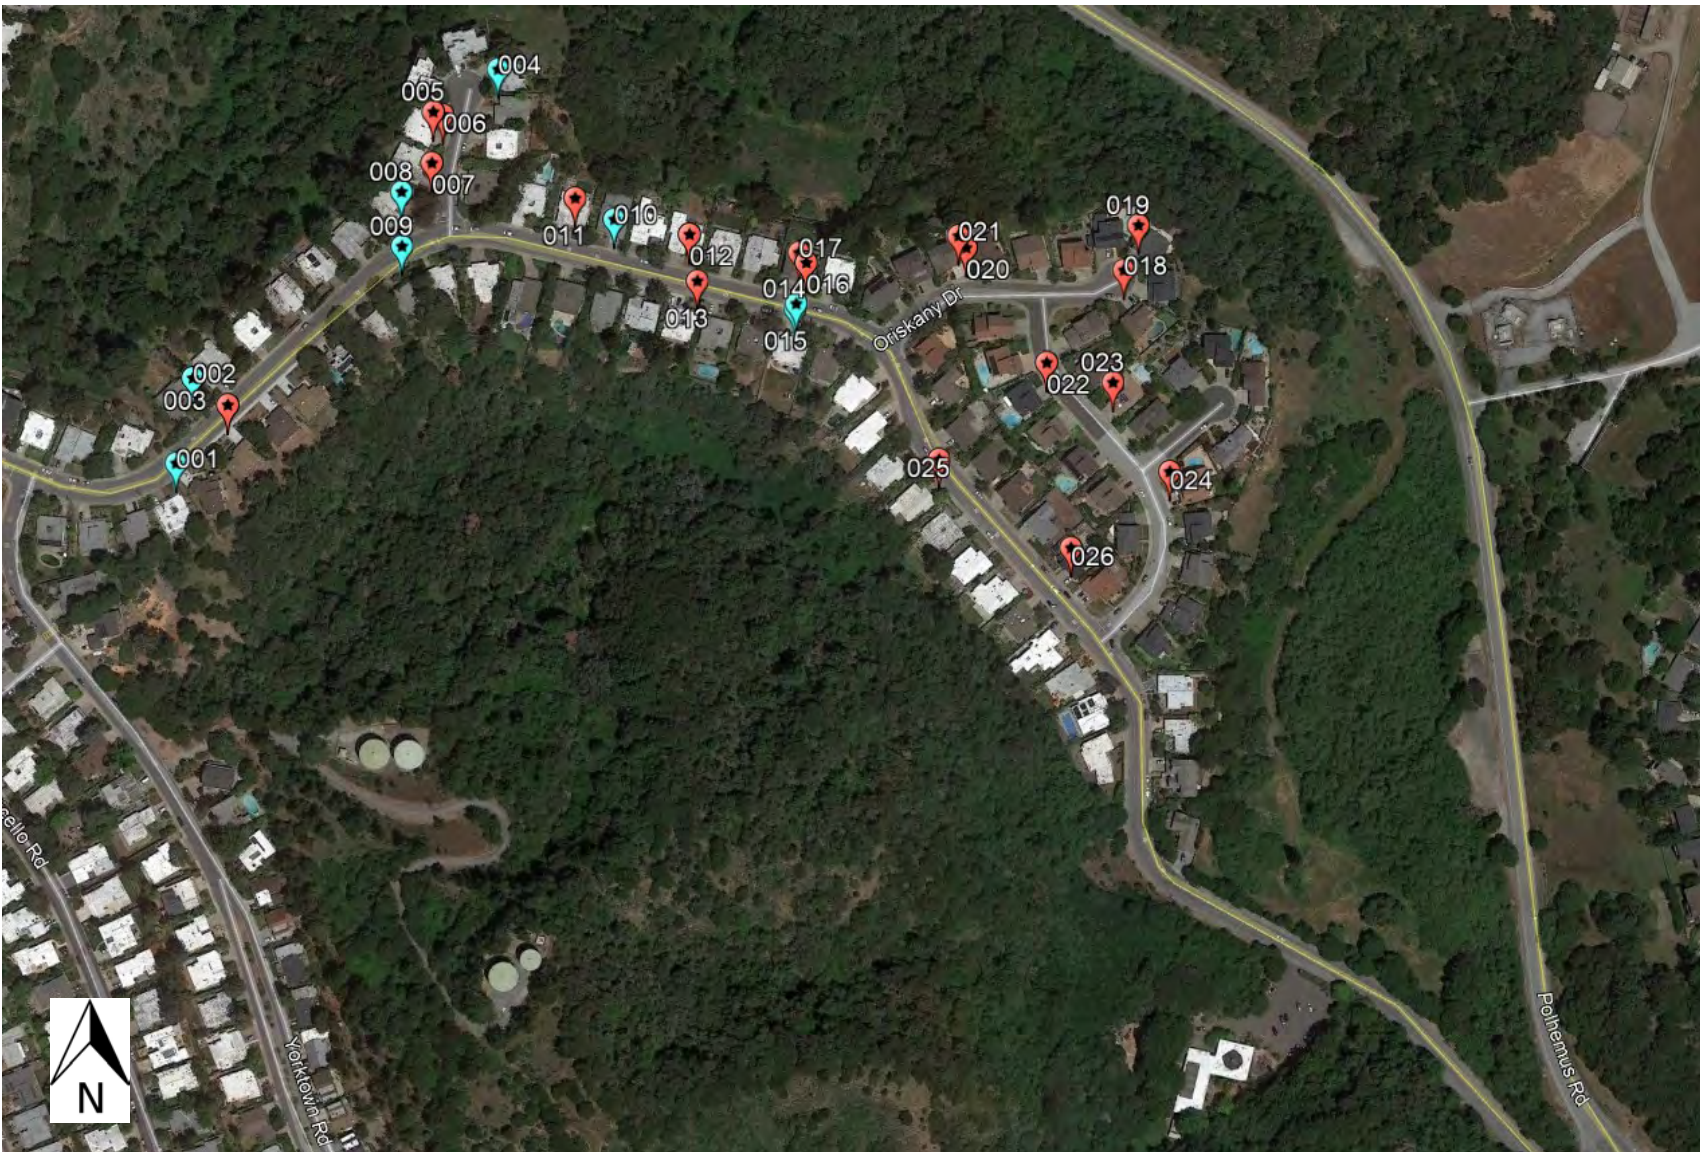
Figure 4: Basin CS-10 Area Defects
(Blue star: Smoke testing form pages 1 & 2 completed. Red star: Standard cleanout. Smoke testing form page 2 completed)

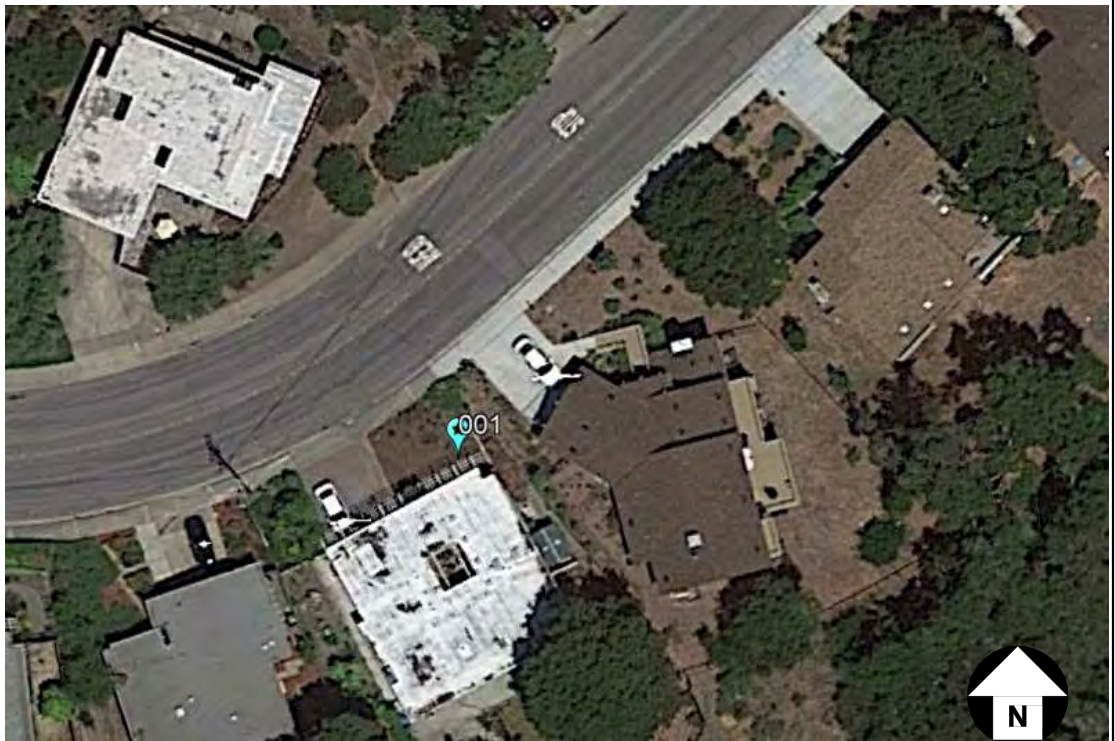
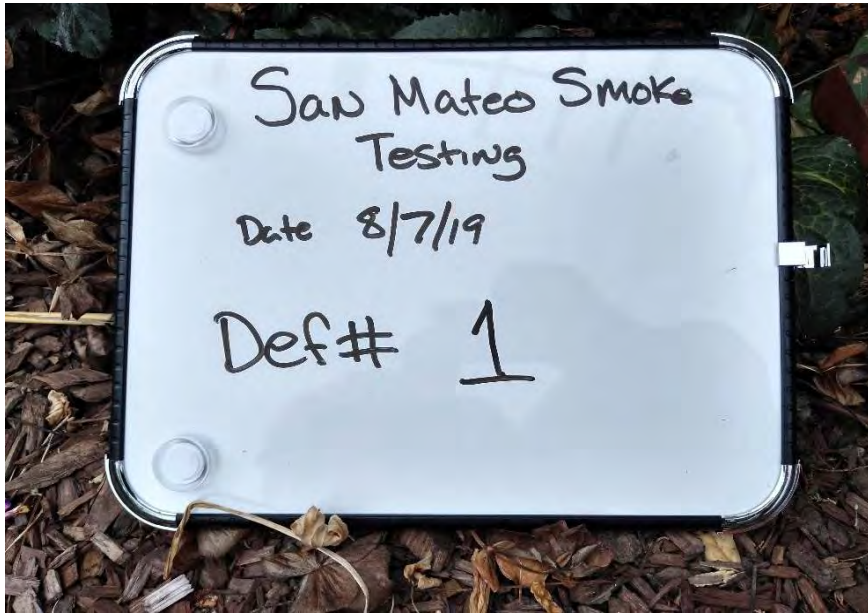
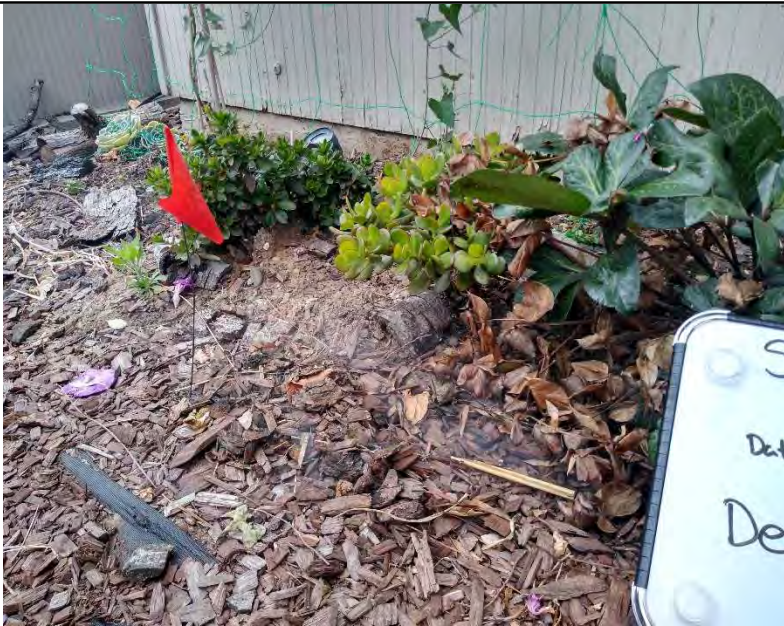
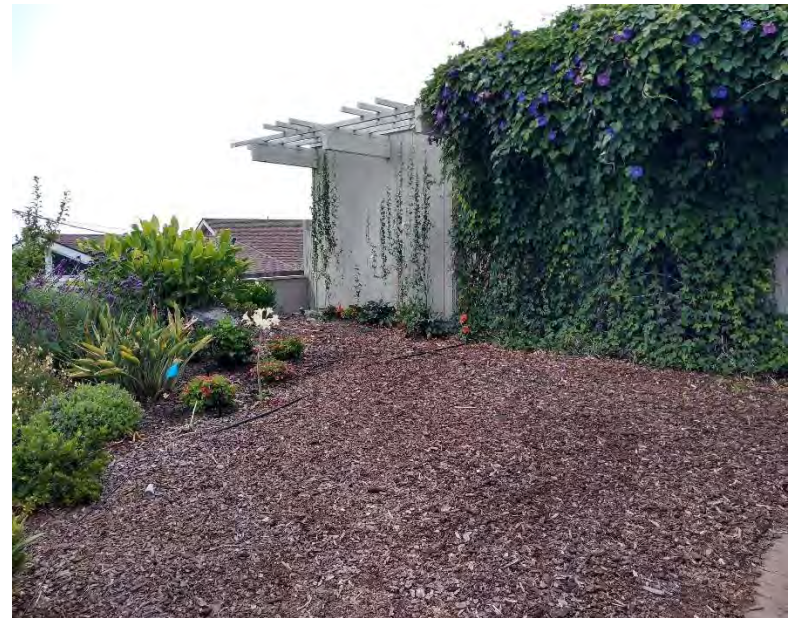
Project: San Mateo Smoke Testing 2019
Date: 8/7/2019
Defect: 001

Comments: May be lateral or burried cleanout

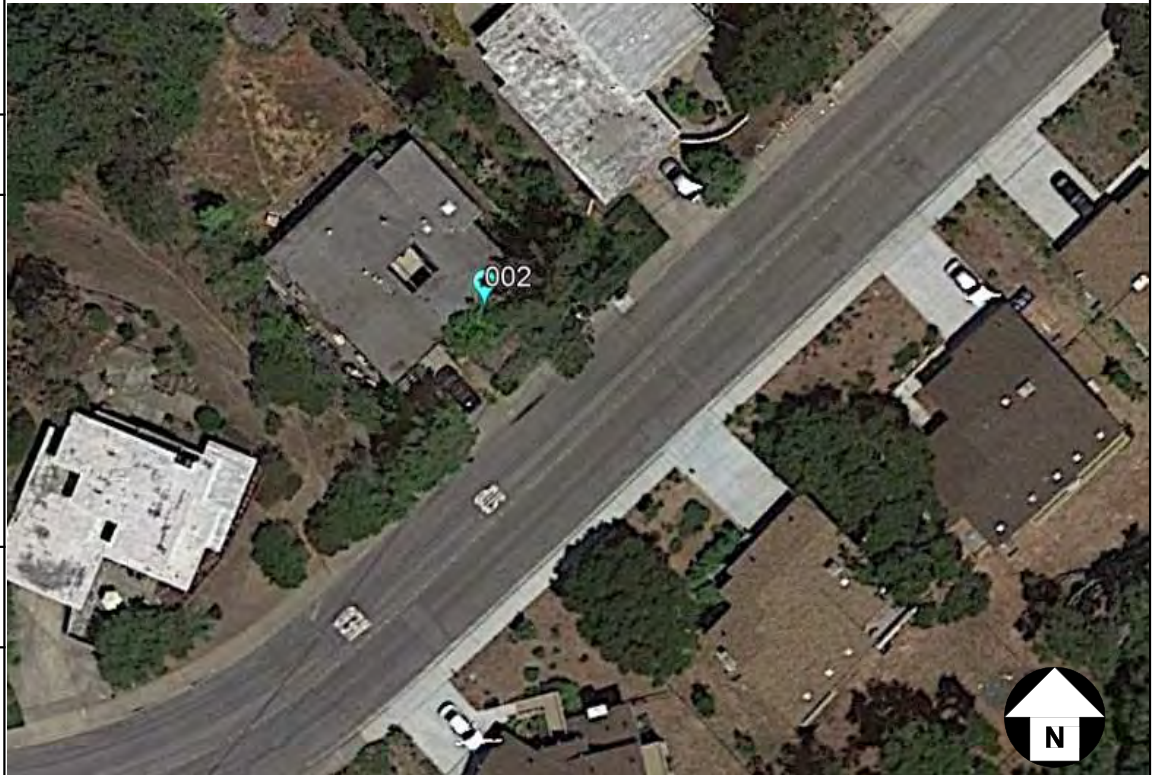
Project: San Mateo Smoke Testing 2019
Date: 8/7/2019
Defect: 002

Comments: Surcharge evidence. Cap removed

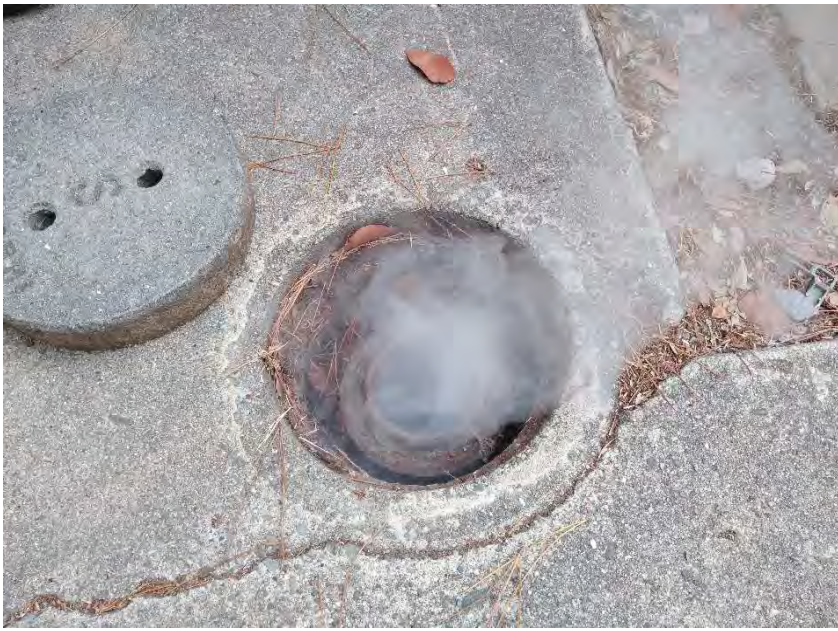
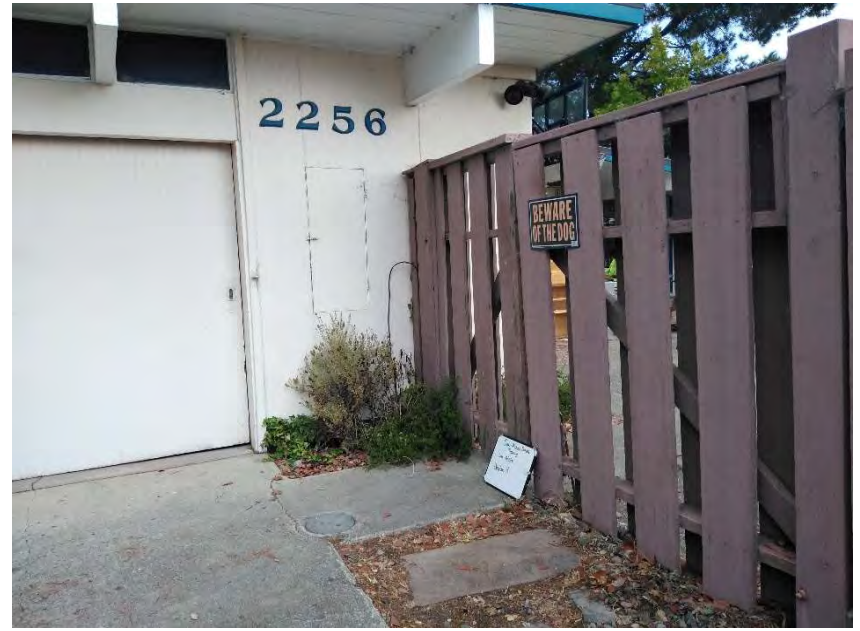
Project: San Mateo Smoke Testing 2019
Date: 8/7/2019
Defect: 008

Comments: No Cap

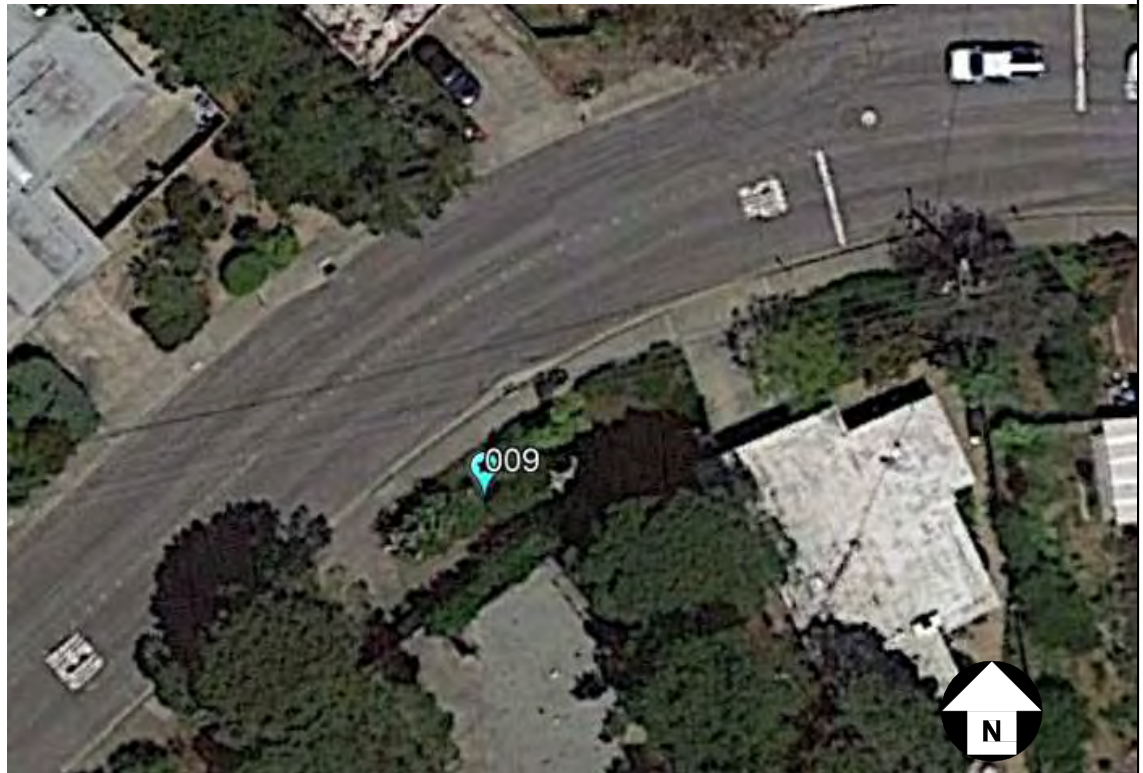
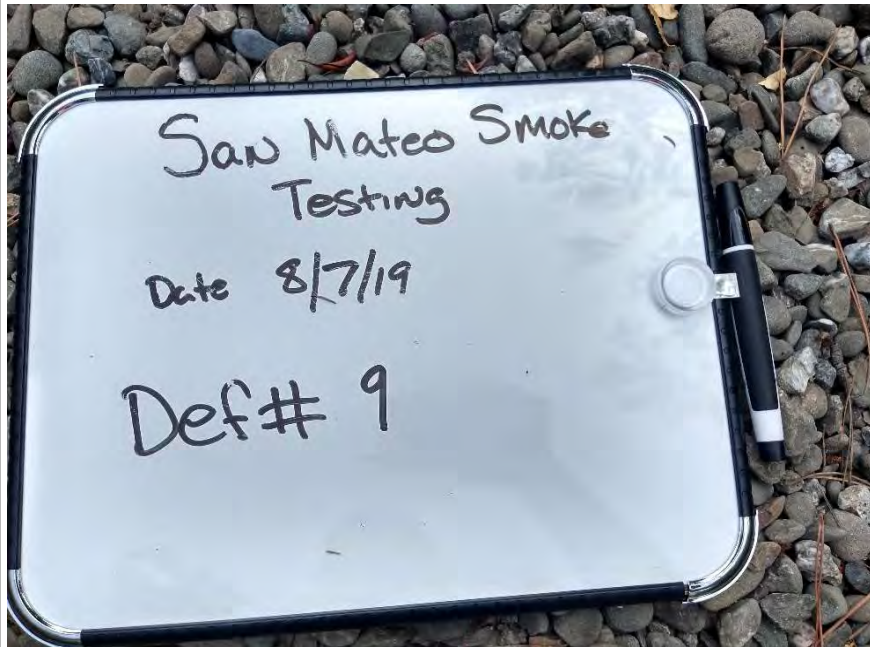
Project: San Mateo Smoke Testing 2019
Date: 8/7/2019
Defect: 009

Comments: Could be burried cleanout but could not locate

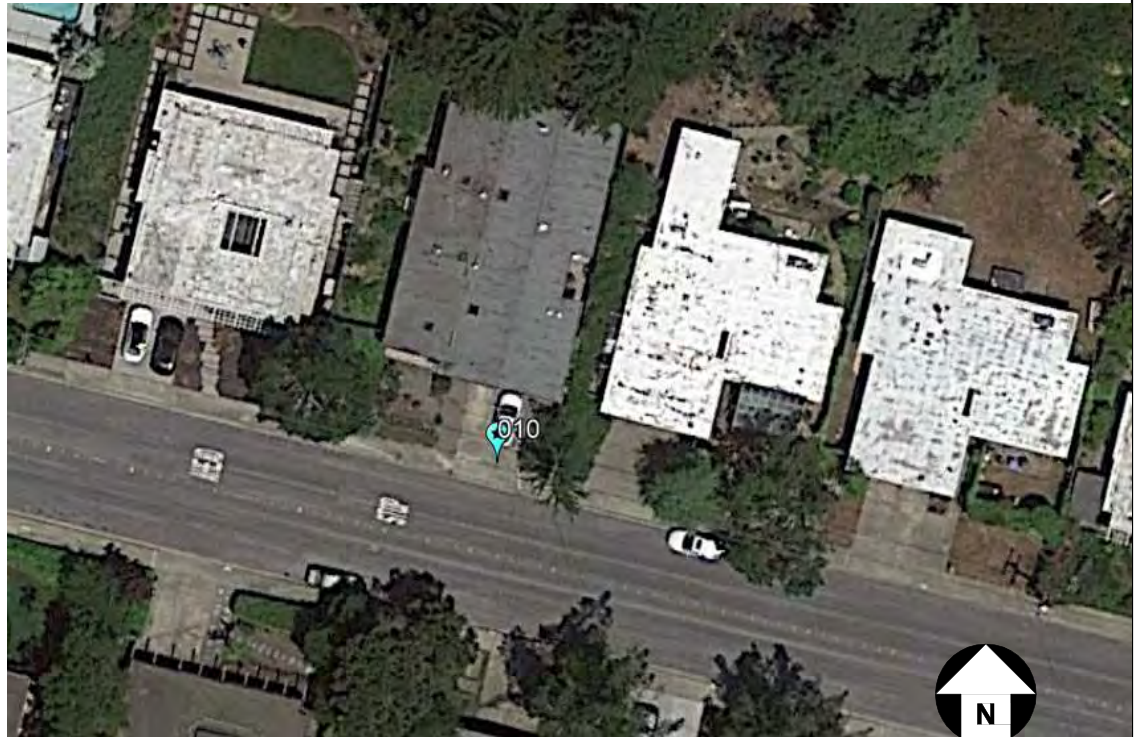
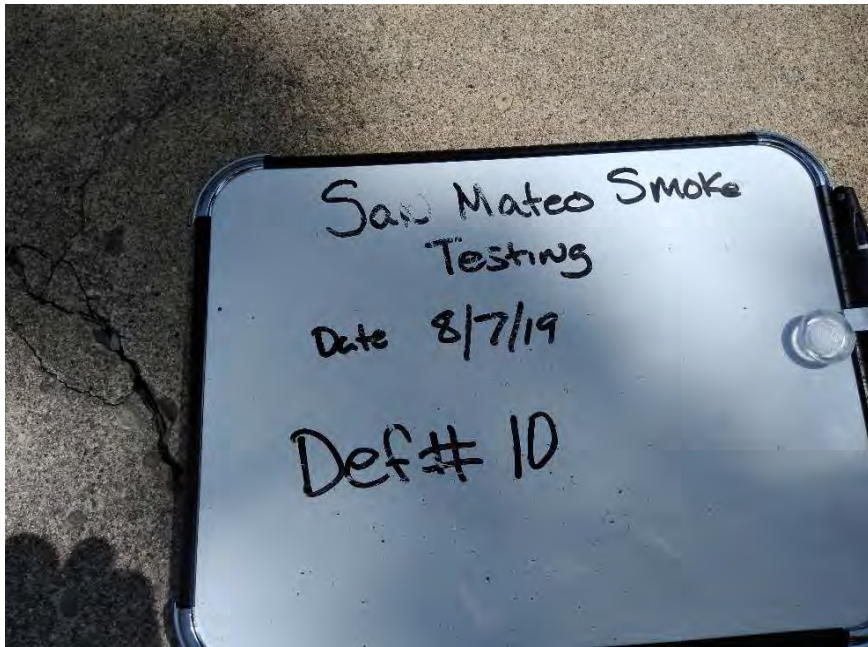
Defect #	Address/Location	Results	Status	Source Type	Smoke	Area		Run Off	Photo #
						FT	FT		
010	2240 Bunker Hill Dr	1	1	16	3	10'	6'	5

Comments: No cap

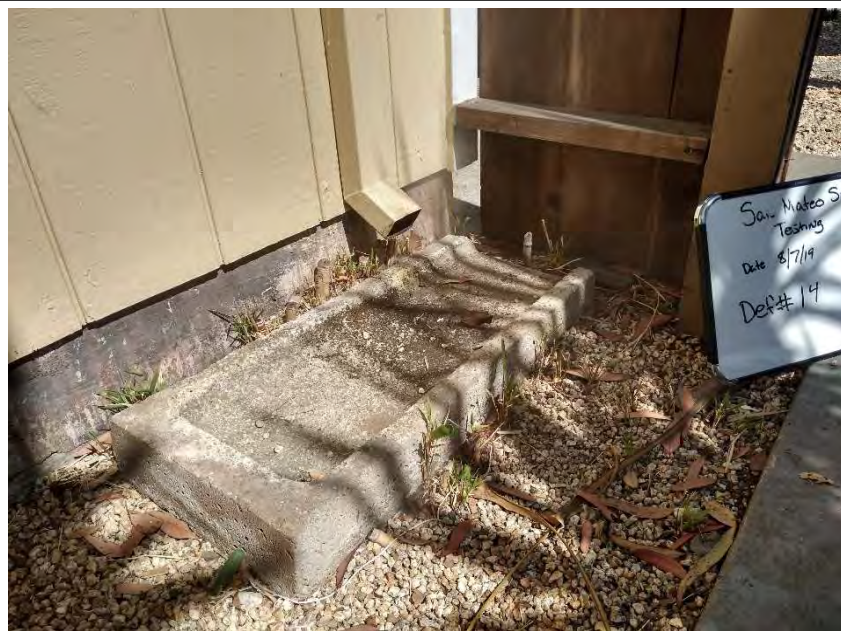
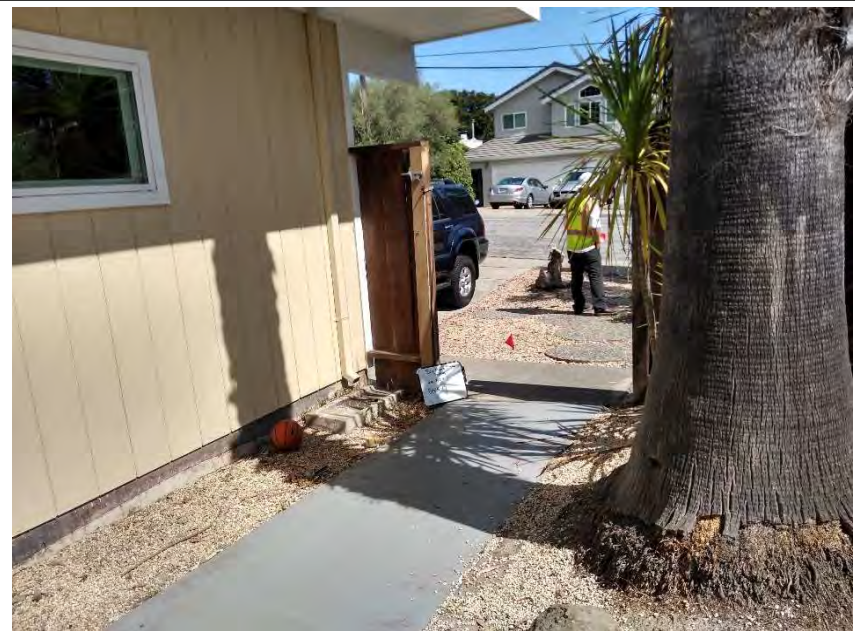
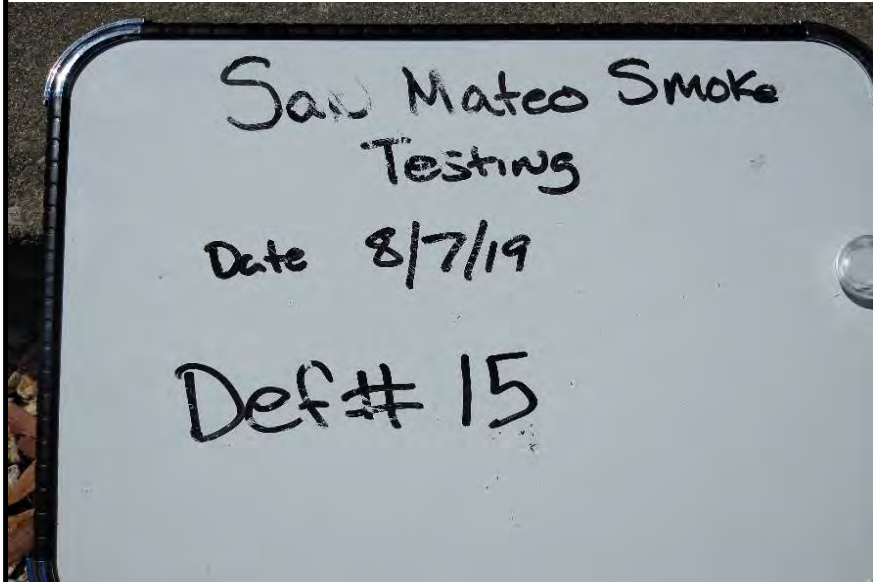
Project: San Mateo Smoke Testing 2019
Date: 8/7/2019
Defect: 014

Defect #	Address/Location	Results	Status	Source Type	Smoke	Area		Run Off	Photo #
						FT	FT		
014	2213 Bunker Hill Dr	1	1	1	2	8'	8'	3	
	Lat: 37.525247°								
	Long: -122.344722°								
015	2213 Bunker Hill Dr	1	1	1	2	7'	3'	5	
	Lat: 37.525272°								
	Long: -122.344714°

Comments: 014: Cracked lateral near downspout 015: Smoke coming from edge of concrete

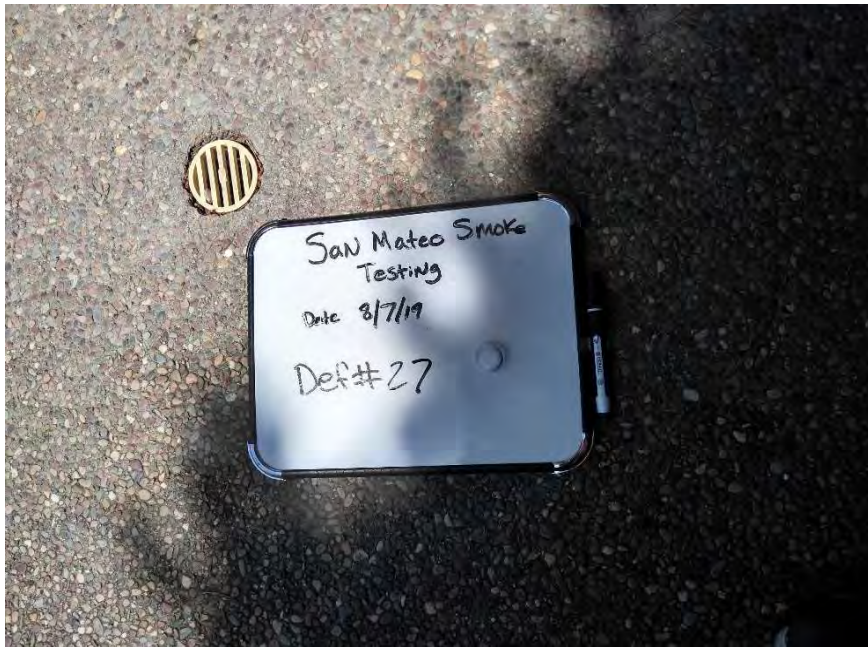
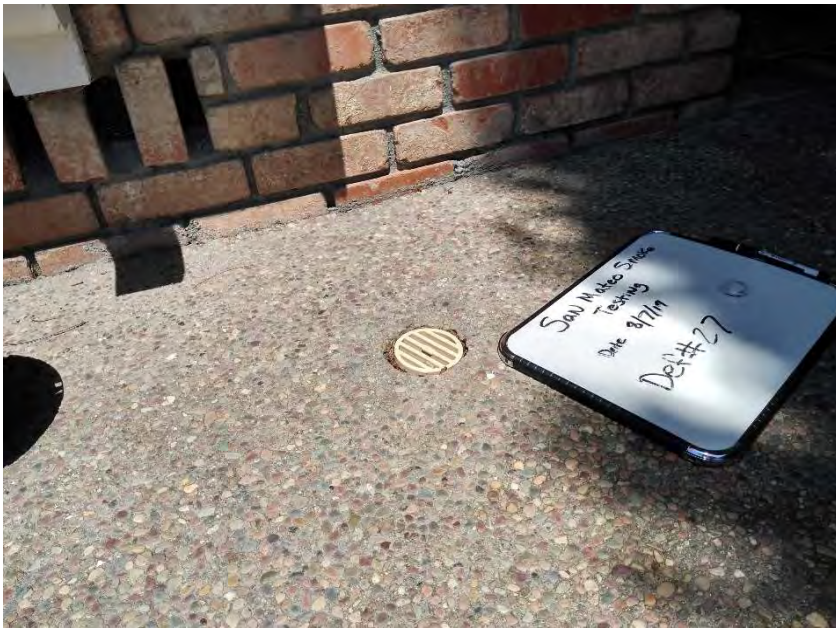
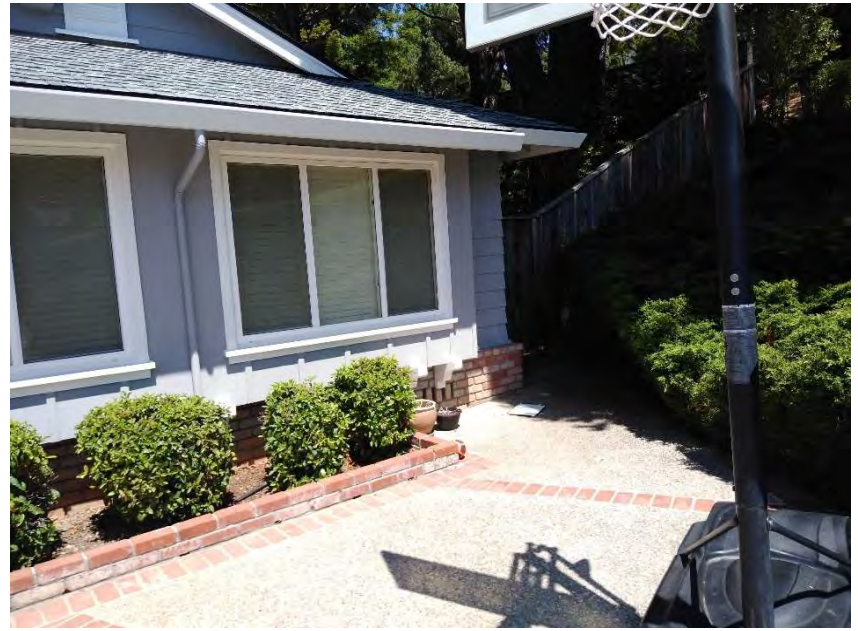
Project: San Mateo Smoke Testing 2019
Date: 8/7/2019
Defect: 027

Comments: Area drain not lowest point

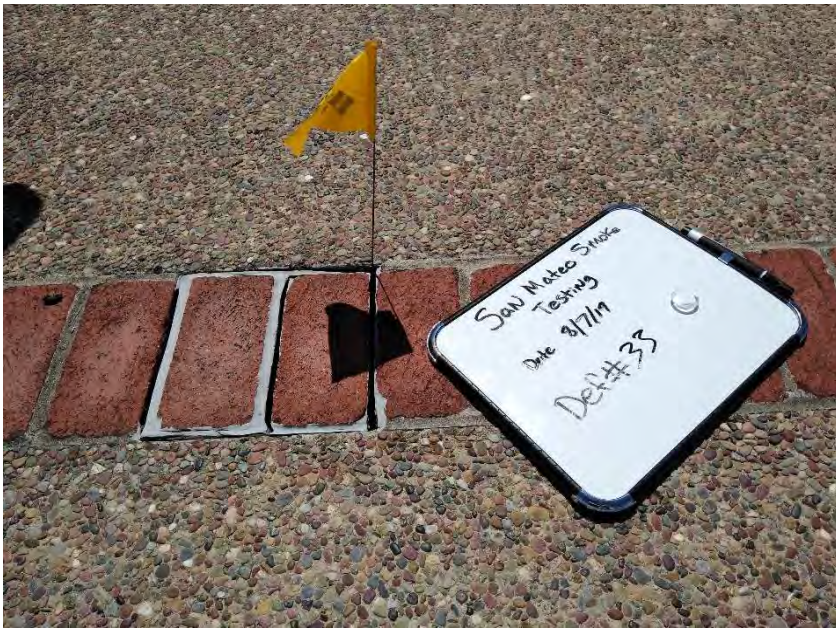
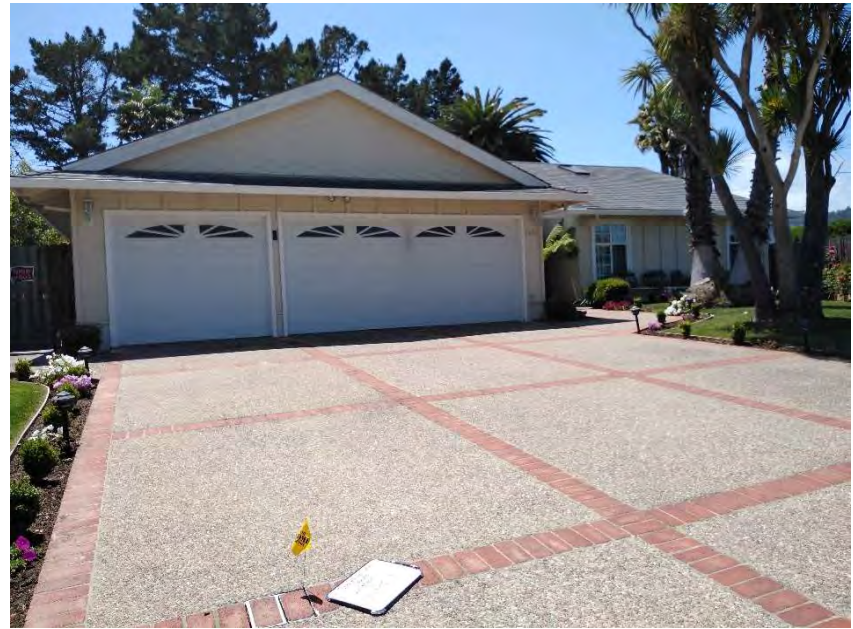
Project: San Mateo Smoke Testing 2019
Date: 8/7/2019
Defect: 033

Defect #	Address/Location	Results	Status	Source Type	Smoke	Area		Run Off	Photo #
						FT	FT		
033	1245 Laurel Hill Dr	1	1	16	1	3'	4'	5

Comments: Rusty/Deteriorated Cap
