MEMORANDUM

DATE: January 19, 2024
TO: Mark Chow, County of San Mateo
FROM: Ben Shick, PE
SUBJECT: Crystal Springs County Sanitation District – Pipe
and Manhole Assessment and Recommendations

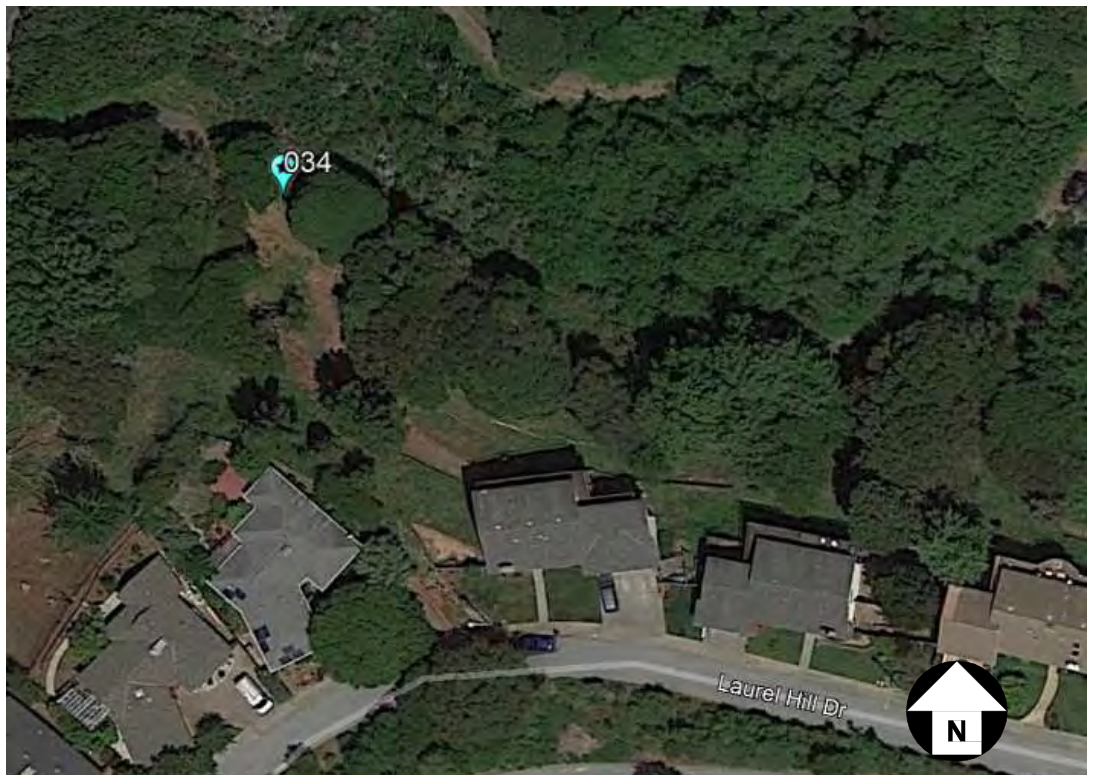
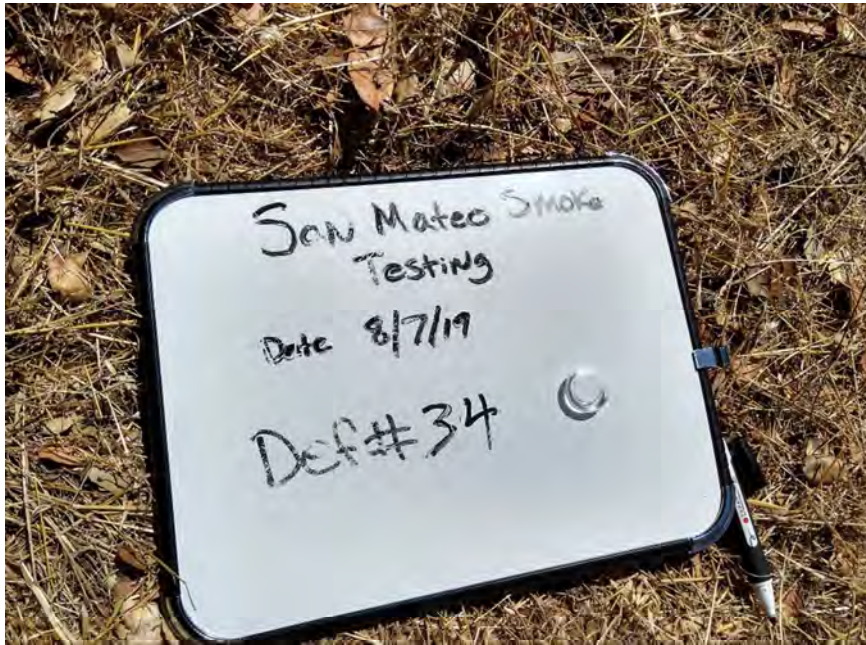
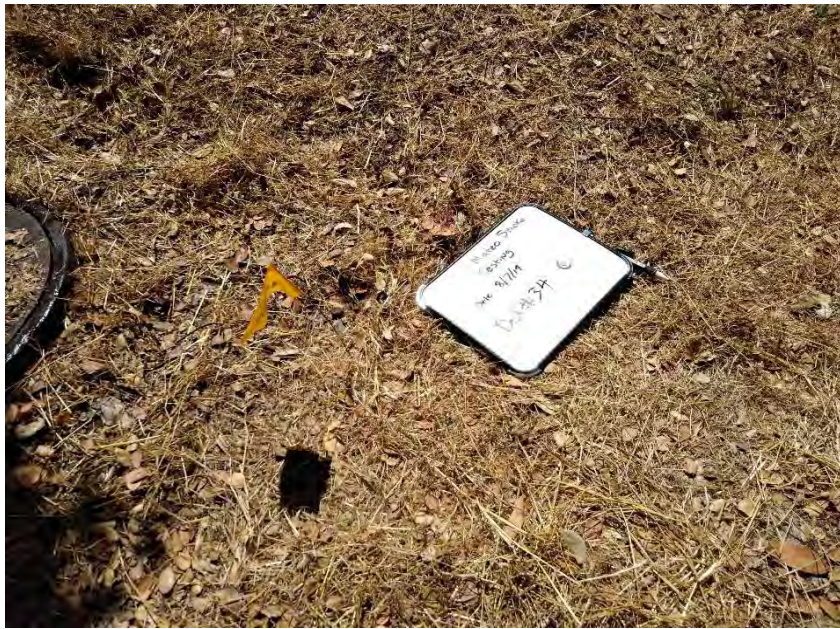
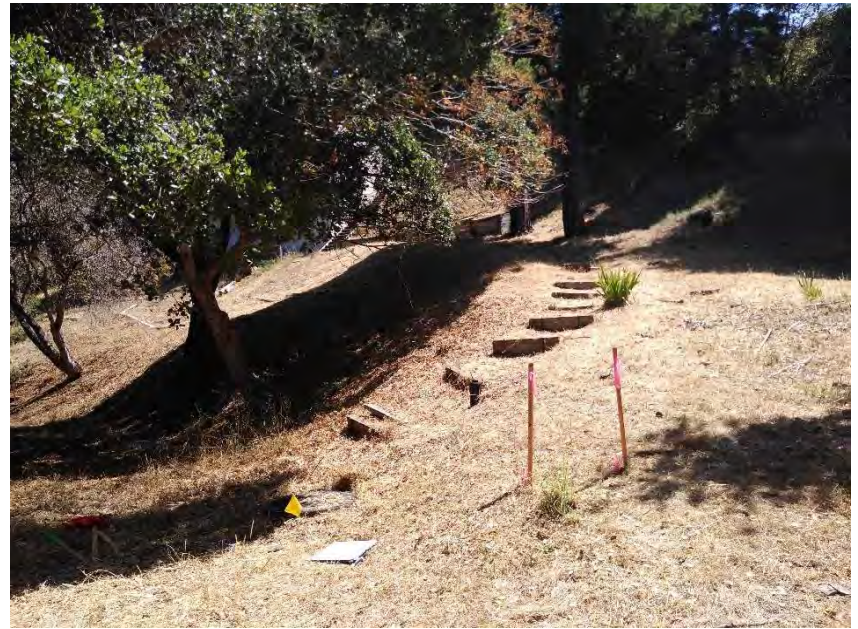
Project: San Mateo Smoke Testing 2019
Date: 8/7/2019
Defect: 034

Defect #	Address/Location	Results	Status	Source Type	Smoke	Area		Run Off	Photo #
						FT	FT		
034	1287 Laurel Hill Dr	1	1	14	1	3'	5'	1

Comments: Smoke coming from next to manhole lid

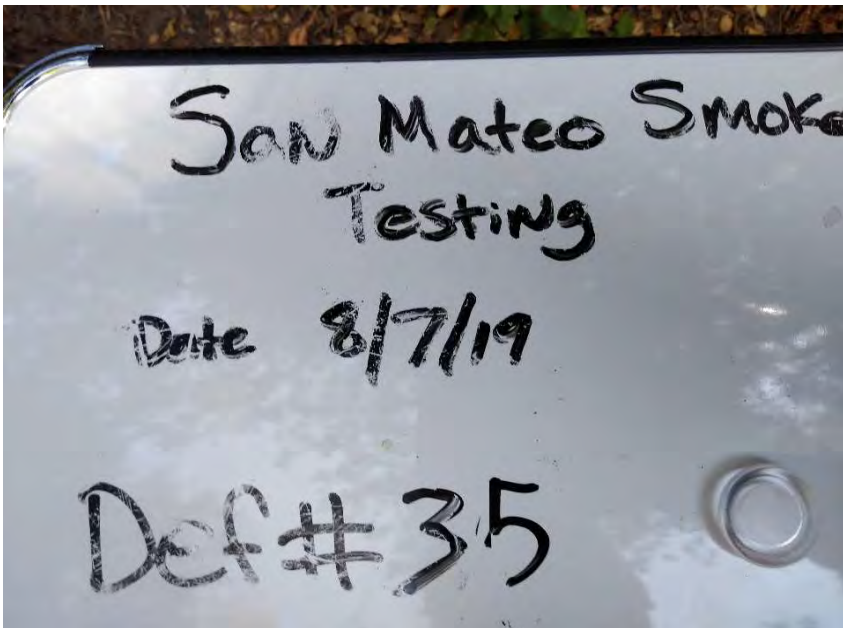
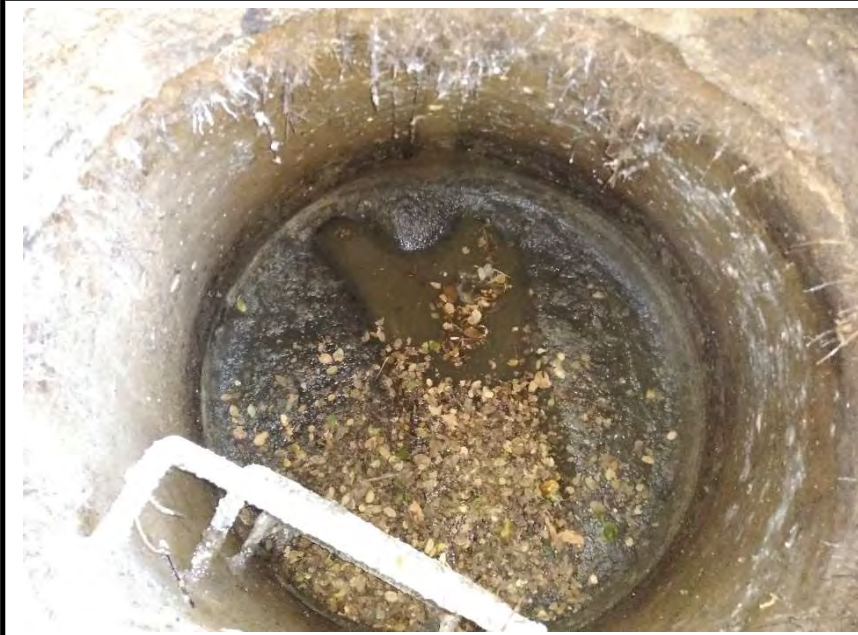
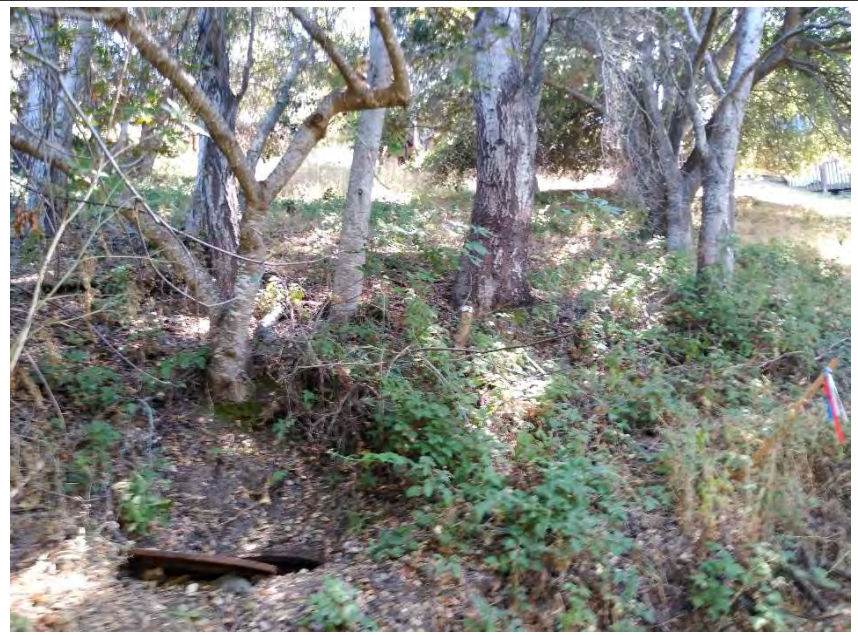
Project: San Mateo Smoke Testing 2019
Date: 8/7/2019
Defect: 035

Defect #	Address/Location	Results	Status	Source Type	Smoke	Area		Run Off	Photo #
						FT	FT		
035	1295 Laurel Hill Dr	2	2	14				1

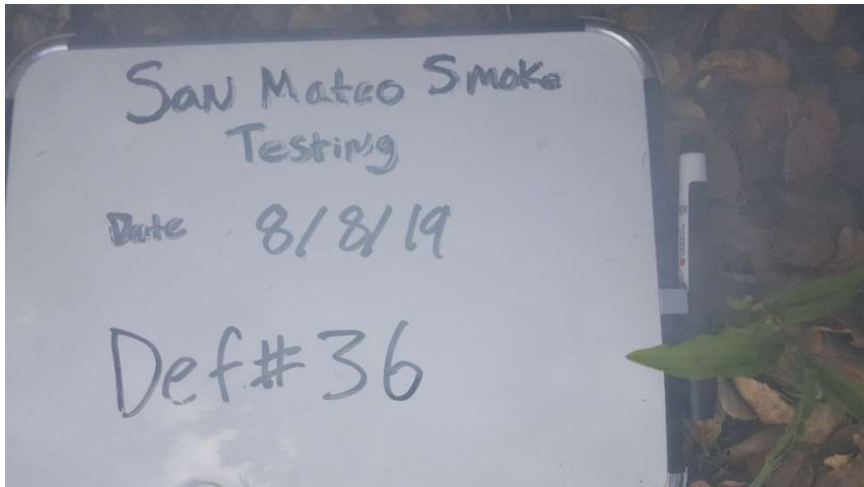
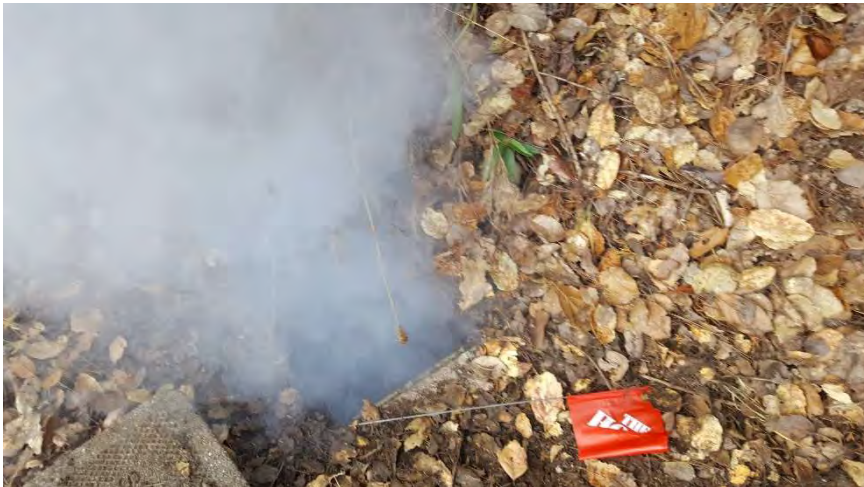
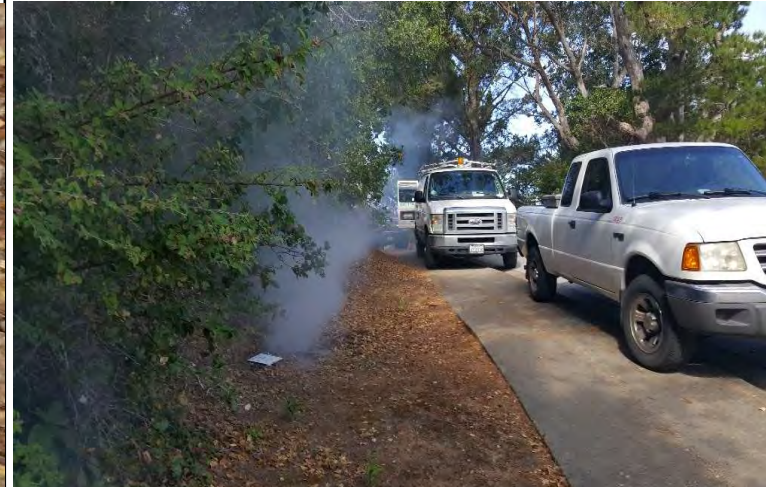
Project: San Mateo Smoke Testi
Date: 8/8/2019
Defect: 036

Defect #	Address/Location	Results	Status	Source Type	Smoke	Area		Run Off	Photo #
						FT	FT		
036	1415 Laurel Hill Dr	1	2	16	3	4'	10'	1

Comments: Missing cap; low spot; Backside of property

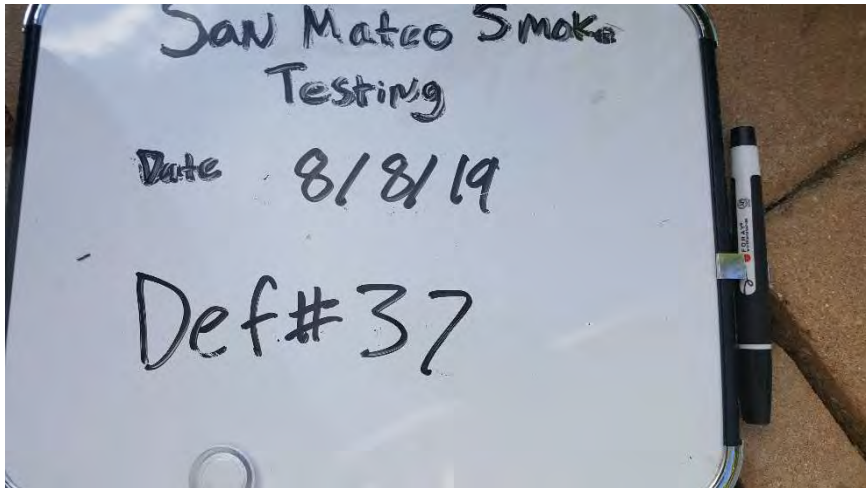
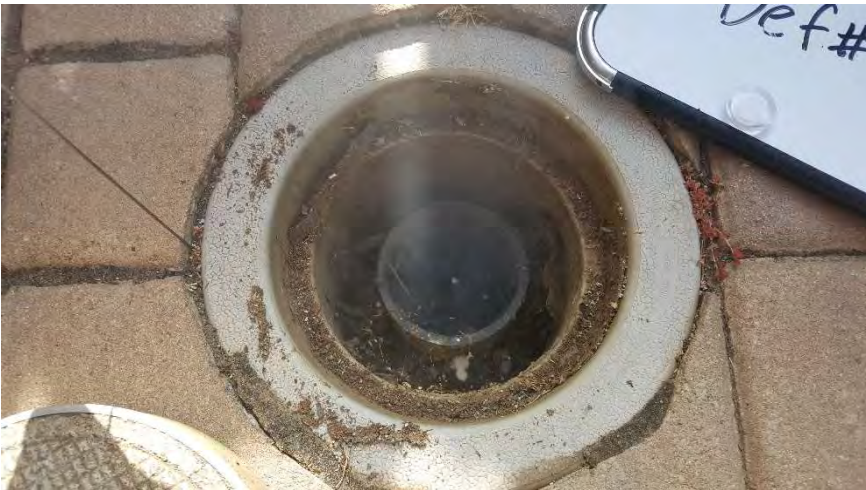
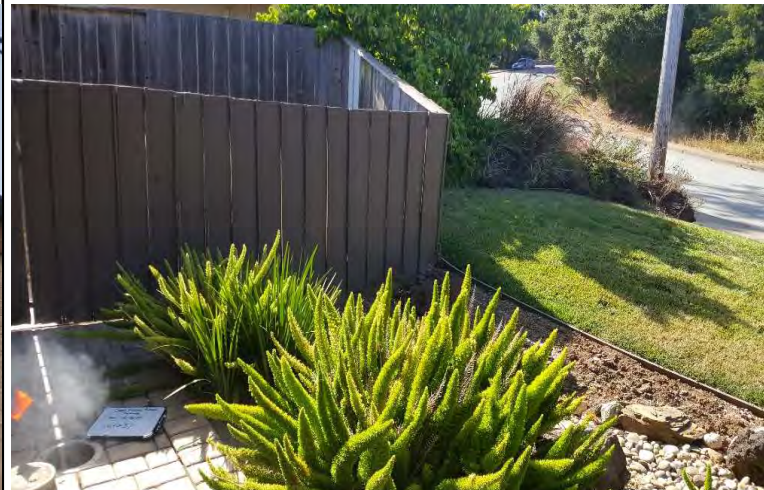
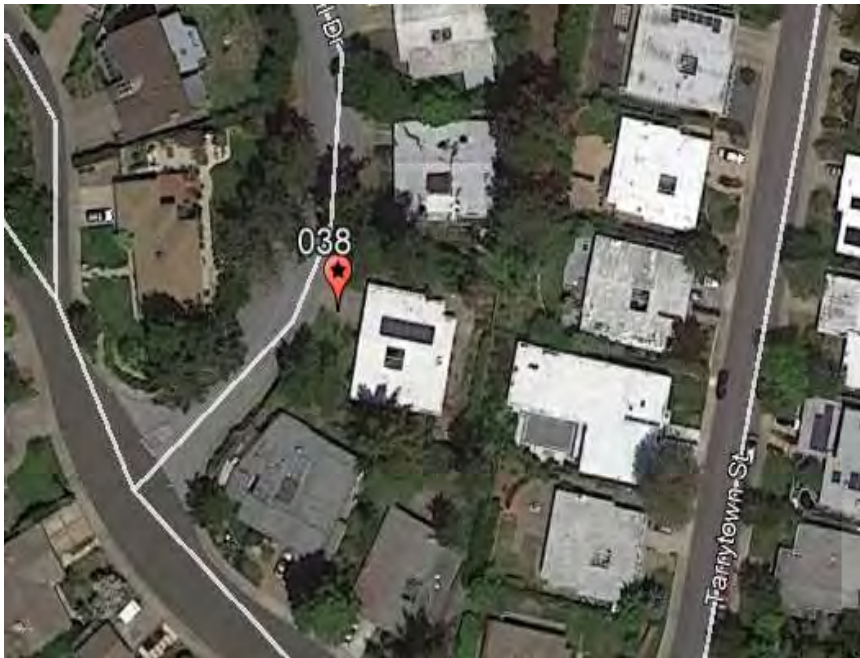
Project: San Mateo Smoke Testing 2019
Date: 8/8/2019
Defect: 037

Defect #	Address/Location	Results	Status	Source Type	Smoke	Area		Run Off	Photo #
						FT	FT		
037	1471 Laurel Hill Dr	1	1	16	3	3'	3'	5

Comments: Missing cap; low spot;

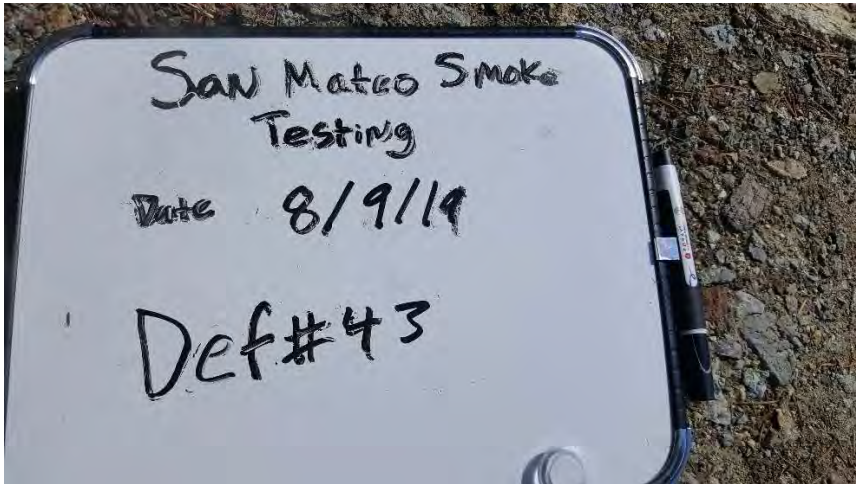
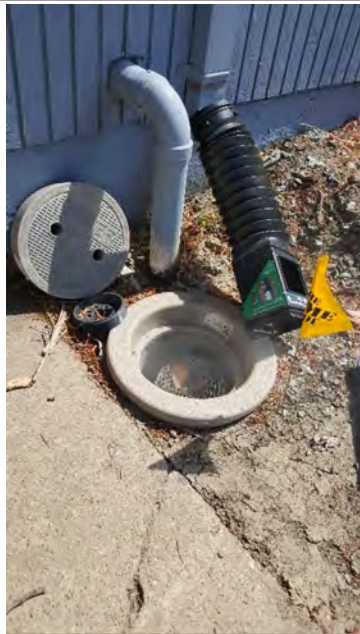
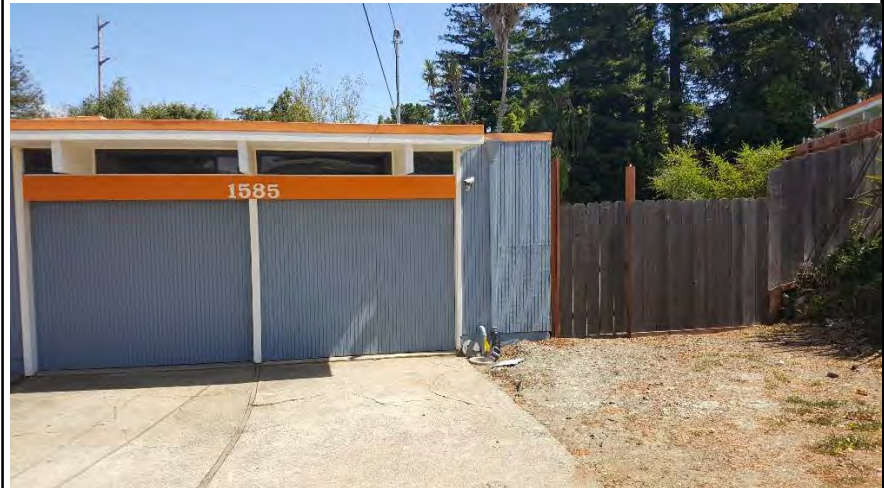
Project: San Mateo Smoke Testing 2019
Date: 8/8/2019
Defect: 043

Defect #	Address/Location	Results	Status	Source Type	Smoke	Area		Run Off	Photo #
						FT	FT		
043	1585 Lexington Ave	1	1	16/7	2	12'	12'	3

Comments: Downspout draining into cleanout.

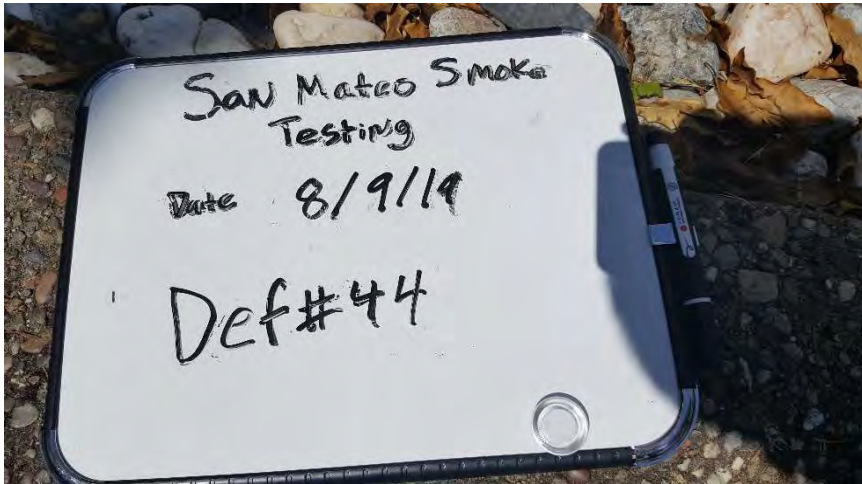
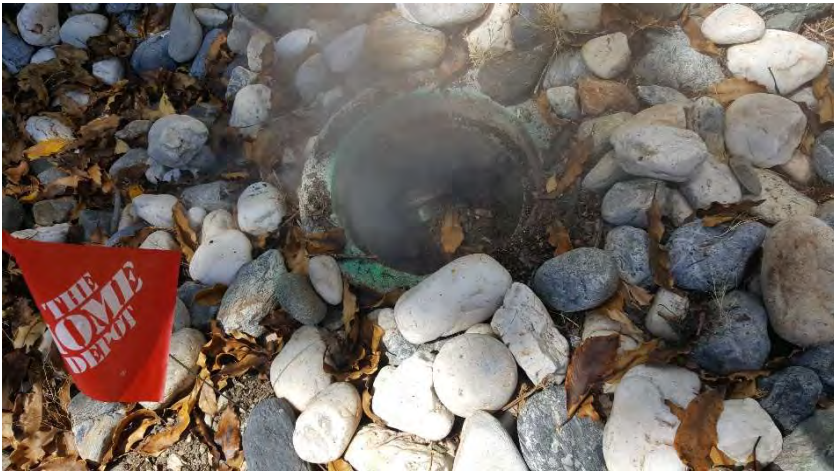
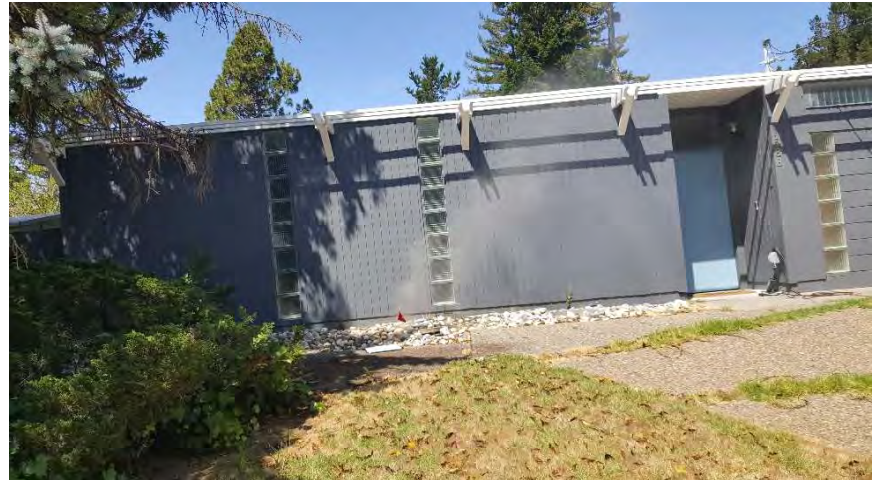
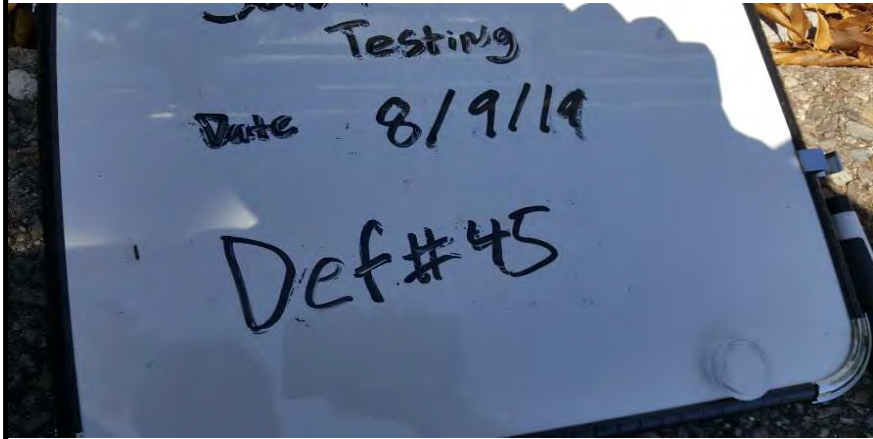
Project: San Mateo Smoke Testing 2019
Date: 8/8/2019
Defect: 044

Defect #	Address/Location	Results	Status	Source Type	Smoke	Area		Run Off	Photo #
						FT	FT		
044	1588 Tarrytown St	1	1	16	3	4"	4"	2	
	Lat: 37.525870°								
	Long: -122.353137°								
045	1588 Tarrytown St	1	2	1	2	5'	3'	2	
	Lat: 37.525860°								
	Long: -122.353135°

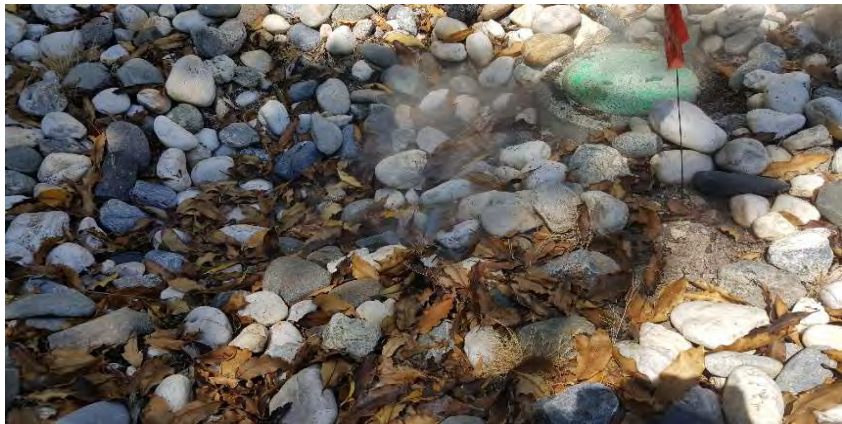
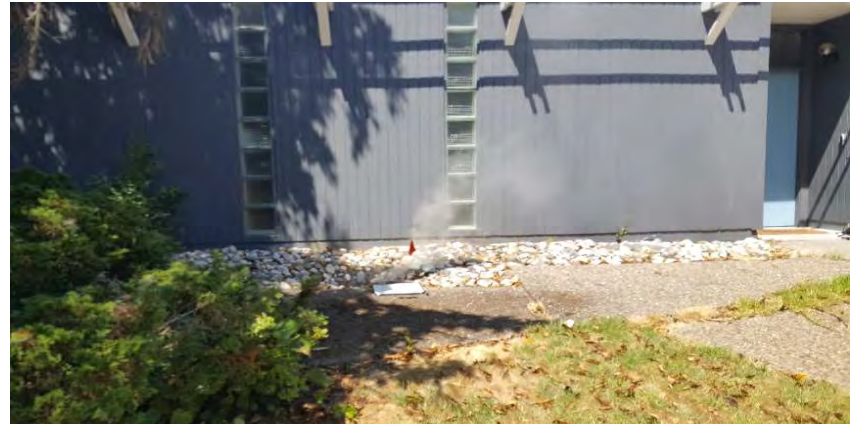
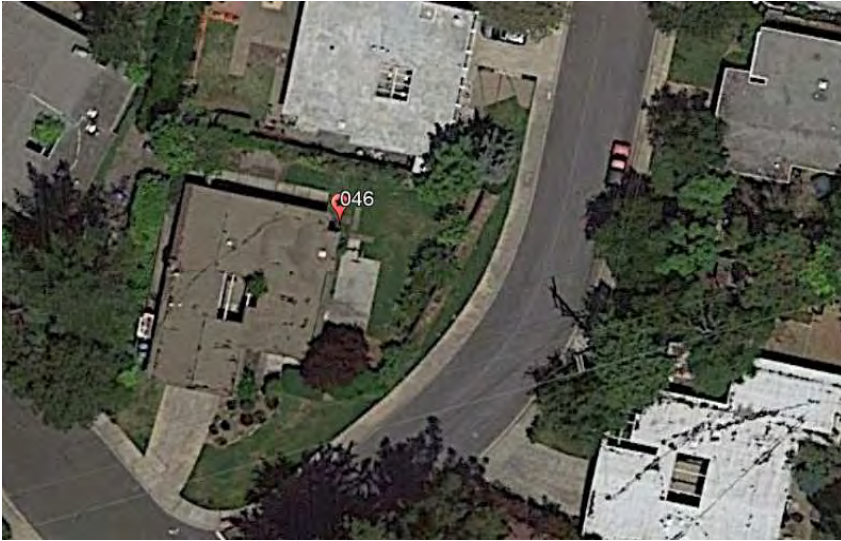
Project: San Mateo Smoke Testing 2019
Date: 8/8/2019
Defect: 045

045: May have cracked lateral or the cleanout is just off the

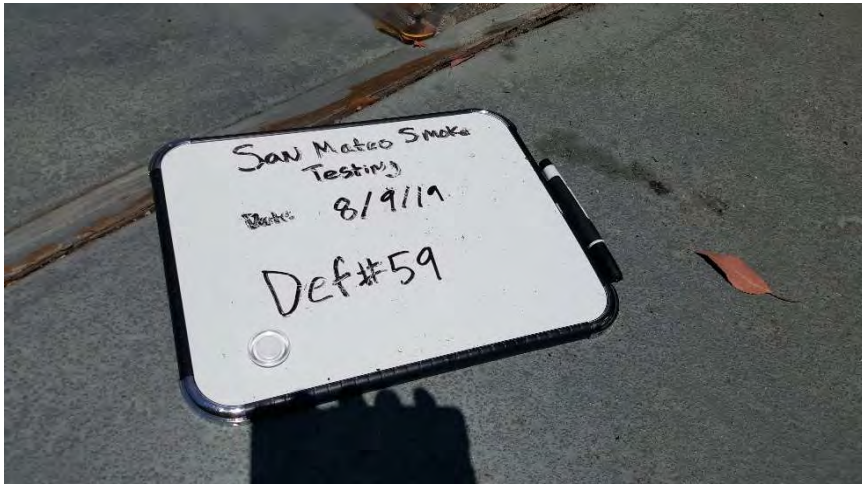
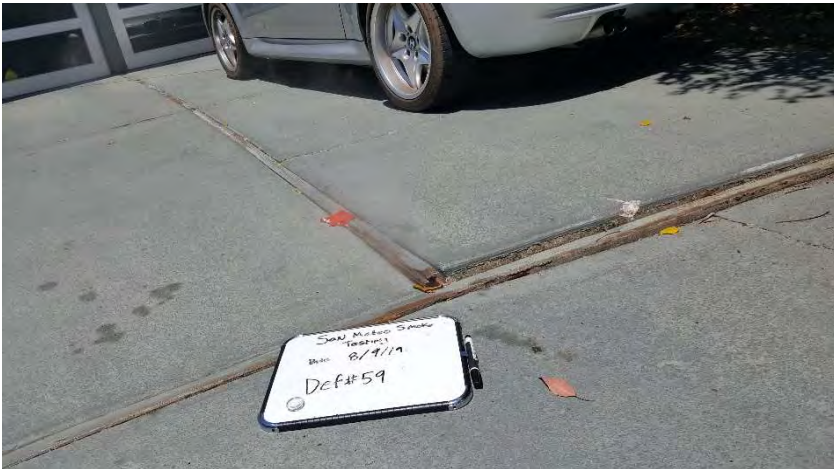
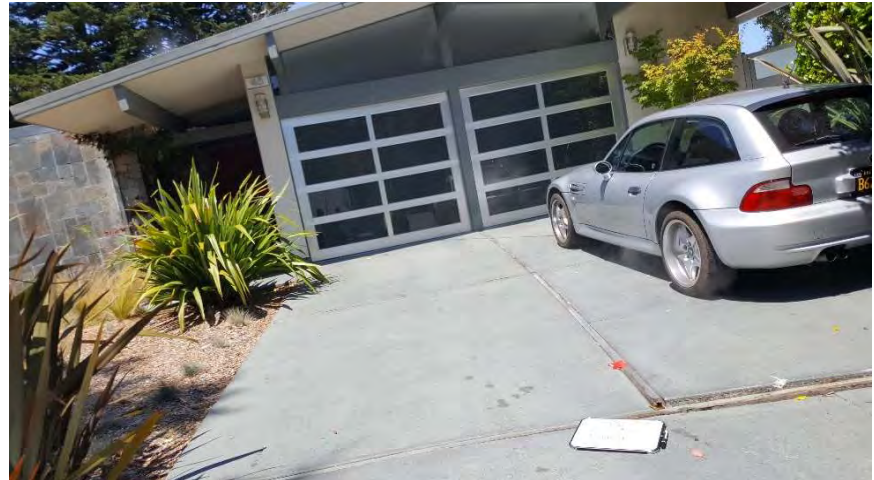
Project: San Mateo Smoke Testing 2019
Date: 8/8/2019
Defect: 059

Comments: 059: Smoke coming from concrete joints in driveway. Water should drain into crack
 060: Smoke coming from edge of concrete and dirt. Water should drain into this edge

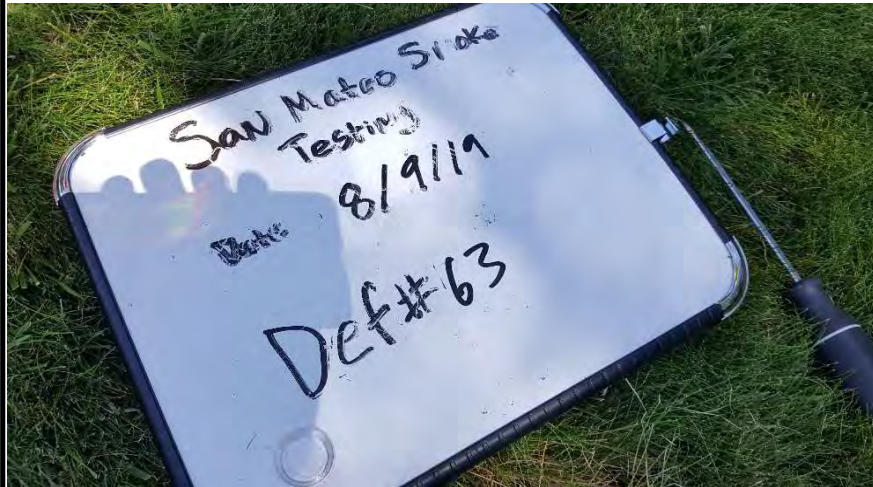
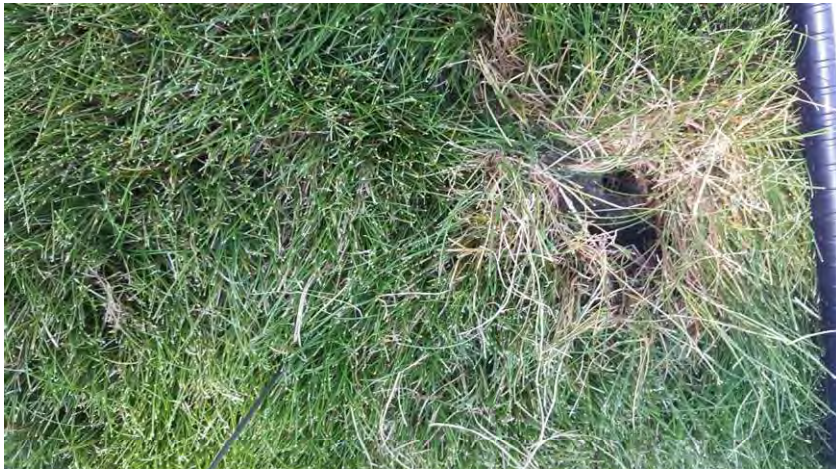
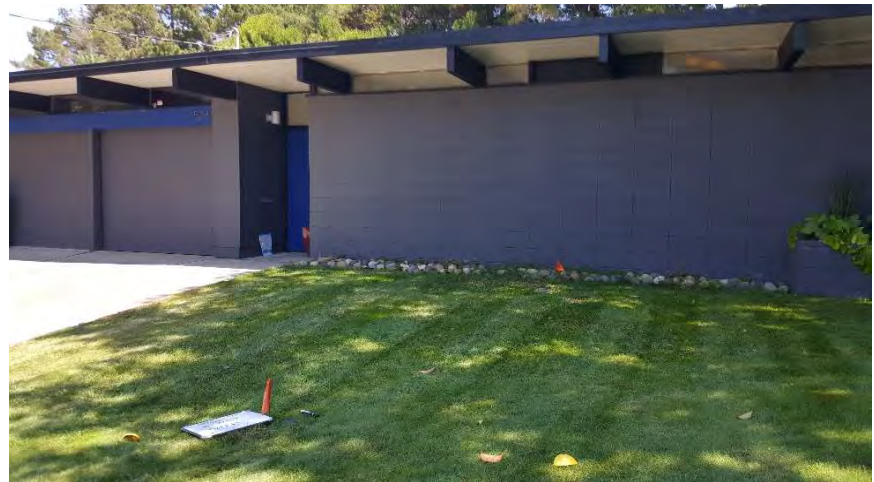
Project: San Mateo Smoke Testing 2019
Date: 8/8/2019
Defect: 063

Comments: 063: Could not open. A low area. 064: No cap

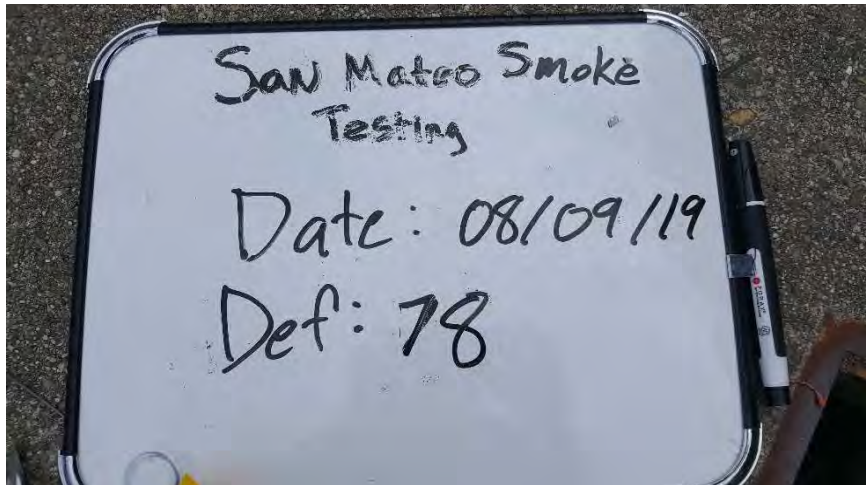
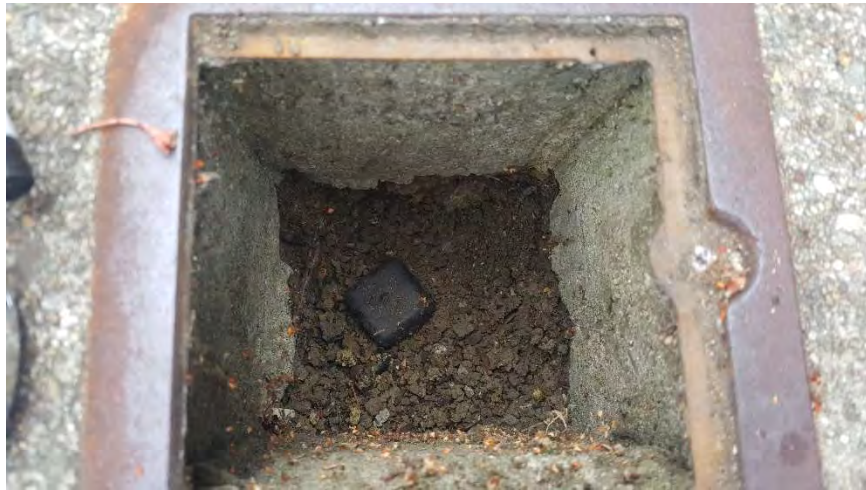
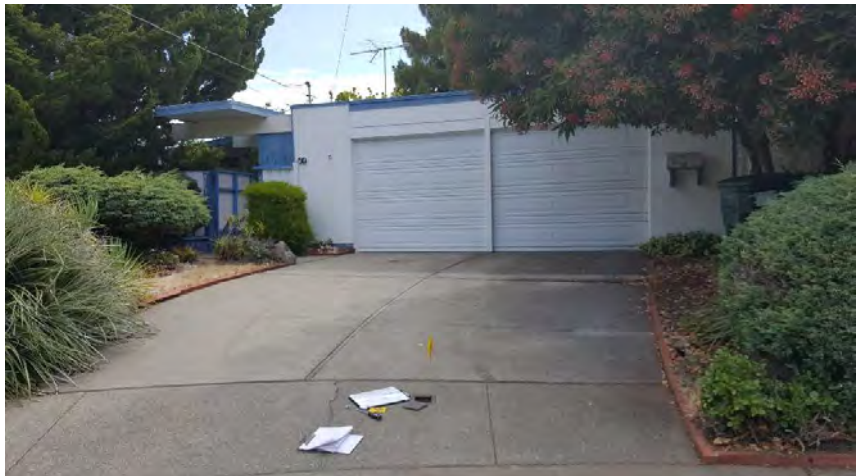
Project: San Mateo Smoke Testing 2019
Date: 8/9/2019
Defect: 078

Defect #	Address/Location	Results	Status	Source Type	Smoke	Area		Run Off	Photo #
						FT	FT		
078	50 Trenton Pl	1	1	16	1	6'	10'	5

Comments: Water flows over and will drain into cleanout

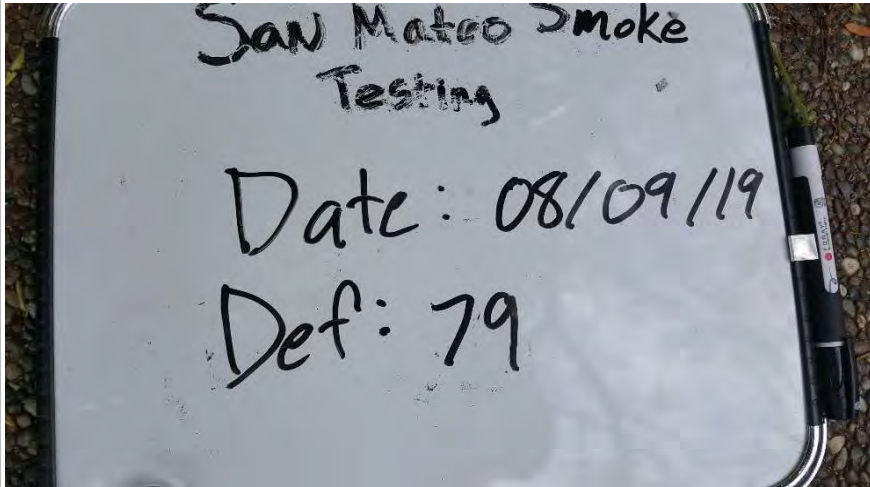
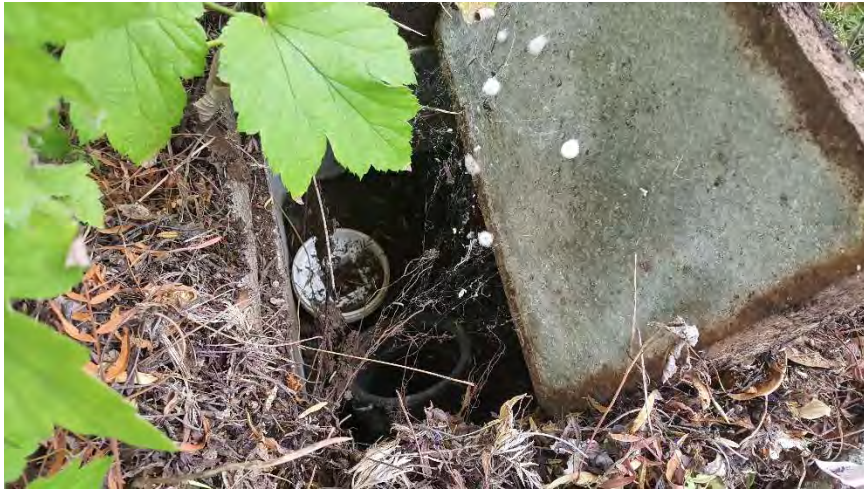
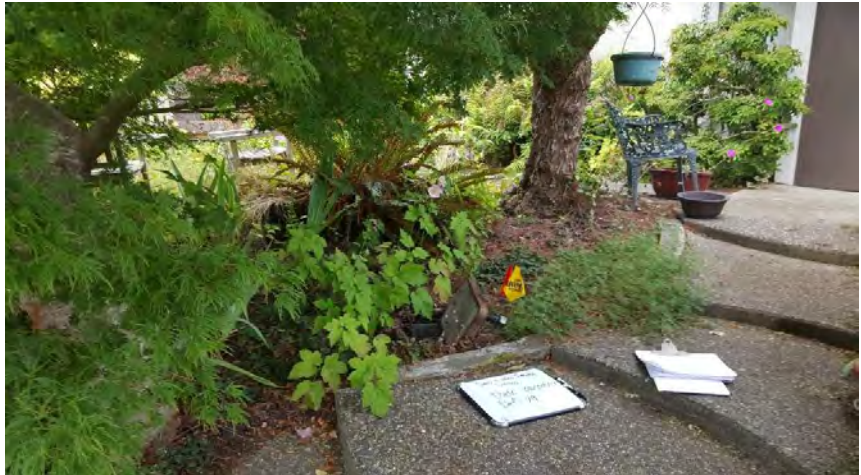
Project: San Mateo Smoke Testing 2019
Date: 8/9/2019
Defect: 079

Defect #	Address/Location	Results	Status	Source Type	Smoke	Area		Run Off	Photo #
						FT	FT		
079	35 Trenton Pl	1	1	16	1	4'	4'	2

Comments: Cap off. Low point could drain into cleanout

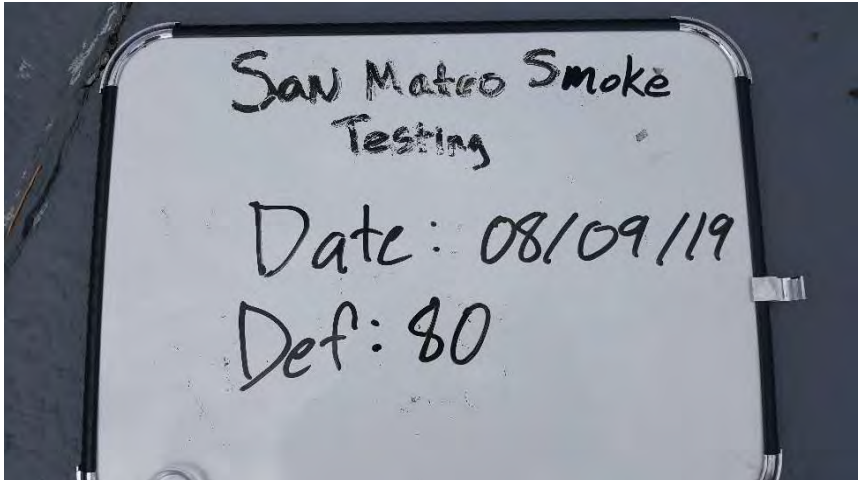
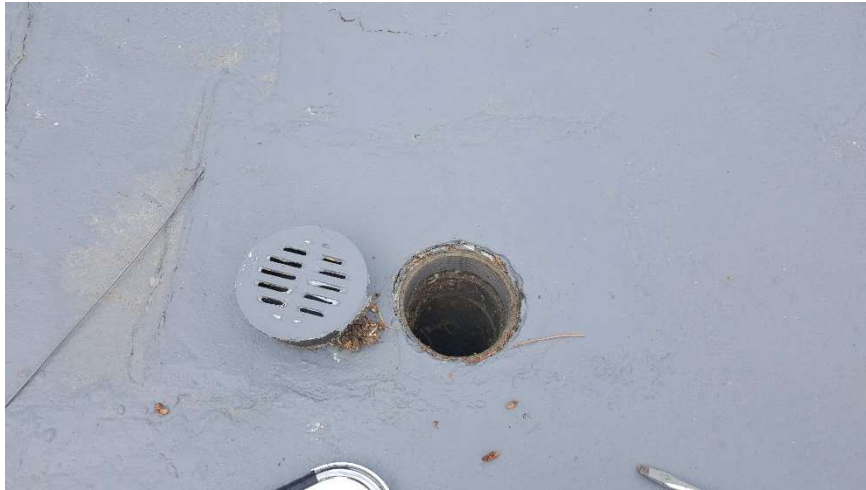
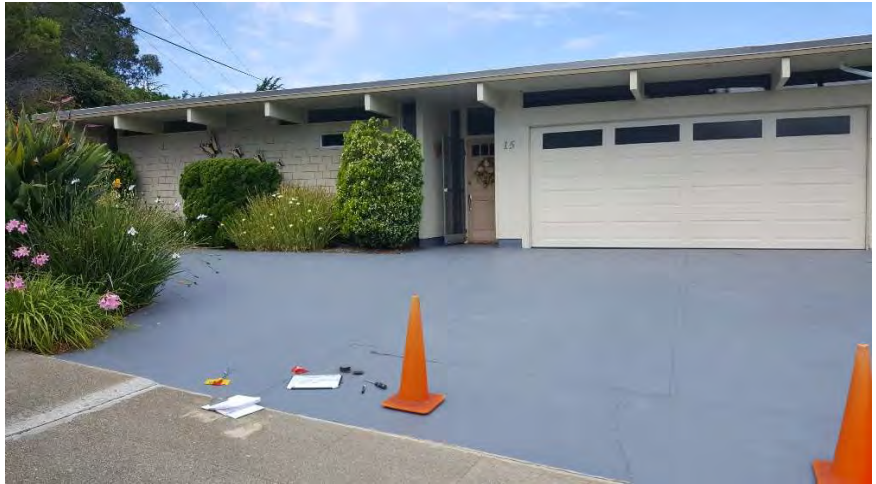
Project: San Mateo Smoke Testing 2019
Date: 8/9/2019
Defect: 080

Defect #	Address/Location	Results	Status	Source Type	Smoke	Area		Run Off	Photo #
						FT	FT		
080	15 Trenton Pl	1	1	6	1	6'	12'	5

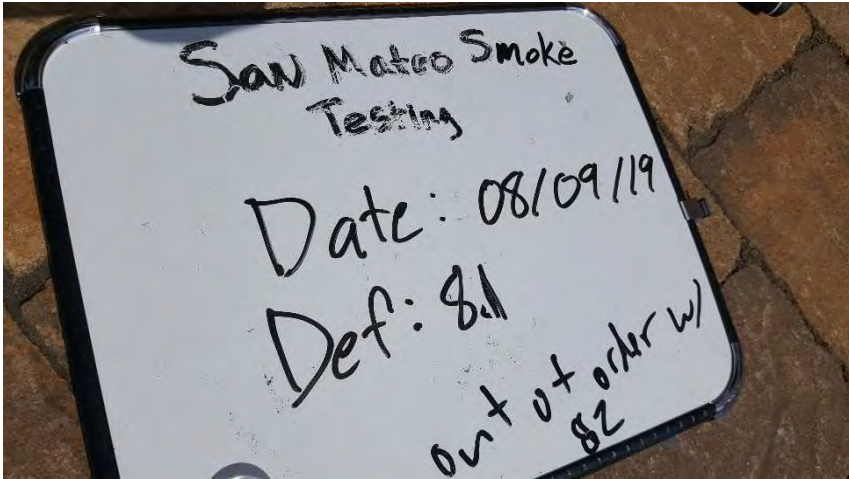
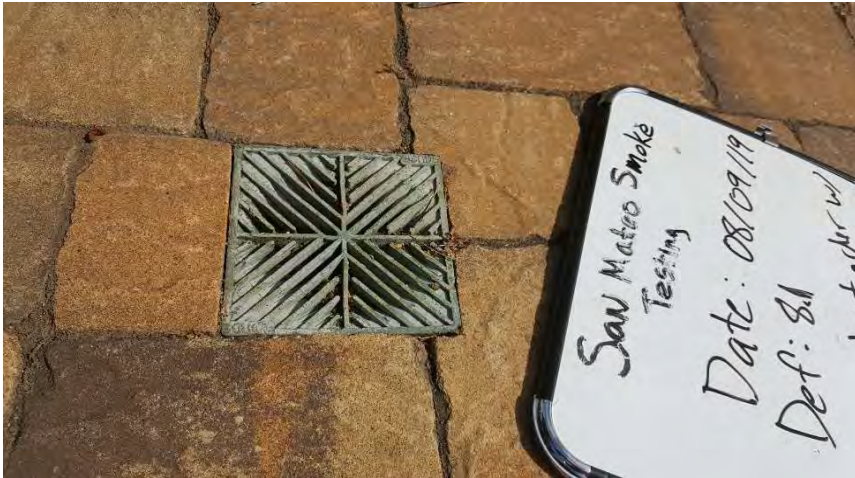
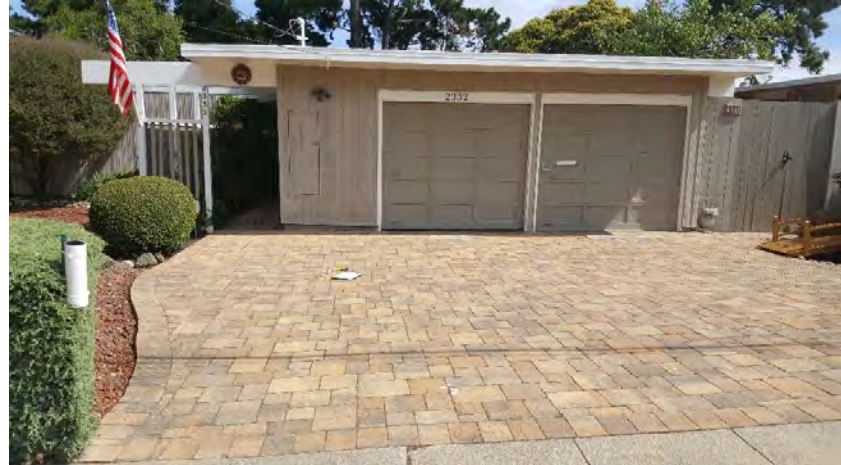
Project: San Mateo Smoke Testing 2019
Date: 8/9/2019
Defect: 081

Comments: 081: Area drain low point of driveway. 082: Gutters feed to these drains.

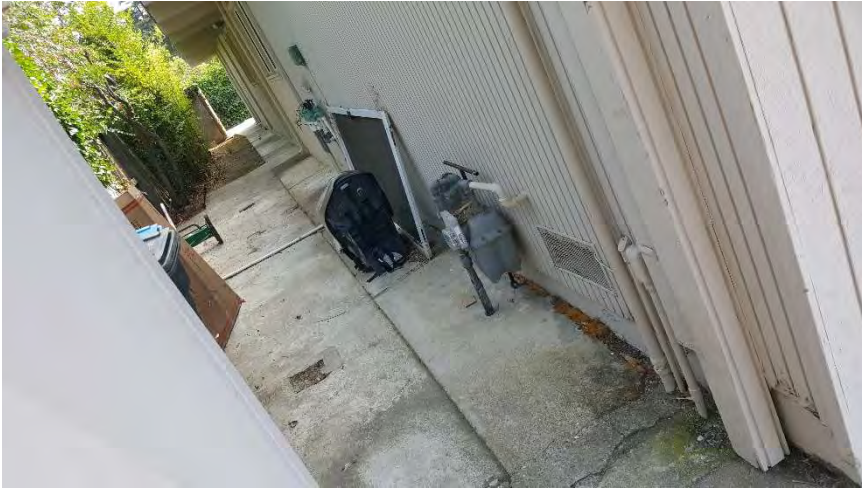
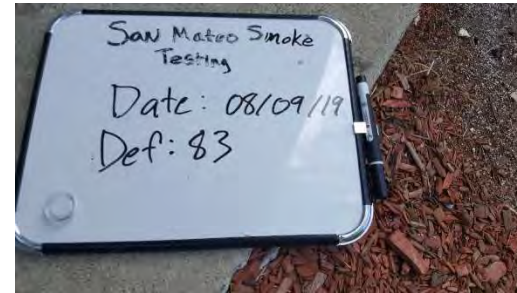
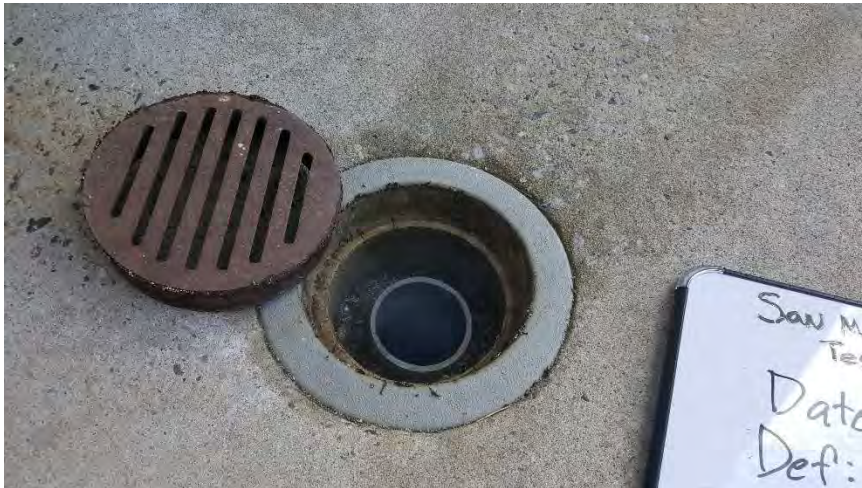
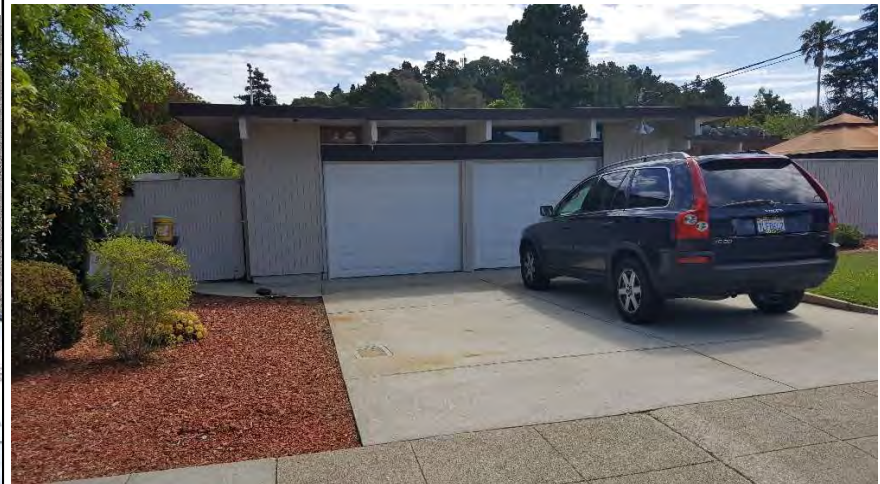
Project: San Mateo Smoke Testing 2019
Date: 8/9/2019
Defect: 083

Defect #	Address/Location	Results	Status	Source Type	Smoke	Area		Run Off	Photo #
						FT	FT		
083	1723 Lexington Ave	1	1	6	2	20'	30'	3

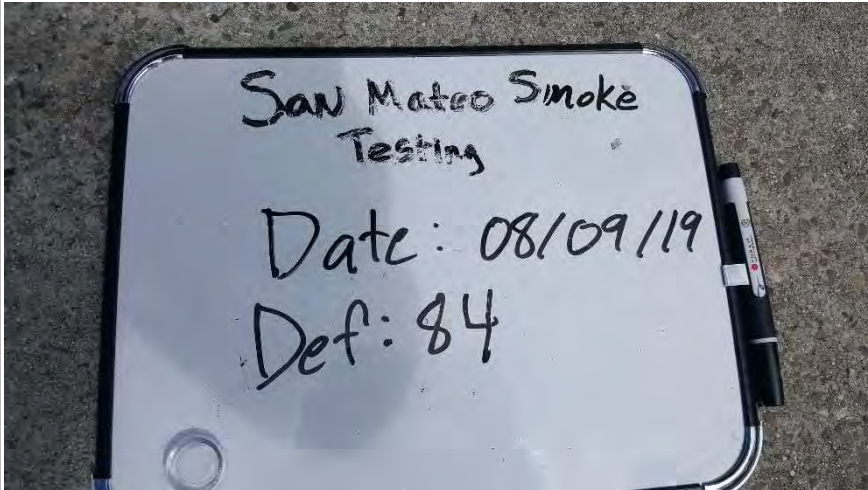
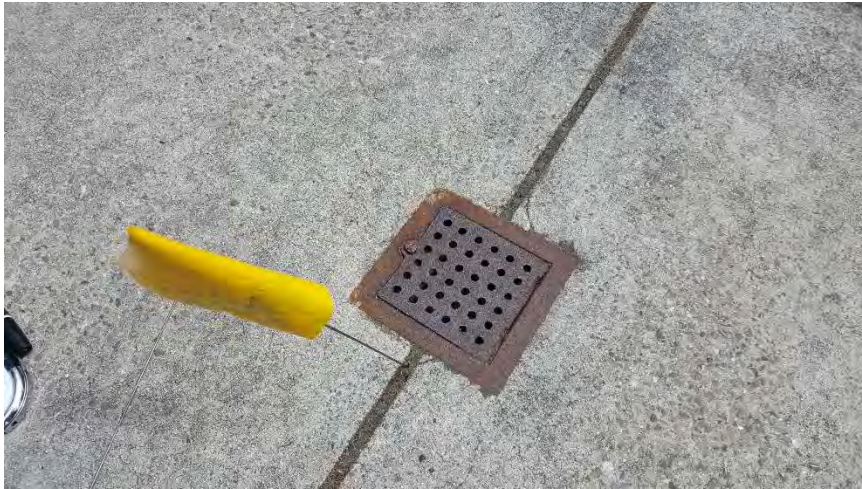
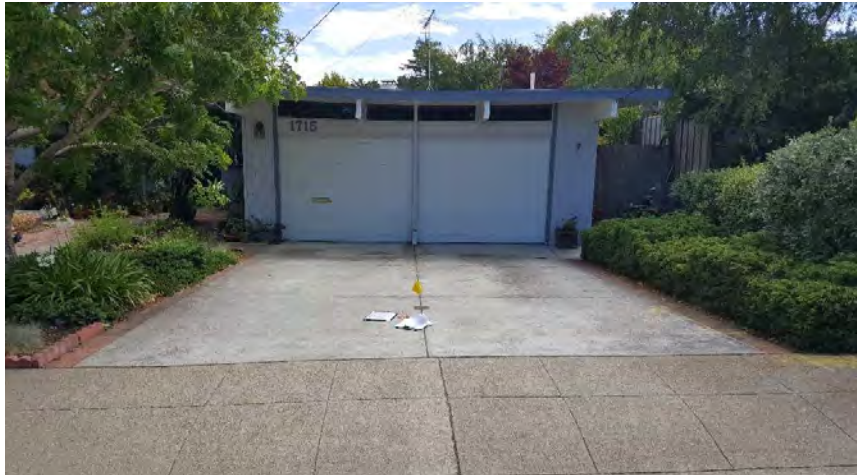
Project: San Mateo Smoke Testing 2019
Date: 8/9/2019
Defect: 084

Defect #	Address/Location	Results	Status	Source Type	Smoke	Area		Run Off	Photo #
						FT	FT		
084	1715 Lexington Ave	1	1	6	1	5'	16'	5

Comments: Not lowest point but does funnel here through pavement groove. Gutter also drain here
