MEMORANDUM

DATE: January 19, 2024
TO: Mark Chow, County of San Mateo
FROM: Ben Shick, PE
SUBJECT: Crystal Springs County Sanitation District – Pipe
and Manhole Assessment and Recommendations

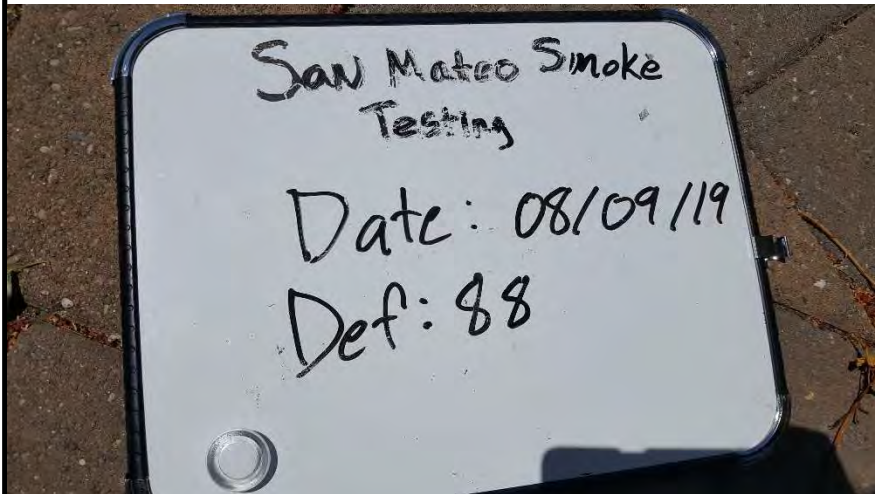
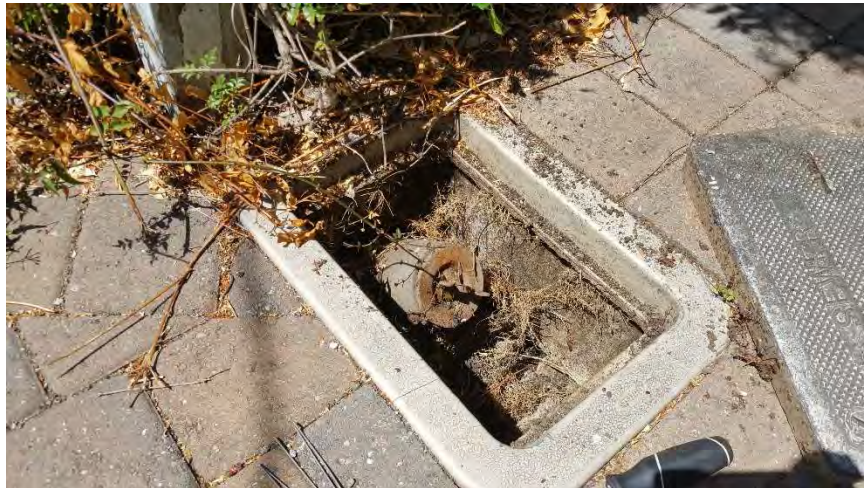
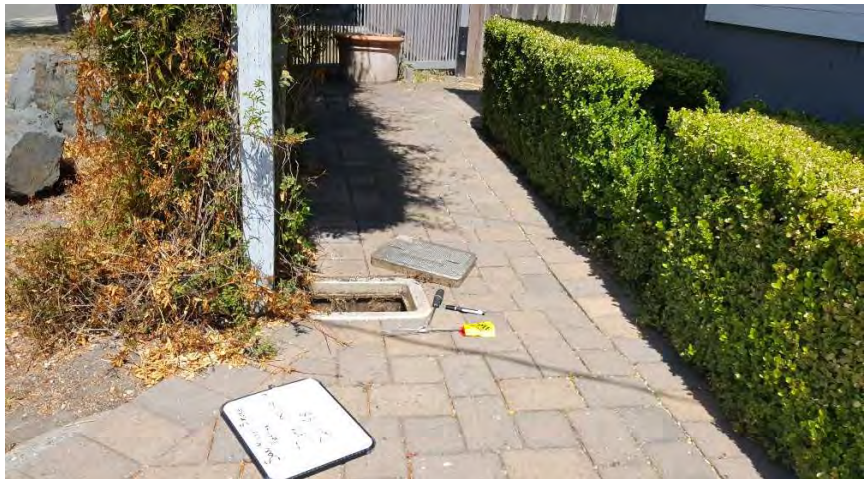
Project: San Mateo Smoke Testing 2019
Date: 8/9/2019
Defect: 088

Defect #	Address/Location	Results	Status	Source Type	Smoke	Area		Run Off	Photo #
						FT	FT		
088	1635 Lexington Ave	1	1	16	1	3'	8'	4

Comments: low spot; cap loose

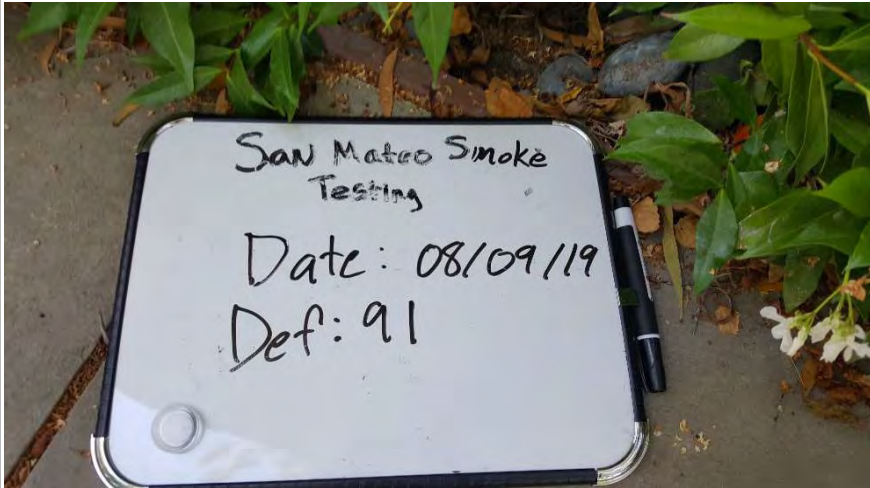
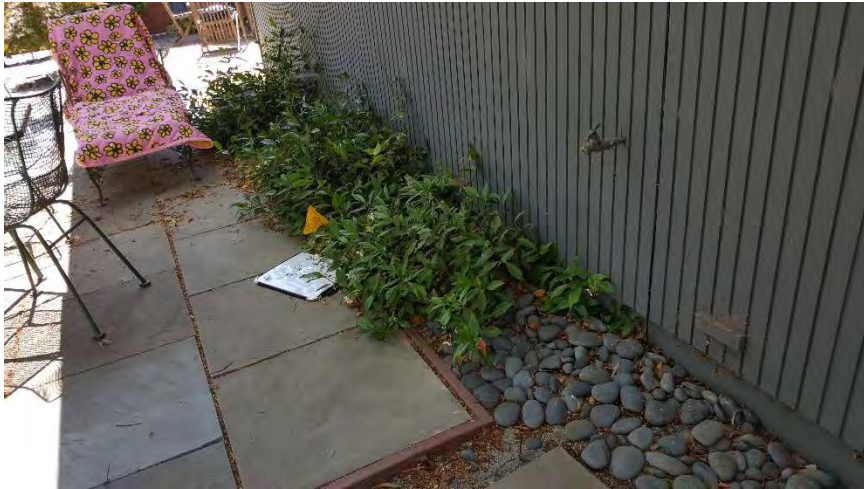
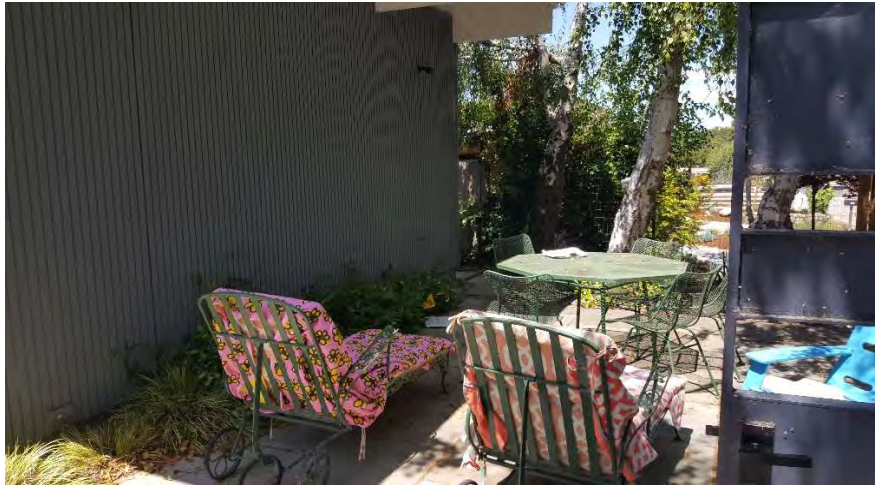
Project: San Mateo Smoke Testing 2019
Date: 8/9/2019
Defect: 091

Defect #	Address/Location	Results	Status	Source Type	Smoke	Area		Run Off	Photo #
						FT	FT		
091	1620 Lexington Ave	1	1	1/6	1	3'	8'	3

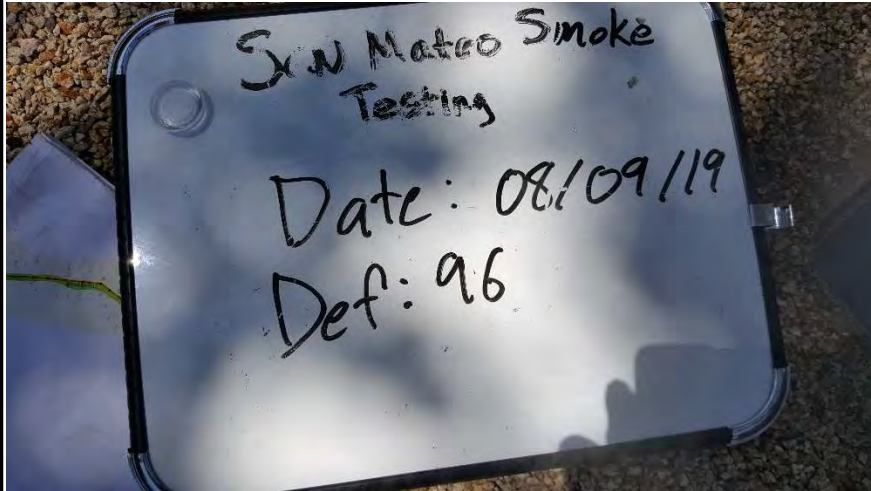
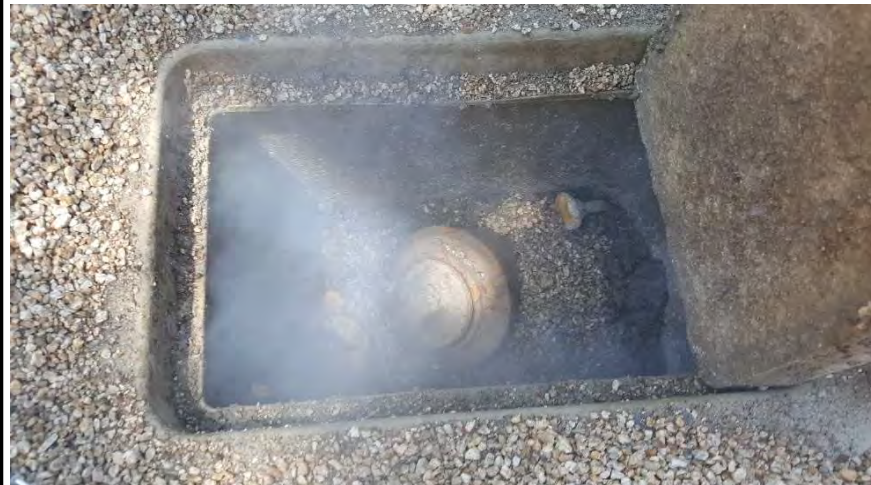
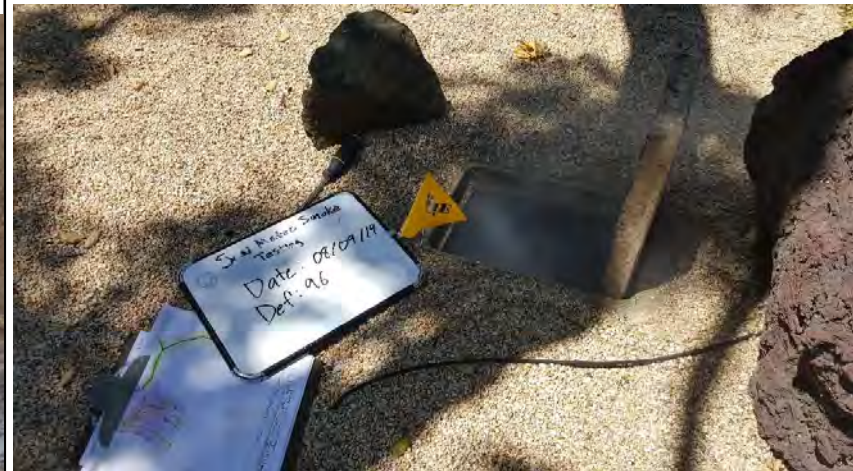
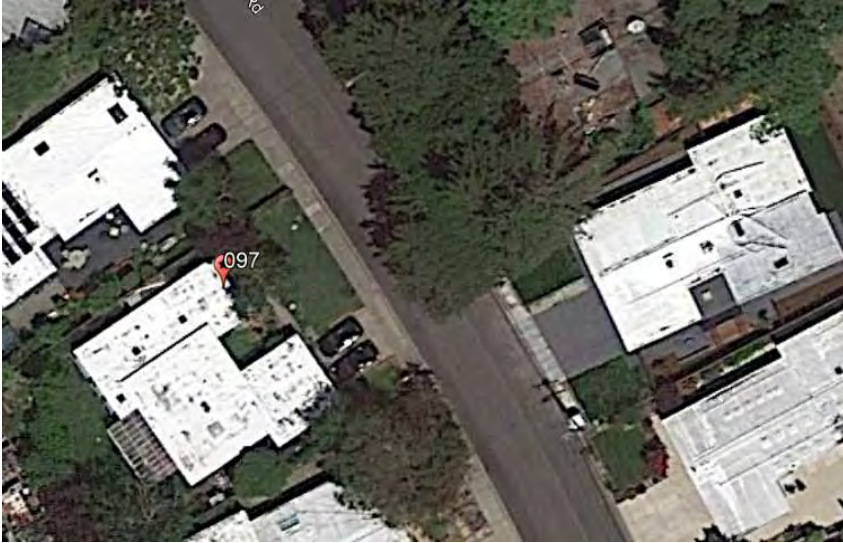
Project: San Mateo Smoke Testing 2019
Date: 8/9/2019
Defect: 096

Comments: Rusty/Deteriorated Cap. Low point

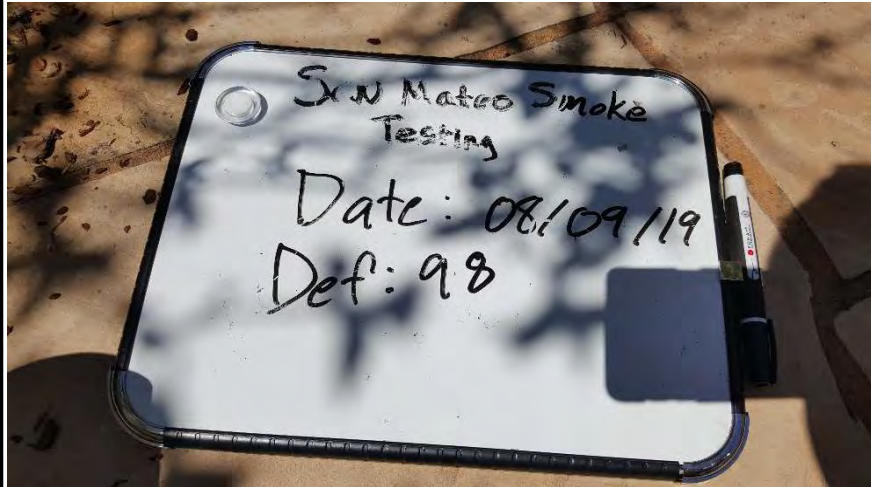
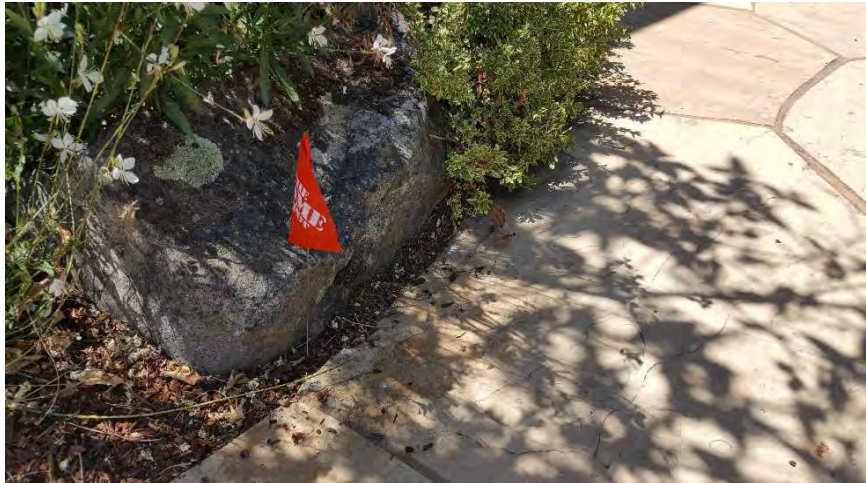
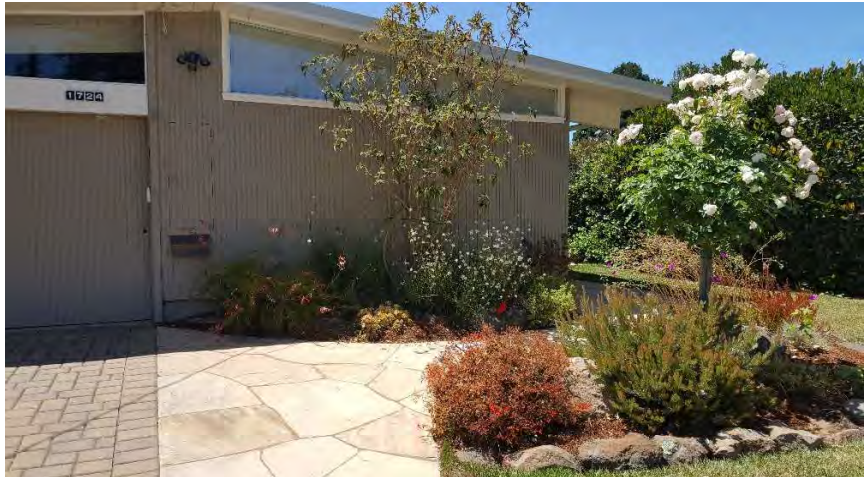
Project: San Mateo Smoke Testing 2019
Date: 8/9/2019
Defect: 098

Comments: Cleanout could not be located. Low point near walkway

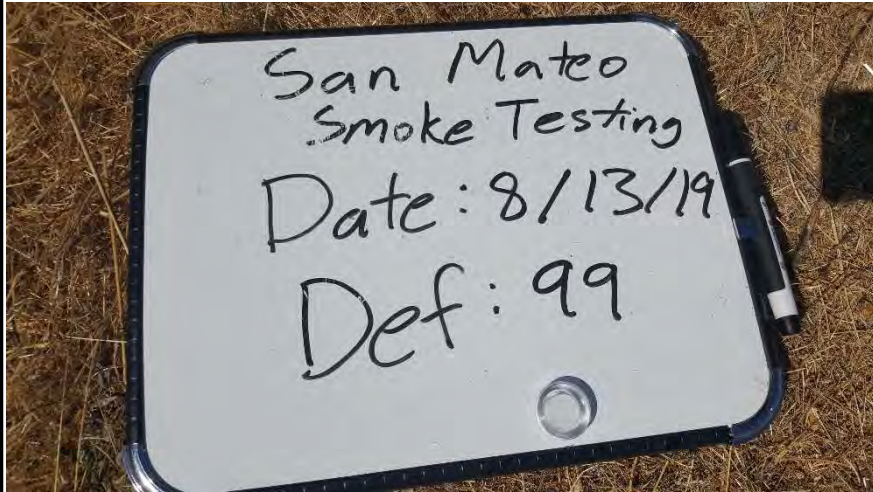
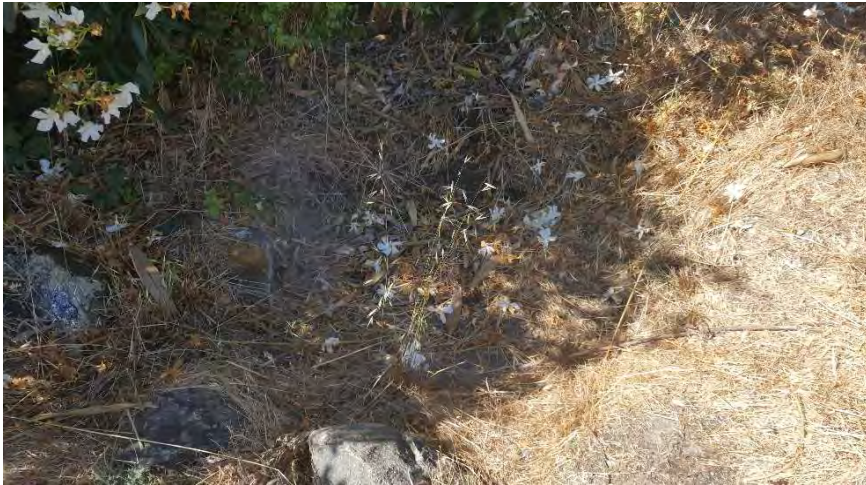
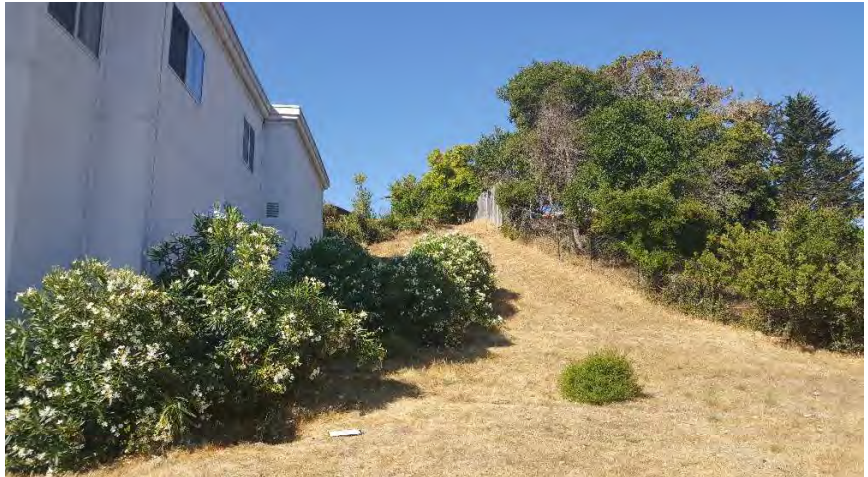
Project: San Mateo Smoke Testing 2019
Date: 8/13/2019
Defect: 099

Comments: Sewer manhole lid low point on hill; infiltration disk recommended

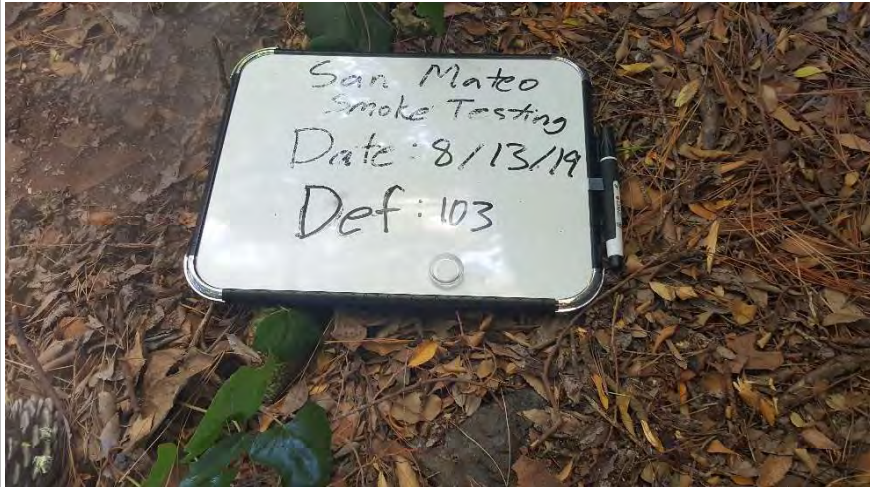
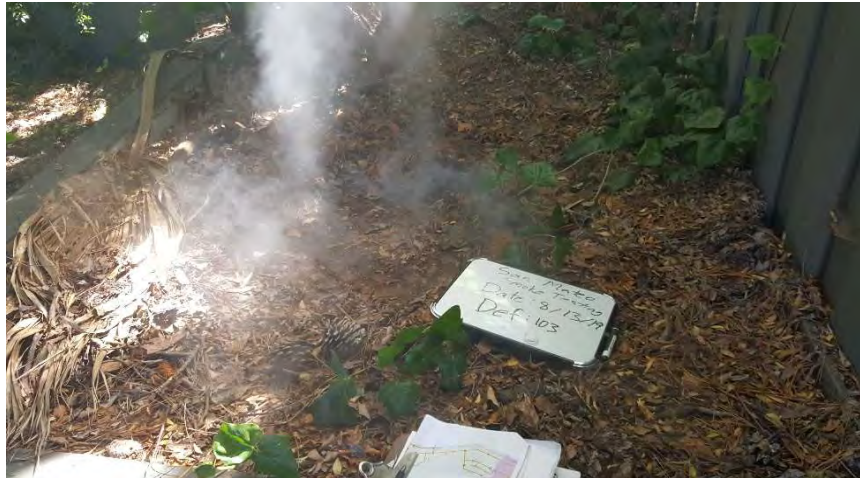
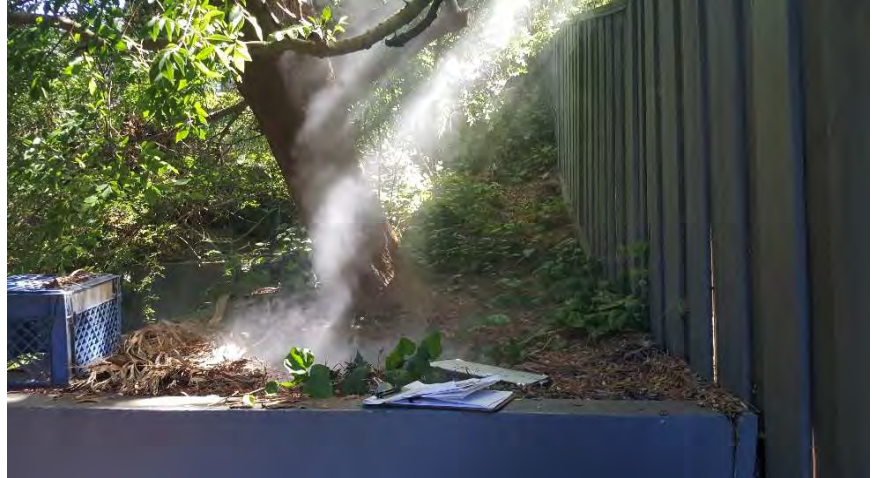
Project: San Mateo Smoke Testing 2019
Date: 8/13/2019
Defect: 103

Comments: 103: Sewer manhole lid low point on hill; infiltration disk recommended.
 104: Rusty/ deteriorated cap

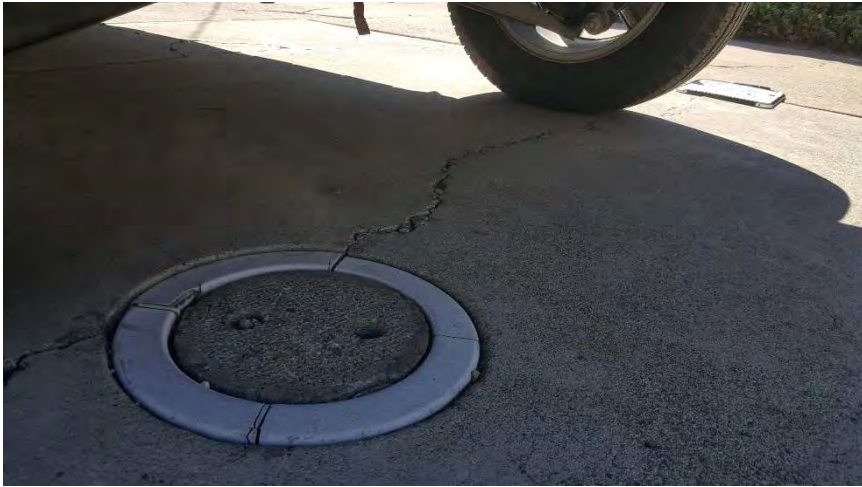
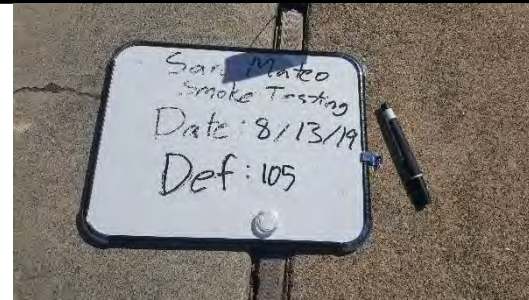
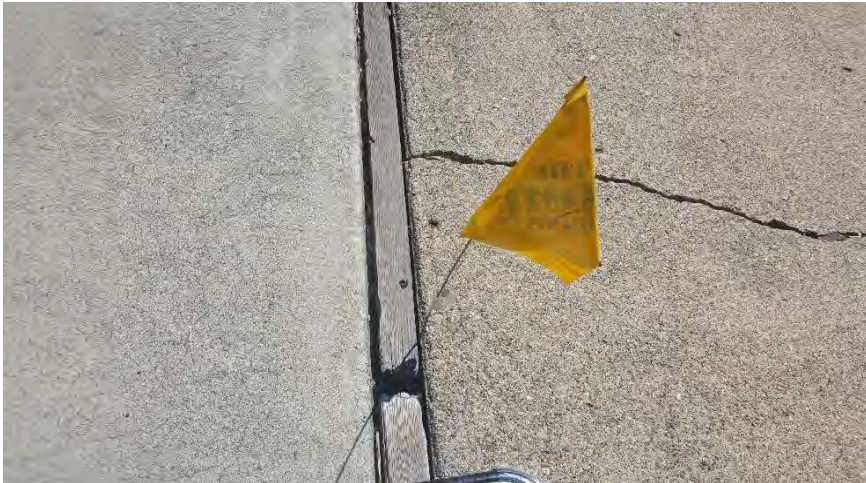
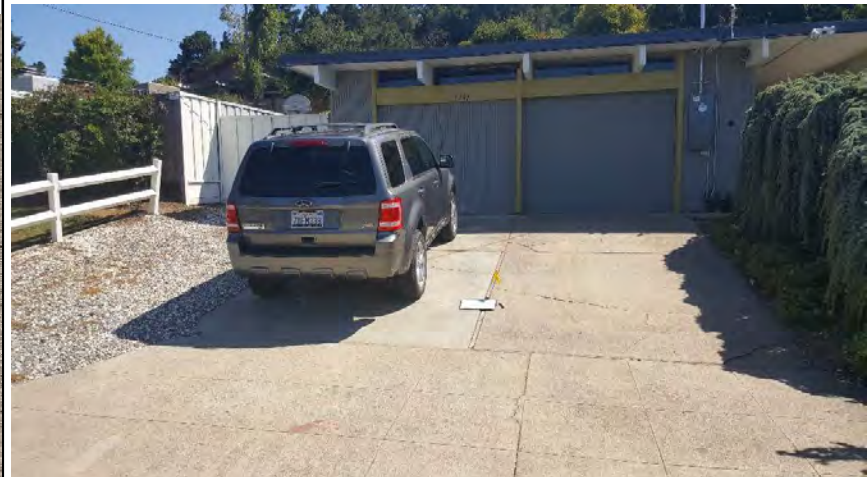
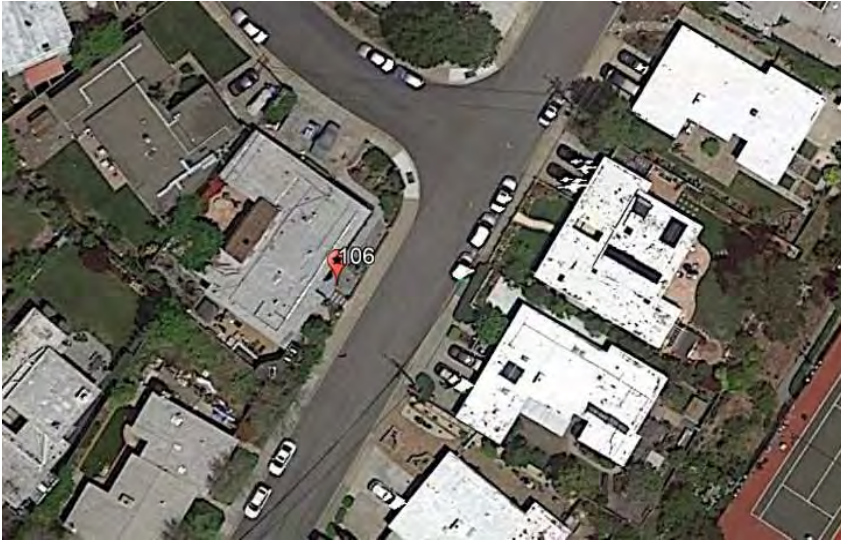
Project: San Mateo Smoke Testing 2019
Date: 8/13/2019
Defect: 105

Comments: Smoke coming from cracks in driveway and cleanout. Included part of the roof since downspout drains here. Probably crack lateral

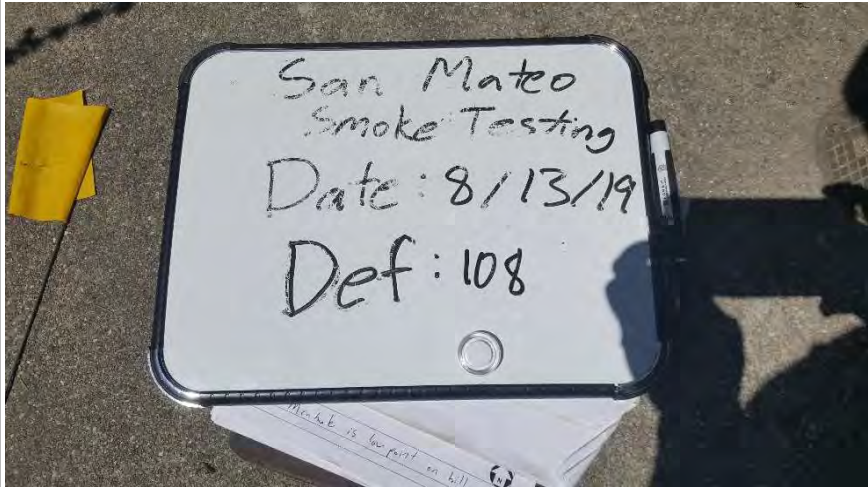
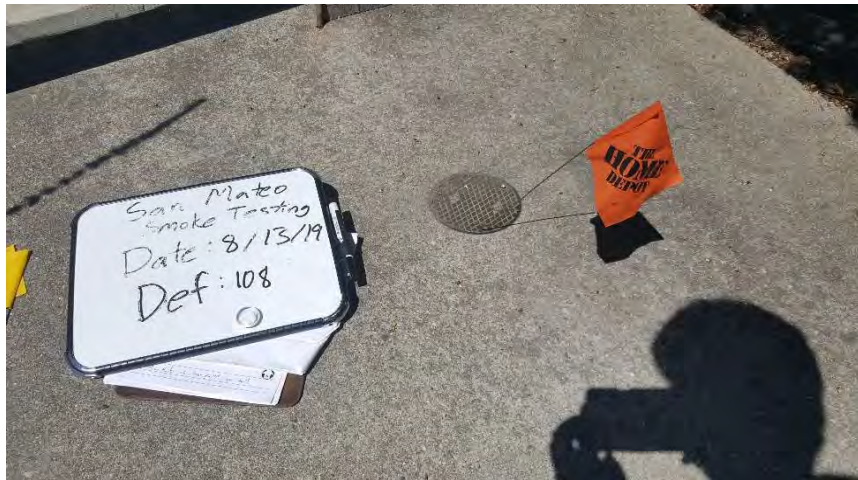
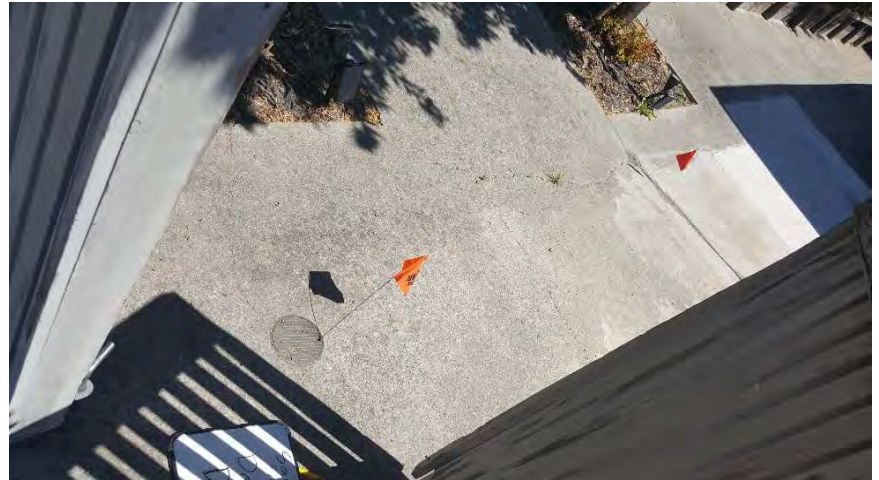
Project: San Mateo Smoke Testing 2019
Date: 8/13/2019
Defect: 108

Comments: 108: Cannot open cover

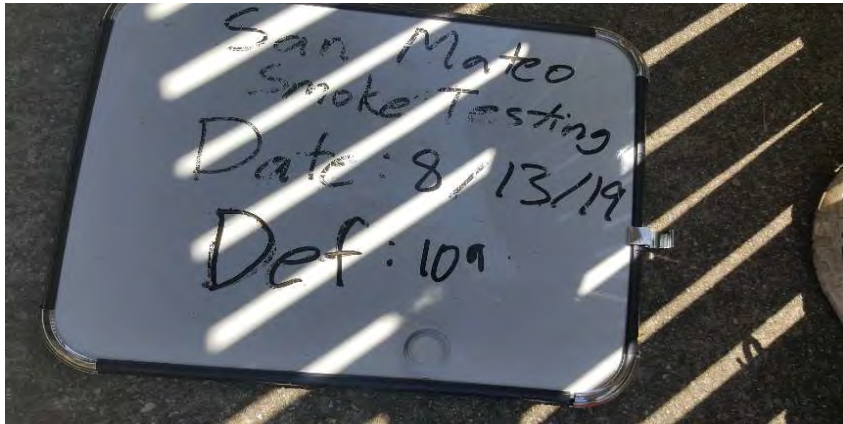
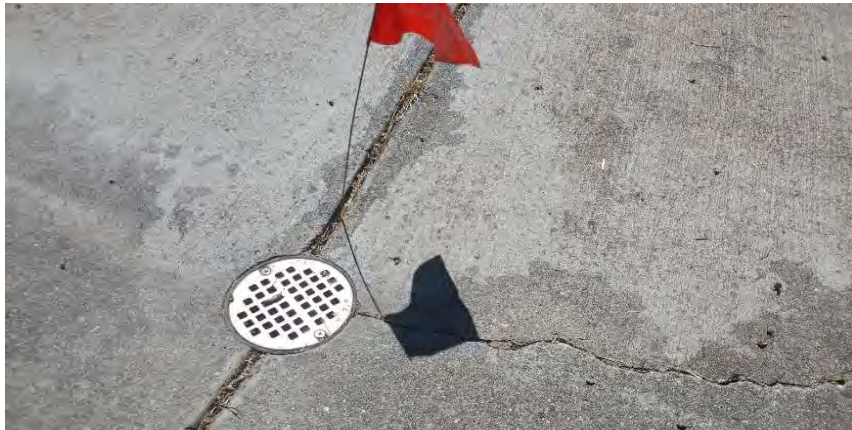
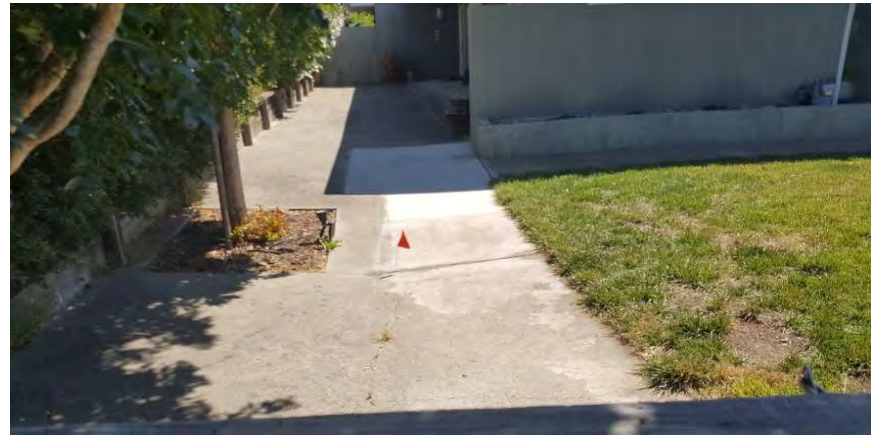
Project: San Mateo Smoke Testing 2019
Date: 8/13/2019
Defect: 109

109: Downspouts drain to here. Low point.

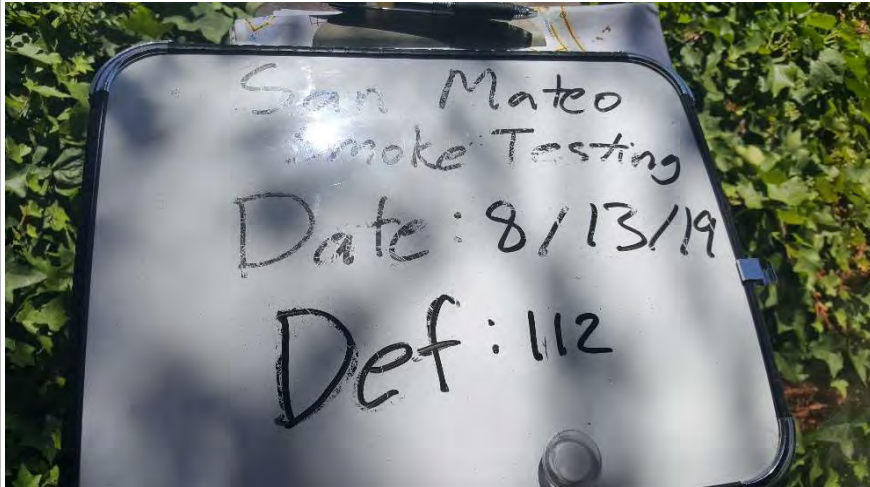
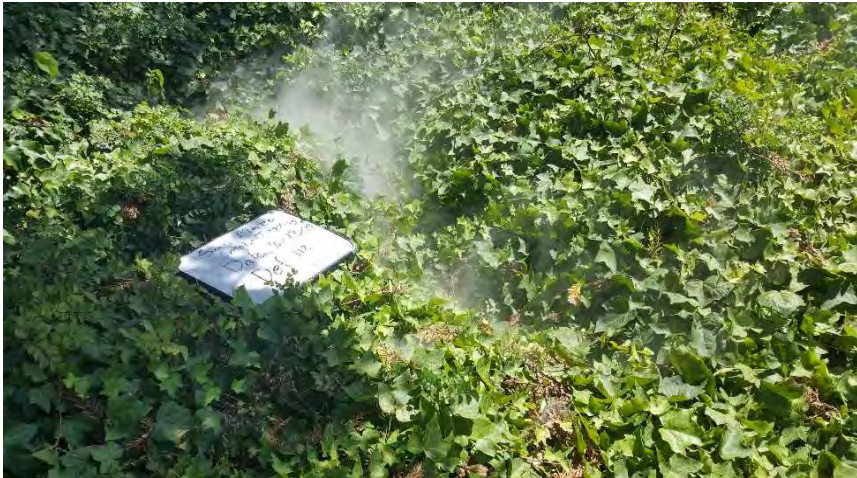
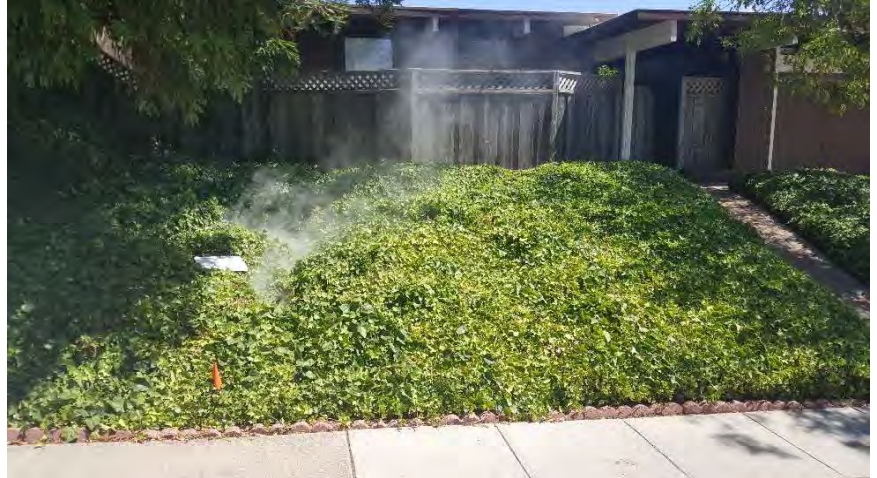
Project: San Mateo Smoke Testing 2019
Date: 8/13/2019
Defect: 112

Comments: 112: Most likely a lateral

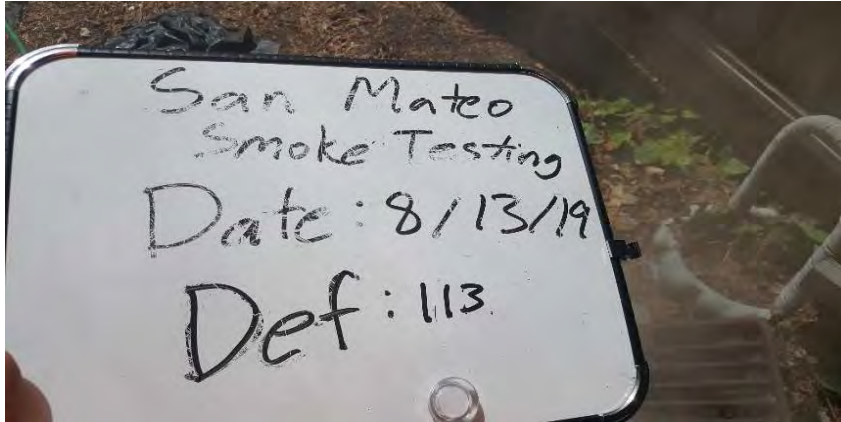
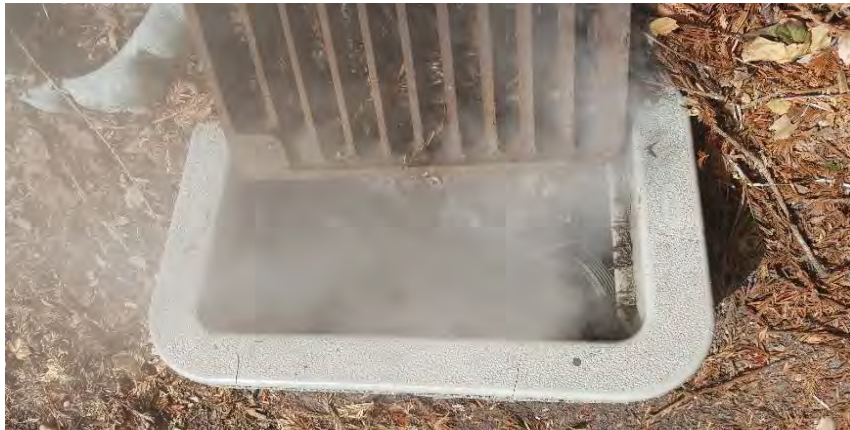
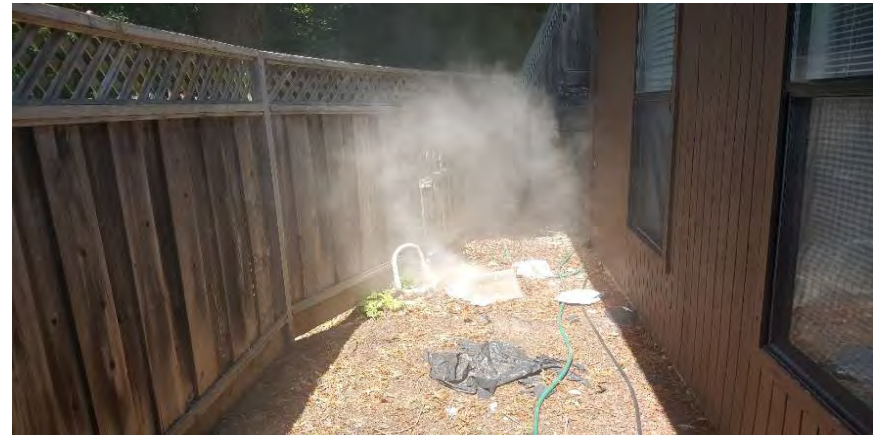
Project: San Mateo Smoke Testing 2019
Date: 8/13/2019
Defect: 113

113: Grated cleanouts with caps off

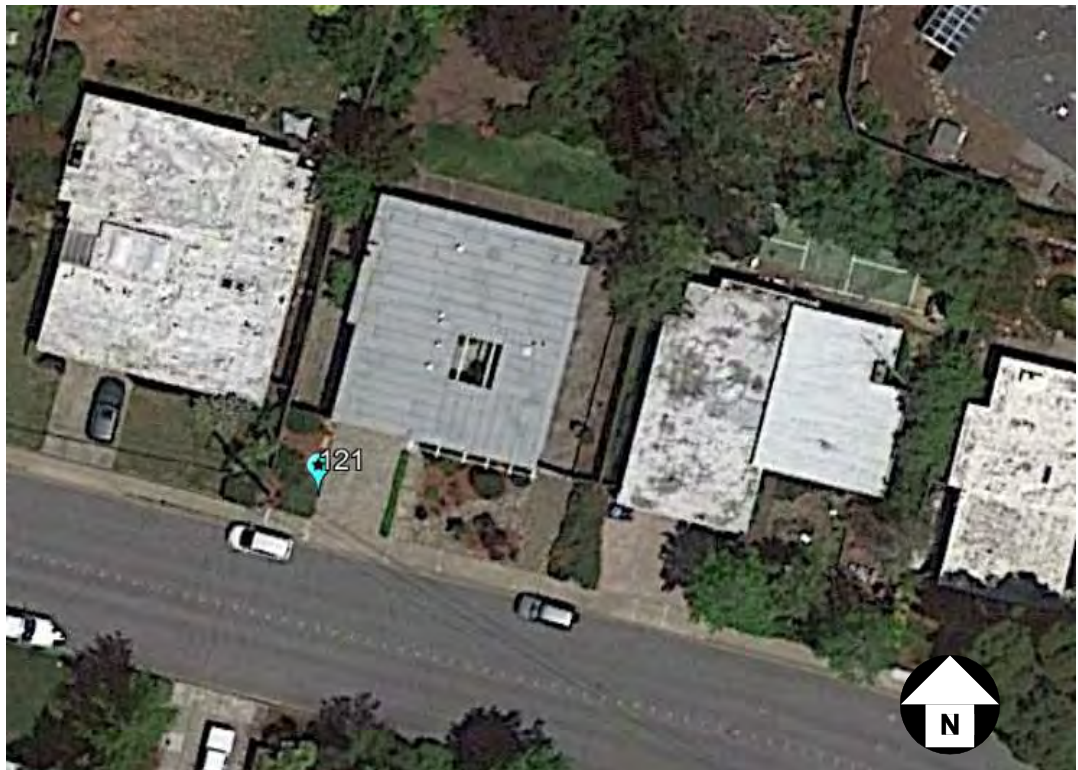
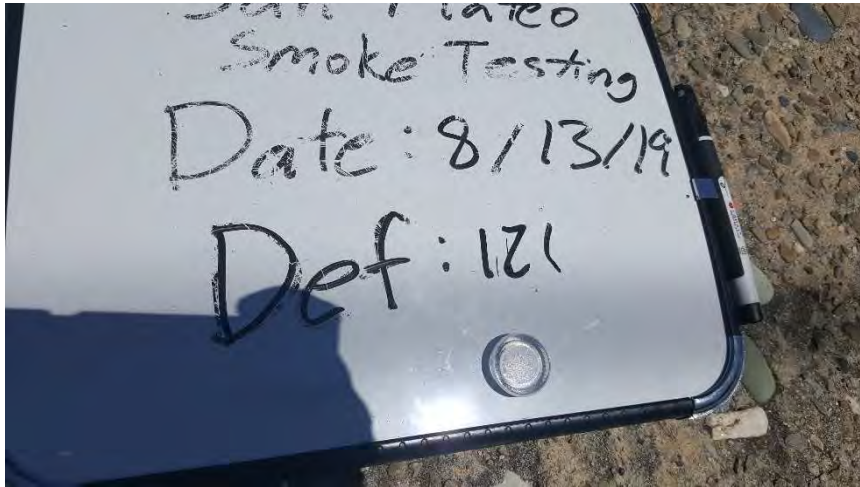
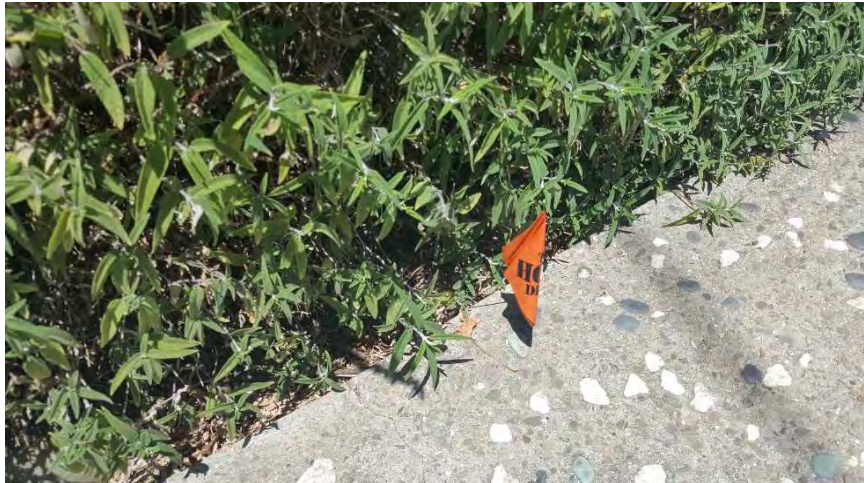
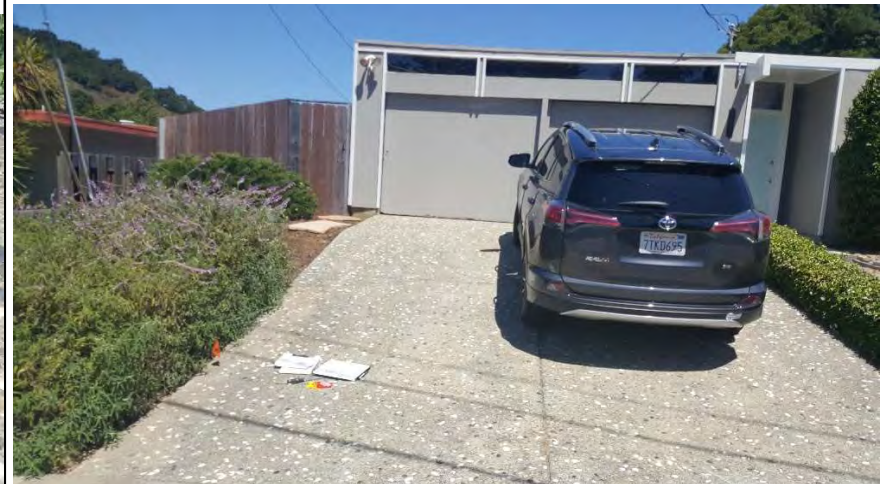
Project: San Mateo Smoke Testing 2019
Date: 8/13/2019
Defect: 121

Defect #	Address/Location	Results	Status	Source Type	Smoke	Area		Run Off	Photo #
						FT	FT		
121	1951 Ticonderoga Dr	1	1	1	1	4'	12'	3

Comments: No cleanout present. Most likely lateral

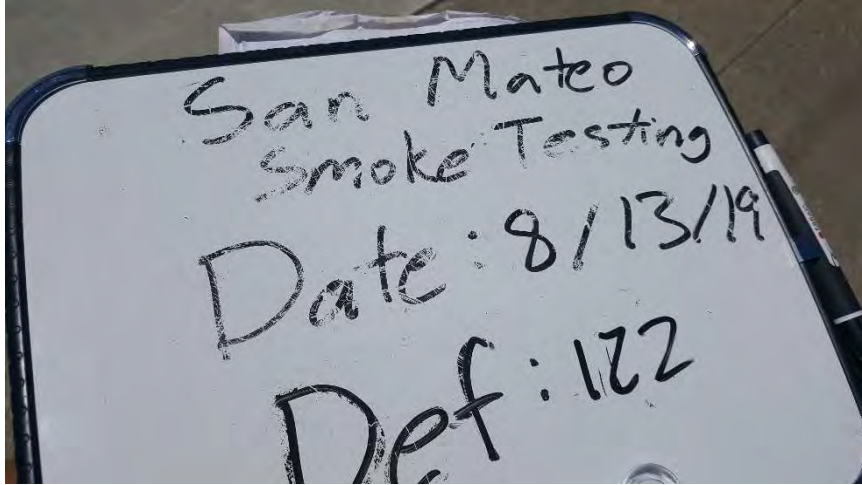
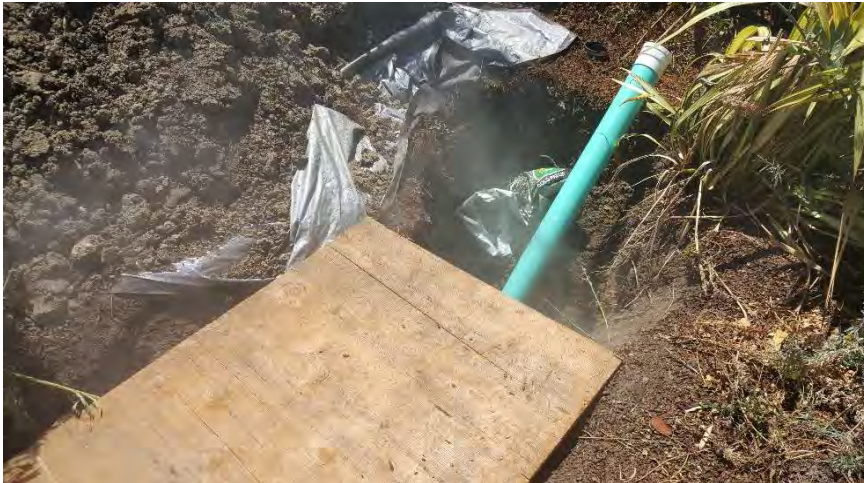
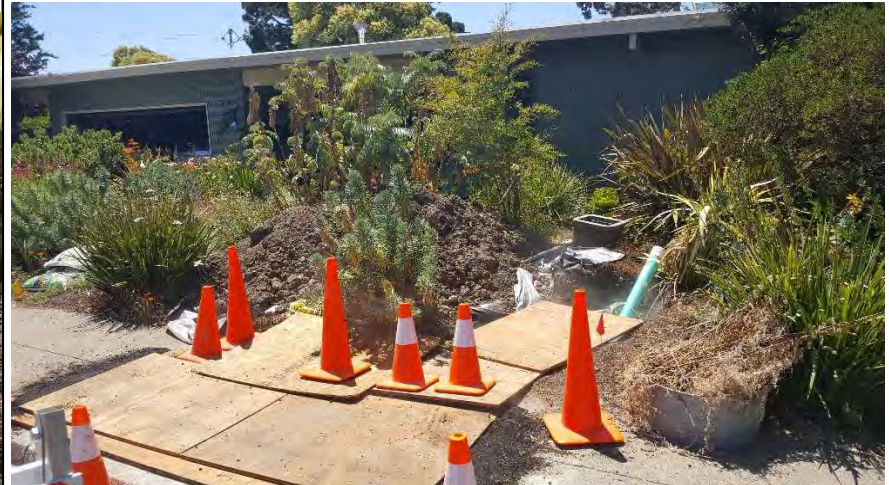
Project: San Mateo Smoke Testing 2019
Date: 8/13/2019
Defect: 122

Defect #	Address/Location	Results	Status	Source Type	Smoke	Area		Run Off	Photo #
						FT	FT		
122	1956 Lexington Ave	1	1	1	3	8'	10'	1

Comments: Work being done to lateral line

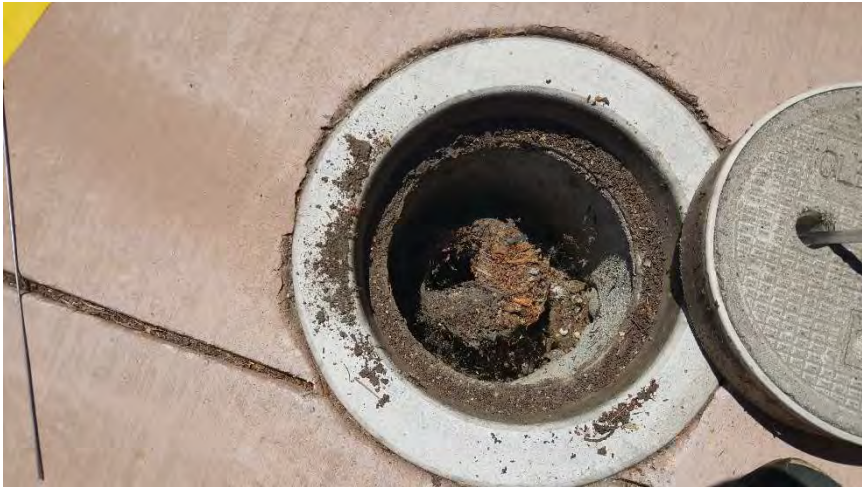
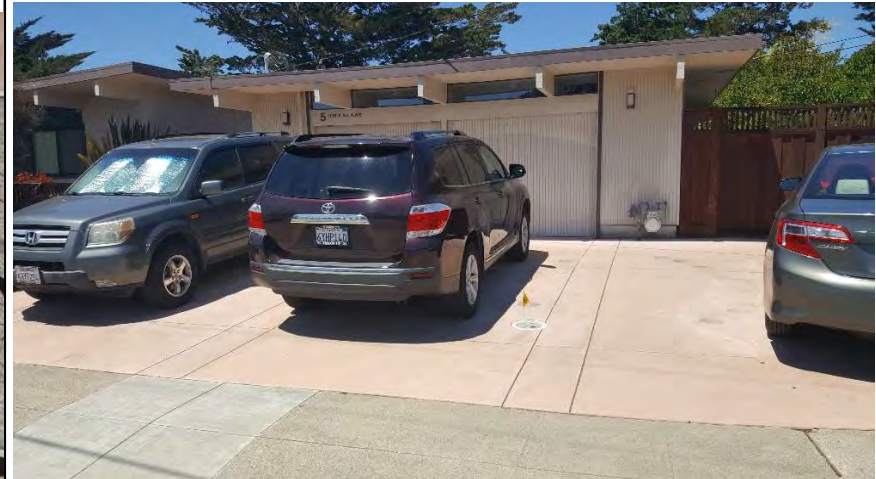
San Mateo
Smoke Testing
Date: 8/13/19
Def: 123

Defect #	Address/Location	Results	Status	Source Type	Smoke	Area		Run Off	Photo #
						FT	FT		
123	5 Turtle Bay Pl	1	1	16	1	4"	4"	5

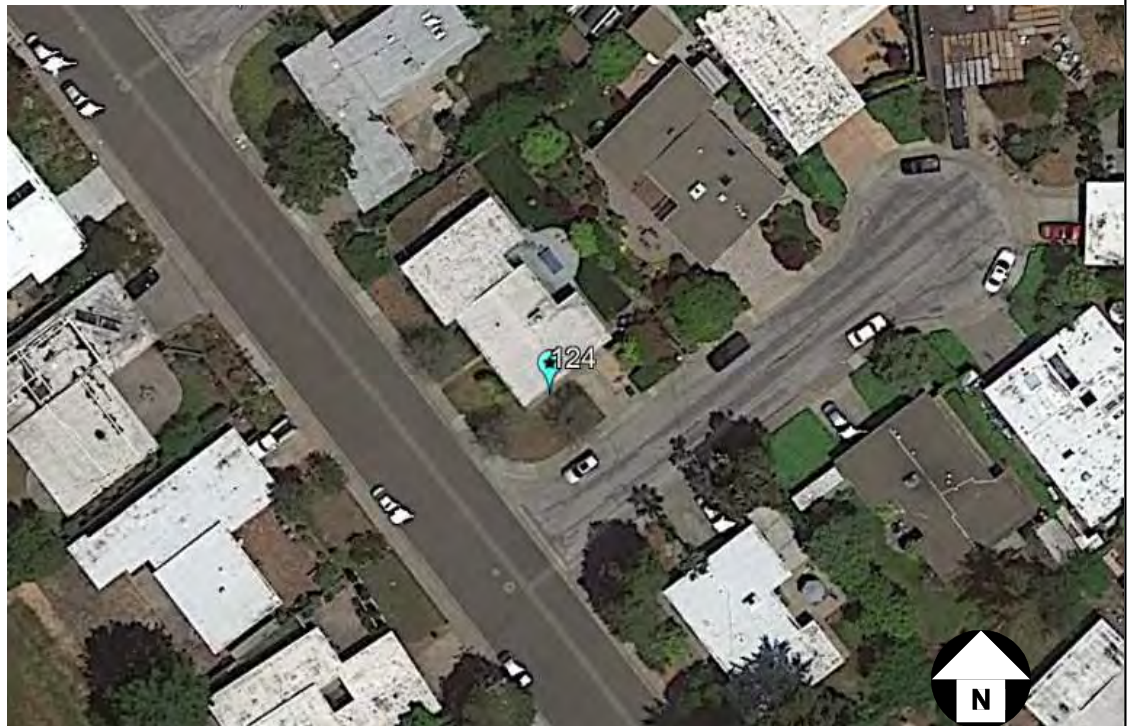
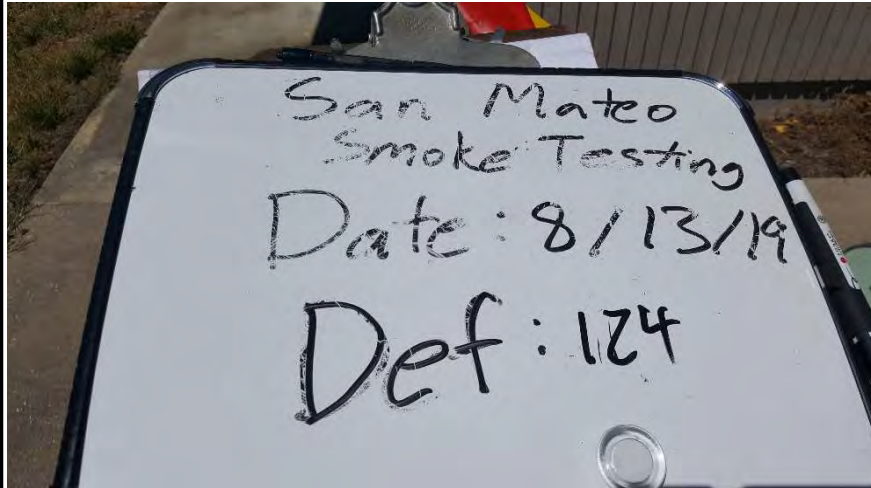
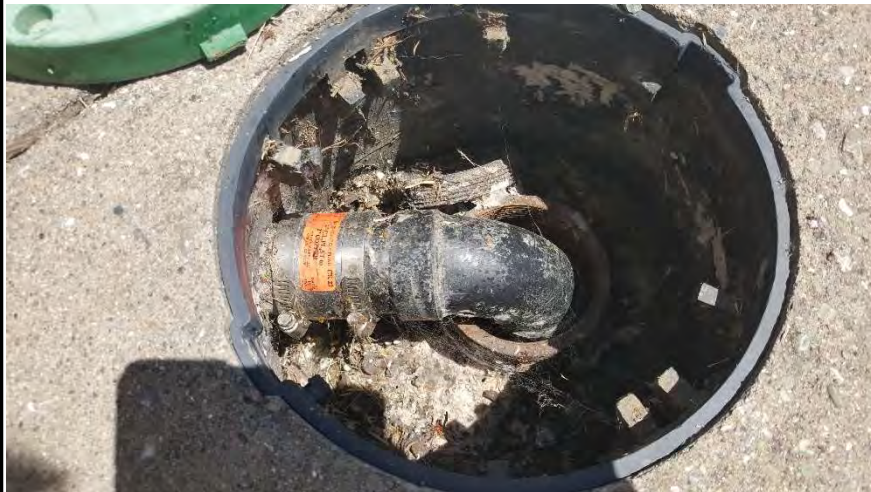
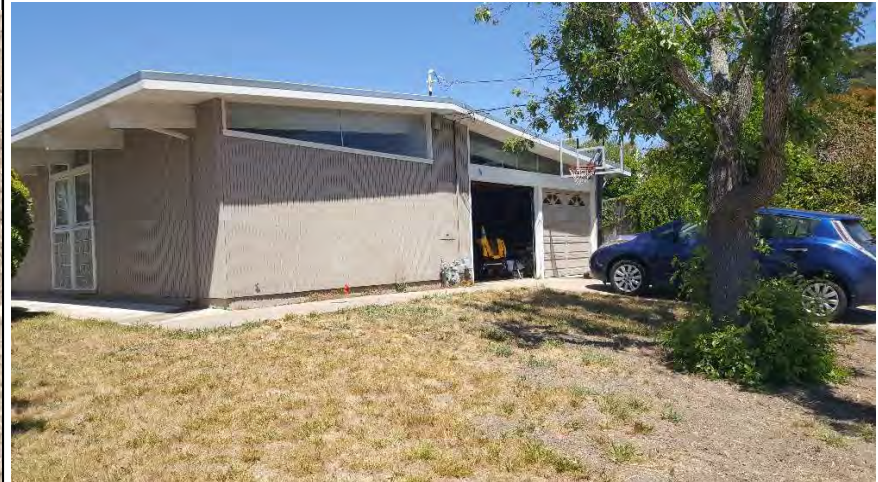
Project: San Mateo Smoke Testing 2019
Date: 8/13/2019
Defect: 124

Defect #	Address/Location	Results	Status	Source Type	Smoke	Area		Run Off	Photo #
						FT	FT		
124	5 Shelburne Pl	1	1	16	1	4"	4"	2

Comments: Cap off. Another pipe is being draining into the line from here. Surcharge evidence

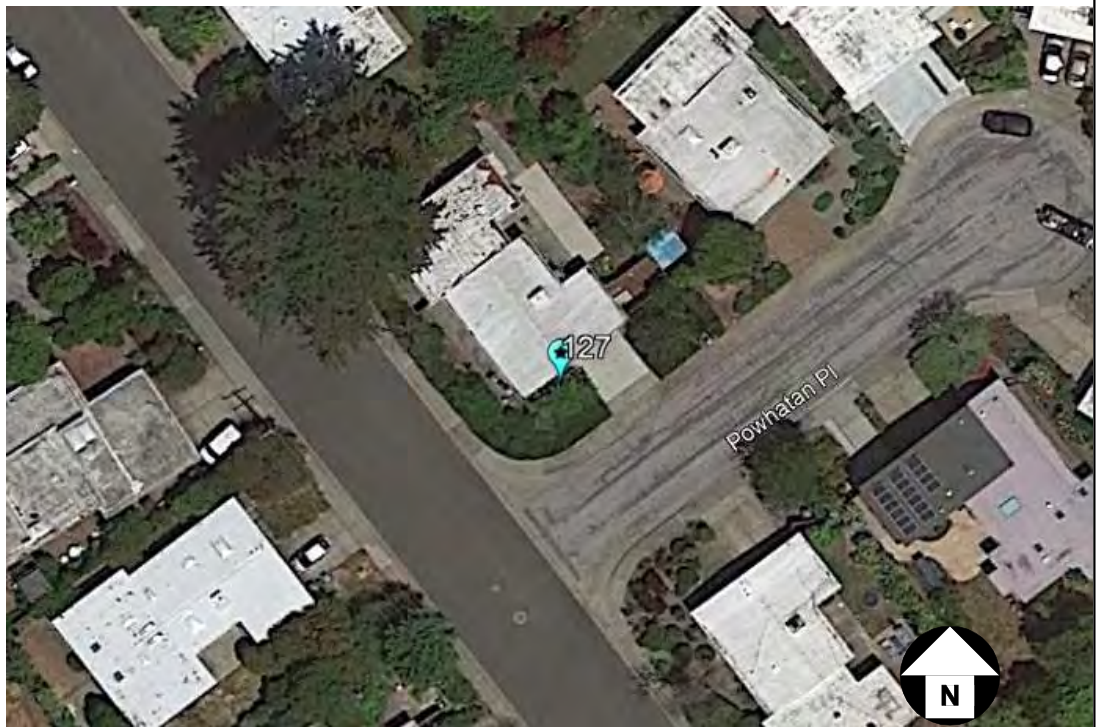
Inspection Crew Aby Takanohara/ Rickey Bradley **Defect#** 127

Defect #	Address/Location	Results	Status	Source Type	Smoke	Area		Run Off	Photo #
						FT	FT		
127	5 Powhatan Pl	1	1	16	1	4'	4'	2

Comments: Cap off. Low point could drain into cleanout
