MEMORANDUM

DATE: January 19, 2024
TO: Mark Chow, County of San Mateo
FROM: Ben Shick, PE
SUBJECT: Crystal Springs County Sanitation District – Pipe
and Manhole Assessment and Recommendations

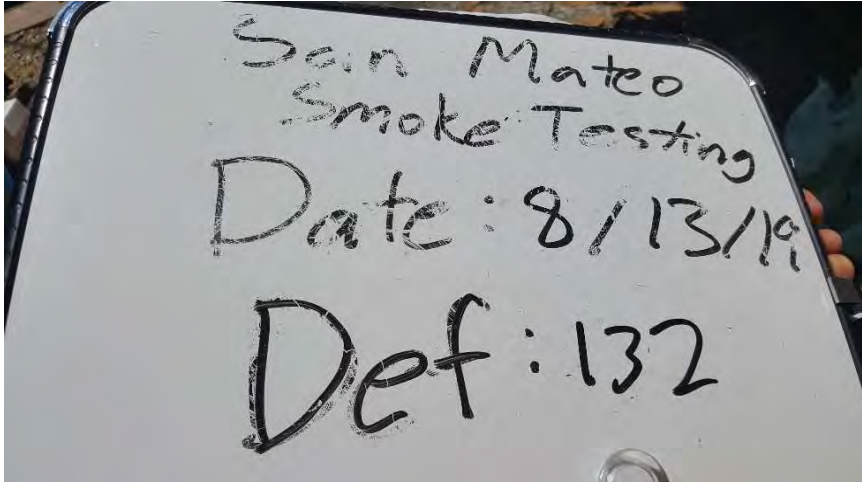
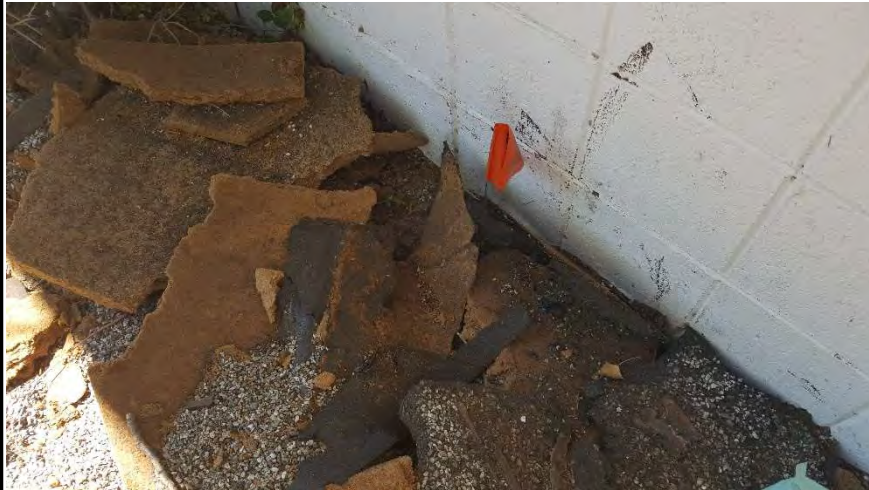
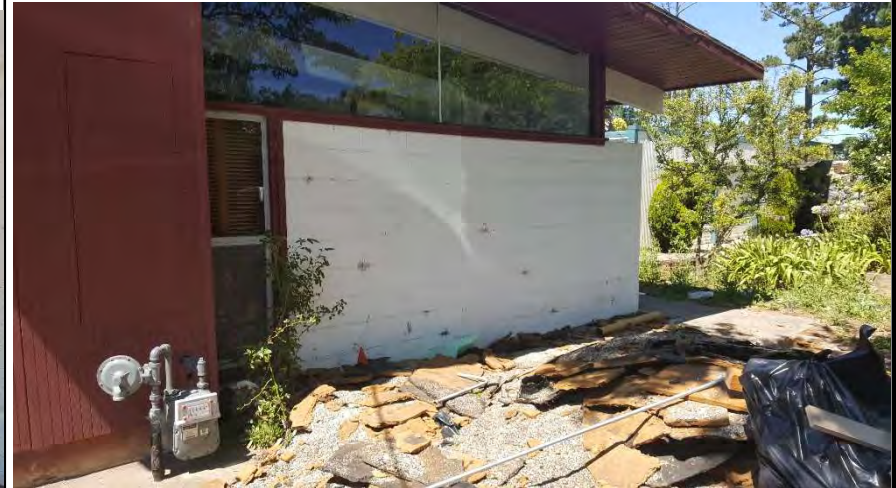
Project: San Mateo Smoke Testing 2019
Date: 8/13/2019
Defect: 132

Defect #	Address/Location	Results	Status	Source Type	Smoke	Area		Run Off	Photo #
						FT	FT		
132	15 Stoney Point Pl	1	1	17	1	4'	4'	3

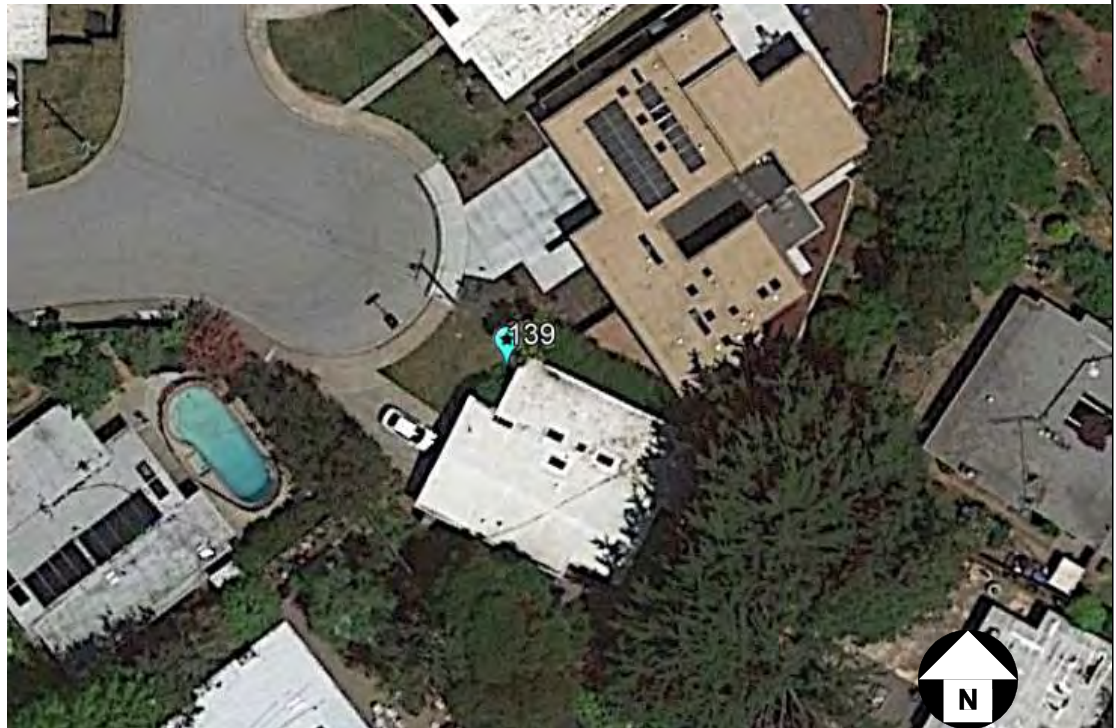
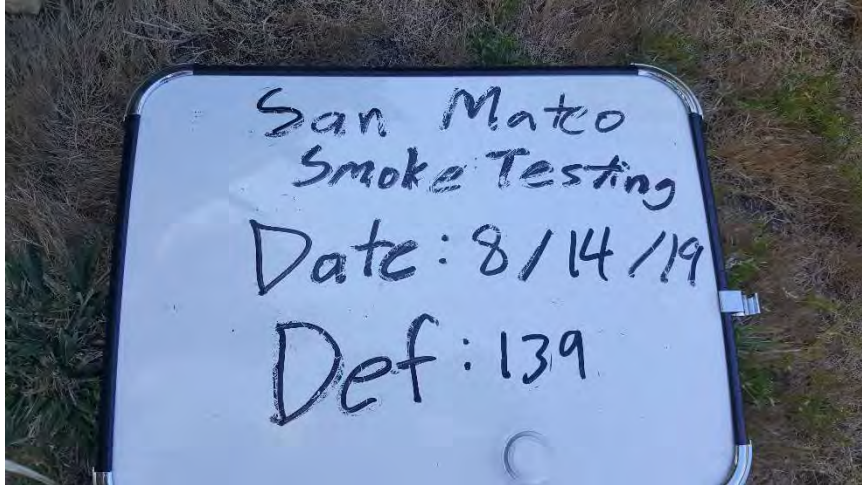
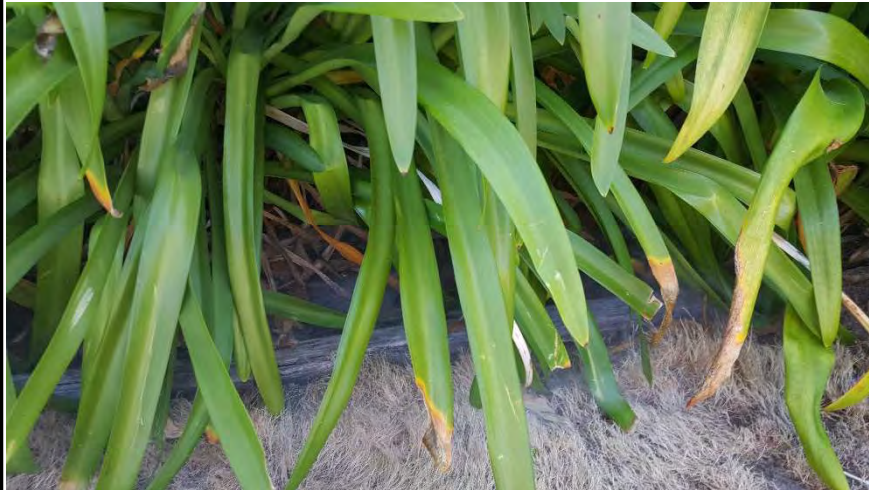
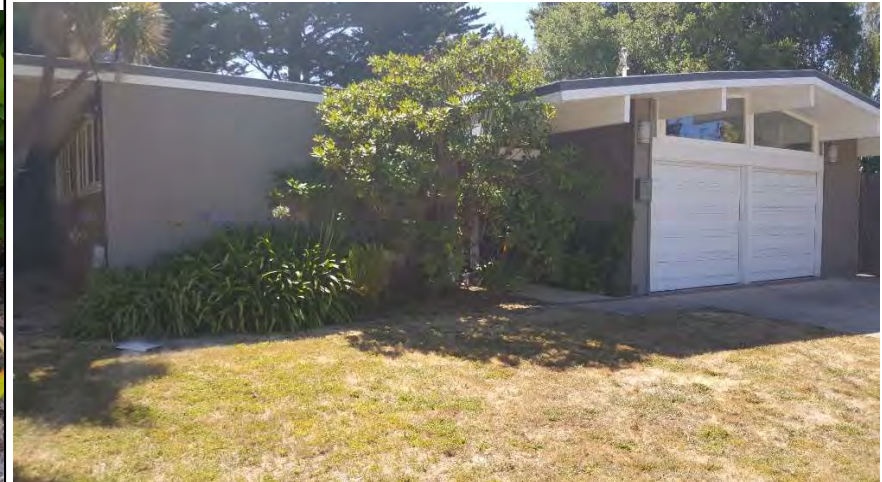
Project: San Mateo Smoke Testing 2019
Date: 8/14/2019
Defect: 139

Defect #	Address/Location	Results	Status	Source Type	Smoke	Area		Run Off	Photo #
						FT	FT		
139	2251 Sheraton Pl	1	1	1	1	3'	4'	1

Comments: Cannot access due to debris. Most likely cleanout.

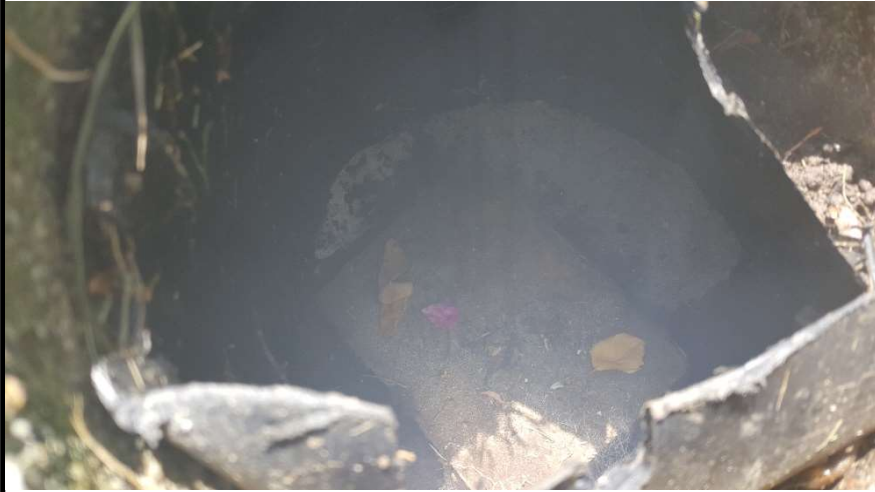
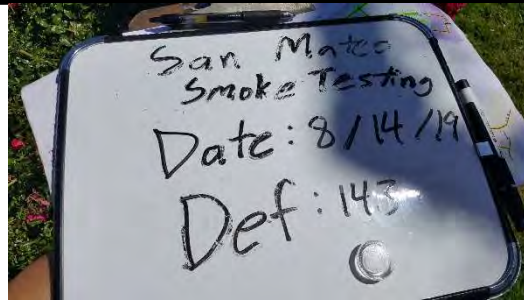
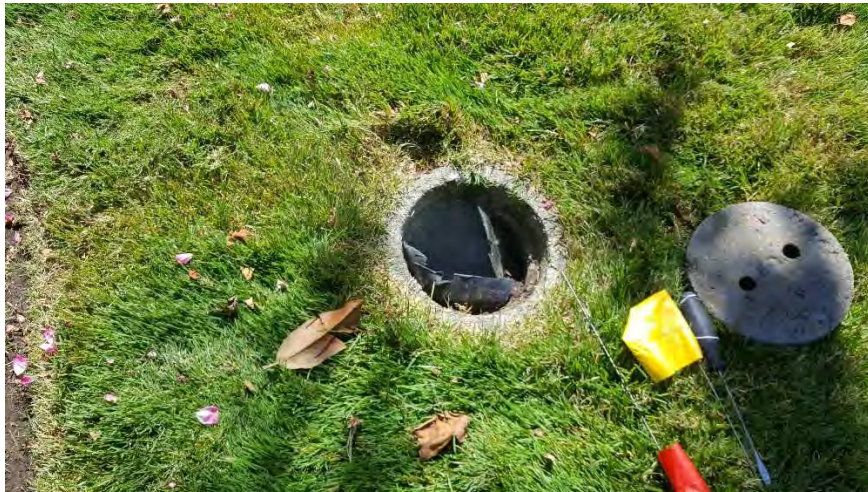
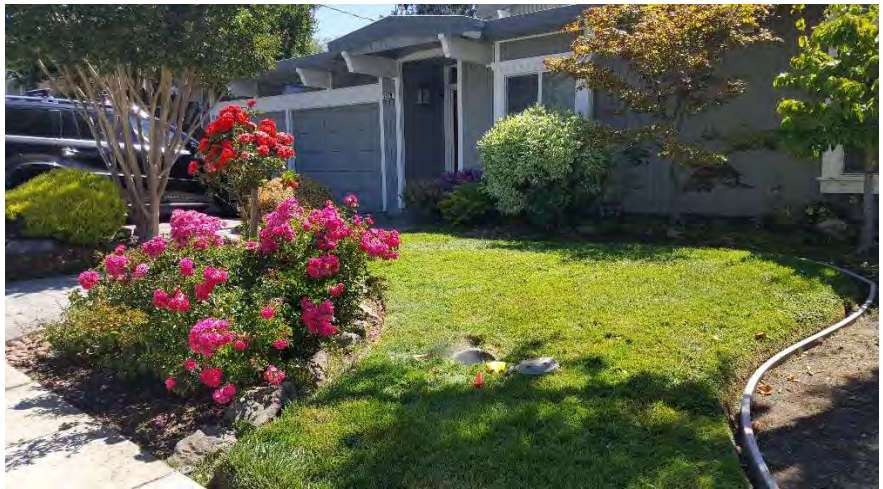
Project: San Mateo Smoke Testing 2019
Date: 8/14/2019
Defect: 143

Defect #	Address/Location	Results	Status	Source Type	Smoke	Area		Run Off	Photo #
						FT	FT		
143	2289 Sheraton Pl	1	1	16	2	4'	8'	1

Comments: No cap. Flows funnel here. Damaged pipe?

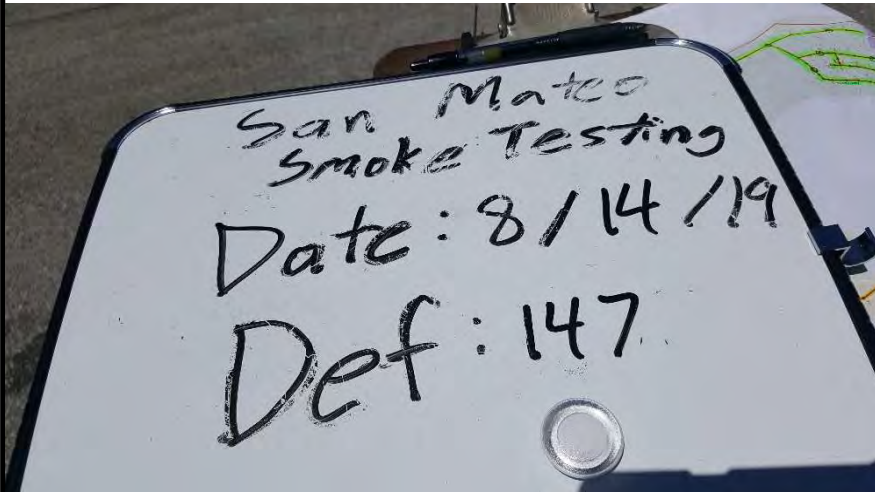
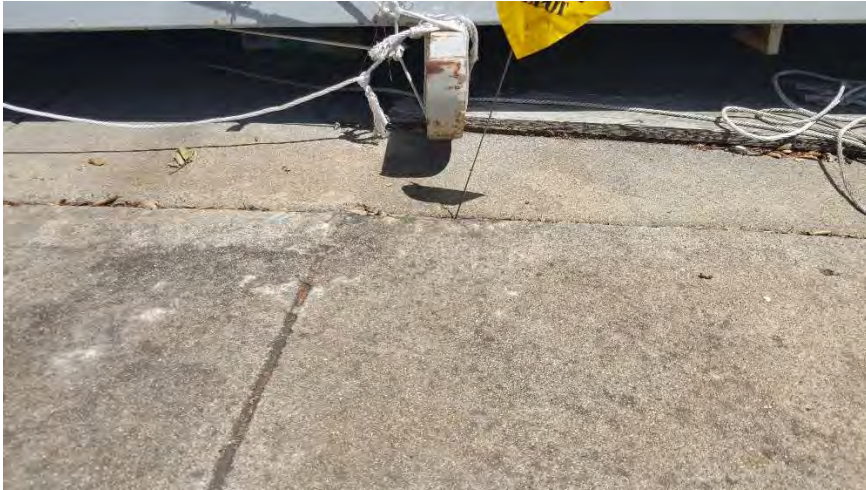
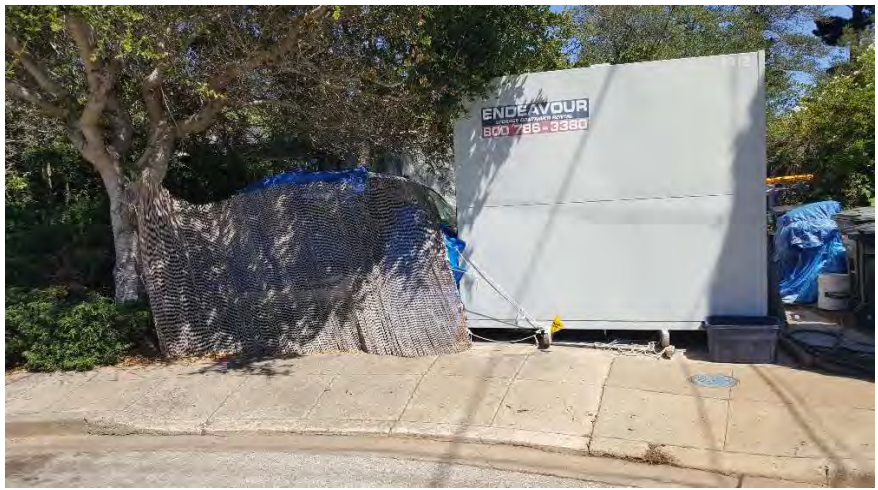
Project: San Mateo Smoke Testing 2019
Date: 8/14/2019
Defect: 147

Defect #	Address/Location	Results	Status	Source Type	Smoke	Area		Run Off	Photo #
						FT	FT		
147	25 Amboy Ct	1	1	17	2	8'	12'	5

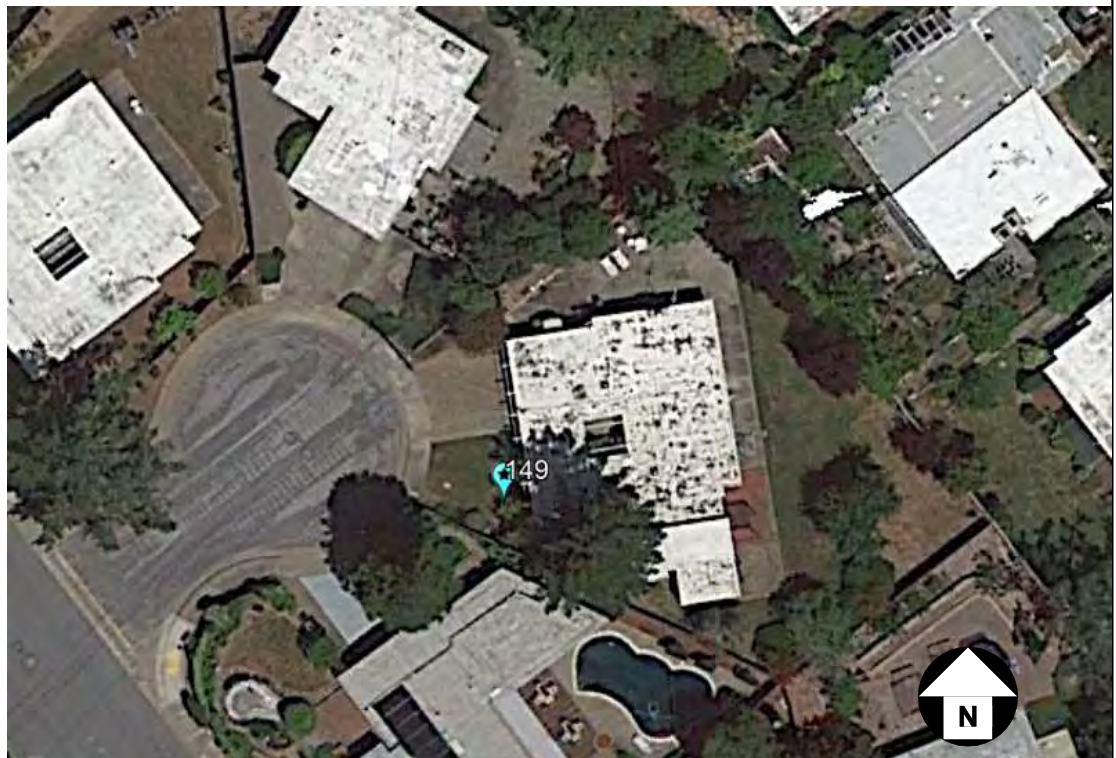
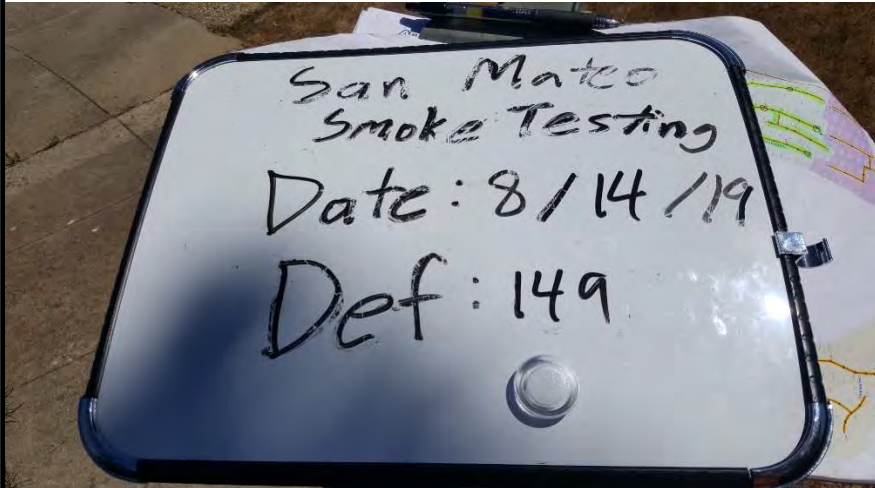
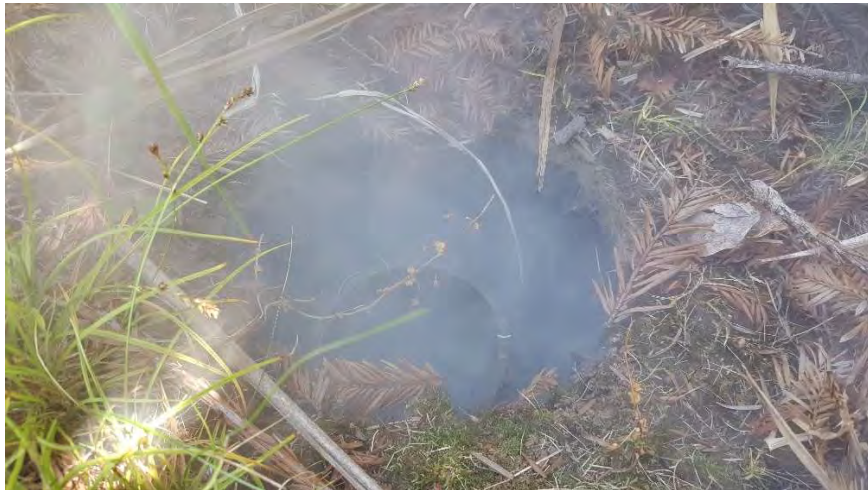
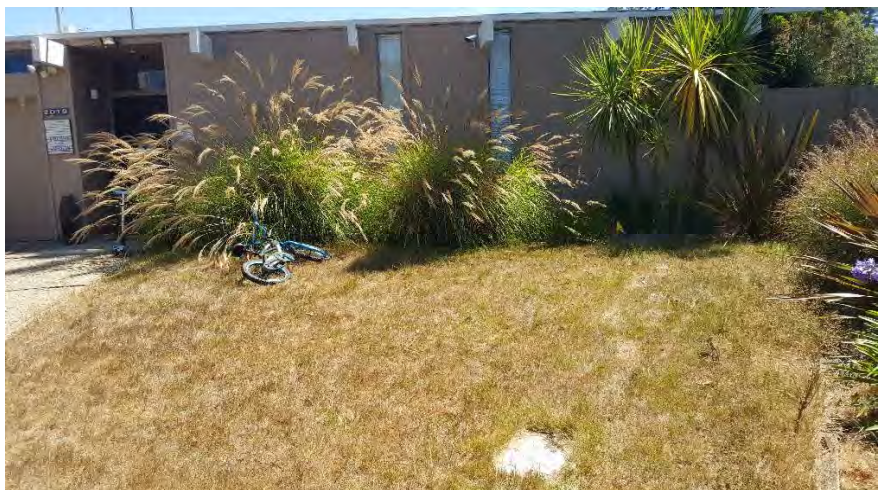
Project: San Mateo Smoke Testing 2019
Date: 8/14/2019
Defect: 149

Defect #	Address/Location	Results	Status	Source Type	Smoke	Area		Run Off	Photo #
						FT	FT		
149	2019 Ticonderoga Dr	1	1	16	2	2'	2'	1

Comments: No cap. Low point

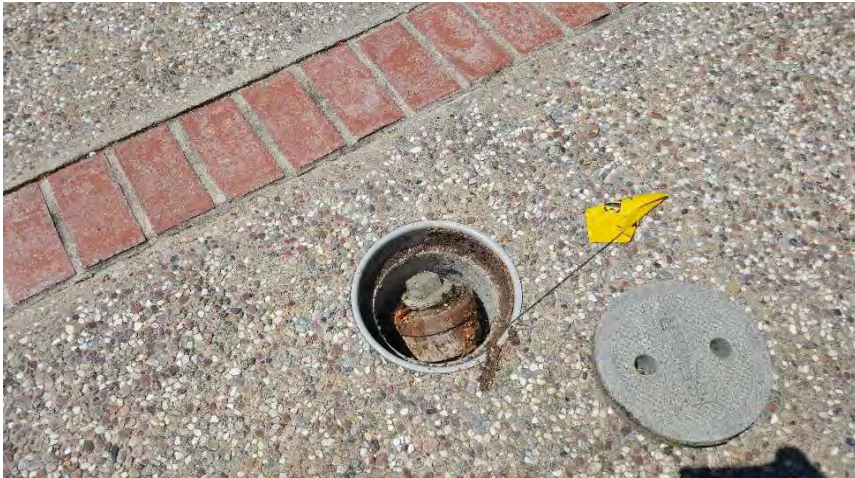
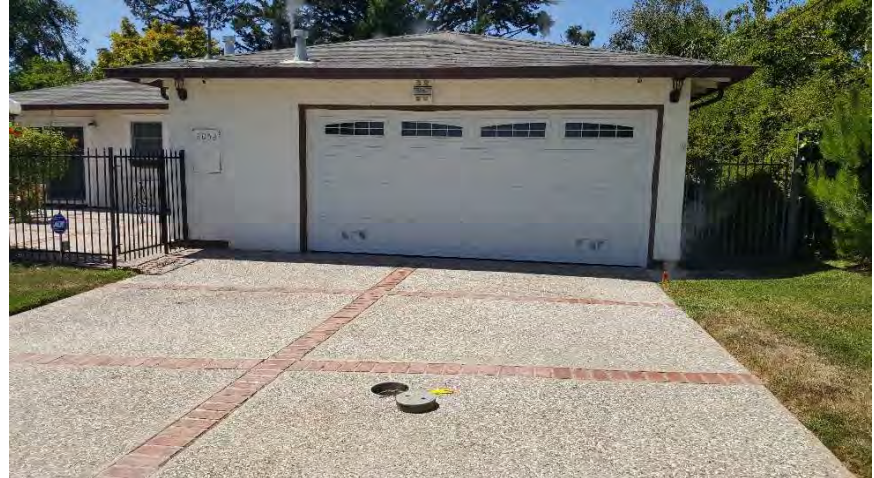
Project: San Mateo Smoke Testing 2019
Date: 8/14/2019
Defect: 150

Comments: 150: Rusty/ deteriorated cap

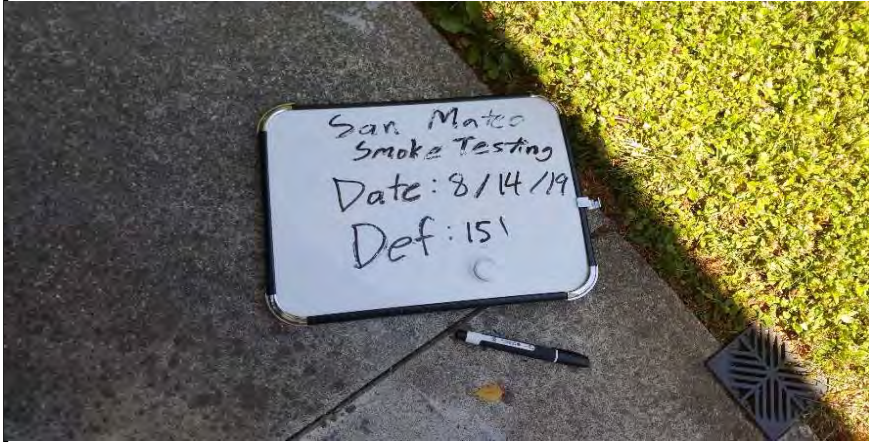
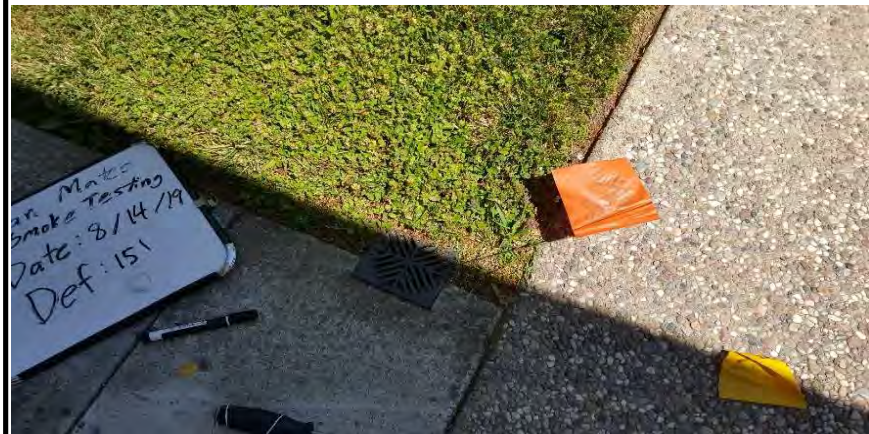
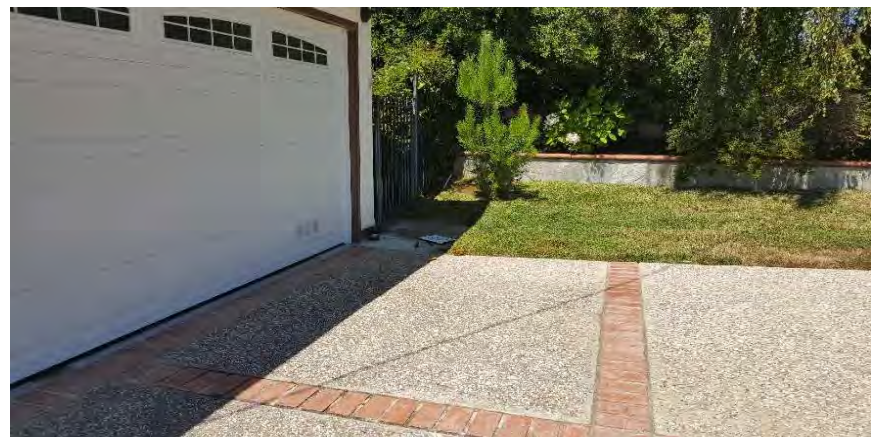
Project: San Mateo Smoke Testing 2019
Date: 8/14/2019
Defect: 151

Defect #	Address/Location	Results	Status	Source Type	Smoke	Area		Run Off	Photo #
						FT	FT		
150	2052 Ticonderoga Dr	1	1	16	1	4"	4"	5	
	Lat: 37.516394°								
	Long: -122.341476°								
151	2052 Ticonderoga Dr	1	1	6	3	8'	20'	3	
	Lat: 37.516382°								
	Long: -122.341547°

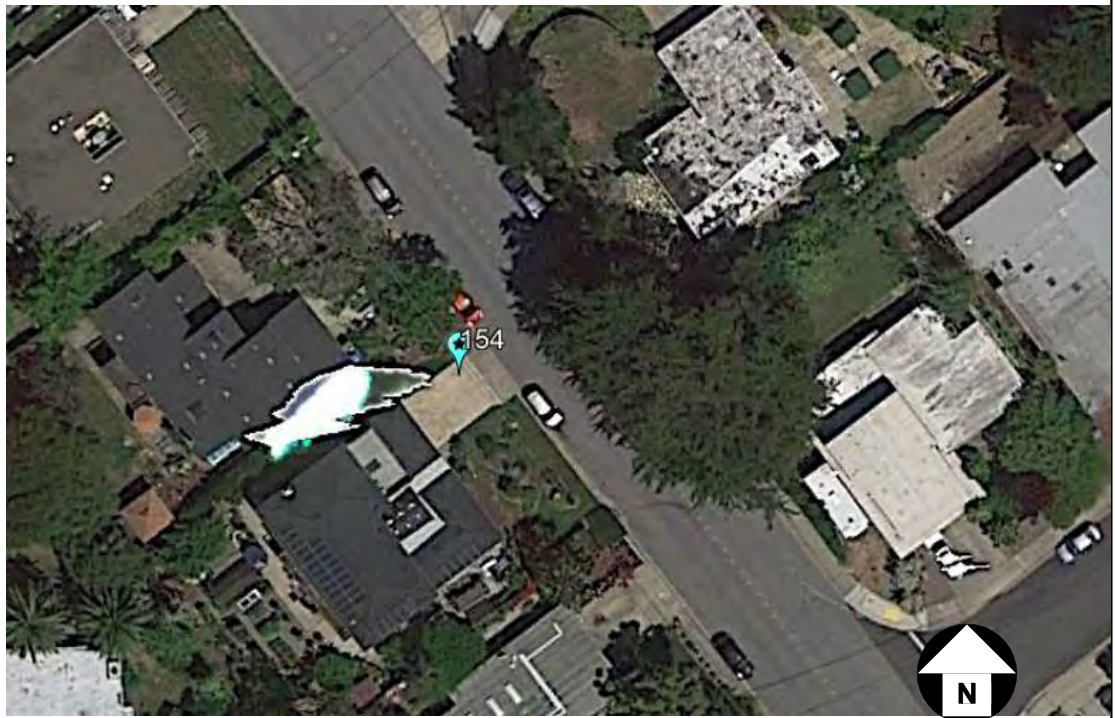
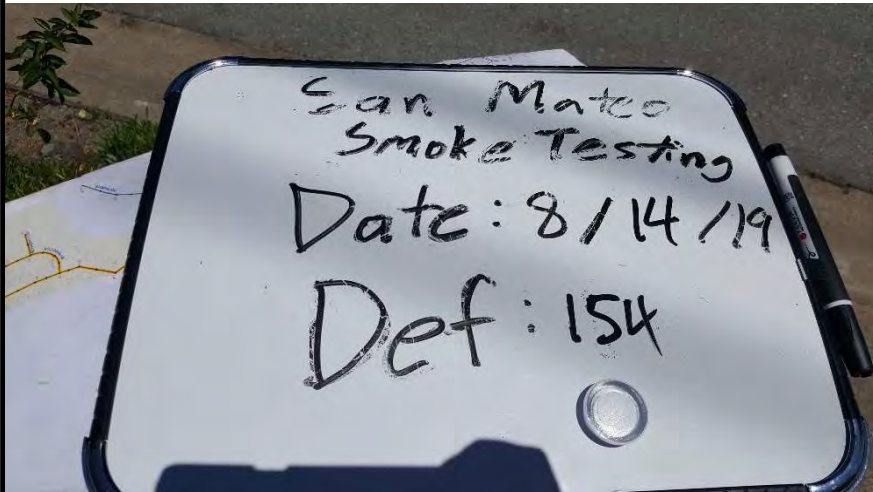
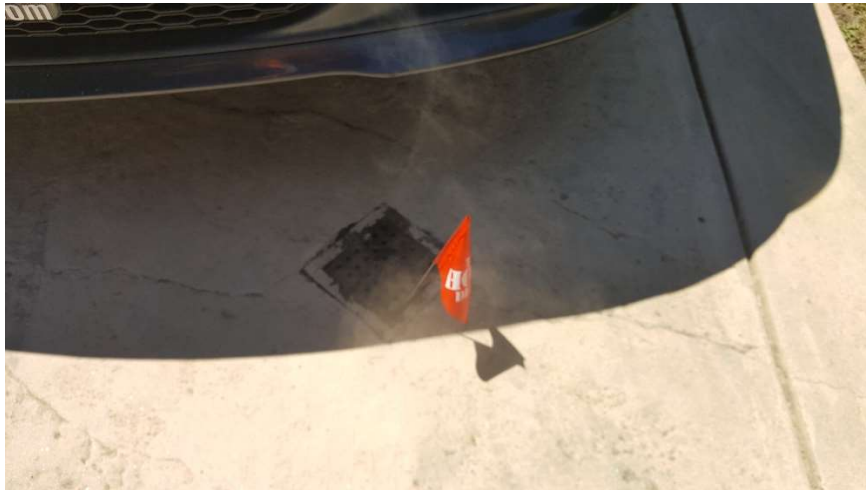
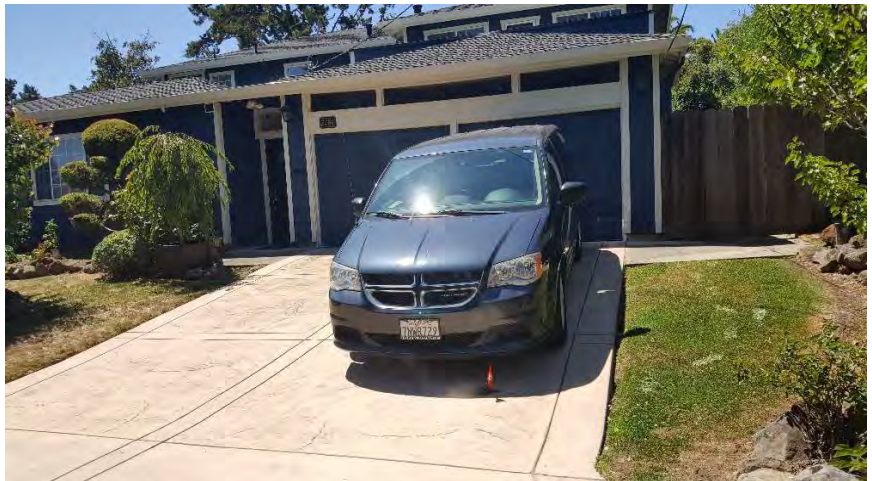
Project: San Mateo Smoke Testing 2019
Date: 8/14/2019
Defect: 154

Defect #	Address/Location	Results	Status	Source Type	Smoke	Area		Run Off	Photo #
						FT	FT		
154	2084 Ticonderoga Dr	1	1	16	2	2'	6'	5

Comments: Cap off.

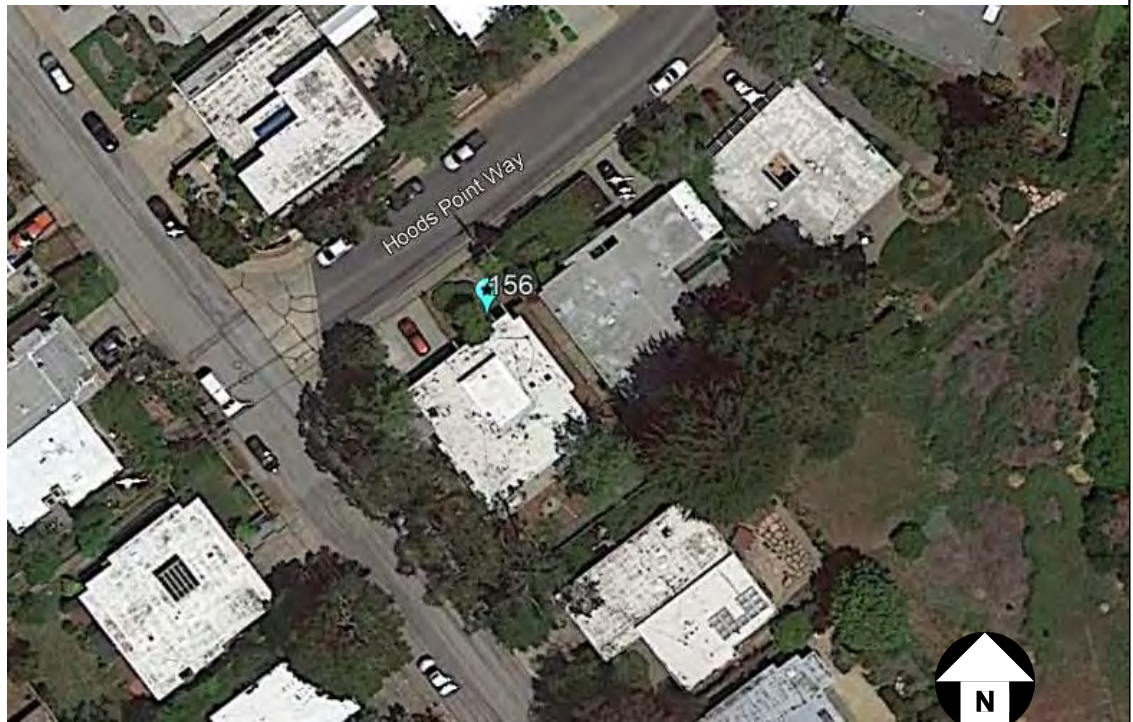
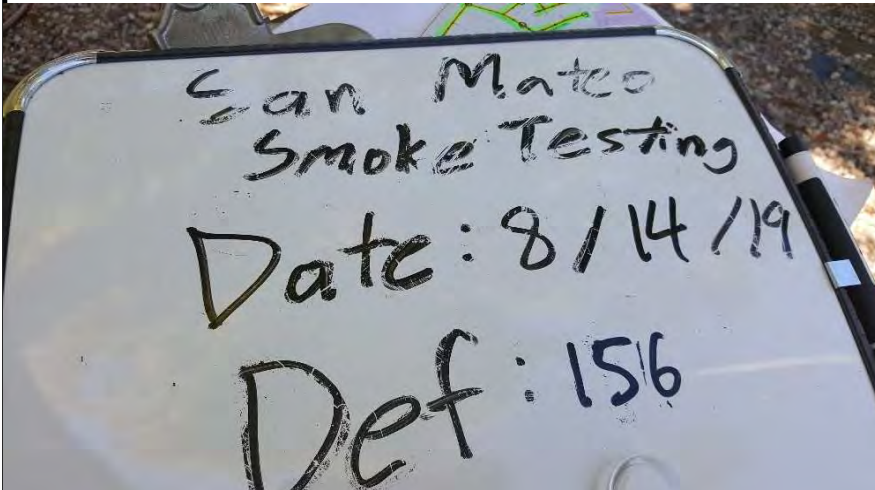
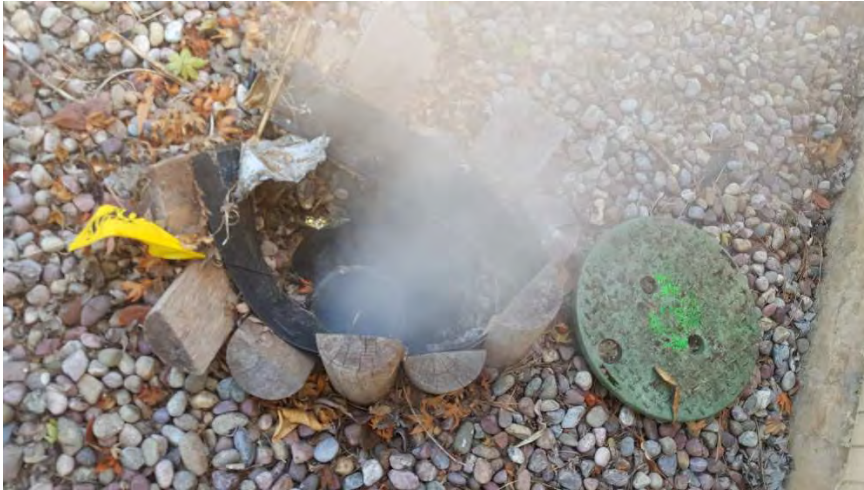
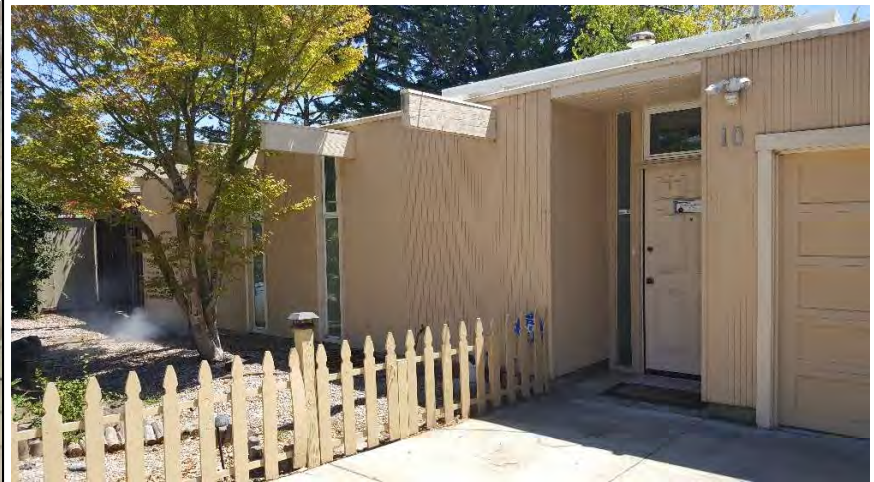
Project: San Mateo Smoke Testing 2019
Date: 8/14/2019
Defect: 156

Defect #	Address/Location	Results	Status	Source Type	Smoke	Area		Run Off	Photo #
						FT	FT		
156	10 Hoods Point Way	1	1	16	3	3'	3'	1

Comments: Low point. No cap

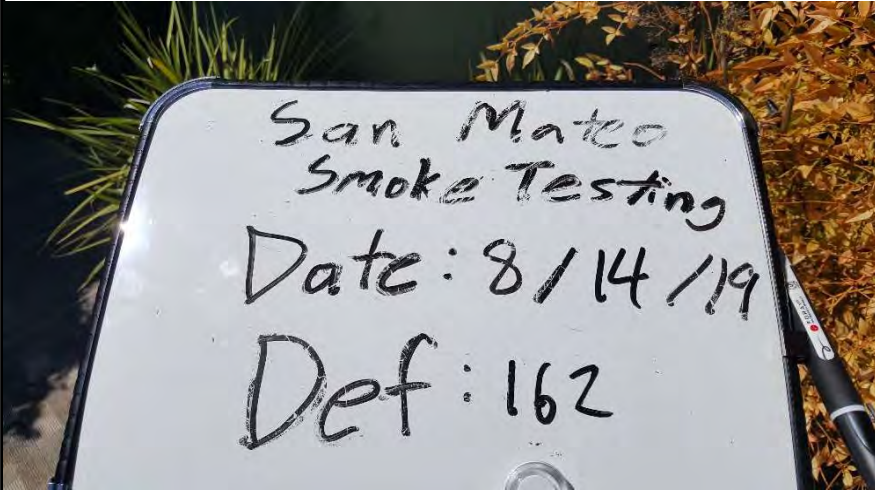
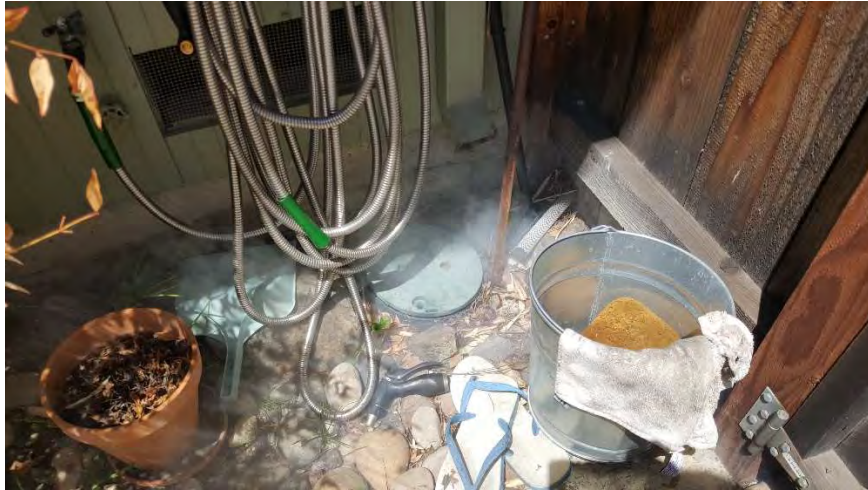
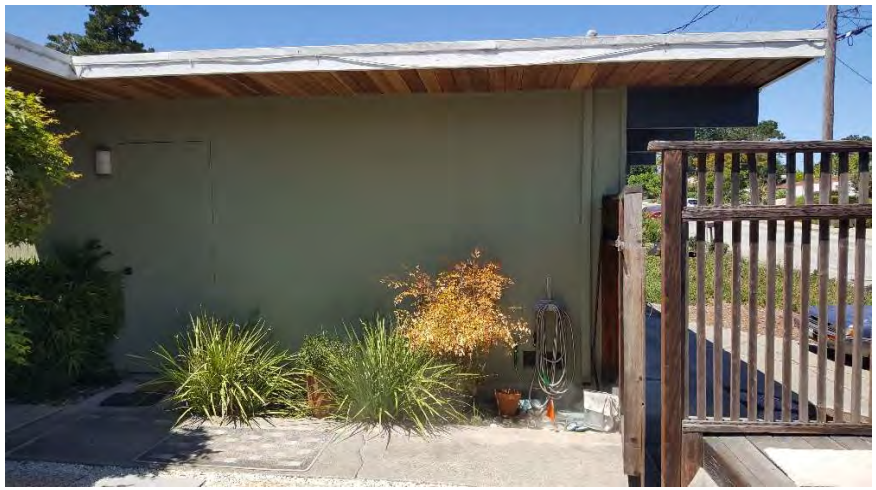
Project: San Mateo Smoke Testing 2019
Date: 8/14/2019
Defect: 162

Comments: No cap. Downspout drains here

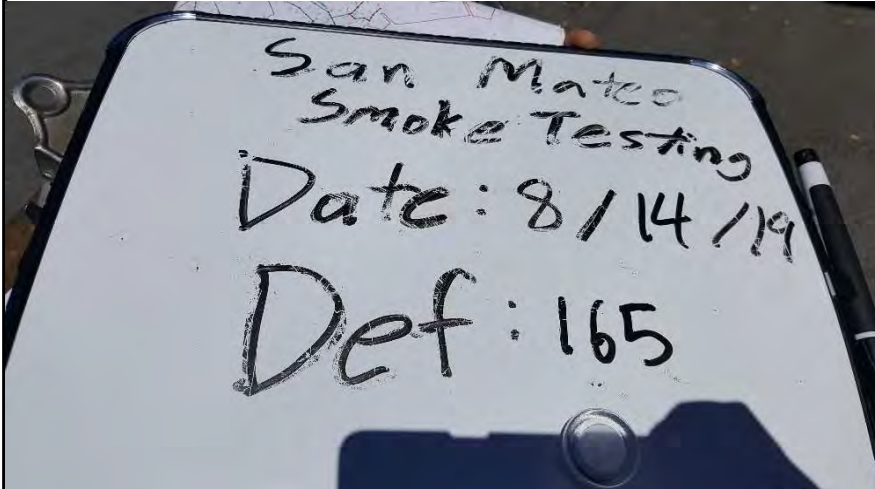
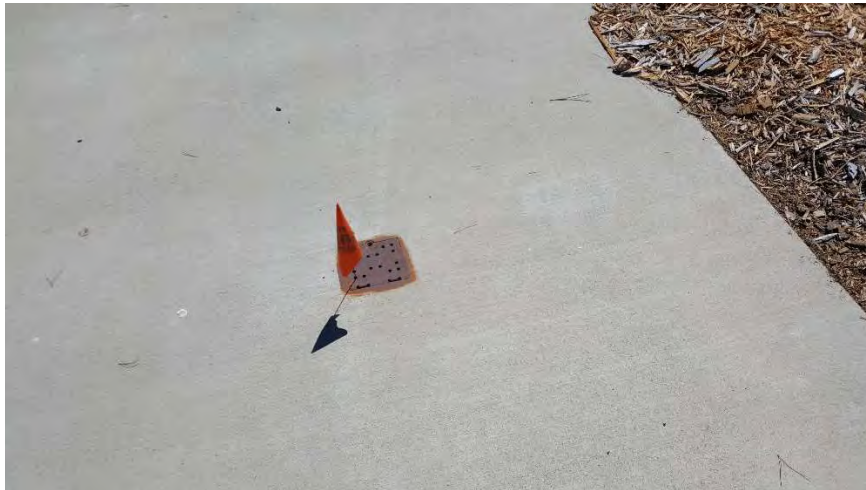
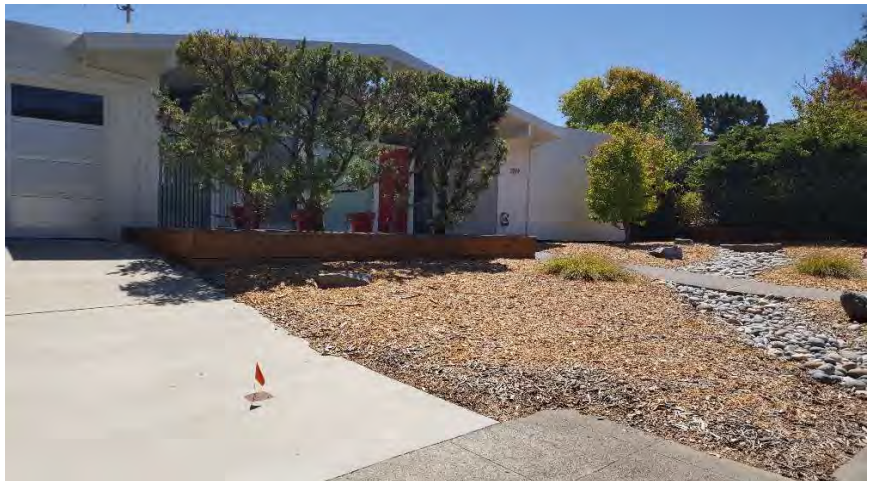
Project: San Mateo Smoke Testing 2019
Date: 8/14/2019
Defect: 165

Comments: Cap loose. Water flows over top.

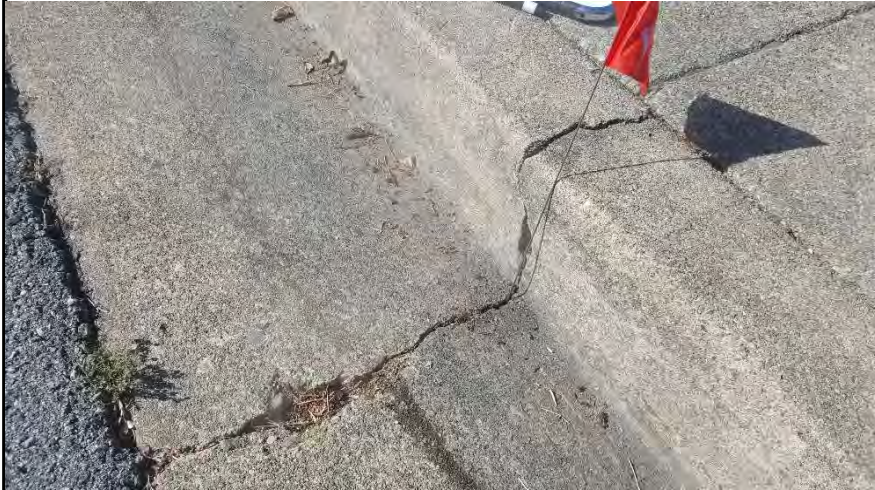
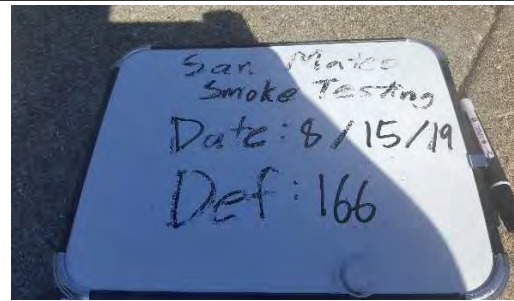
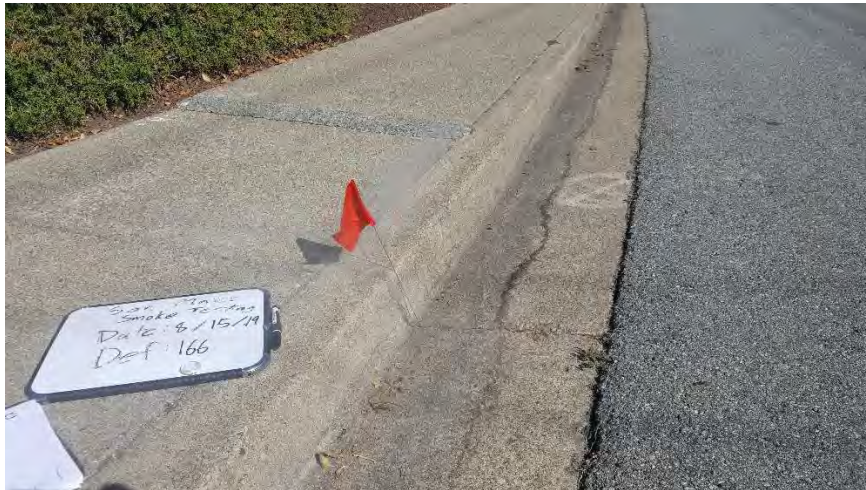
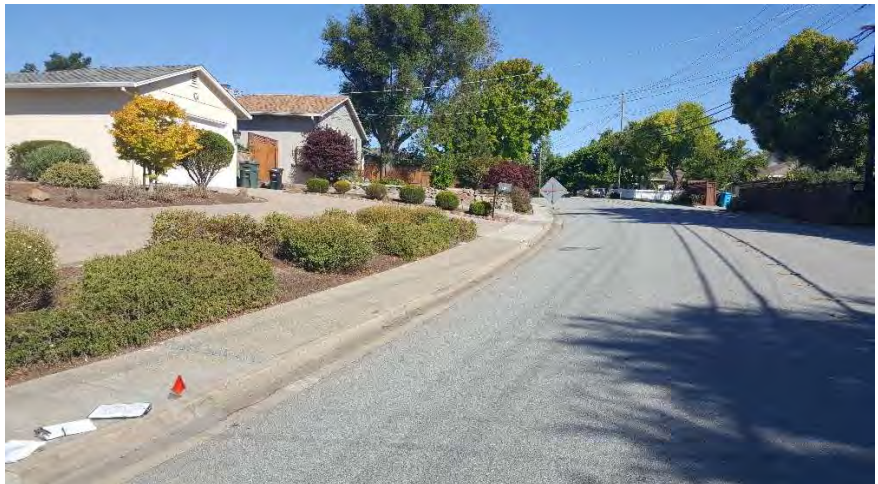
Project: San Mateo Smoke Testing 2019
Date: 8/15/2019
Defect: 166

Comments: Crack in road/ sidewalk. Could be lateral or main sewer line. On hill and flow will drain over crack. Might have root infiltration .

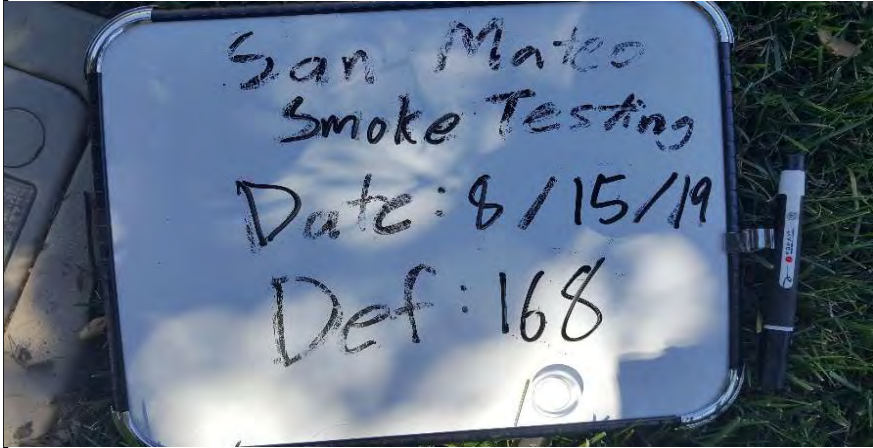
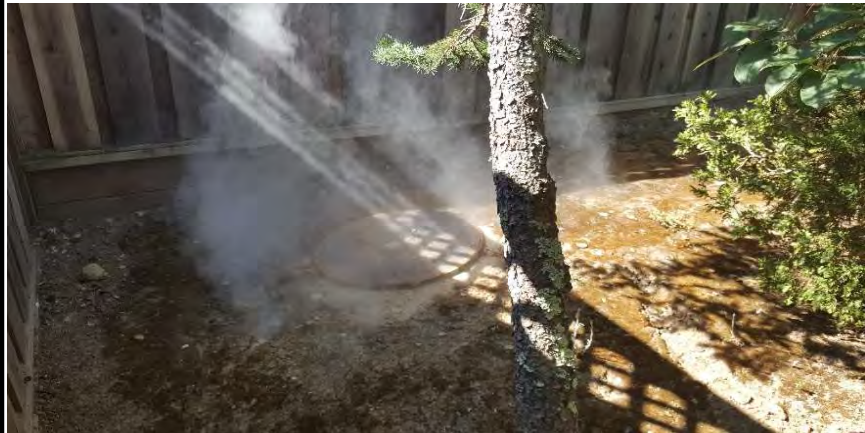
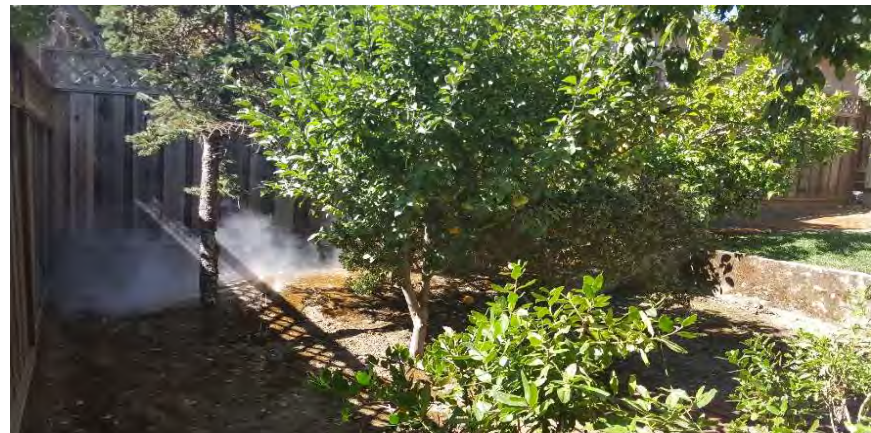
Project: San Mateo Smoke Testing 2019
Date: 8/15/2019
Defect: 168

168: Smoke coming from cracks in dirt around manhole
