Geotechnical Investigation and Geologic Hazards Review

Four Single-Family Homes

Ticonderoga Drive

San Mateo, California

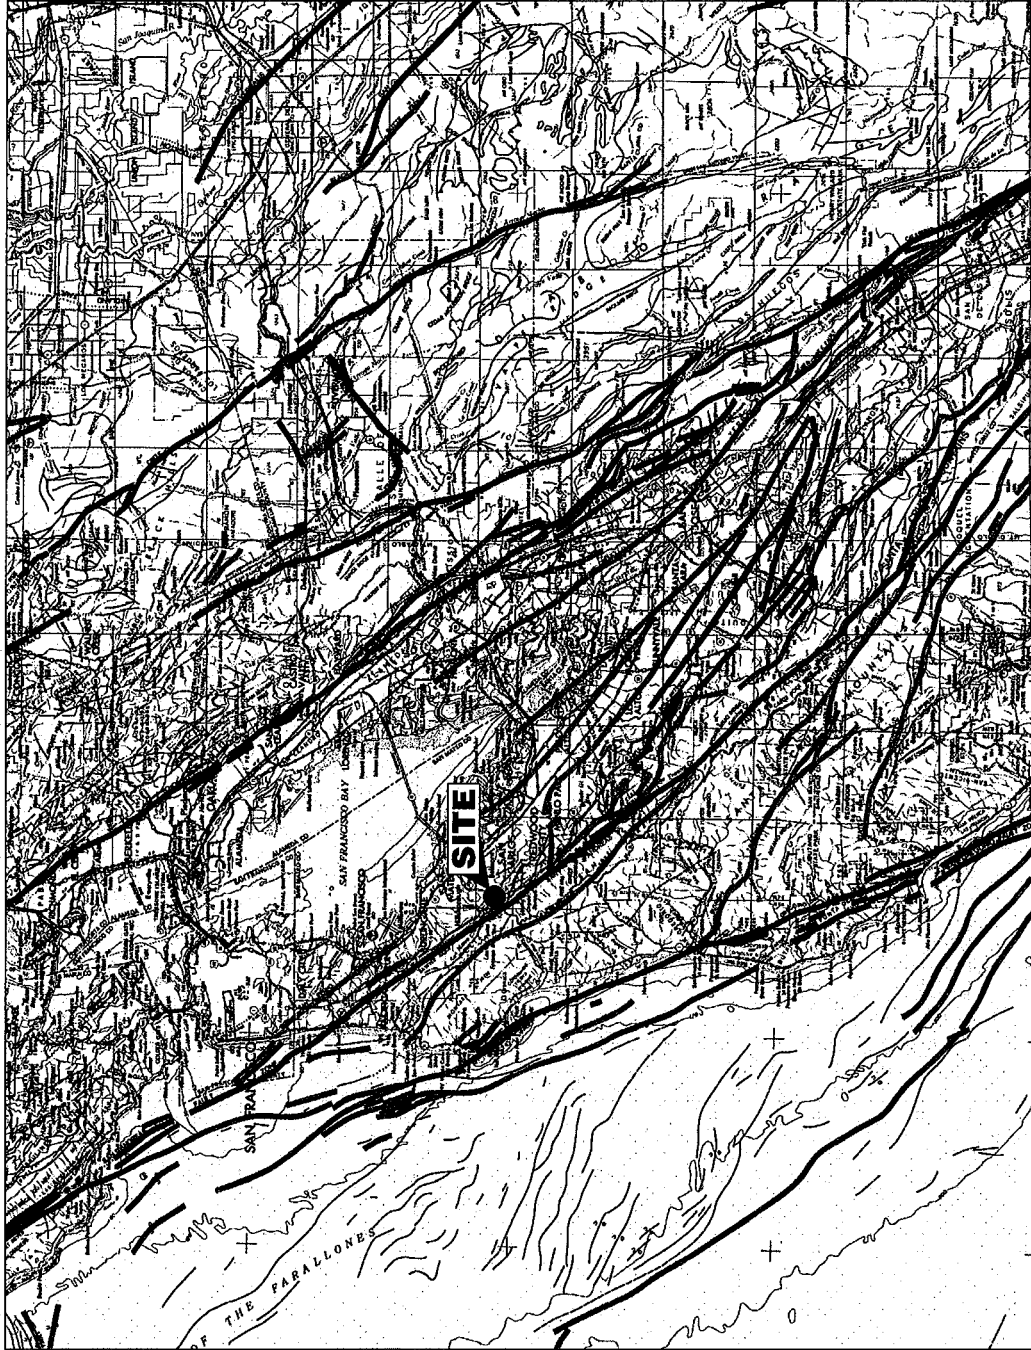
FIGURE 5
 1291-2B

Note: Some faults highlighted in purple are not considered active (Holocene Movement) by the State of California.

A regional fault map showing active faults relative to the site is presented in Figure 5. The site is not located within a currently designated Alquist-Priolo Earthquake Fault Zone, known formerly as a Special Studies Zone (CDMG, 2001), and no known surface expression of active faults is believed to exist within the site. The closest active fault to the site is the San Andreas, which passes beneath Crystal Springs Reservoir to the southwest. The site is about 0.9 miles from the San Andreas Fault. Primary fault rupture through the site, therefore, is not anticipated.
